Subject: OCD Closure Reports – 1st Reporting Quarter, 1999

**PIT REMEDIATION AND CLOSURE REPORT**

## **Groundwater Site Summary Report**

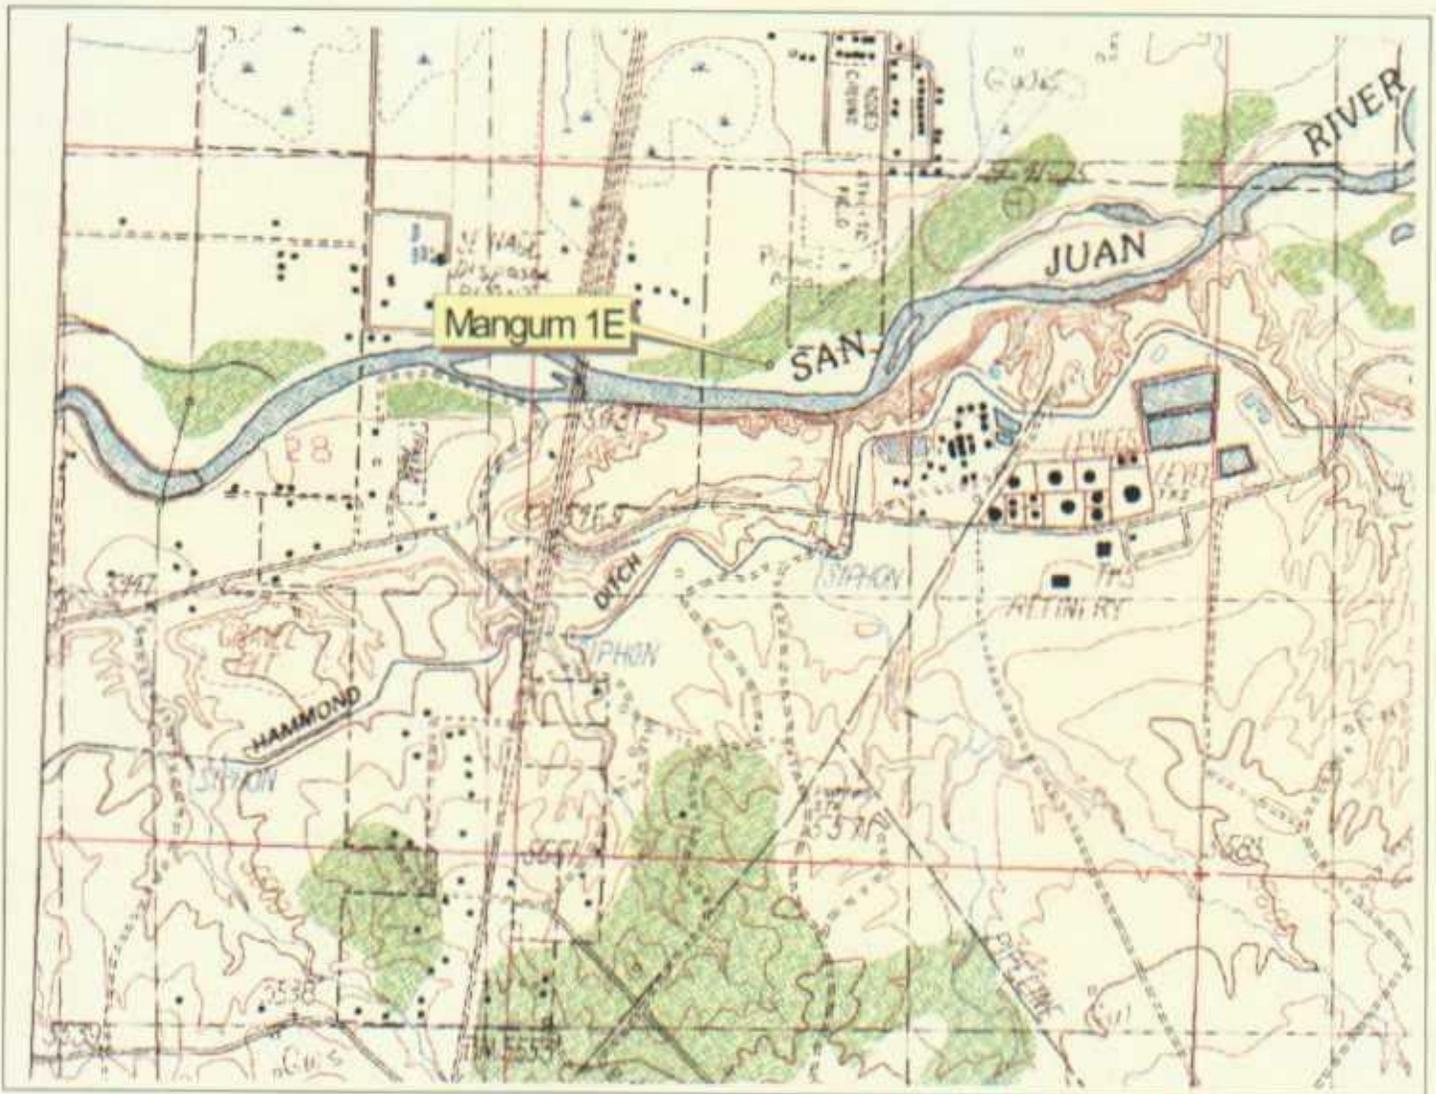
**Figure 1.**  
**Mangum 1E Groundwater Site**  
**Twn. 29N Rng. 11W Sec. 27 Unit F**

The Mangum 1E site lies about 100 feet from the San Juan River, on the north bank just east of the bridge near Bloomfield, New Mexico. The elevation of the site is about 5420 ft. amsl, with the river being 5 to 10 feet lower in elevation. Depth to water is only a few feet at the site, as evidenced by the four monitor wells installed there (see Figure 1).

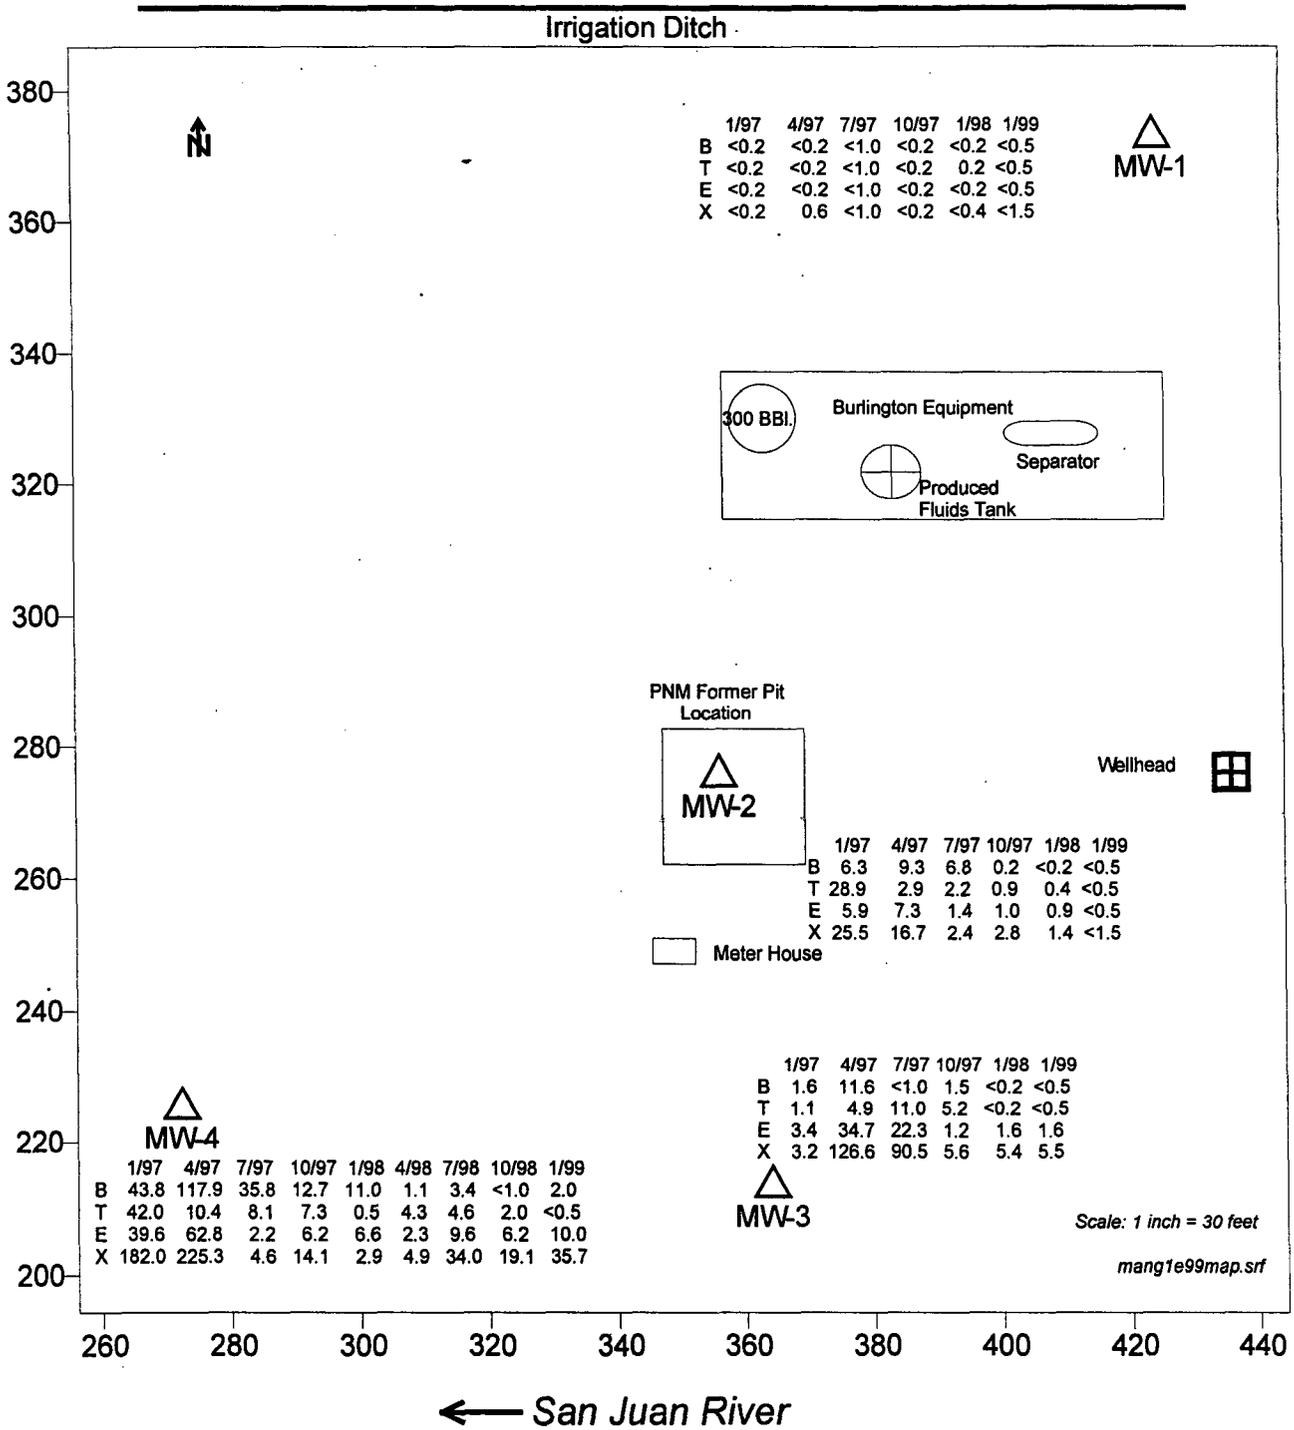
## Figure 2. Mangum 1E Site Map with Analytical Results (concentrations in ppb)

Figure 2 is a site map showing benzene, toluene, ethylbenzene and xylenes (BTEX) analytical data for each monitoring well at the site. BTEX concentrations in MW-1 (the upgradient well) and MW-2 (the source well) have been below standard since they were installed after the initial source removal activities in January, 1997. BTEX in downgradient well MW-3 decreased over time, and has remained below WQCC standards for four quarterly sampling events. Contamination in downgradient monitor well MW-4 decreased over time, and has now remained below standards for the last four consecutive quarterly sampling events.

Consistent with PNM's San Juan Basin Groundwater Management Plan, PNM requests closure of the Mangum 1E with the submittal of the 1<sup>st</sup> Quarter 1999 Pit Closures Report. This request is based upon the analytical data collected over the last two years at the site. The excavation of source materials appears to have been successful in achieving clean-up at the Mangum 1E over the monitoring period since the BTEX concentrations in downgradient well MW-4 have been below standards for four consecutive quarters. Wells, MW-2 and -3, have shown downward trends in concentration over the last two years. Resampling of all monitor wells also shows that BTEX compounds are below standards in the other wells.

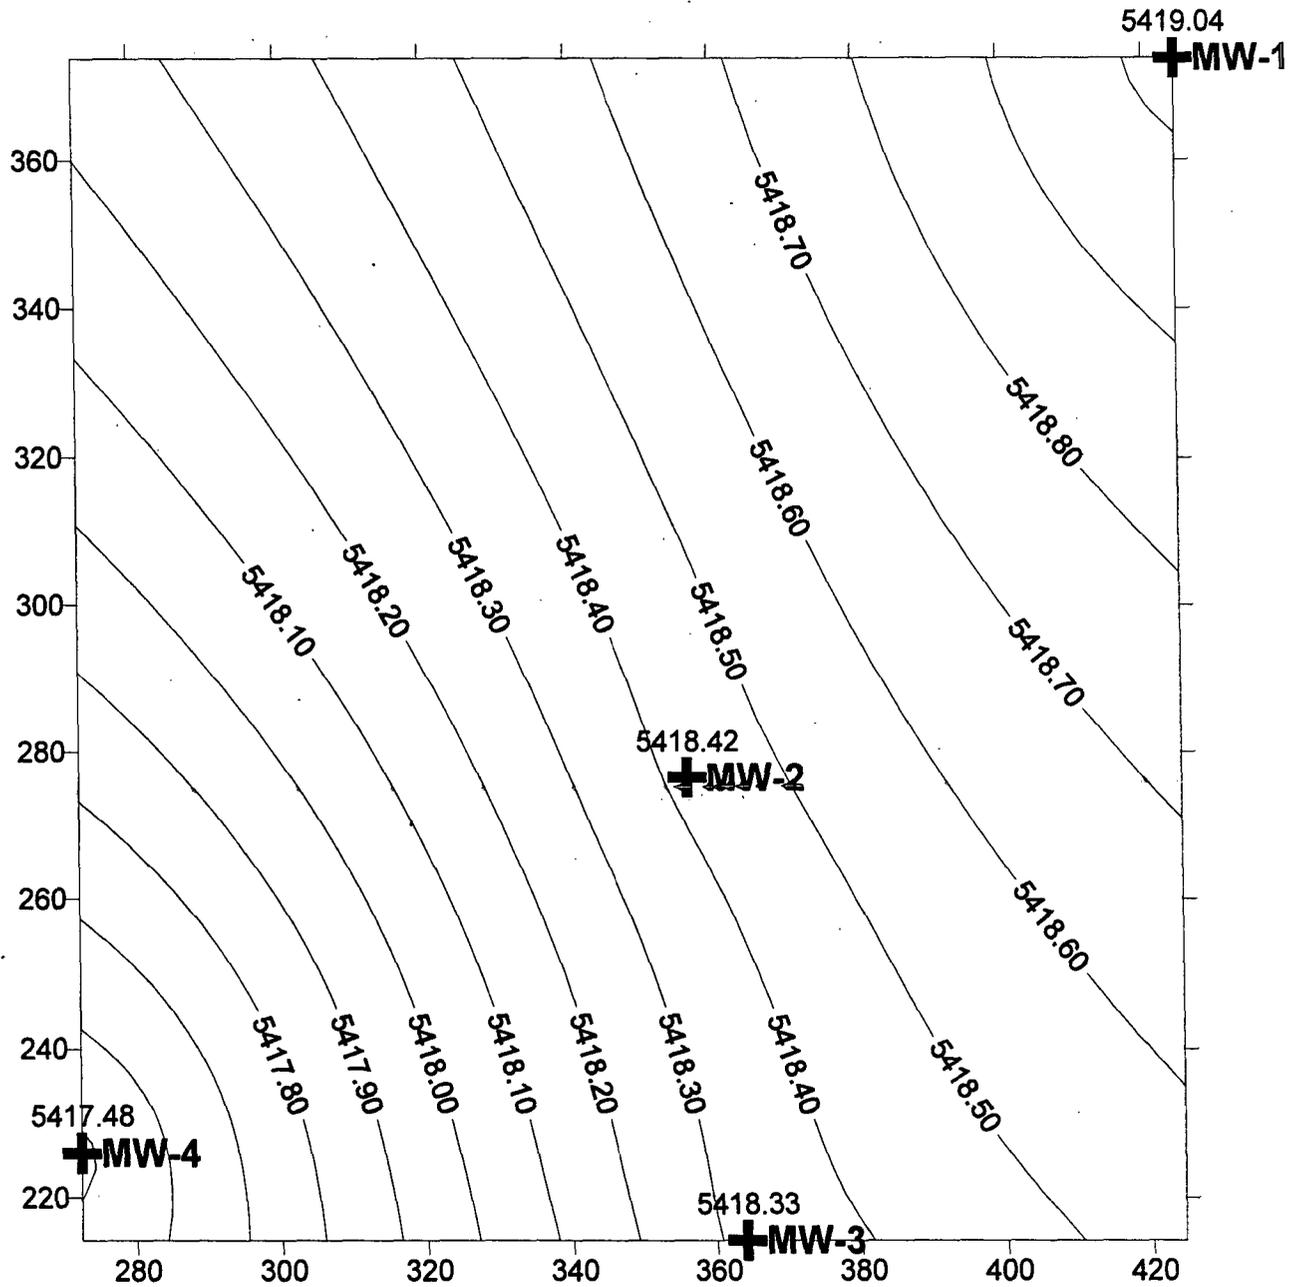
**Figure 3a. Mangum 1E Groundwater Contour Map  
(April 28, 1998)**

Groundwater contour maps were prepared from data collected during the quarterly sampling events. Figures 3a through 3c show the elevation of the water table during April, July, and October, 1998, respectively, and Figure 3d for January, 1999. Flow direction is consistently southwestward, with gradient values of about 0.01 (1 ft. per 100 ft.) regardless of the season.

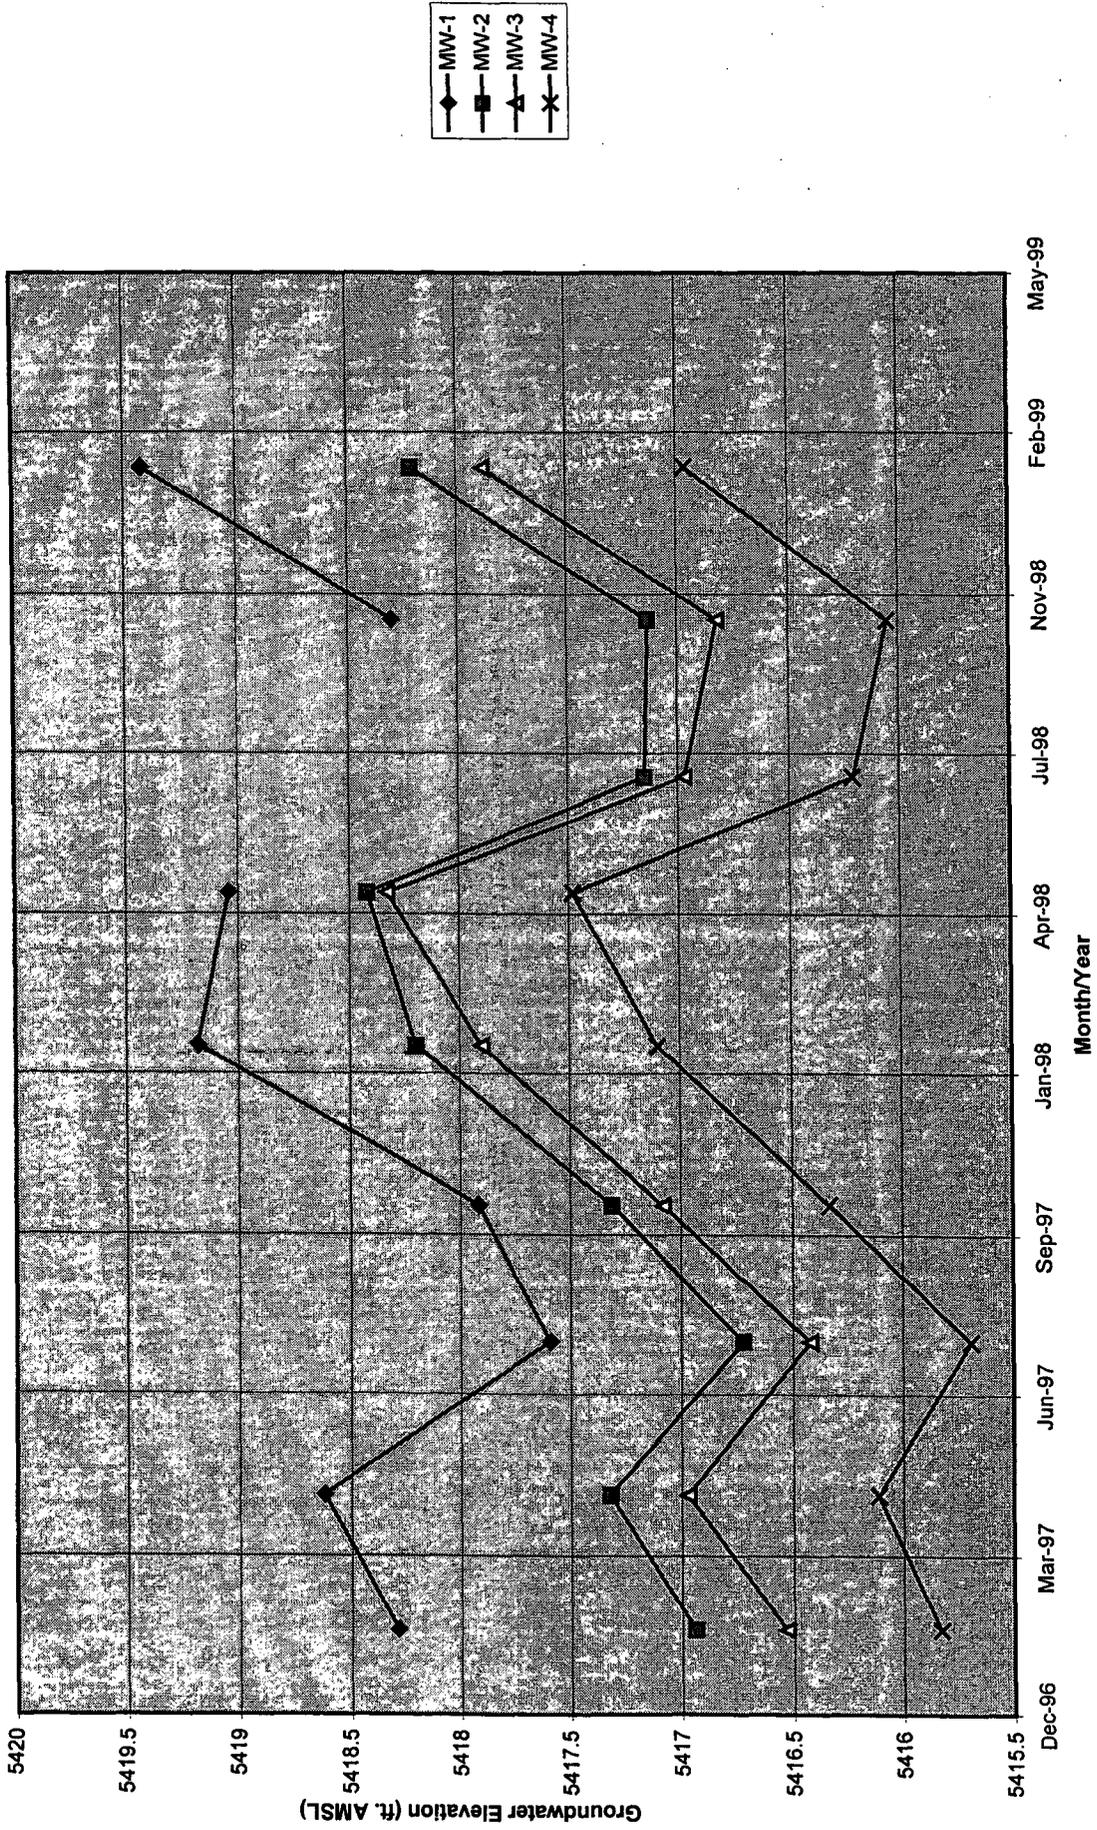
Figure 4. Mangum 1E Hydrograph  
(Water Level vs. Time)

The hydrograph of the site (Figure 4) suggests that groundwater elevations are strongly influenced by the operation of the irrigation ditch in spring and summer months; hydrographs at the site show lowest elevations in the wintertime. Flow direction does not vary appreciably from season to season, as indicated by the "tracking" of water level changes by each well.
