**GALLEGOS GALLUP SAND UNIT  
PIT CLOSURE REPORT**

**SAN JUAN COUNTY  
NEW MEXICO**

**PROJECT # 01079-003**

**DECEMBER 2003**

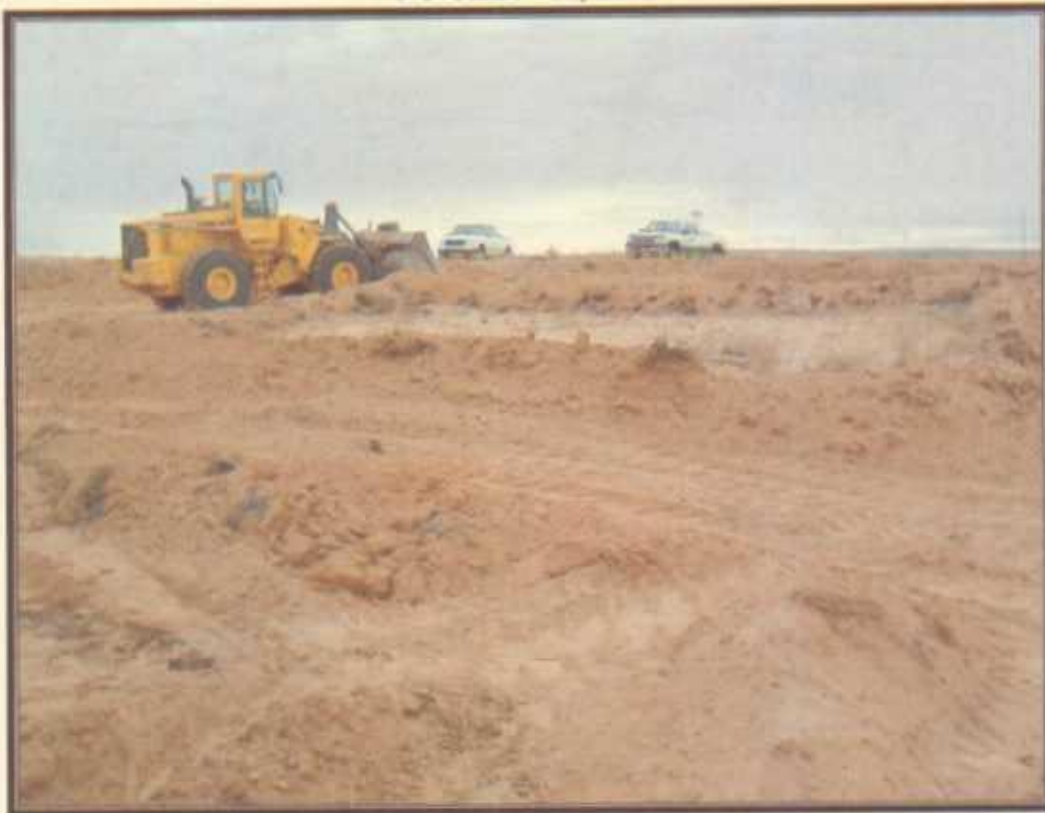
**Photo 1: View to the south showing removal of the overburden**

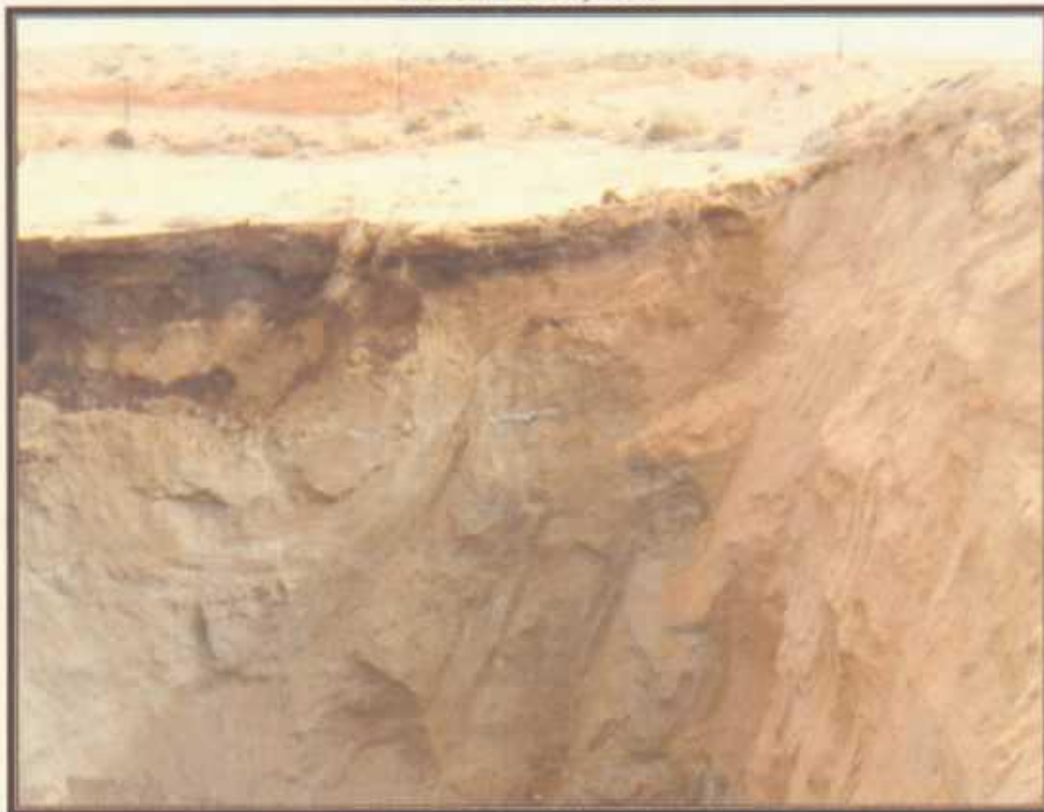
**Photo 2: View to the east showing hydrocarbon-impacted soil.**

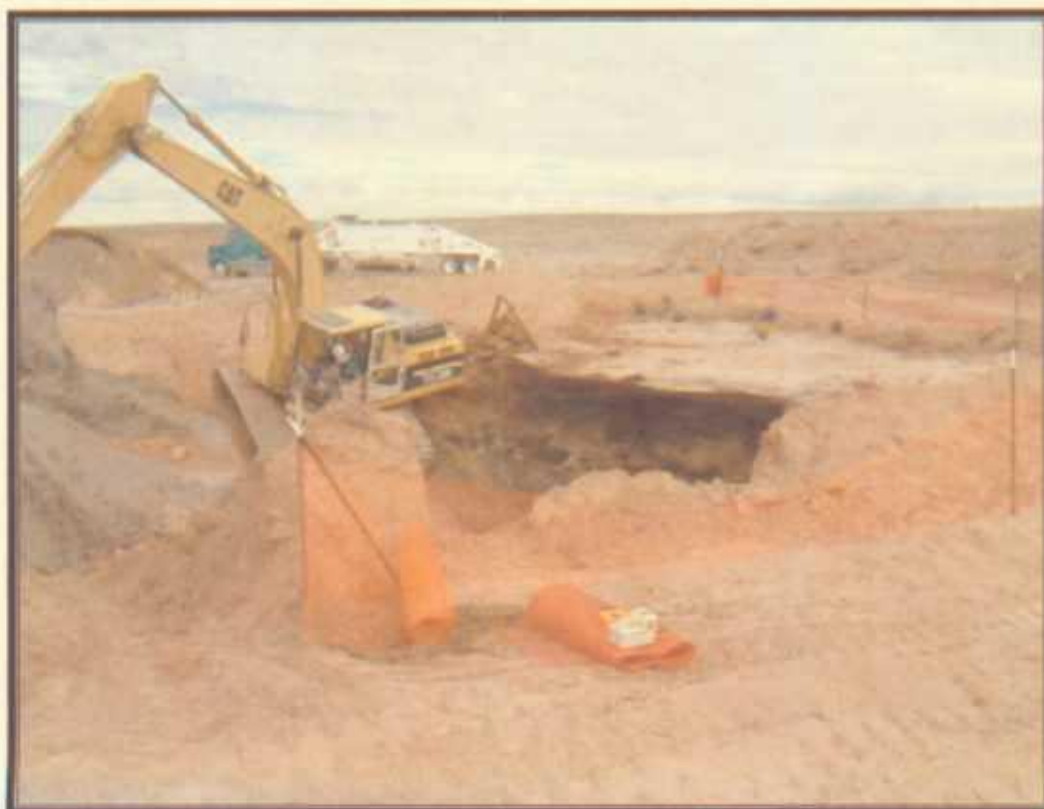
**Photo 3: View to the north showing removal of hydrocarbon-impacted soil.**

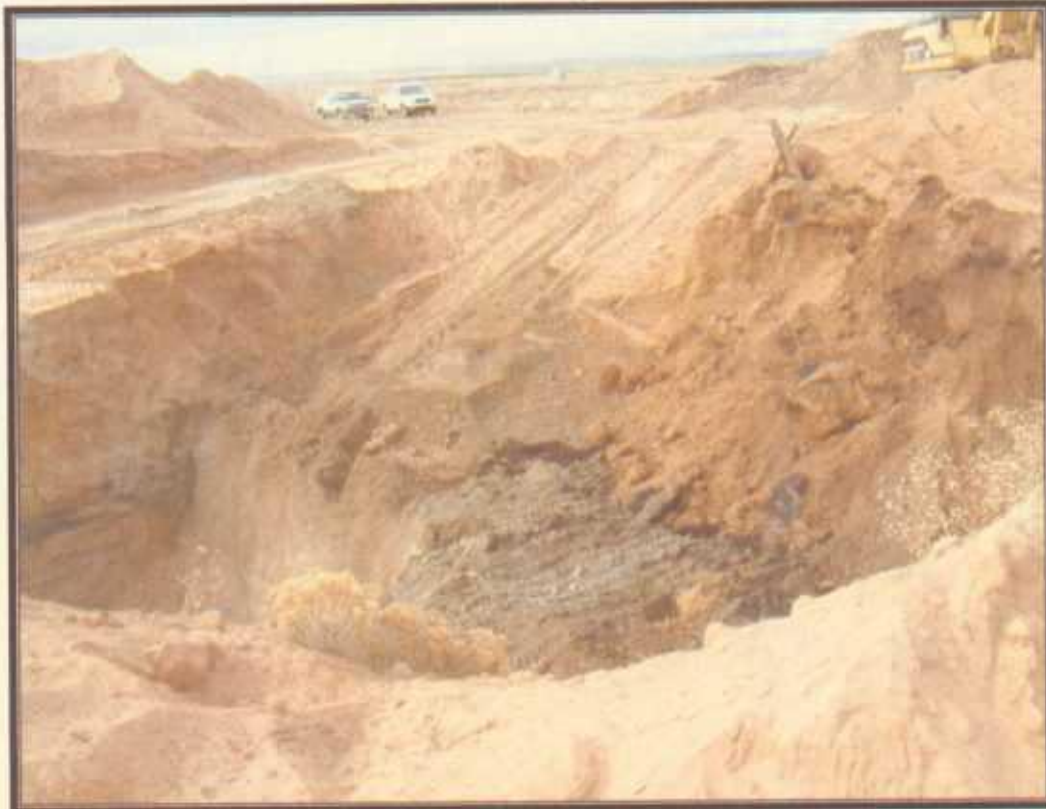
**Photo 4: View to the northwest of the excavation area.**

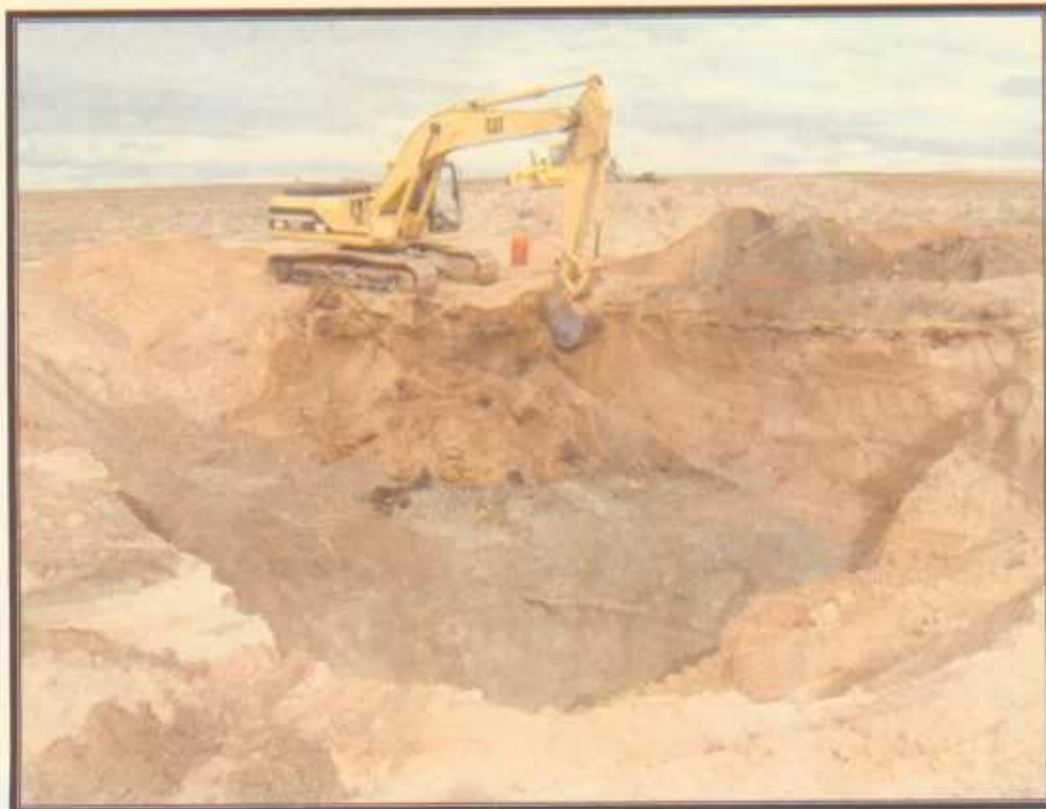
**Photo 5: View to the northeast showing removal of the overburden.**

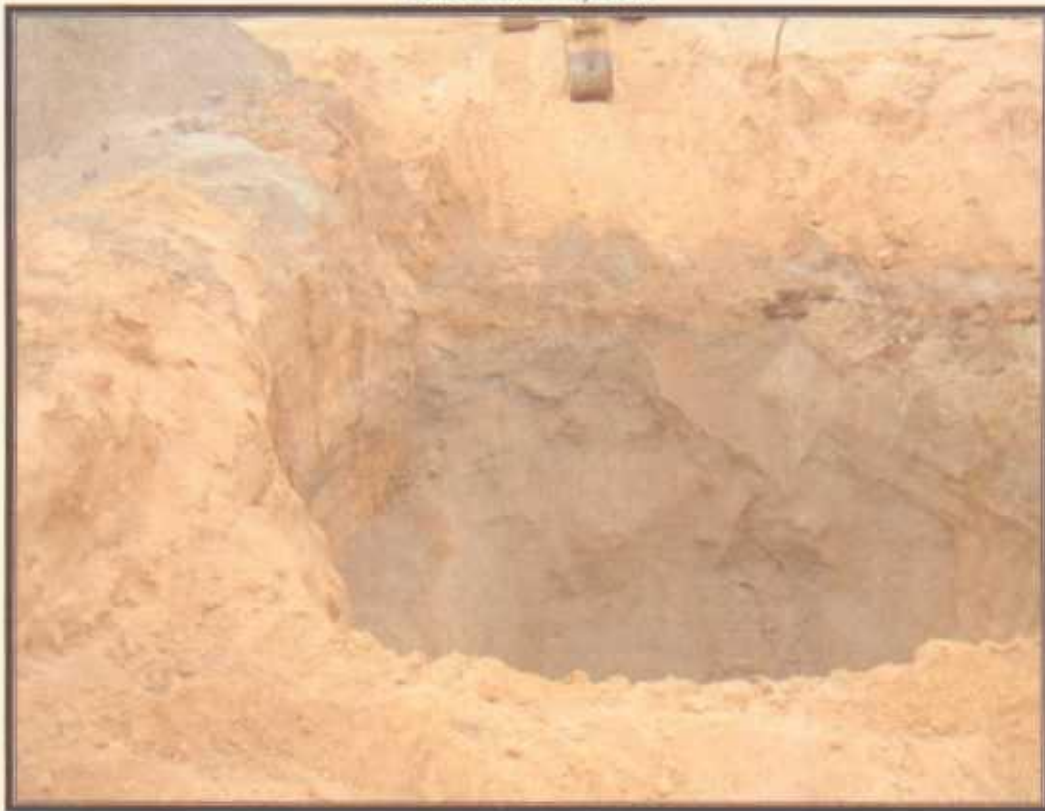
**Photo 6: View to the north showing the excavation area.**

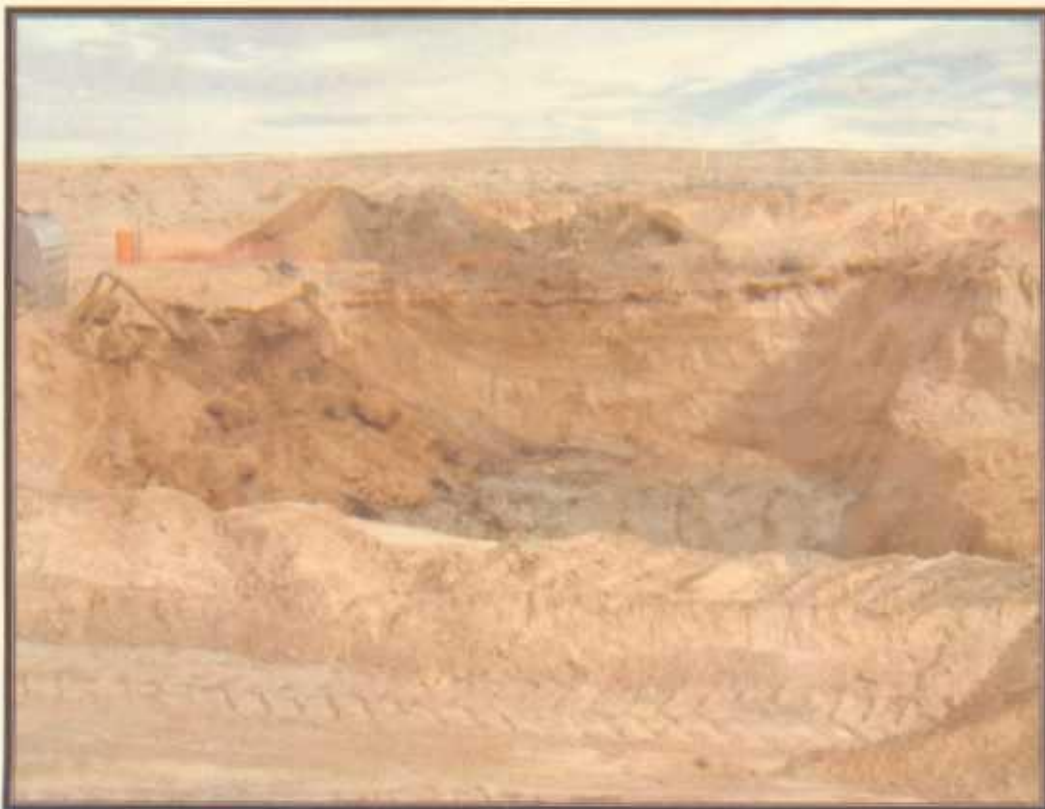
**Photo 7: View to the east showing excavation area.**

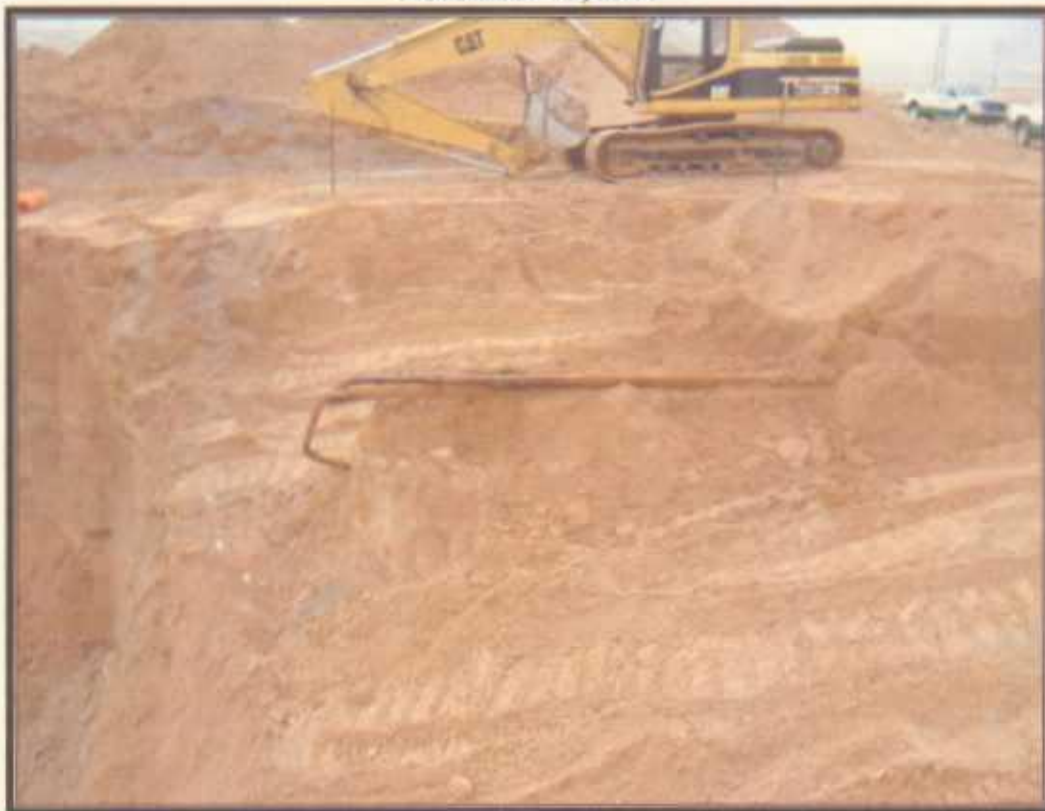
Photo 8: View to the west of the excavation area.

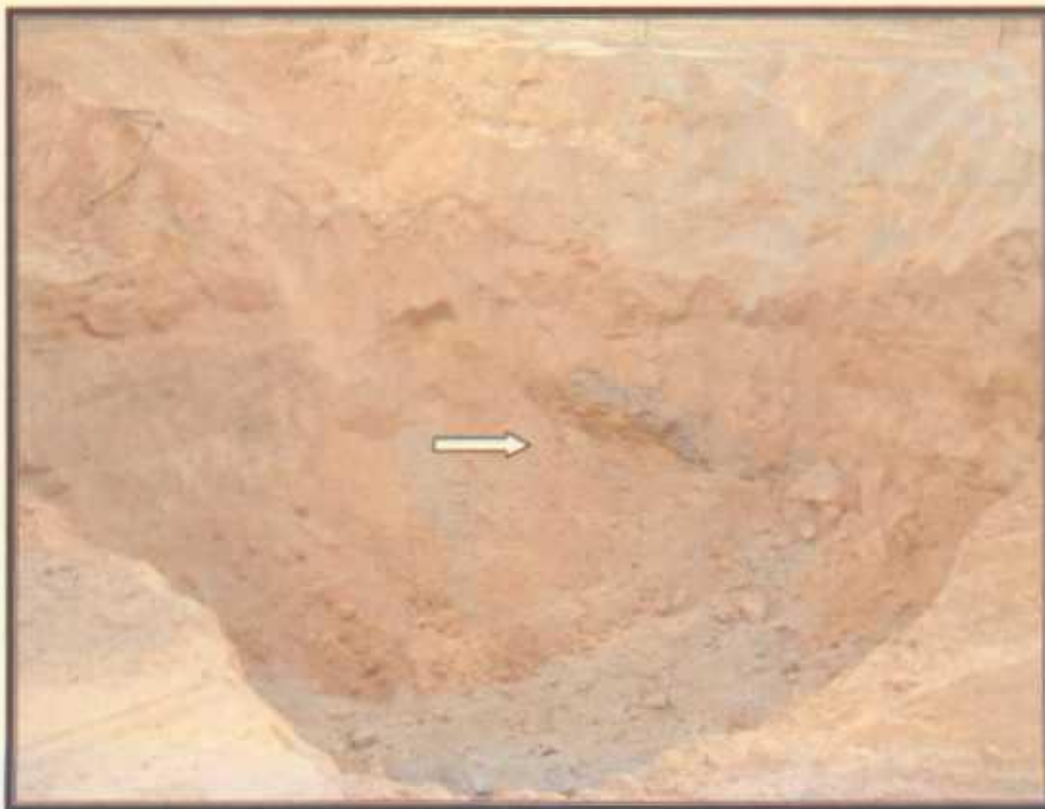
Photo 9: View to the northeast. Shows thin layer of hydrocarbon-impacted soil on east side of pit.

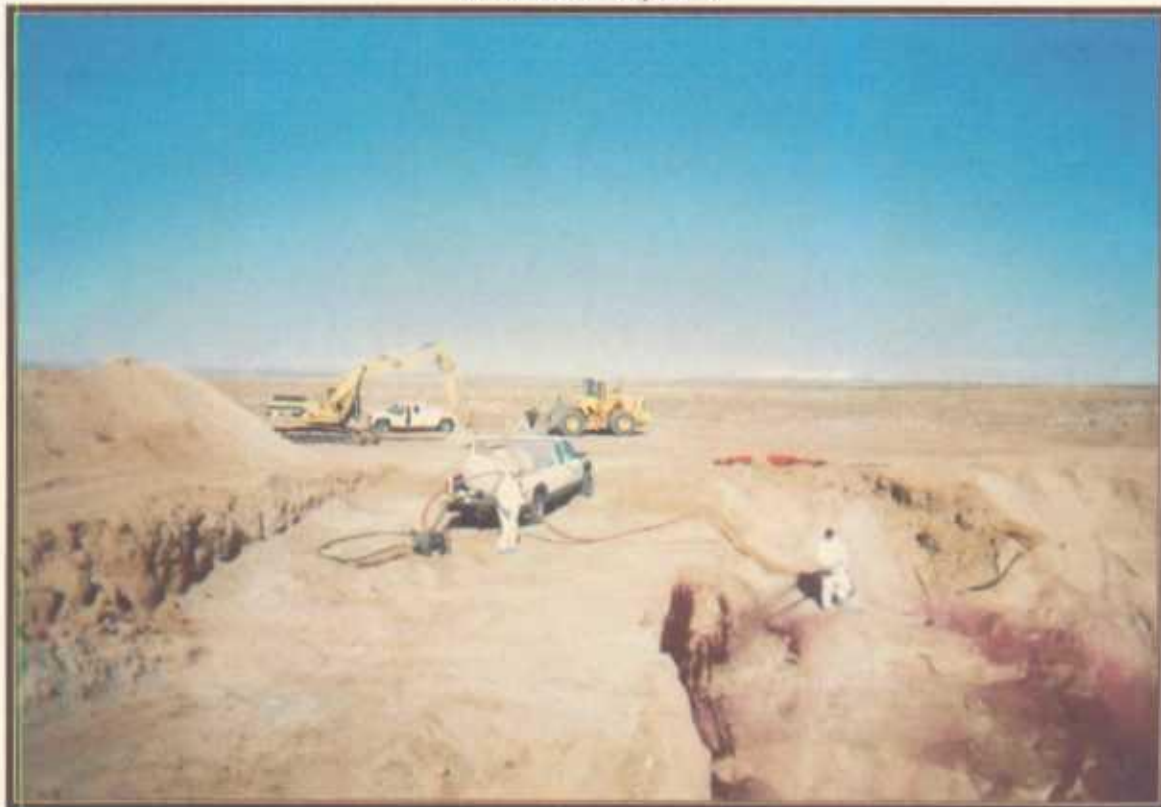
Photo 10: View to the north showing application of "oxidizer".

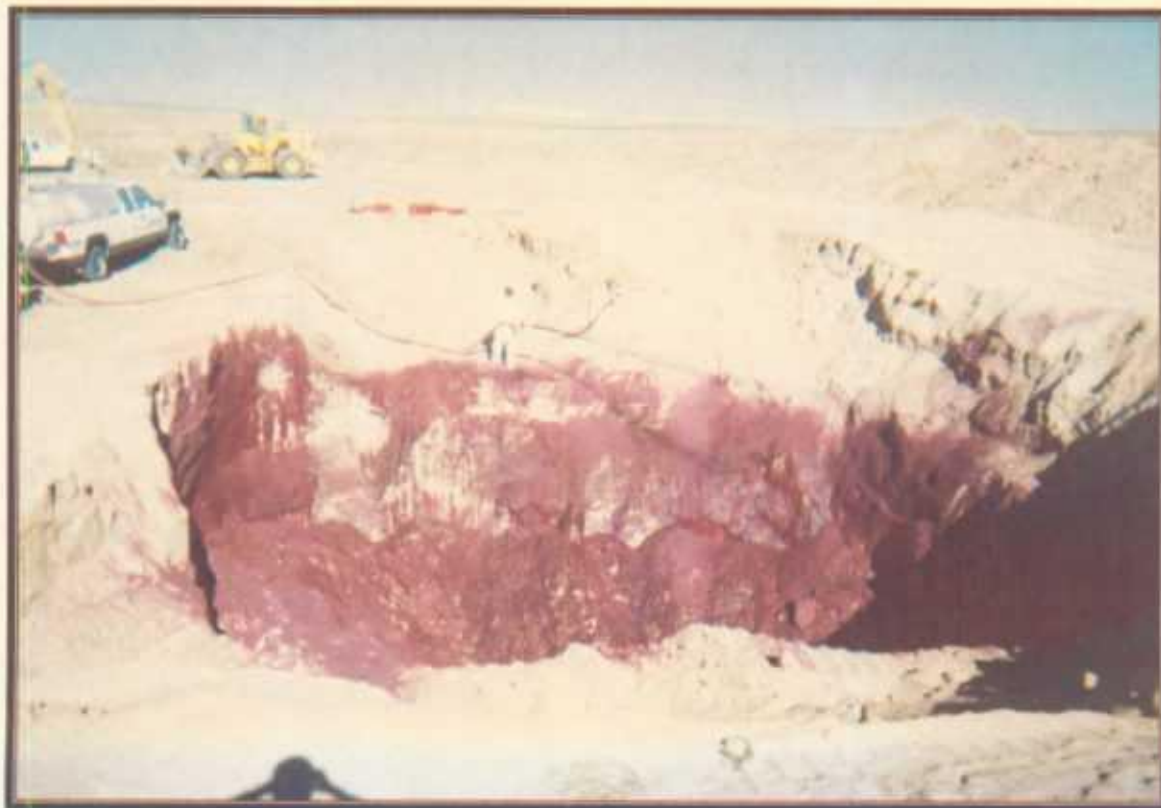
Photo 11: View to the north showing application of "oxidizer".

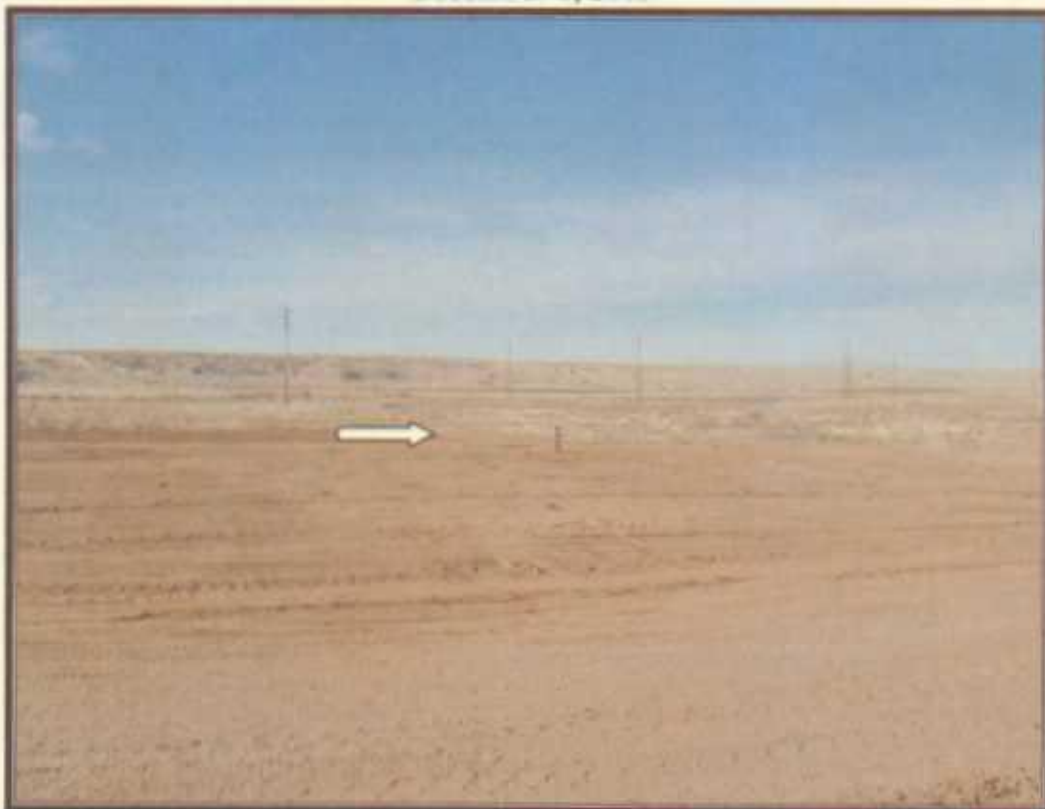
**Photo 13: View to the west showing completion of backfill activities, final grade and MW-7.**

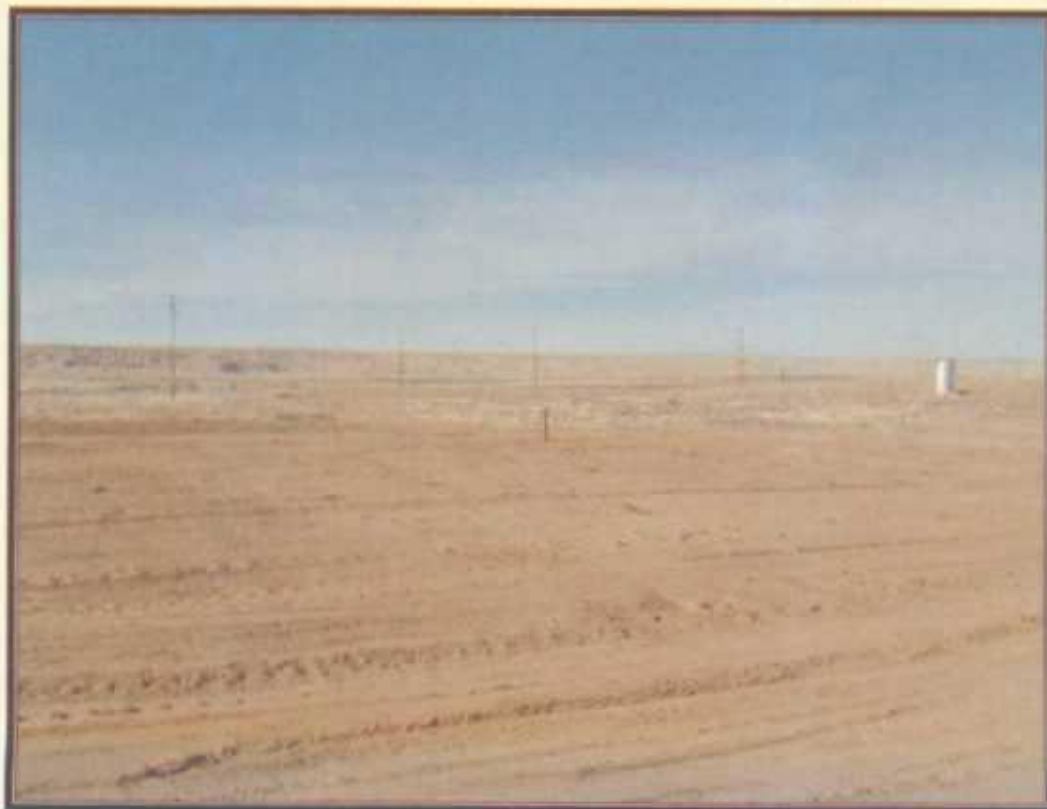
**Photo 14: View to the northwest showing completion of closure activities.**

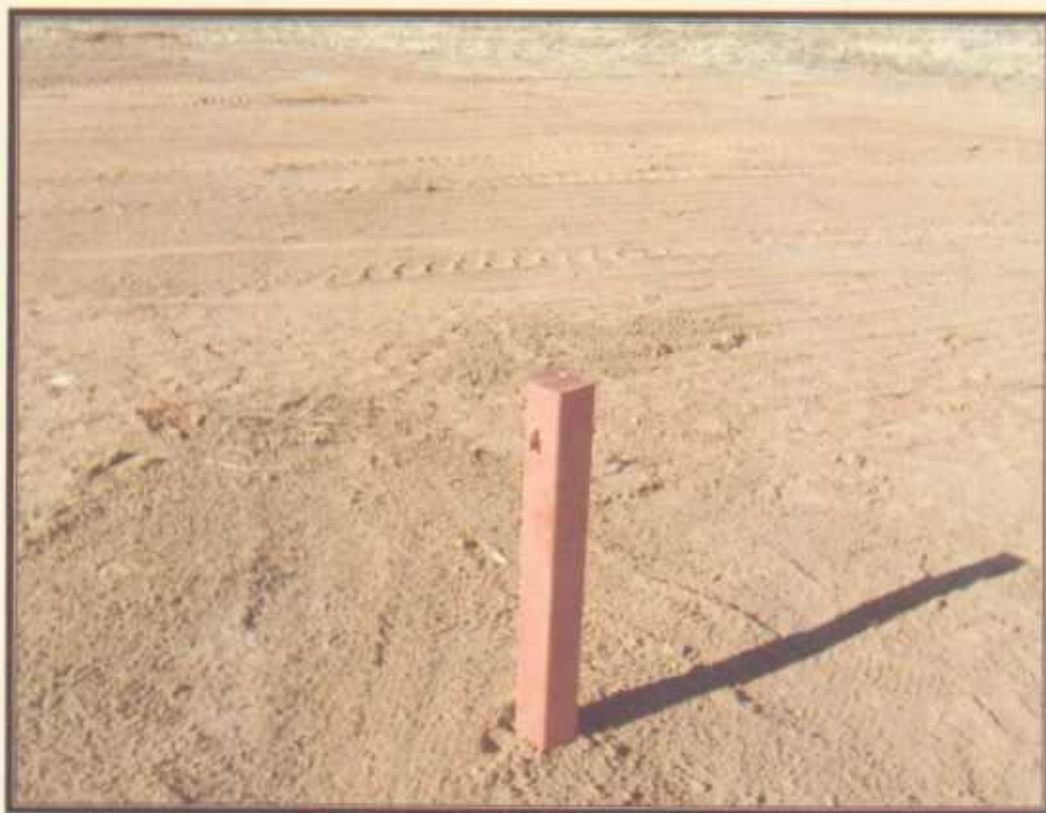
**Photo 15: View to the west of MW-7.**
