Bruce Baker
NEDU Sat 2A
Remediation Plan

API NO. 30-025-34651
1RP-5591
Release Date: 6/26/2019
U/L E, Section 3, Township 21S, Range 37E
Lea County, NM

**RE: Remediation Plan
Apache Corporation
NEDU Sat 2A (Northeast Drinkard Unit Satellite 2A)
U/L E, Section 3, Township 21S, Range 37E
API No. 30-025-34651**

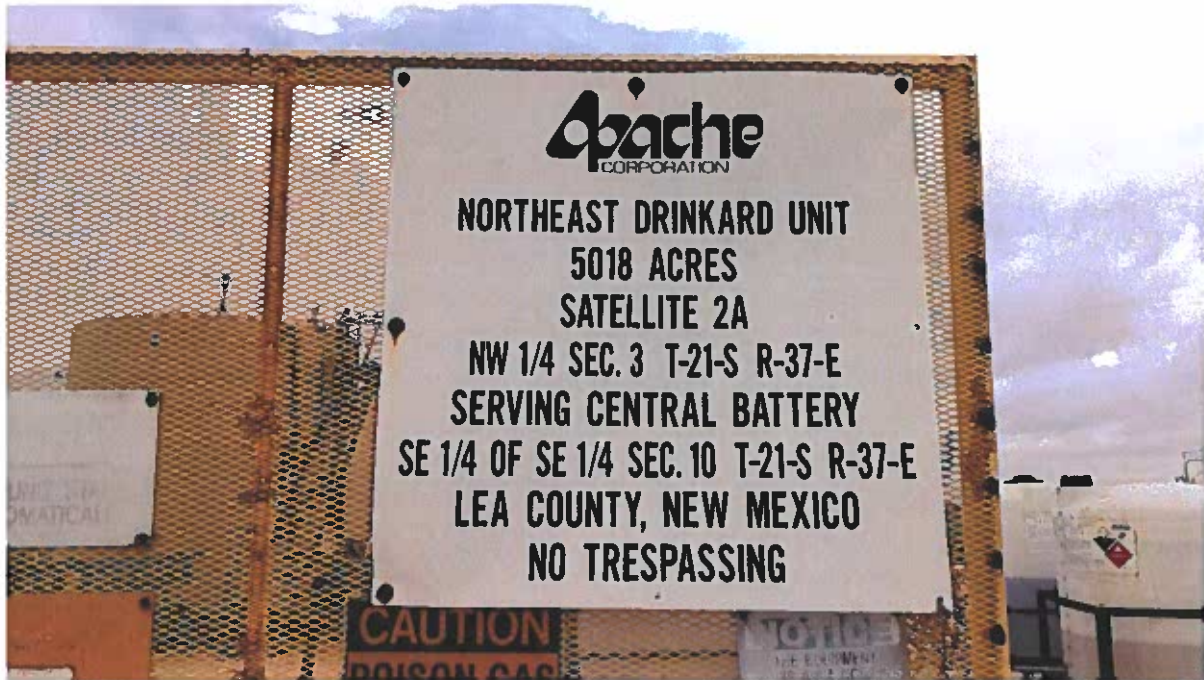
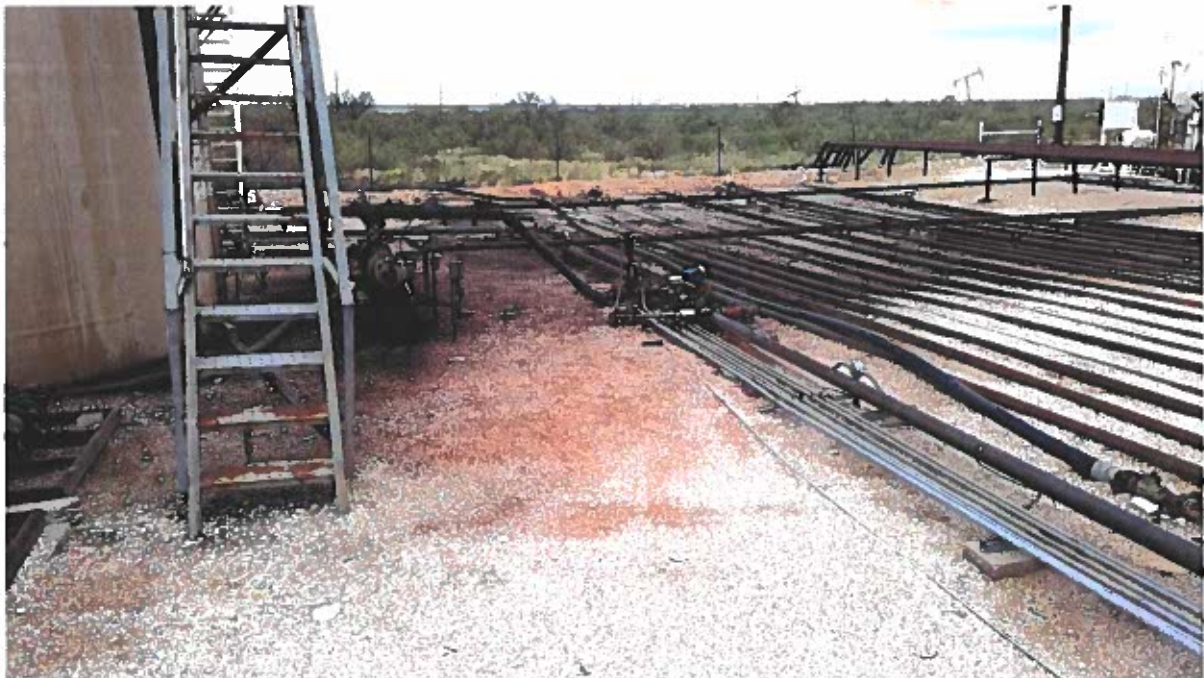
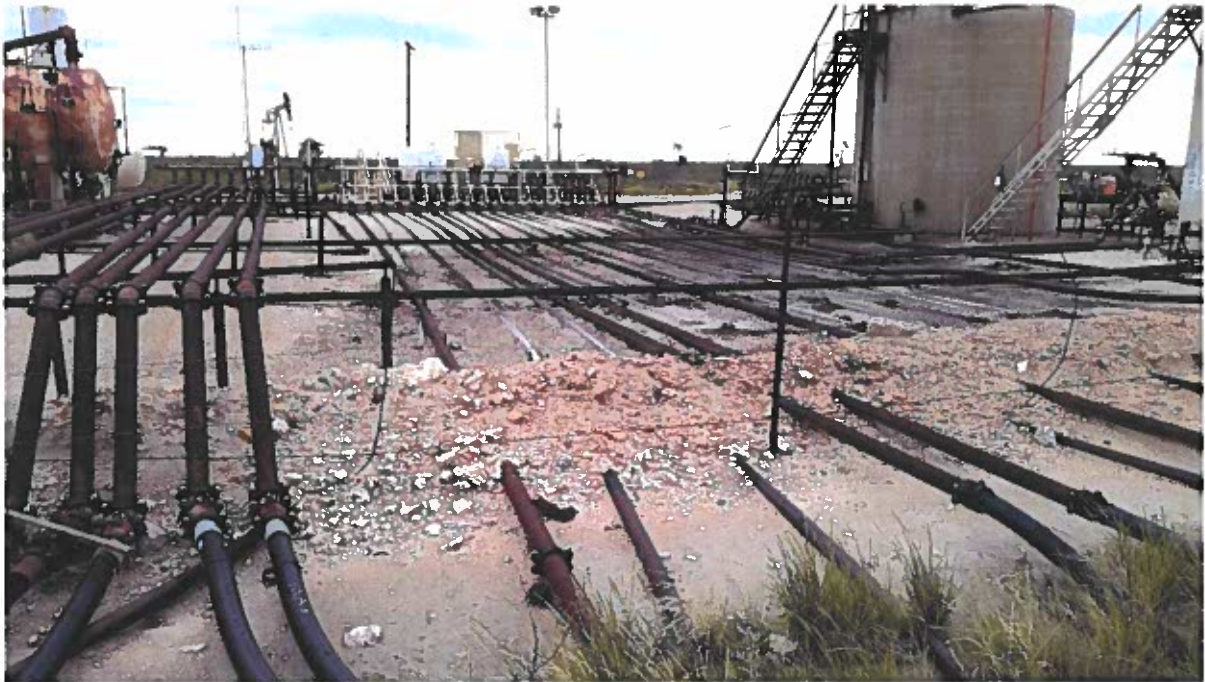
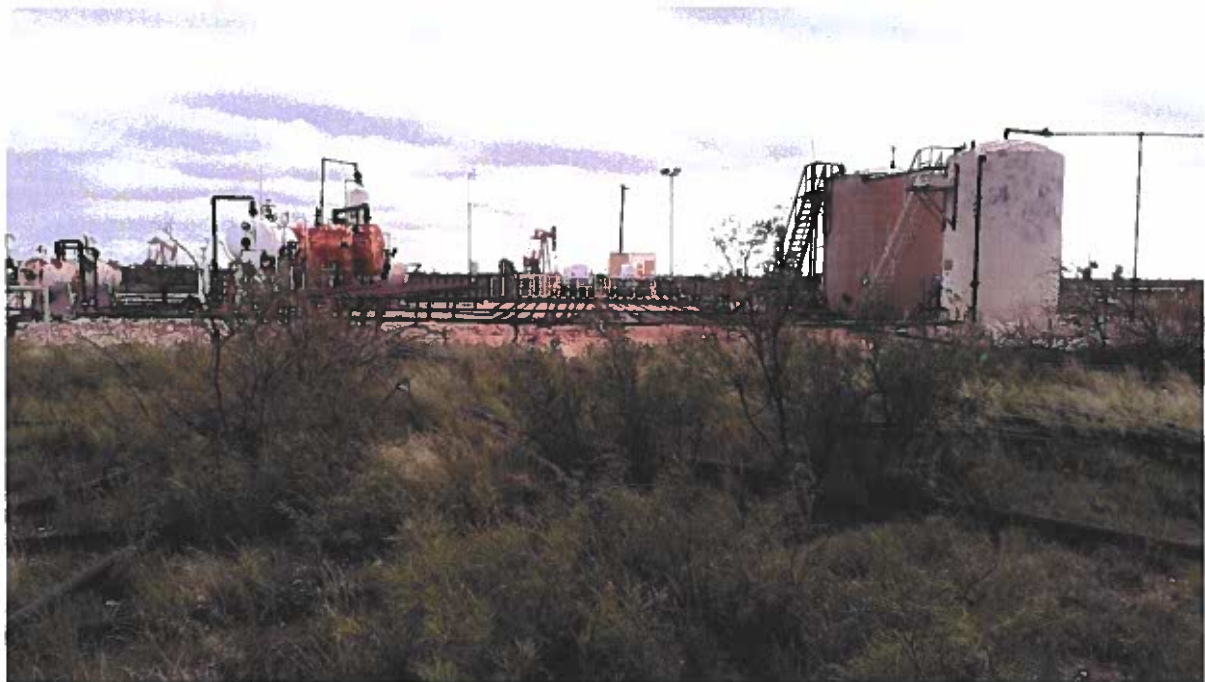
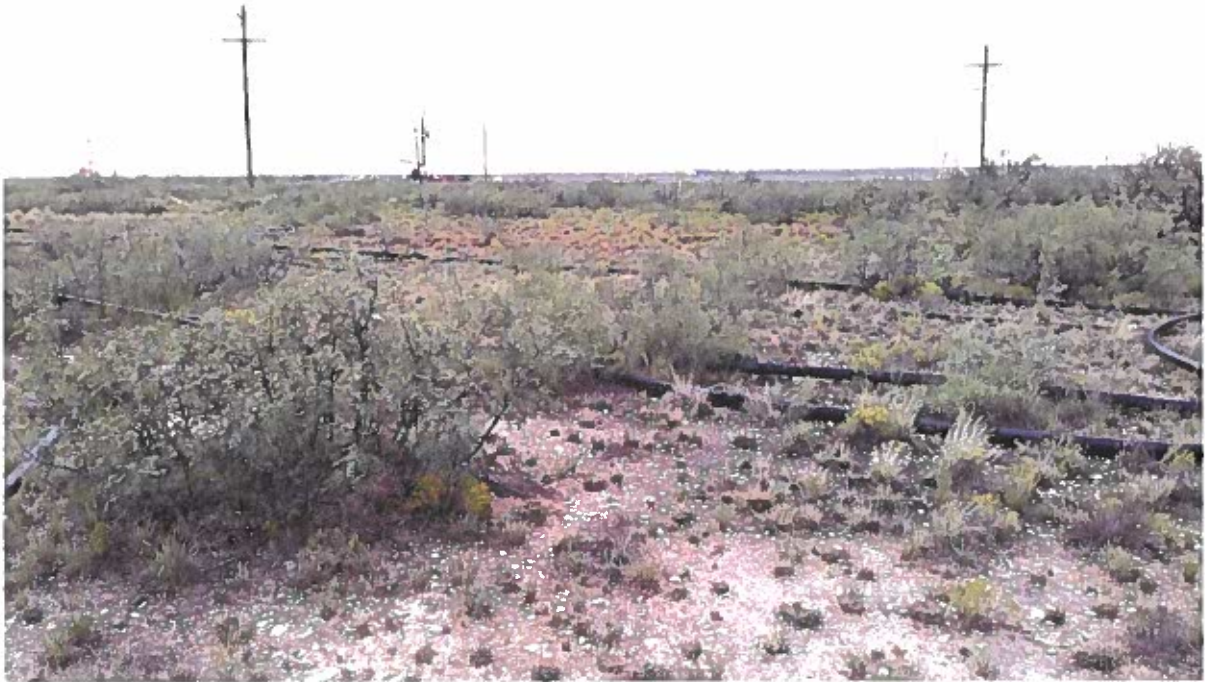
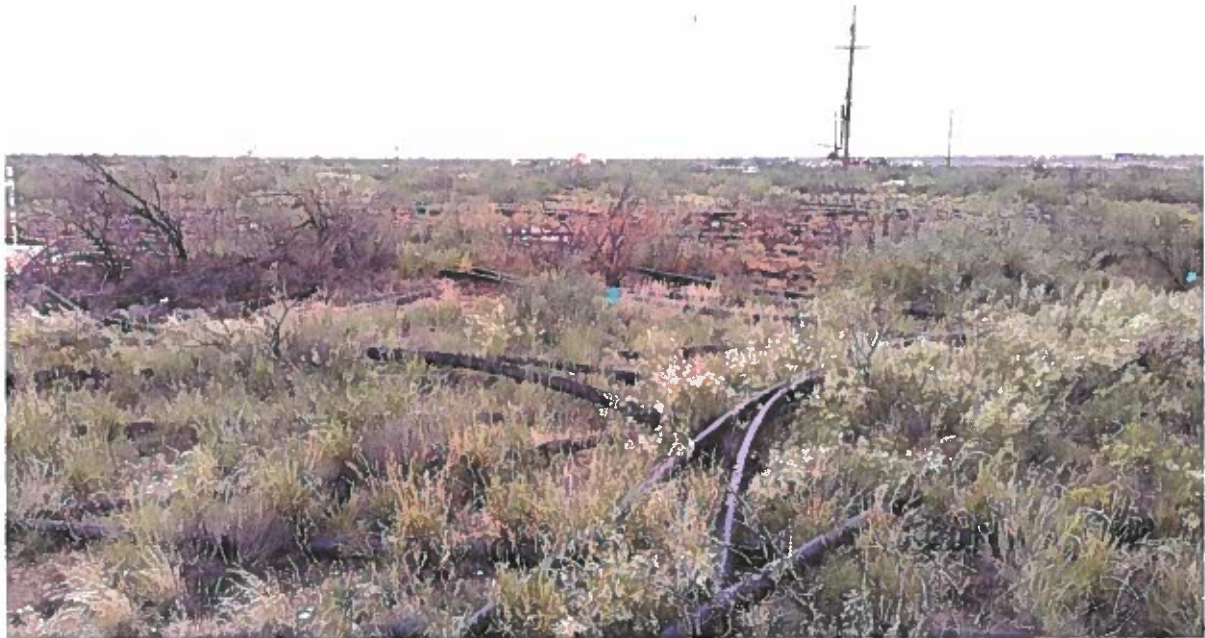
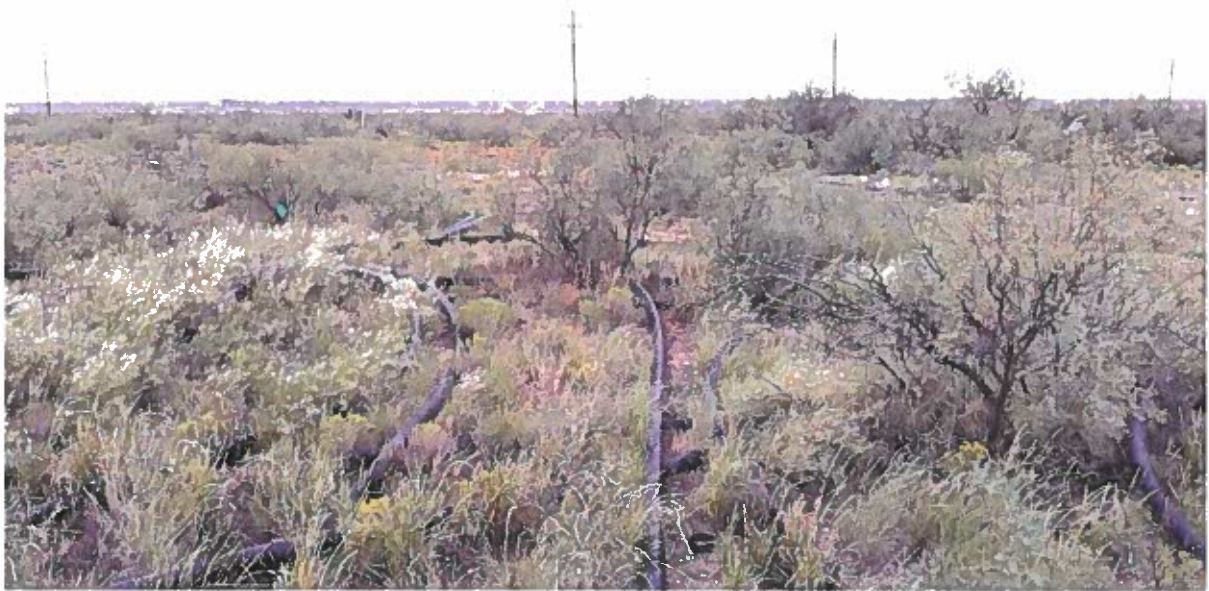
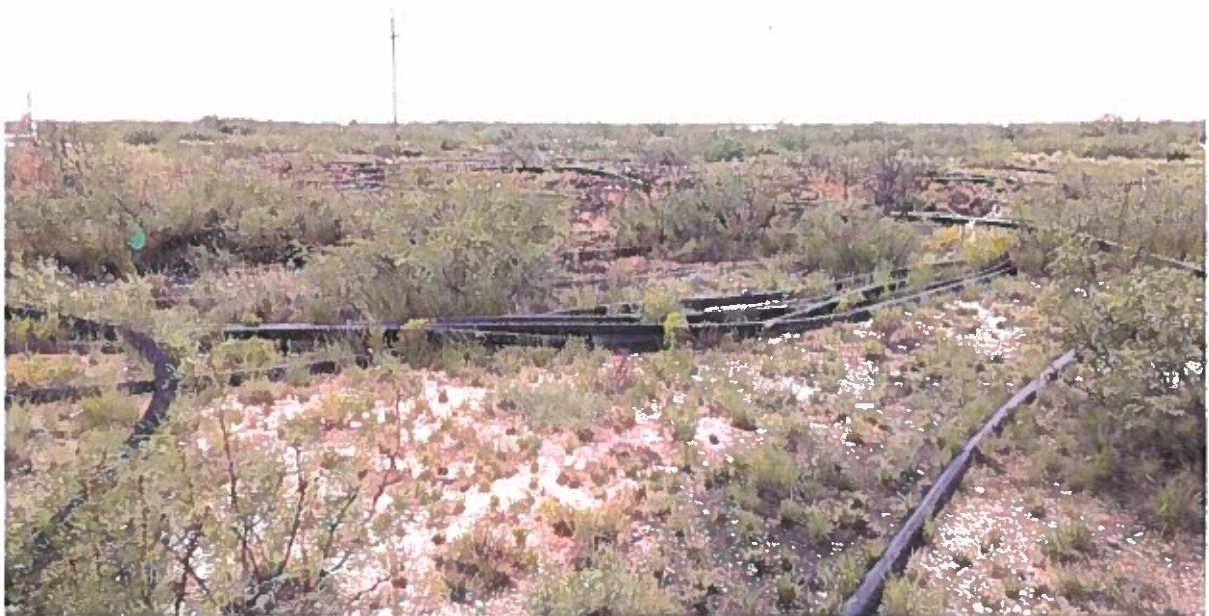
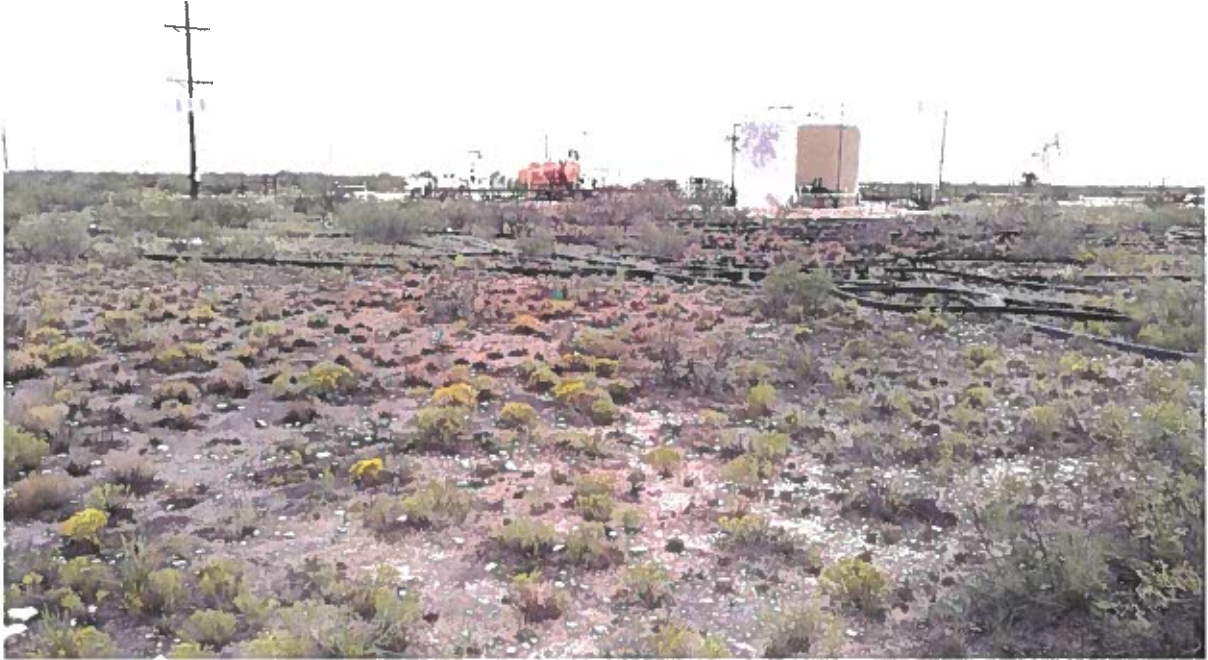
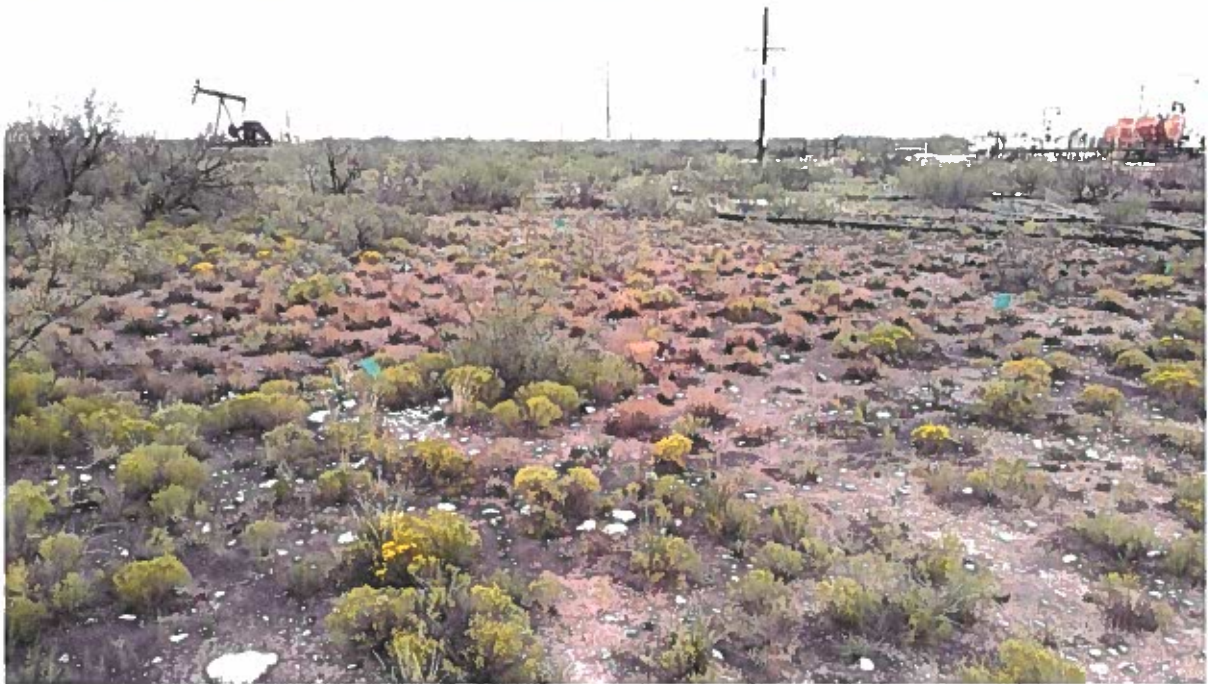
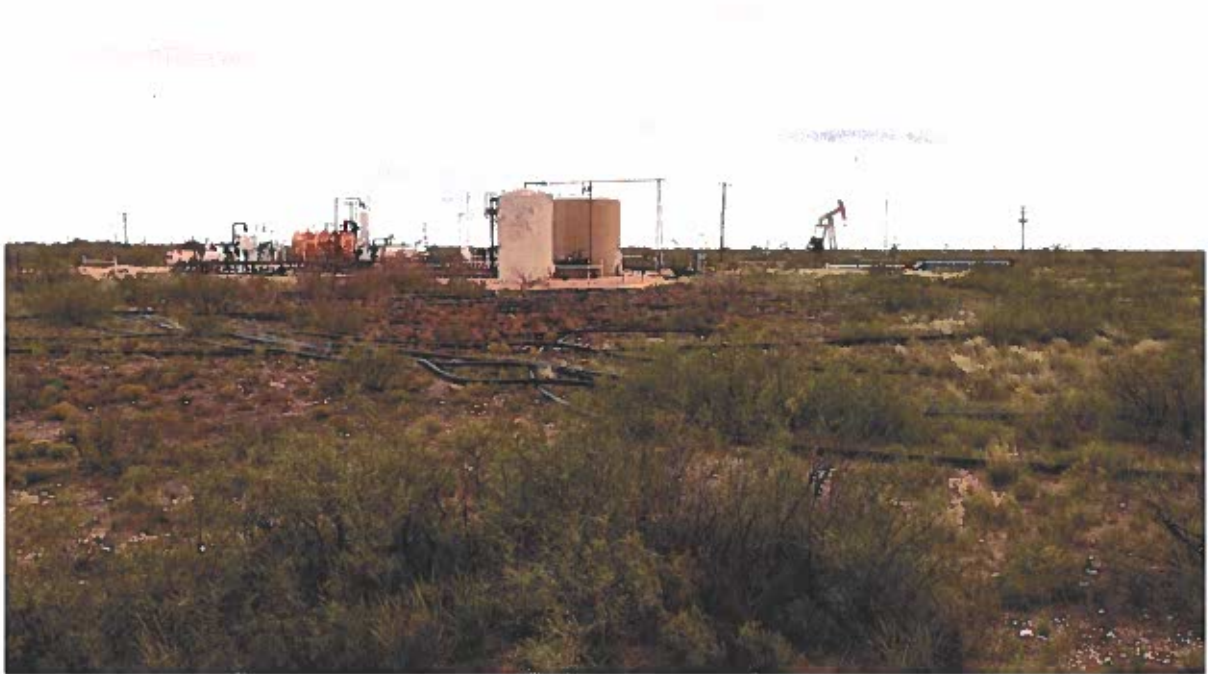
Apache – NEDU Satellite 2A Photo Page

On October 2, 2019 Hungry-Horse, LLC personnel began delineation of the site. The area of the release in the pasture is surrounded by flowlines that go into the header at the NEDU Sat 2A. Therefore, the sampling was completed by use of hand-auger. Backhoes and hydro-vacs could not be used due to the surface flowlines. Please see the site map attached to provide the view of the flowlines in the release area.

Hungry-Horse, LLC on behalf of Apache Corporation would like to purpose applying Micro-blaze to the surface of release area inside the battery at SP 1, SP 2 and in the pasture area of SP 3. At SP 1 we propose loosening up the soil and applying micro-blaze to the elevated hydrocarbons. At SP 2 the area will need to be left alone except for using micro-blaze to breakdown the volatiles until a prior date because of the flow lines that are in place (please see attached Variance Request). SP 4 and SP 5 are within NMOCD requirements therefore will be left alone. Applying the Micro-blaze would clear the flowlines and surface area of hydrocarbon impacted soil. The application will be used in four different cycles to obtain a strong washing of the soil. With the weather cooling off, four applications will need to be applied now. This process will include water that will enhance the microbial degradation rate of hydro-carbons. The site and pasture area are covered with surface polylines which are prohibiting any type of heavy equipment remediation or other means of remediation in the facility and or pasture area. Once the application of Micro-blaze has had time to dry completely, Hungry-Horse will then take closure samples to ensure that the degradation of the hydro-carbons have taken place.

Please see the photo page to justify this remediation plan.
