## Release Notification

Site Name Rosa 089 MV Pipeline	Site Type Natural Gas Pipeline
Date Release Discovered 9/27/19	API# (if applicable)

Natural gas pipeline leak, no liquids

Leak was below-ground and has been repaired

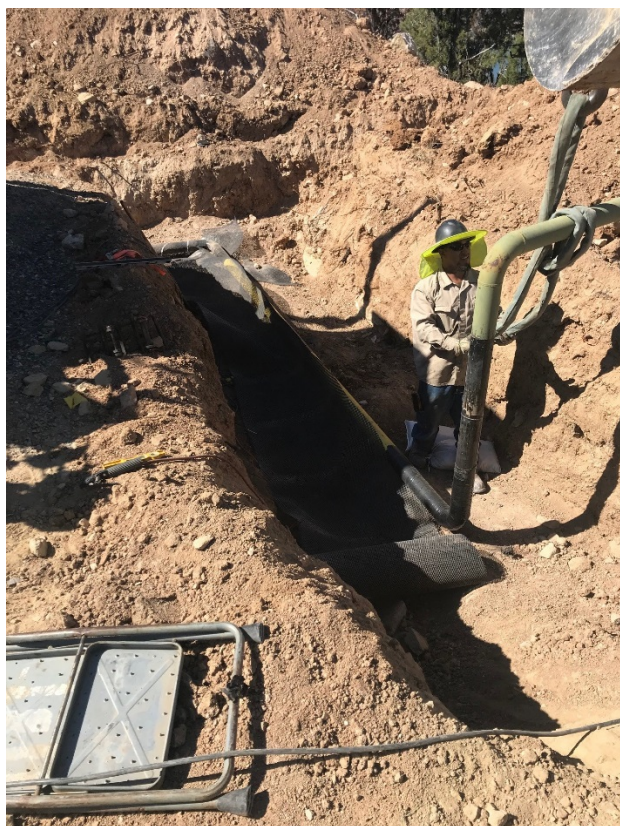
Harvest Midstream Rosa 089 MV Pipeline  
Latitude/Longitude: 36.942783 -107.438431  
Photo Date: 9/27/2019

Soil samples were collected from the excavation base and sidewalls and submitted for laboratory analysis. Results were all below laboratory detection limits. Lab results are attached.

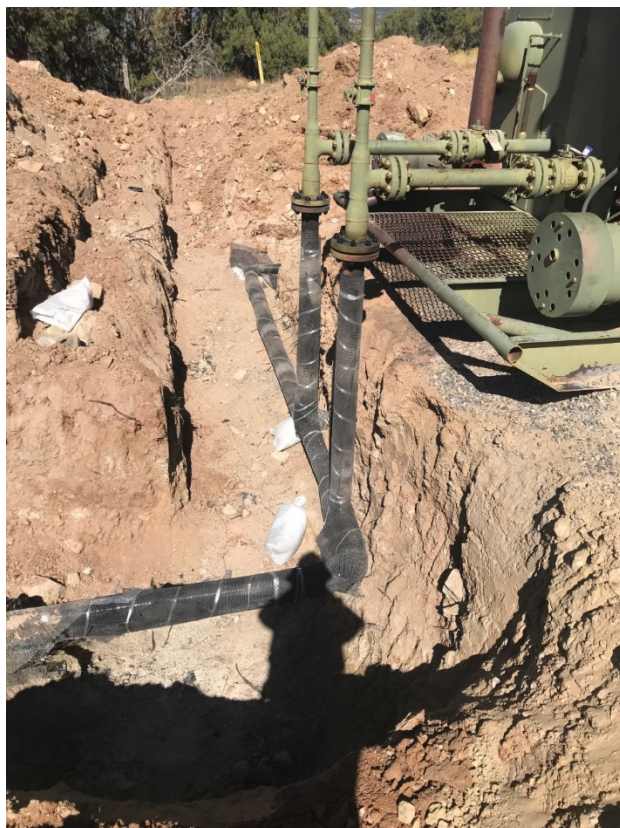
Harvest Midstream Rosa 089 MV Pipeline  
Latitude/Longitude: 36.942783 -107.438431  
Photo Date: 9/27/2019
