## Release Notification BMDKL-190802-C-1410

| Site Name Remuda 100 Tank Battery | Site Type Bulk Storage and Separation Facility |

ATTACHMENT 4: PHOTOGRAPHIC LOG

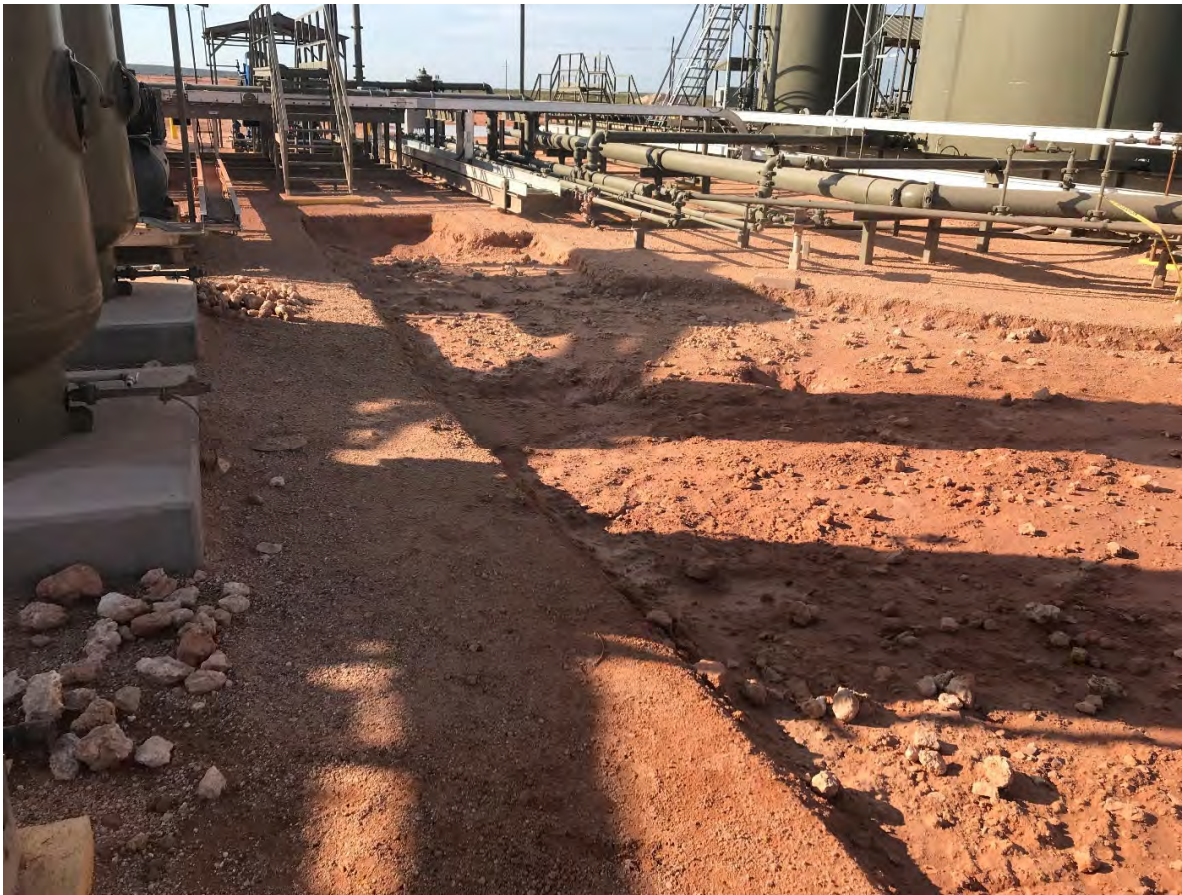
Hydro-excavation conducted around active production equipment at the Site.

Hydro-excavation activities were conducted between October 1 and October 4, 2019 and on October 7, 2019 in the areas around active production equipment. Hydro-excavation activities were conducted to the extent possible; however, aboveground piping, tight spacing between equipment, and high-pressure lines limited the lateral extent that was safe to complete. XTO safety policy restricts soil-disturbing activities to a 2-foot radius of any on-site production equipment and pipelines. This XTO safety policy is established to protect workers and reduce the likelihood of compromising the foundation of the production equipment or pipelines. This policy was enforced where impacted soil was identified within 2 feet of active production equipment or pipelines. Between October 14 and October 16, 2019, LTE personnel oversaw excavation of impacted soil with heavy equipment in areas outside of the active production equipment.

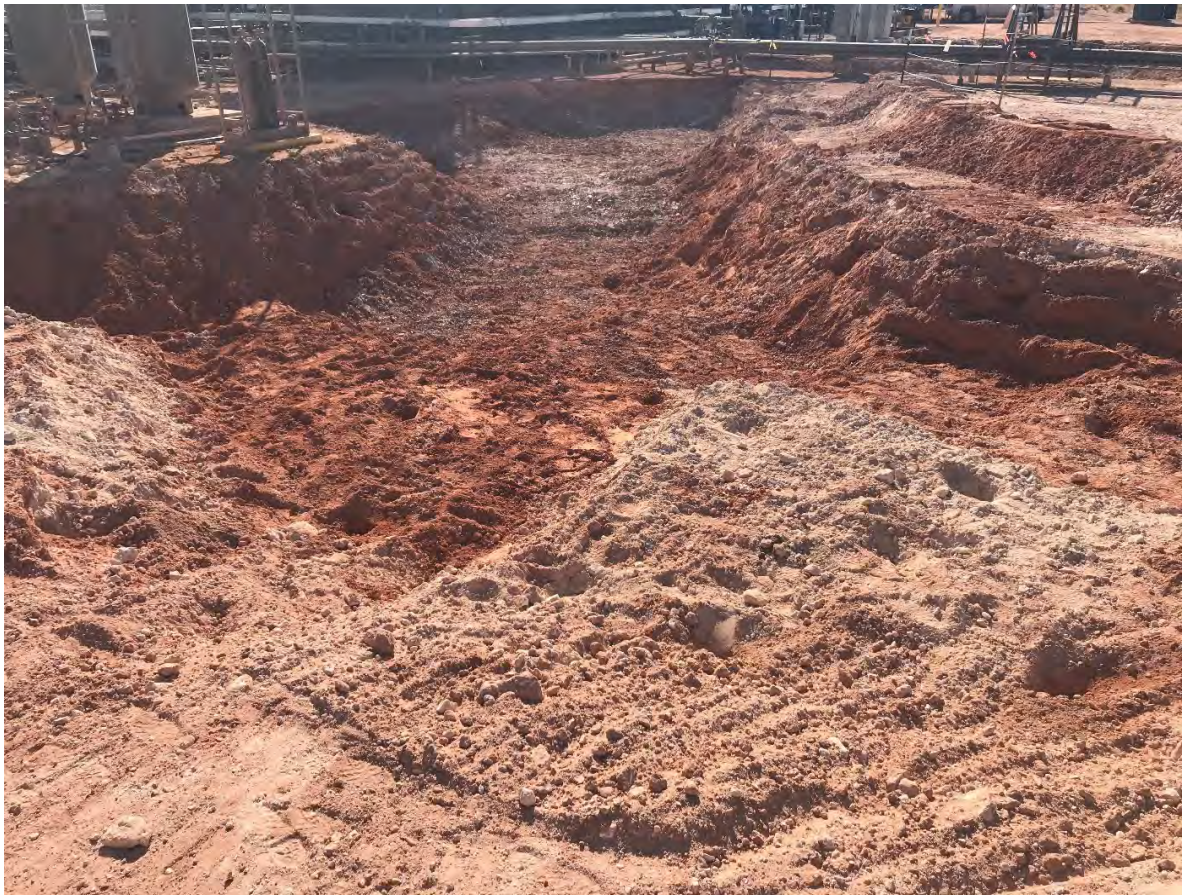
**Extent of excavation limited due to active production equipment. Facing west.**

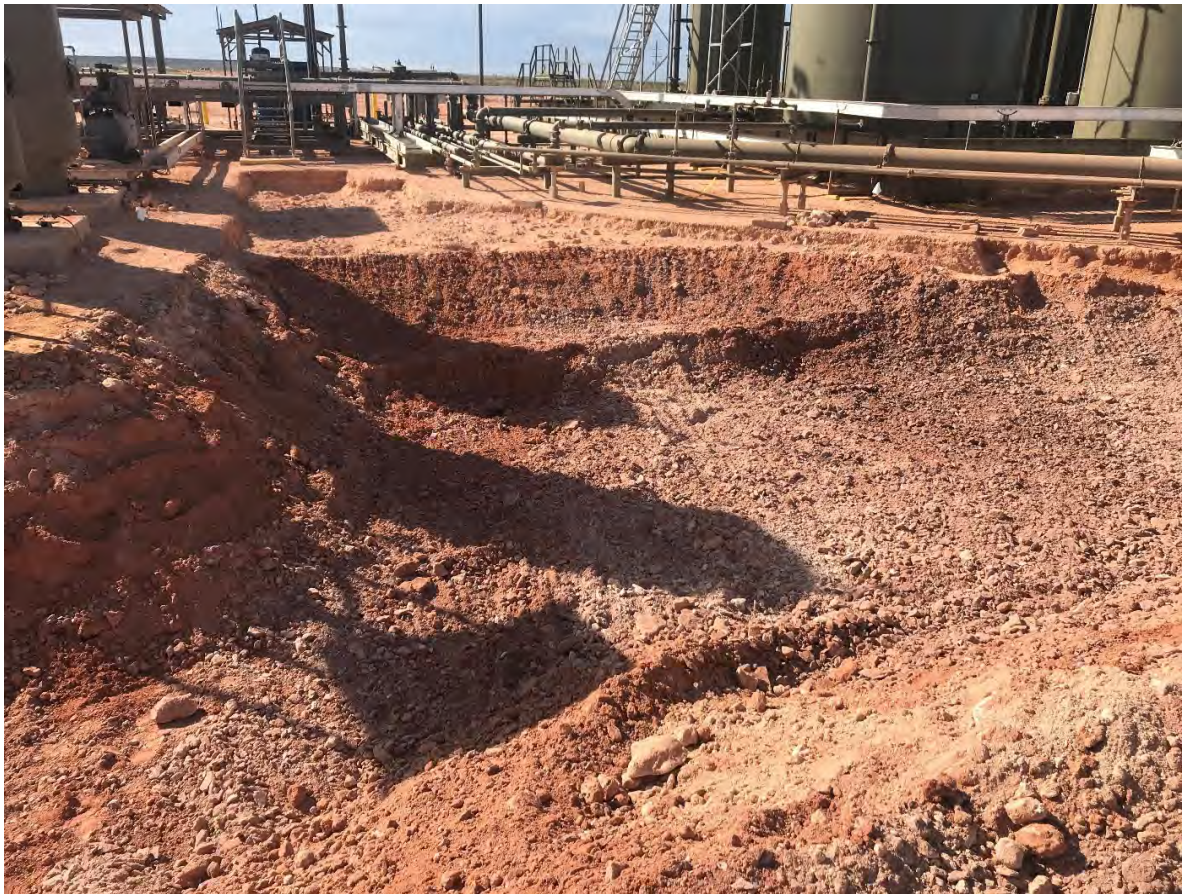
Extent of excavation limited due to active production equipment. Facing south.

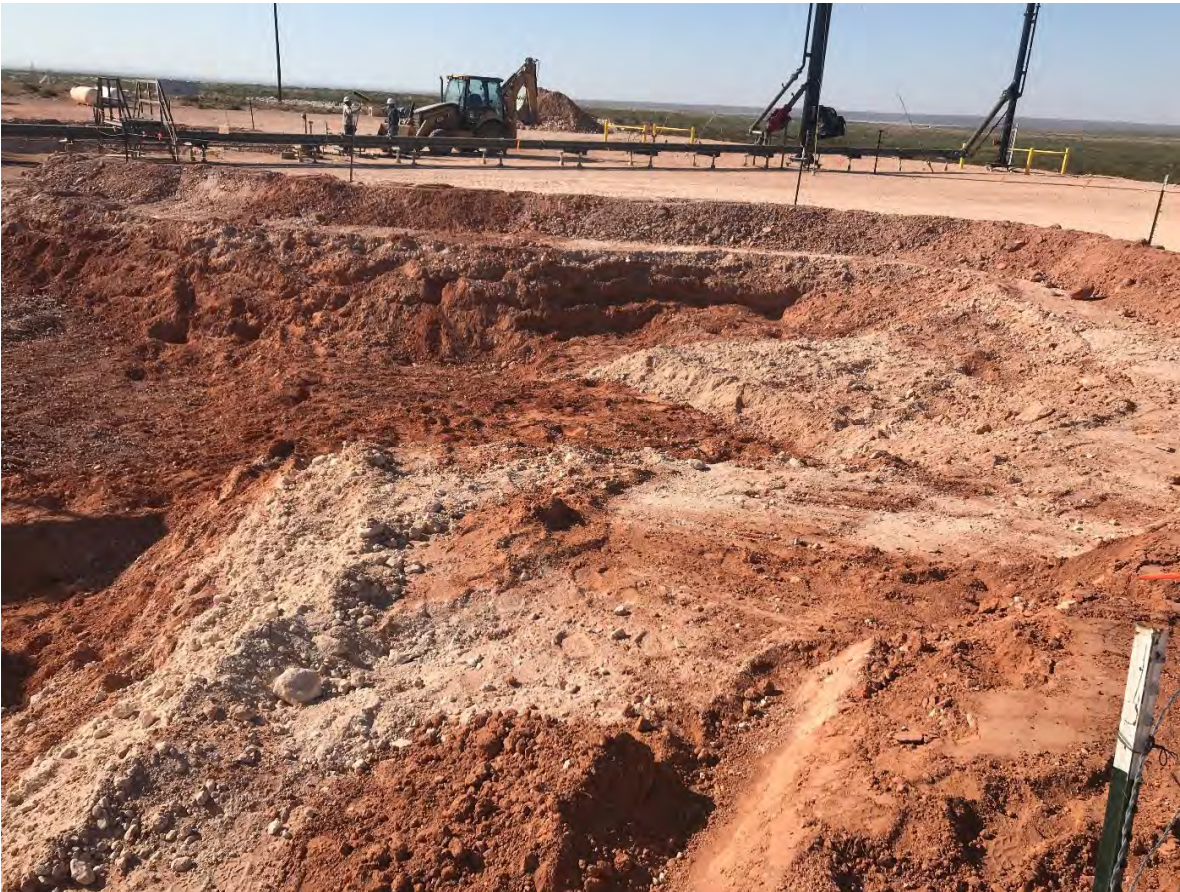
Extent of excavation facing north west.
