## Release Notification

Site Name PLU CVX JV RB 001H	Site Type Pipeline ROW
Date Release Discovered 1-5-19	API# (if applicable) 30-015-40660

**RE: Variance Request  
Poker Lake Unit CVX JV RB 001H Pipeline Right-Of-Way  
Remediation Permit Number 2RP-5185  
Eddy County, New Mexico**

ATTACHMENT 2: PHOTOGRAPHIC LOG

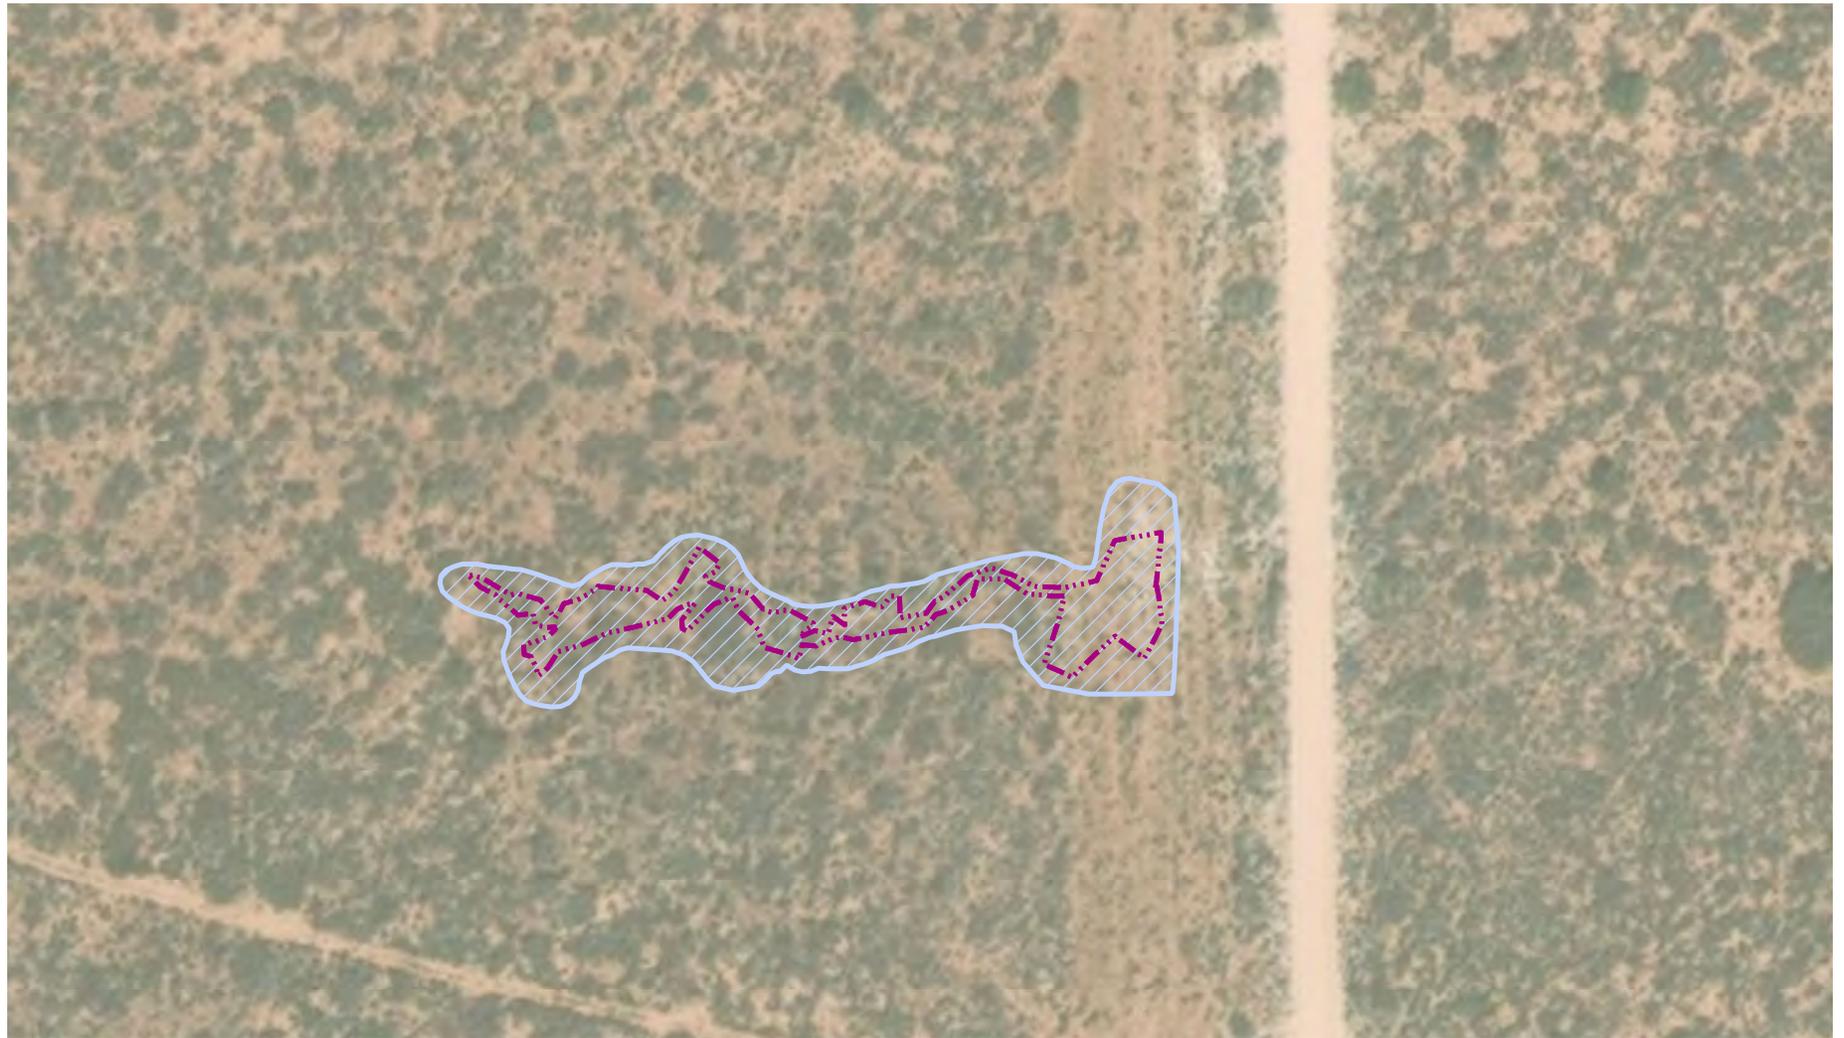
**FIGURE 2**  
**LINER LOCATION**  
POKER LAKE UNIT CVX JV RB 001H  
UNIT F SEC 4 T24S R30E  
EDDY COUNTY, NEW MEXICO  
**XTO ENERGY, INC.**

RELEASE EXTENT

LINER FOOTPRINT

Based on the nature of the release and extent of residual impact in the subsurface adjacent to the pipeline ROW, XTO installed approximately 20,000 square feet of 20-mil impermeable liner over the residual impacted soil to mitigate future impacts into the subsurface (Figure 2). The installation of the 20-mil impermeable liner was completed from July 26, 2019 through August 1, 2019. After liner installation, the excavation was backfilled with approximately 4,520 cubic yards of clean backfill material to protect the liner and minimize potentially unsafe conditions associated with an open excavation. On November 5, 2019, initial surface contouring of the backfill material was completed. On November 22, 2019, a tractor and lister were used for final backfill contouring. One hundred pounds of Elbon Rye and 20 pounds of Bureau of Land Management (BLM) seed mix were applied via seed drill. A photographic log of the excavation, liner installation, backfilling, grading, and seeding is included as Attachment 2.

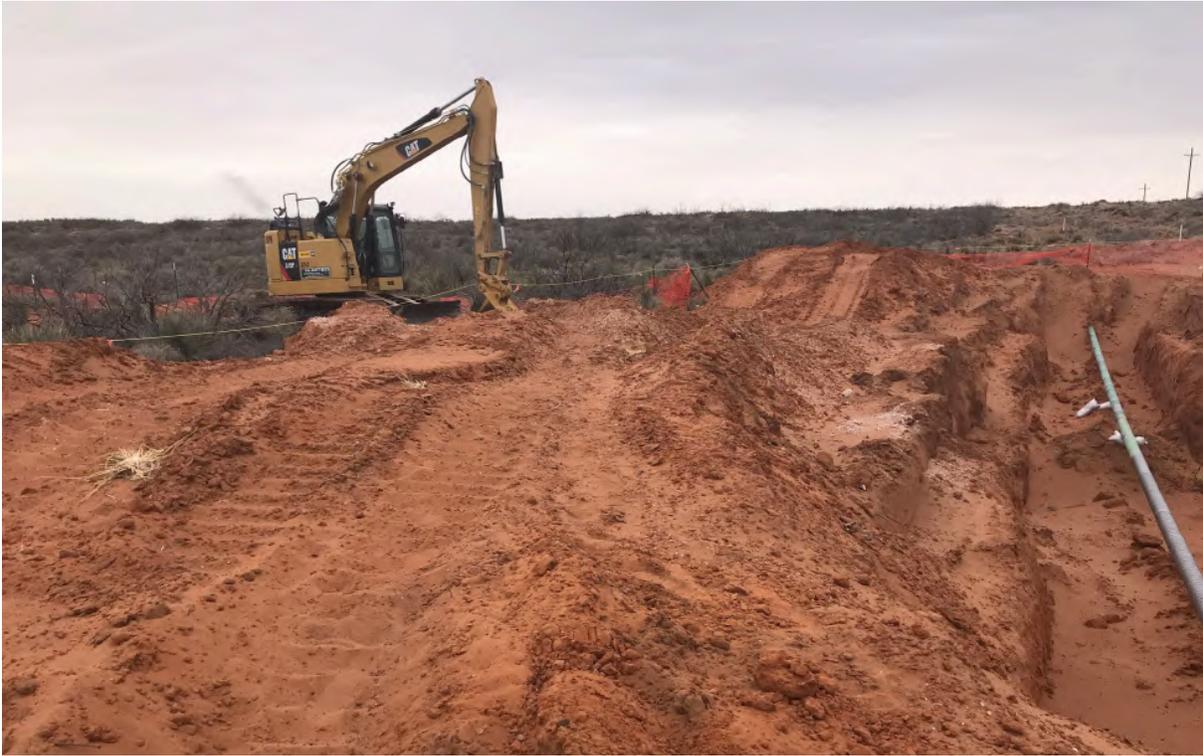
**Photo 1** Photo viewing excavation

The impacted soil was excavated from the release area to a depth of 4 feet to 4.5 feet below ground surface (bgs). A total of approximately 3,680 cubic yards of impacted soil was excavated from the Site. This is less than the volume estimated to be removed in the Remediation Work Plan, but was based on actual conditions and confirmation sampling results. Impacted soil at the area of release was excavated to a depth of approximately 10 feet bgs. Residual impacted soil was left in place below 4 feet bgs in the central and western portions of the excavation. An estimated 8,000 cubic yards of impacted soil remain in place based on vertical delineation described in the Remediation Work Plan.

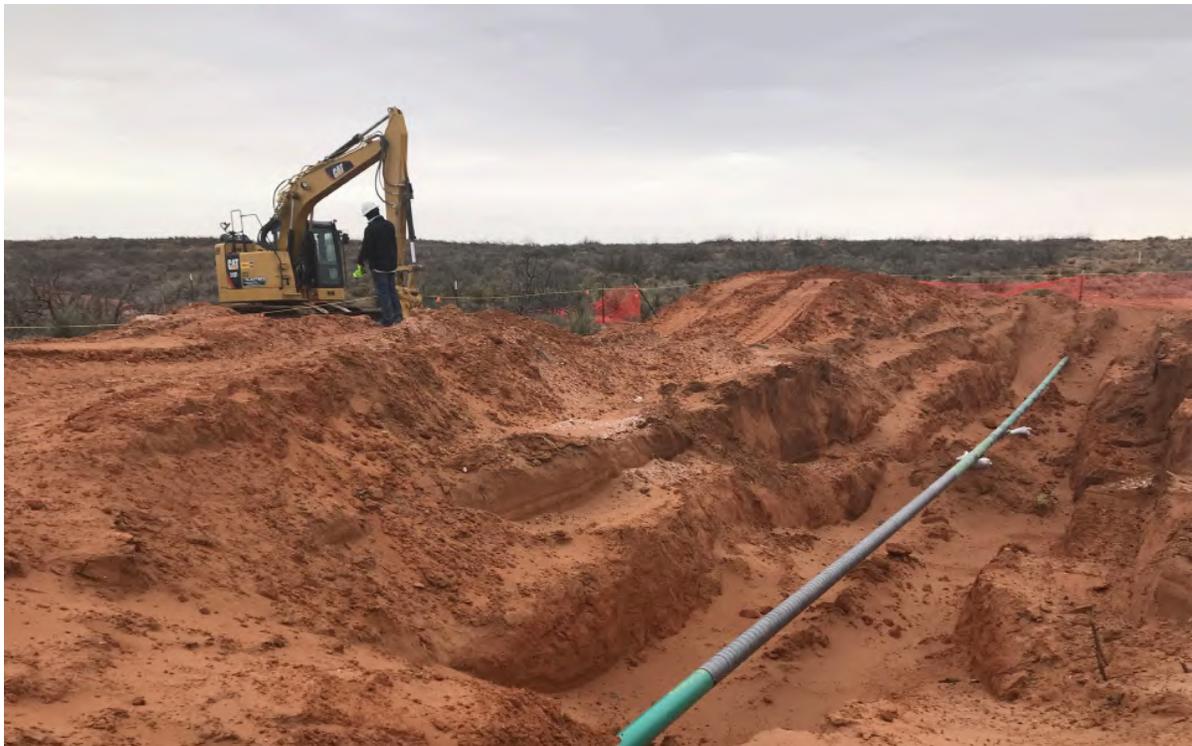
**Photo 2** Photo viewing excavation

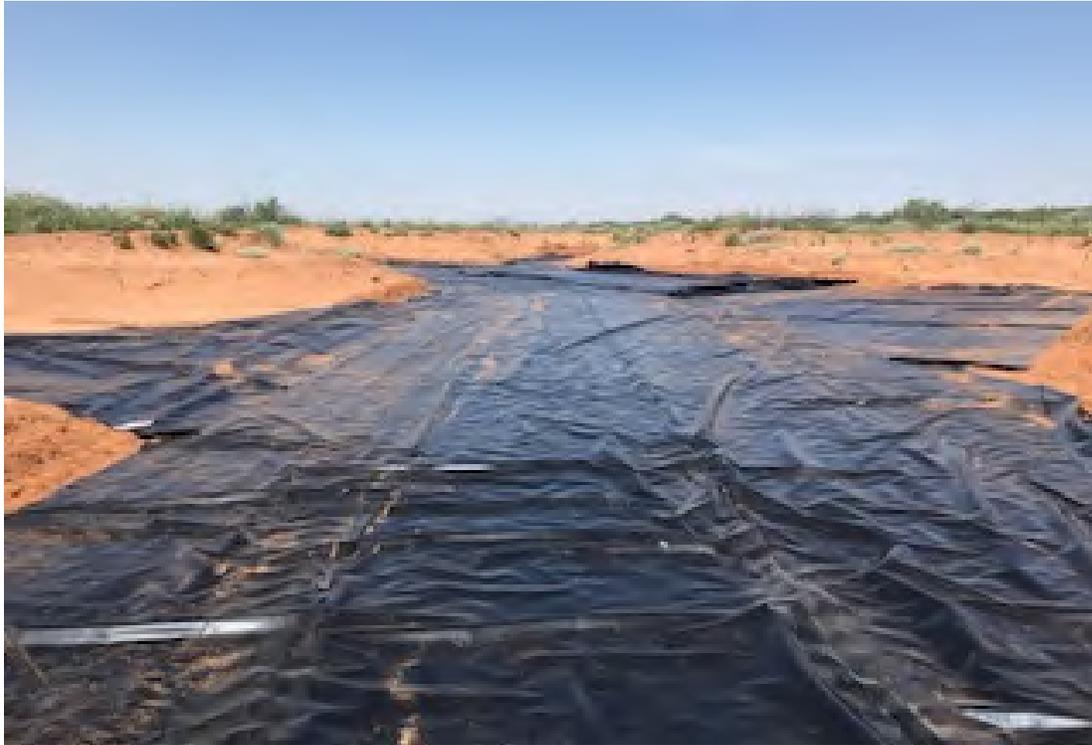
**Photo 3** Photo viewing liner

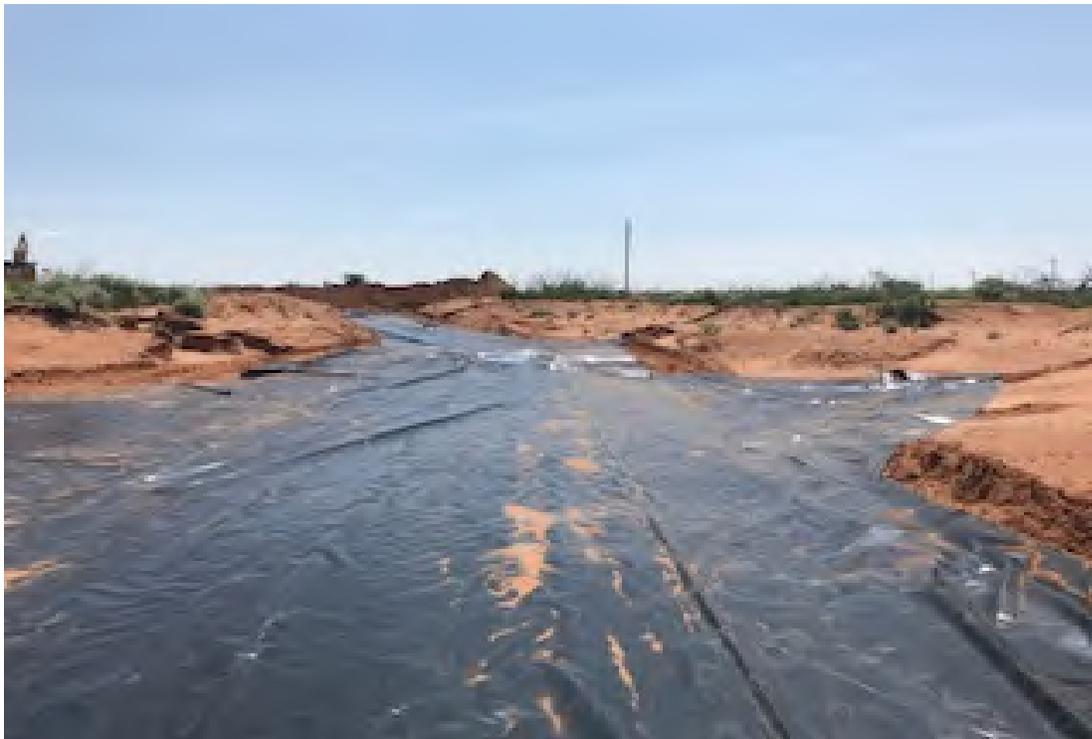
**Photo 4** Photo viewing liner

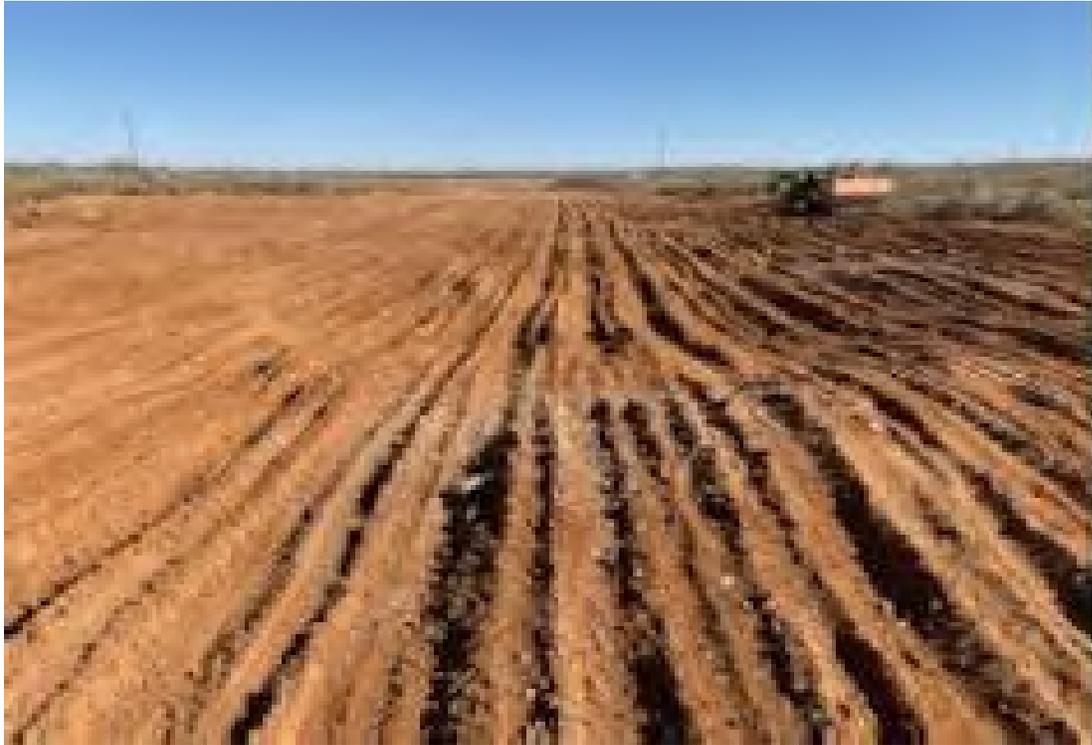
**Photo 5** Photo viewing post grading & seeding

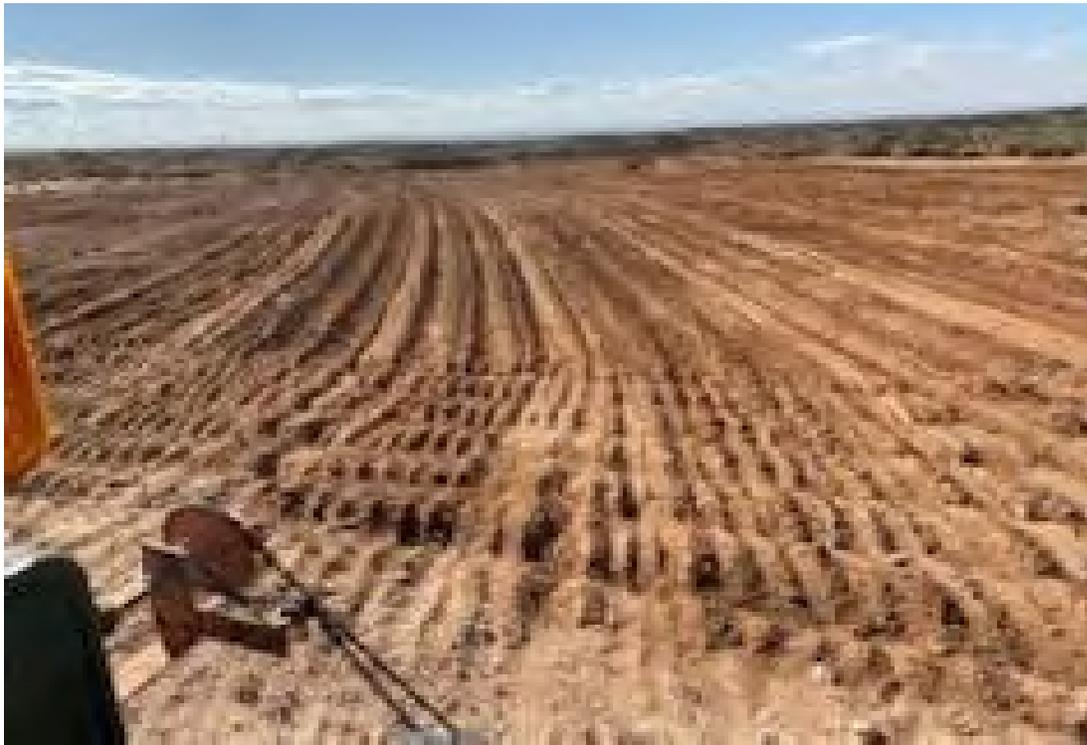
**Photo 6** Photo viewing post grading & seeding
