Re: Boyd X State #10 Battery
O-16-19S-25E
Eddy County, NM
2RP-

EOG Resources, Inc. is submitting the enclosed Closure Report for the above referenced site. The report is being submitted accompanying the C-141 Final.

EOG Resources, Inc.
Boyd X State #10 Battery
Closure Report
O-16-19S-25E
Eddy County, NM
January 17, 2020
2RP-

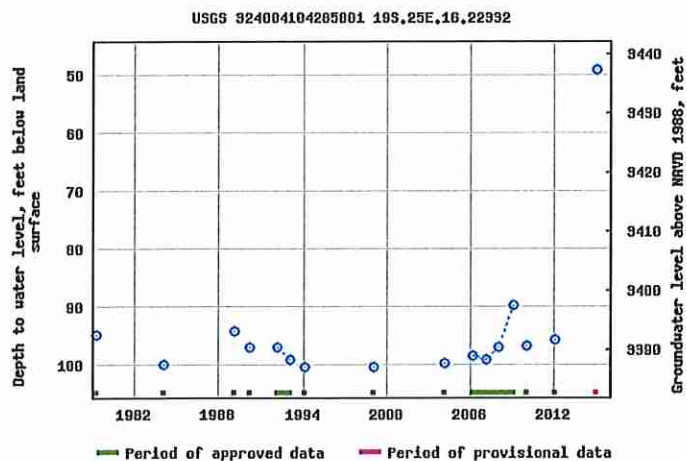
USGS 324004104285801 19S.25E.16.22332

This well is completed in the Alluvium, Bolson Deposits and Other Surface Deposits (110AVMB) local aquifer.

Breaks in the plot represent a gap of at least one year between field measurements.

Area geology is Cenozoic Quaternary. Based on information from the New Mexico Office of the State Engineer and the United States Geological Survey National Water Information System (USGS) regarding this location (Section 16, T19S-R25E), depth to groundwater was determined to be 112 feet with the nearest water wells being approximately 0.8 mile to the northeast and 0.88 mile to the southeast. The site sits between the 2 water well sites, with the northeast well lying north of the draw and having a groundwater depth of 95 feet. The southeast well lying south of the draw, same as the release site, has a groundwater depth of 130 feet. Besides the aquifer trend of groundwater being deeper moving south across the draw, elevation for the site and water wells was also evaluated. The release site has an elevation of 3,501 feet above sea level, the water well to the northeast of the site has an elevation of 3,485 feet above sea level, and the water well to the southeast of the site has an elevation of 3,477 feet above sea level. The release site has the highest elevation point of the three, and the southeast water well is the lowest in elevation, but also has groundwater 35 feet deeper than the northeast water well. The elevation differences and trend for groundwater to be found deeper in depth to the south, leads to the determination of approximately 112 feet to groundwater beneath the release site.

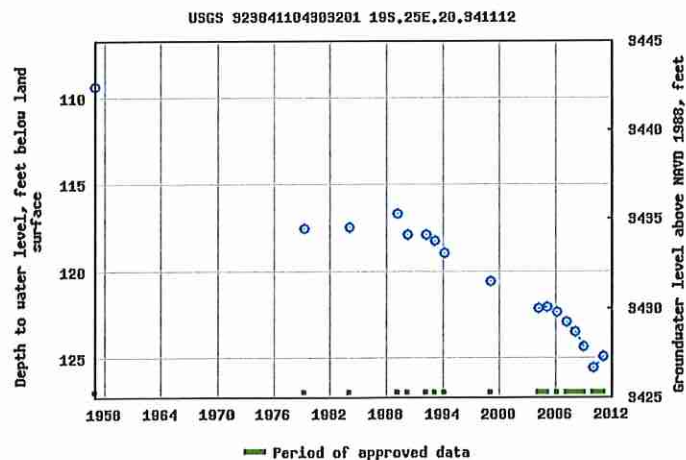
USGS 323841104303201 19S.25E.20.341112

The depth of the well is 130 feet below land surface.

This well is completed in the Alluvium, Bolson Deposits and Other Surface Deposits (110AVMB) local aquifer.

Breaks in the plot represent a gap of at least one year between field measurements.
