Revised Closure Report

Corazon State Unit #5H
API # 30-025-40947 *1RP-5474
Talon Project #700778.119.01

Subject: **Revised Closure Report**
Corazon State Unit #5H
API # 30-025-40947 *1RP-5474

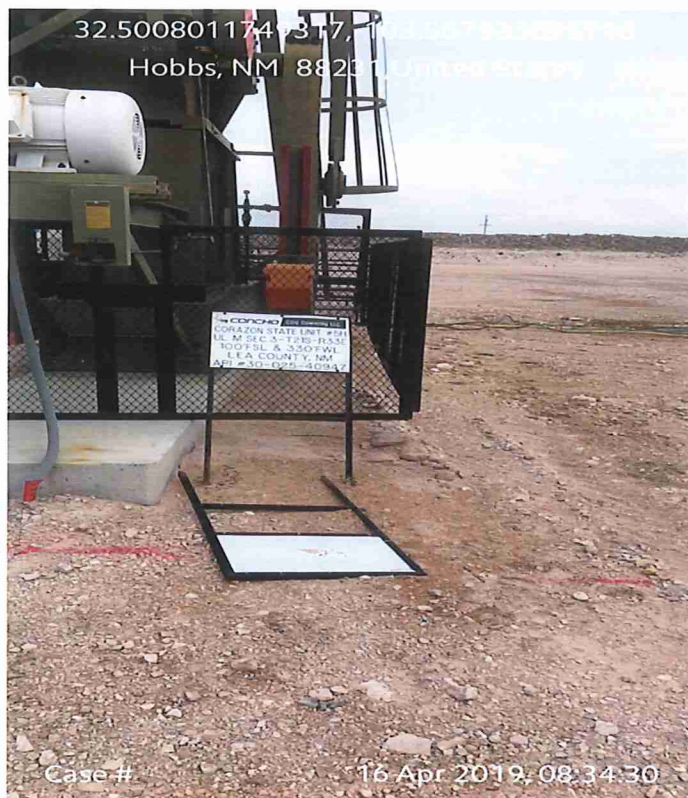
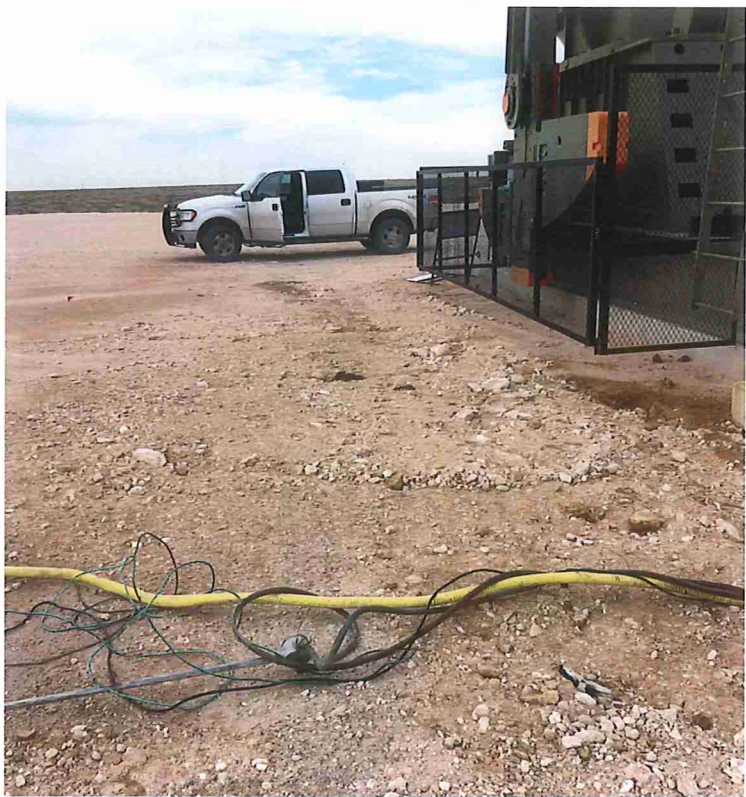
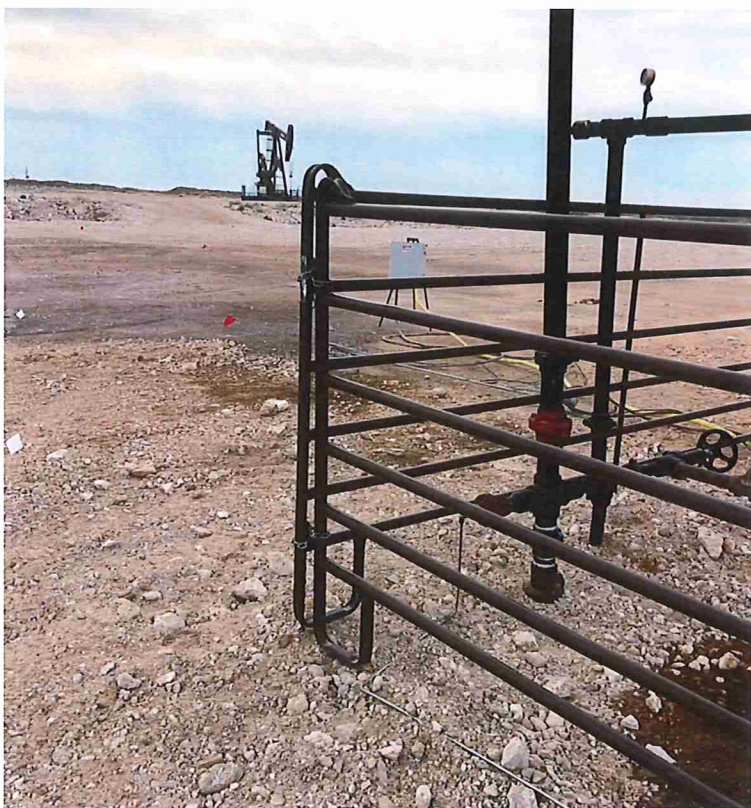
Spill Event

The release was caused by a hole in the flowline. The flowline is being repaired.
The release was on location. A vacuum truck was dispatched to remove all freestanding fluids.
Concho will evaluate the site to determine if we may commence remediation immediately or delineate any possible impact from the release and we will present a remediation work plan to the NMOCD for approval prior to any significant remediation activities.
