January 25, 2020

**RE: Closure Request  
Poker Lake Unit 261  
Remediation Permit Number 2RP-3947  
Eddy County, New Mexico**

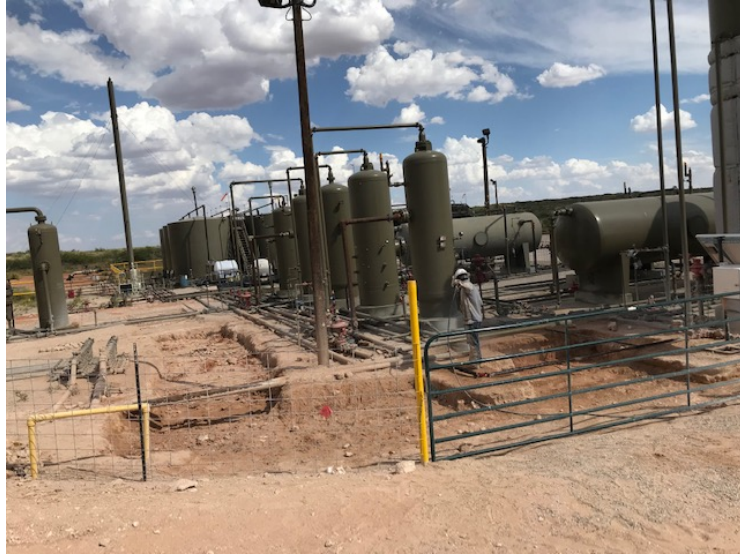
**Photograph 1:** East facing view of excavation.

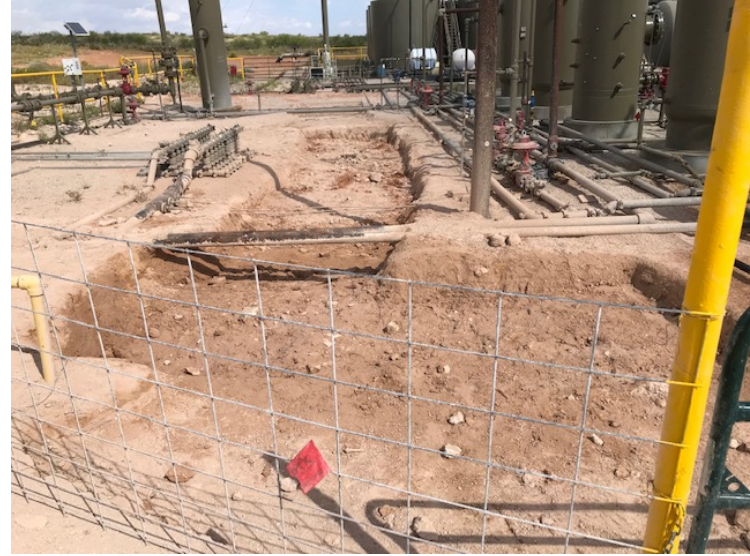
**Photograph 2:** East facing view of excavation.

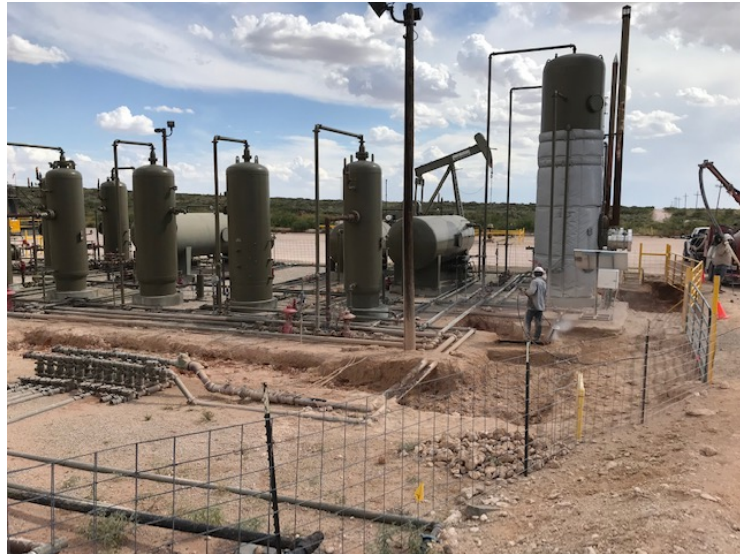
**Photograph 3:** South facing view of excavation.

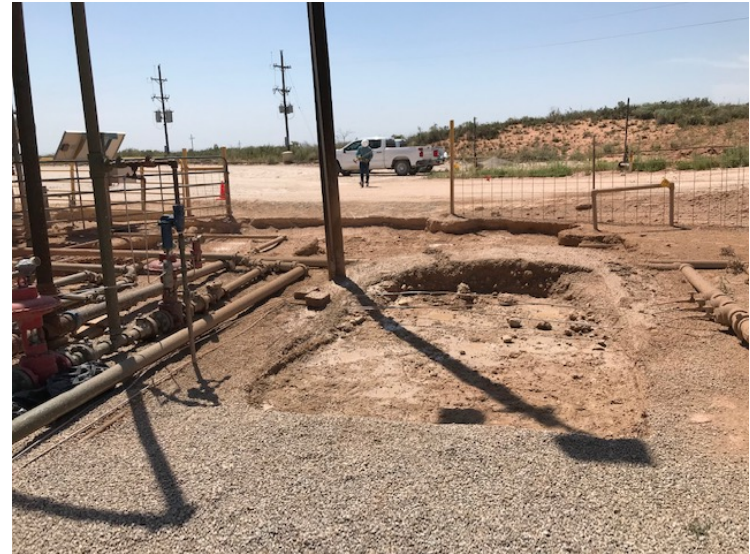
**Photograph 4:** West facing view of excavation.
