State of New Mexico  
Energy Minerals and Natural  
Resources Department

## Release Notification

| Site Name | Palmillo State #001H | Site Type | Production Well Facility flow line |

On October April 1, 2019, 0.9 barrels (bbls) of crude oil and 11.5 bbls of produced water were released to the ground surface due to corrosion of a steel, surface flow line. The line was clamped until repairs could be completed. A vacuum truck was immediately dispatched to the Site, recovering 0.3 bbls of crude oil and 3.7 bbls of produced water. Repairs to the clamped line were completed by XTO personnel. XTO reported the release to the New Mexico Oil Conservation Division (NMOCD) on Form C-141 on April 15, 2019, and RP Number 2RP-5389 was assigned.

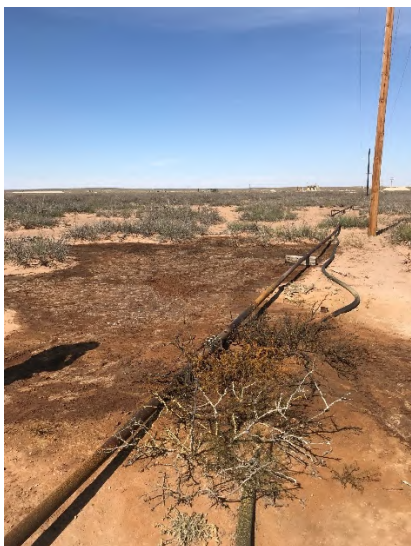
**Photograph 1:** Northeast facing view of the release extent.

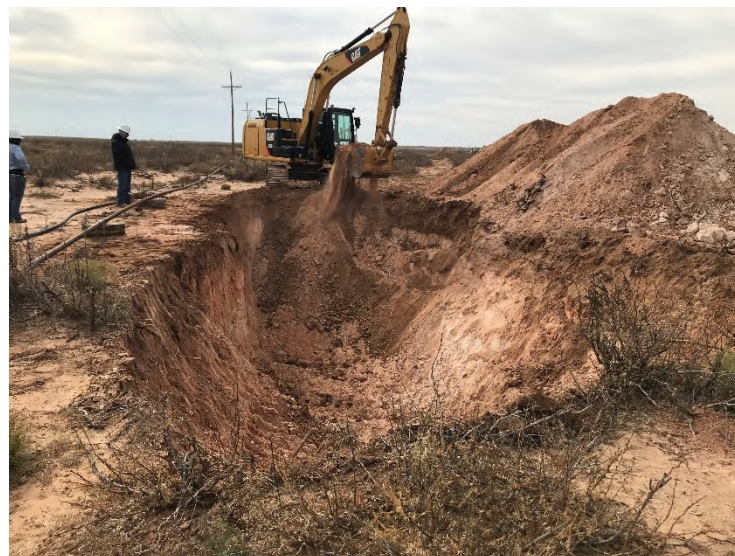
**Photograph 2:** Eastern view of site during excavation activities.

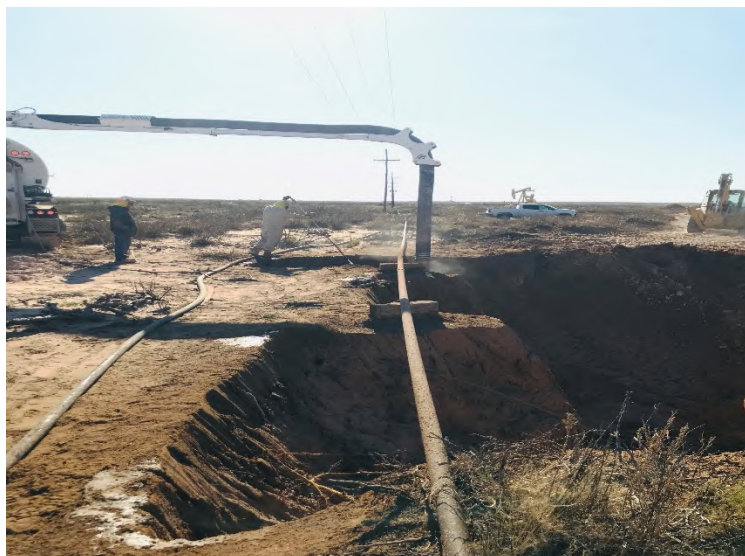
**Photograph 3:** Eastern view of site during Hydro-excavation activities.

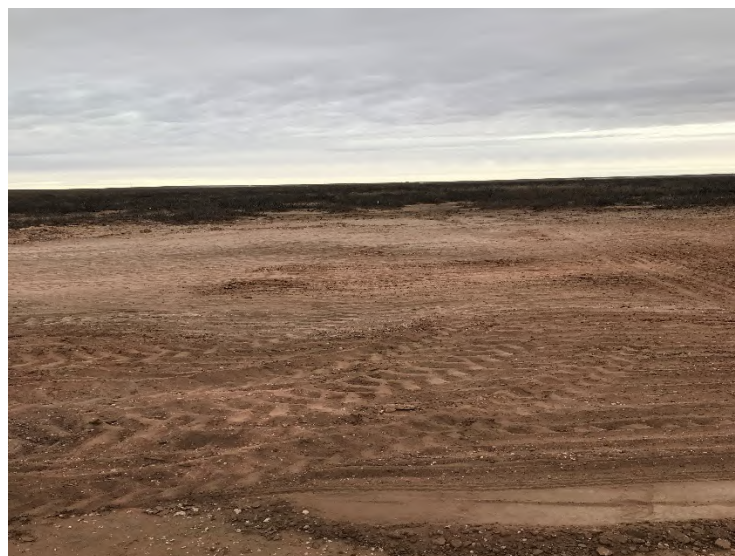
**Photograph 4:** View of backfilled excavation after re-seeding.
