Re: Site Closure Documentation
West Vacuum Unit #49 (RP #3312)

WEST VACUUM UNIT #49 FLOW LINE RELEASE SOIL ASSESSMENT AND DELINEATION ACTIVITIES REPORT

Unit N, Section 34, Township 17 South, Range 34 East
Lea County, New Mexico
RP #3312

September 2014 • 075867 • Report No. 1

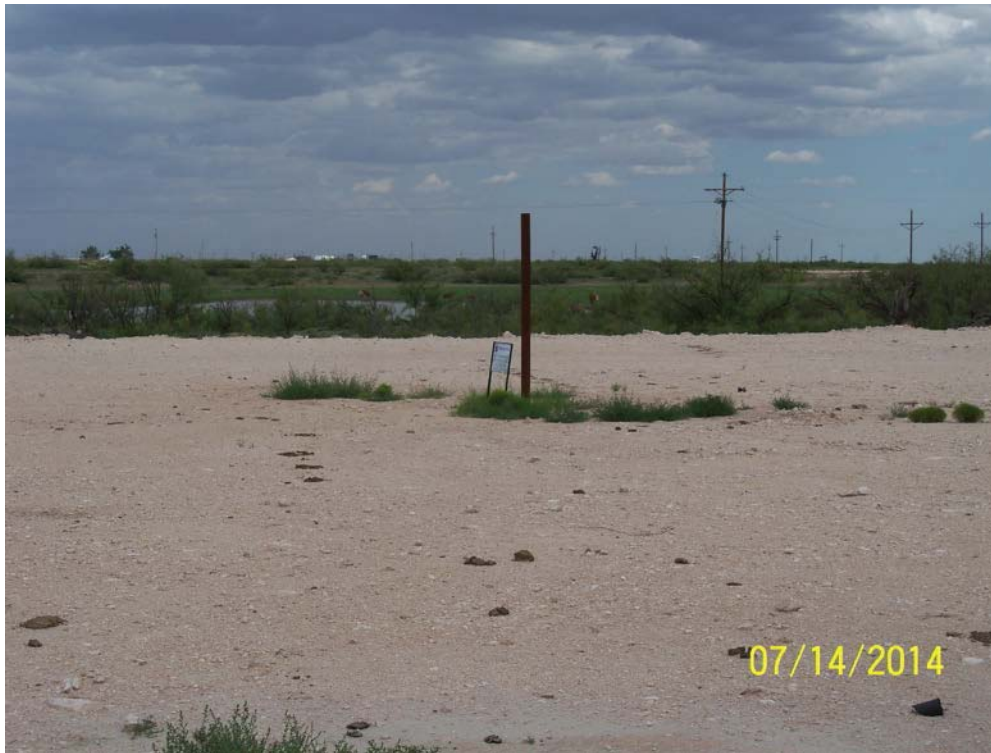
PHOTO 1: View of nearest well pad and soil sampling area in the background facing east

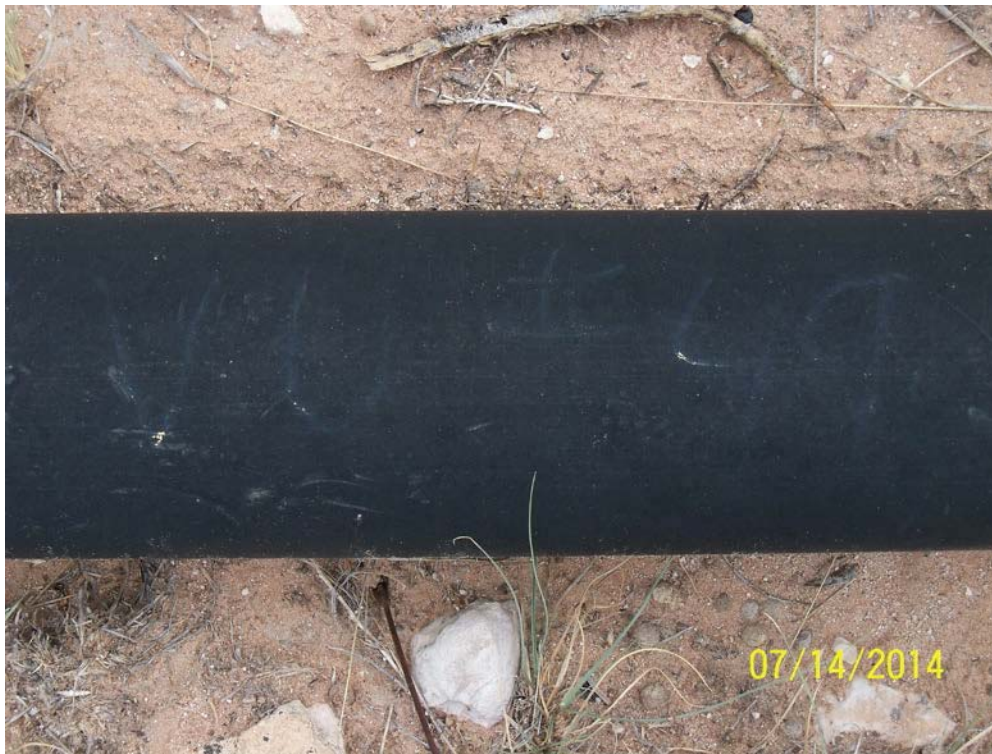
PHOTO 2: View of current WVU #49 Poly Flow Line in proximity to initial sample locations A & B

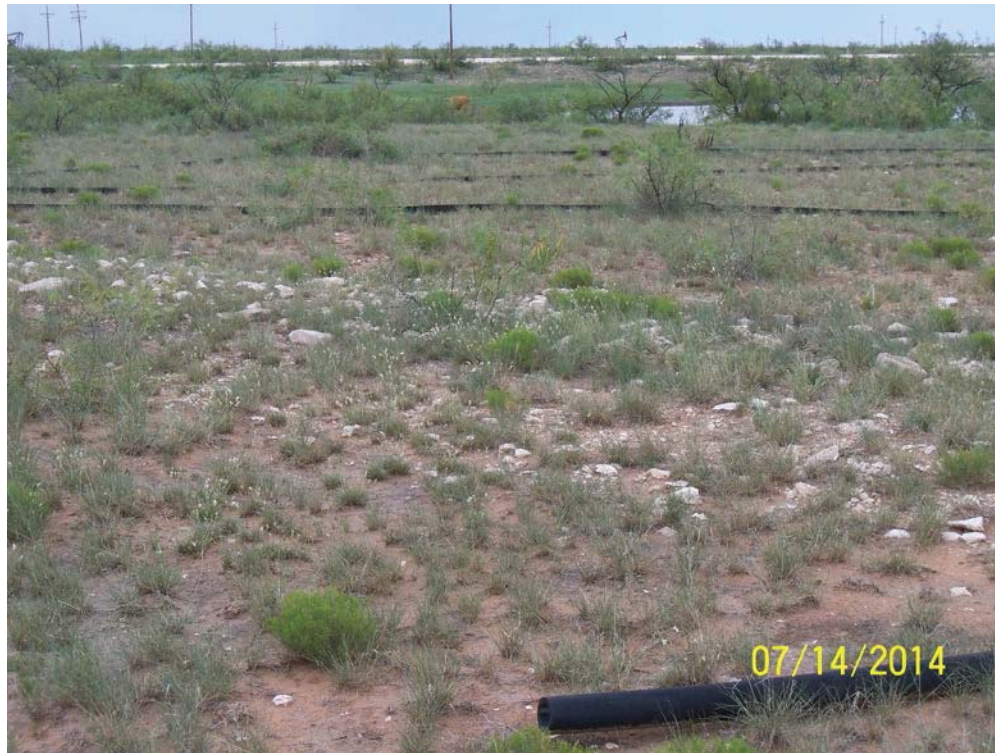
PHOTO 3: View of potentially repaired/replaced Poly Flow Line facing north

Chevron submitted a C-141 Form to the New Mexico Oil Conservation Division (NMOCD), District I, Hobbs, New Mexico office dated April 7, 2011. The NMOCD assigned a Remediation Permit No. 3312 (RP # 3312) to the release in September of 2014. The C-141 described a release of 0.07 barrels (bbls) of oil and 9 bbls of produced water, of which 0 bbls of fluids were recovered. The source of the release was reported to have been due to a failed seam on the poly flow line. Chevron shut-in the line and made arrangements to repair the damaged flow line.

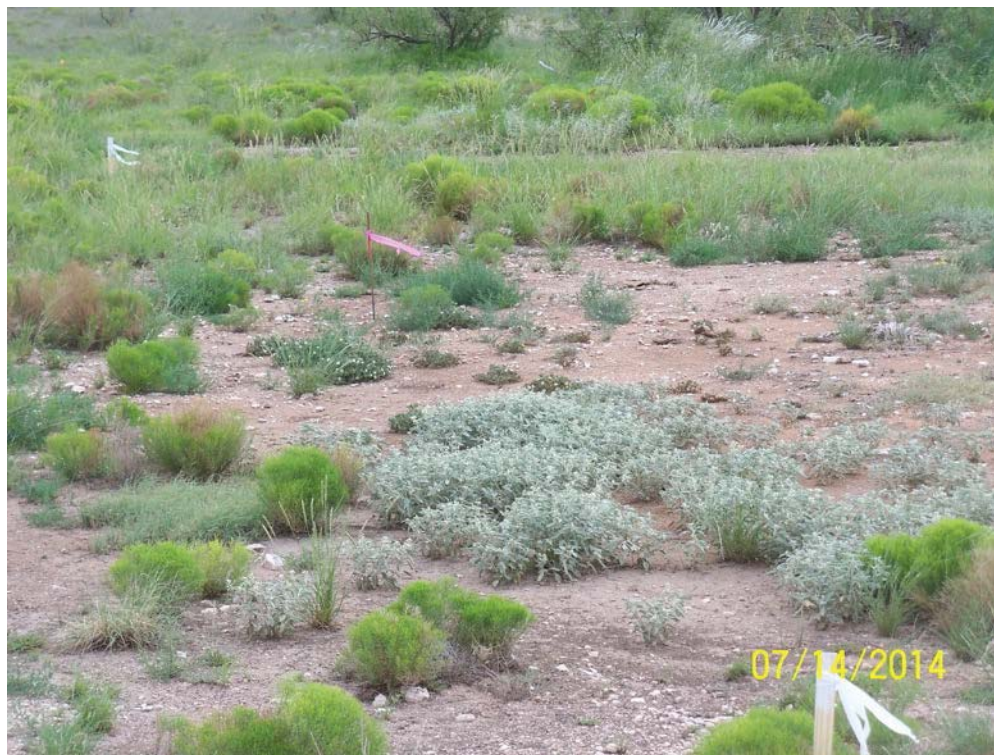
PHOTO 4: View of sampling area including proposed boring location (center) and New Mexico one-call parameters (white) flagged

On July 14, 2014, CRA mobilized to the Site to perform a site visit. During the site visit, proposed hand auger boring locations were marked, and New Mexico one-call parameters were flagged for utility locating purposes. In addition, the Site was walked to observe site features and identify the West Vacuum Unit #49 flow line in proximity to Chevron’s initial soil sample (A and B) collections. A photo log documenting site details and walk-through activities is included as Appendix B.
