DEFERRED REQUEST

**Poker Lake Unit 274**

**Tank Battery**

**RE: Deferral Request  
Poker Lake Unit 274 Tank Battery  
Remediation Permit Number 2RP-2978  
Eddy County, New Mexico**

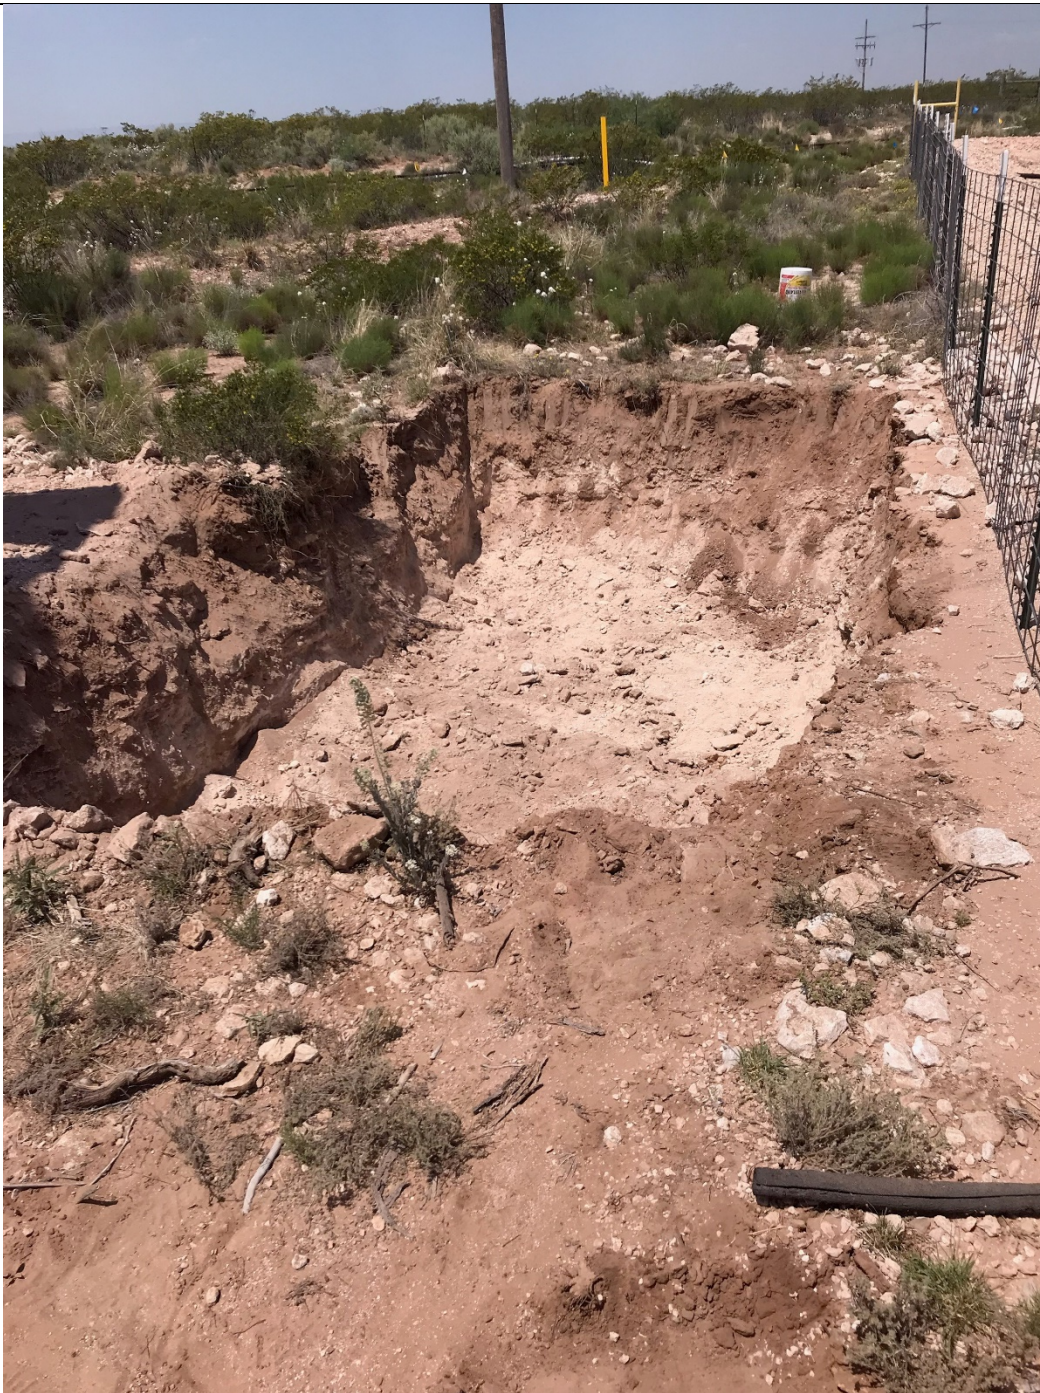
**View facing west of the excavation in the pasture area south of the well pad.**

The excavation in the pasture area south of the well pad measured approximately 130 square feet in area with a depth of 4 feet bgs. Composite soil samples SW01 and SW02 were collected from the sidewalls of the excavation from a depth of 0 to 4 feet bgs. Composite soil sample FS02 was collected from the floor of the excavation from a depth of 4 feet bgs.

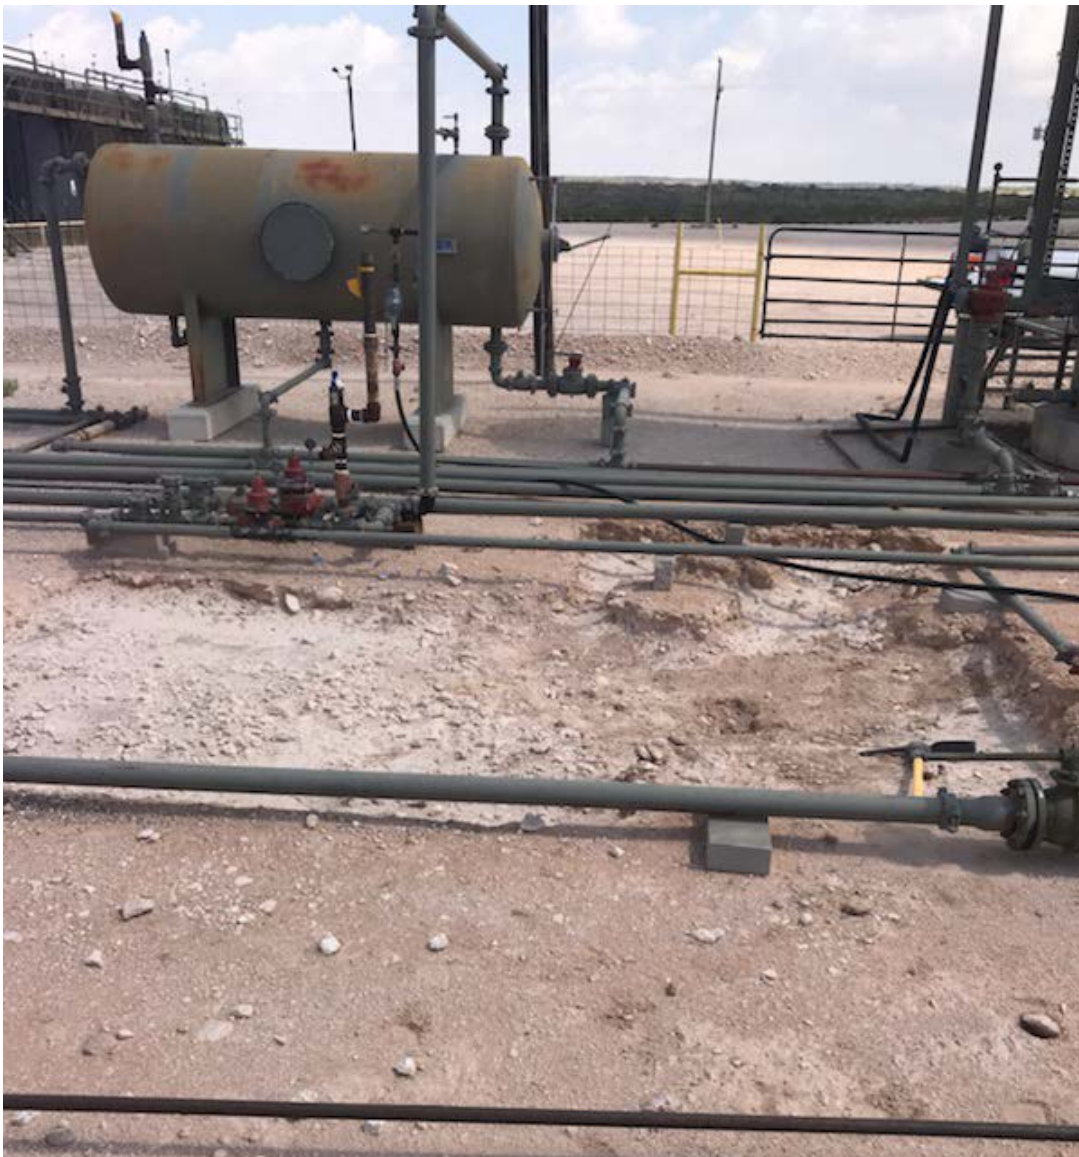
**View facing north of the excavation within the process equipment containment.**

The excavation within the process equipment containment area measured approximately 200 square feet in area with a depth of 0.25 feet bgs. Due to the shallow depth of the excavation, one composite soil sample (FS01) was collected from the floor of the excavation from a depth of 0.25 feet bgs. The excavation soil samples were collected, handled, and analyzed as described above and submitted to Xenco Laboratories in Midland, Texas.

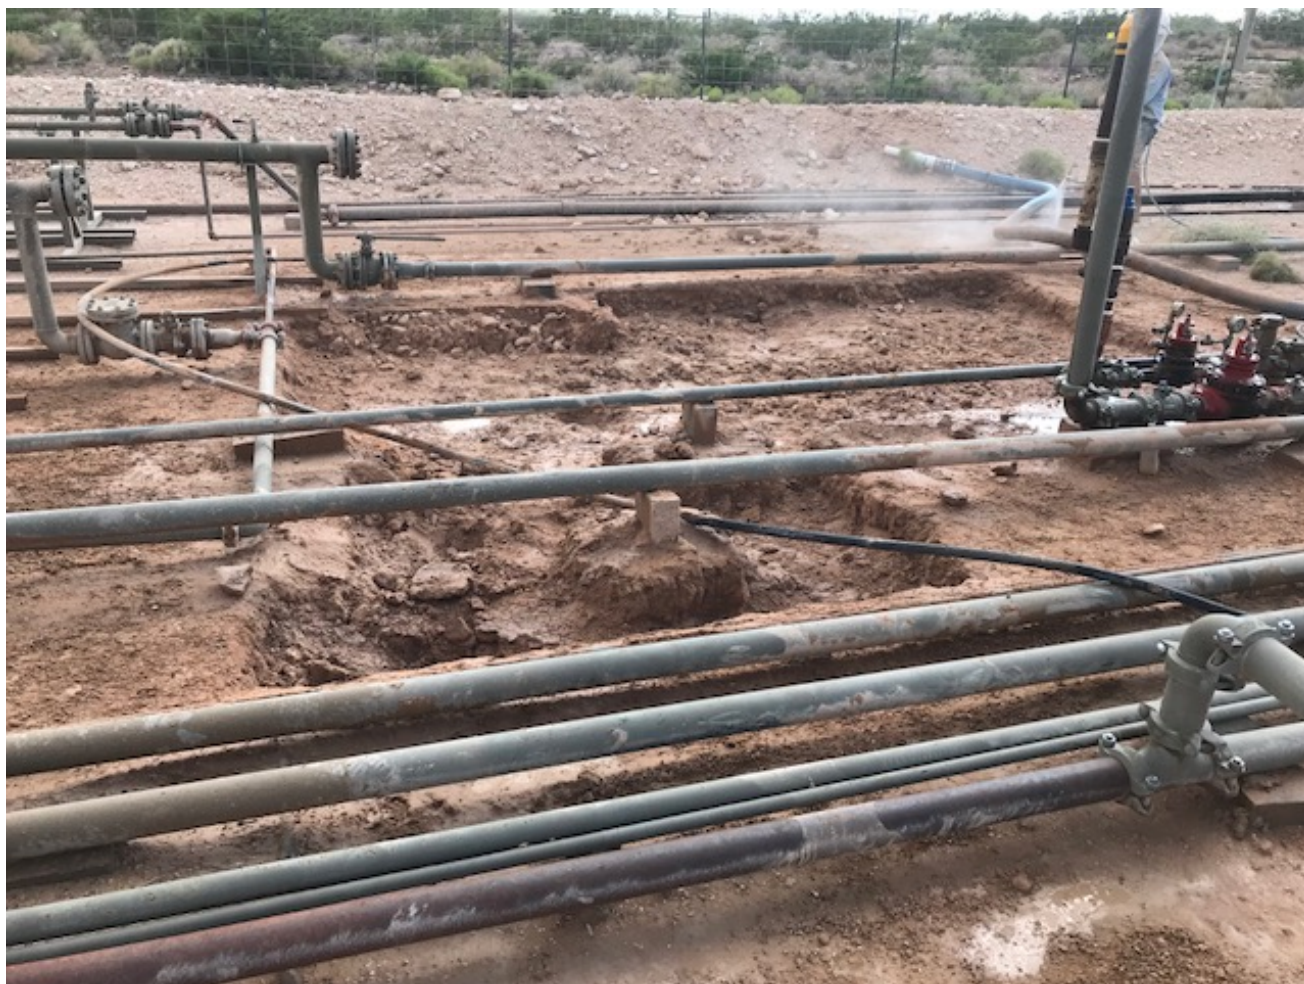
**View facing south of the excavation within the process equipment containment.**
