**1RP-4122**

MARS STATE #1 TB

## **CLOSURE REPORT**

**MACK ENERGY CORPORATION**  
**MARS STATE #1 TB**  
**LEA COUNTY, NEW MEXICO**  
**UNIT LETTER "H", SECTION 5, TOWNSHIP 14 SOUTH, RANGE 34 EAST**  
**LATITUDE 33.13519° N, LONGITUDE 103.52582° W**  
**API NUMBER: 30-025-23172**  
**1RP – 4122**  
**JUNE 2019**

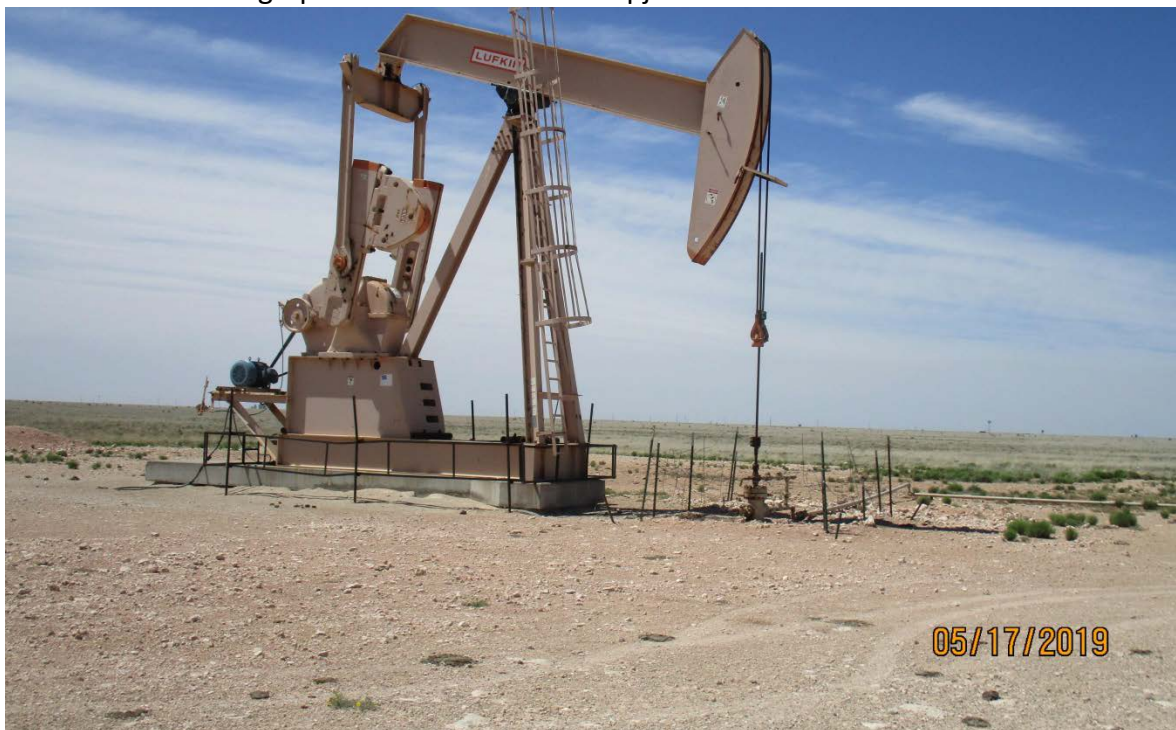
Photograph 1: Mars State # 1 Pumpjack and Location of Release

On the evening of January 25, 2016, the wellhead at Mack Energy Corporation's (Mack) Mars State #1 Tank Battery developed a valve leak, resulting in a minor release of an estimated 5-6 bbls of oil onto the pad. The release was discovered at approximately 7:00am on January 26, 2016, at which time the well was shut in. An area of dirt and caliche was removed to a depth of one foot for approximately 10 feet around the wellhead and an additional 20 feet toward the tank battery where misting had occurred. The contaminated material was removed offsite for proper disposal.

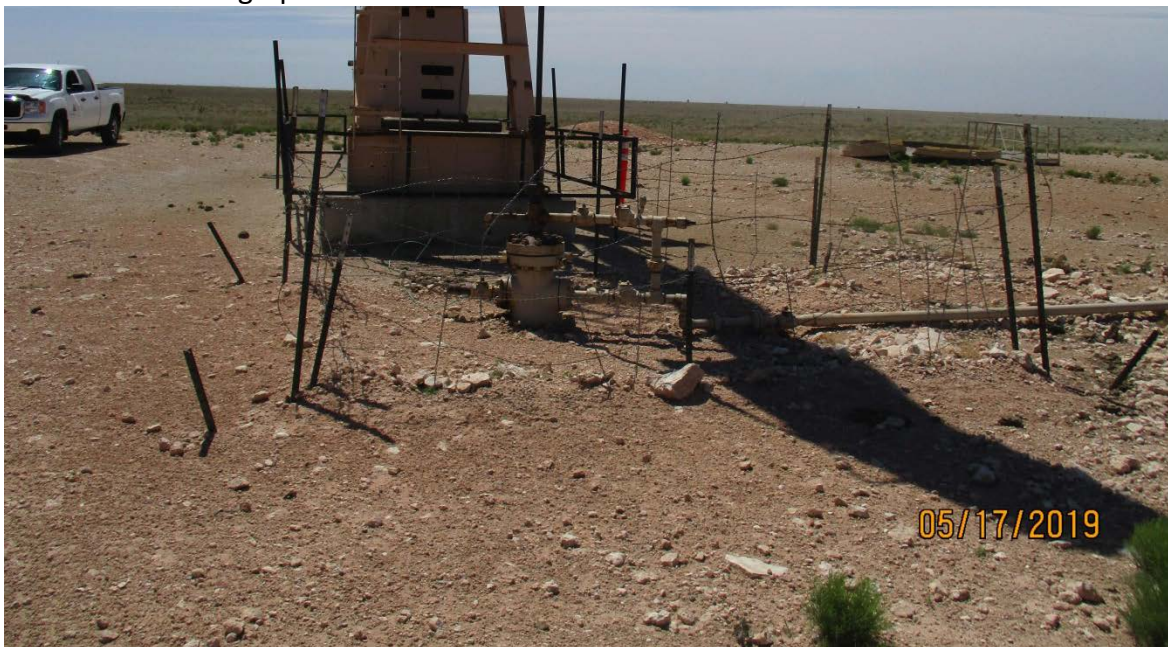
Photograph 2: Mars State Location of Removed Contaminated Soil

On the Mars State Tank Battery a spill occurred due to a leaking valve. We immediately shut well in upon discovery. Removed one foot of contaminated dirt/caliche. Hauled off location to proper disposal. Will fill in with caliche.

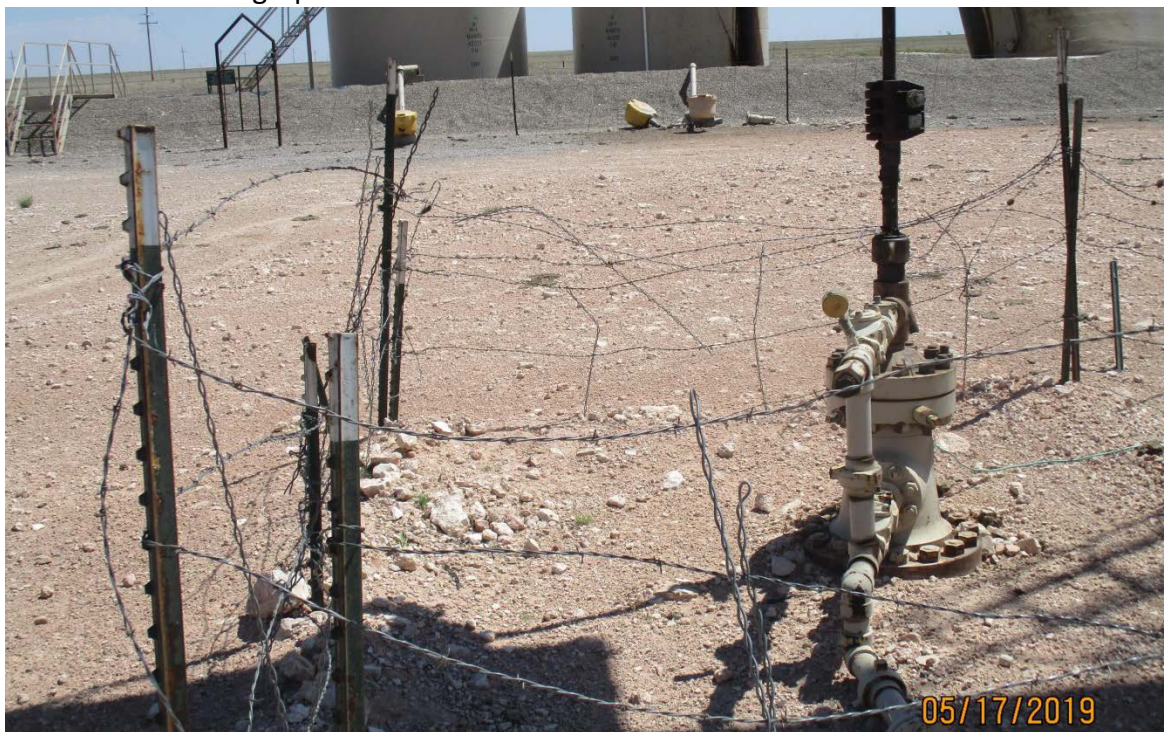
Photograph 3: Remediated Area Around and South of Wellhead

The site evaluation and confirmation sampling conducted on May 17, 2019 revealed no TPH, BTEX, or chlorides concentrations exceeded 19.15.29.12 NMAC closure criteria as shown in Table 2 above, in the area of the release. The inspection confirmed that the spill was confined to the well pad and that the initial soil removal was effective in removing contaminants of concern from the site. The levels of contaminants that remain at the release site fall within NM OCD requirements for sites with a similar depth to groundwater and there are no indications of adverse conditions on or near the site.

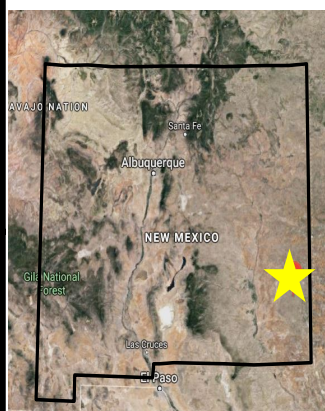
**Figure 1**

Mars State is located on privately-owned land in the northeast portion of Section 5, Township 14 South, Range 34 East in north-central Lea County (Figure 1). This location is within the Permian Basin in southeast New Mexico.

There is no surface water located at Mars State. The nearest significant watercourse as defined in Subsection P of 19.15.17.7 NMAC is an intermittent stream located 18 miles south of the release (Figure 1).

### Site Location Map and Nearest Surface Water Mars State #1
