**Chevron Special
Projects**

VGSAU 16

Re : Chevron Special Projects – VGSAU 16 (RP# 3256)

Please find enclosed for your records, a copy of the final report documenting the final closure activities at the Vacuum Grayburg San Andres Unit No. 16 (RP #3256).

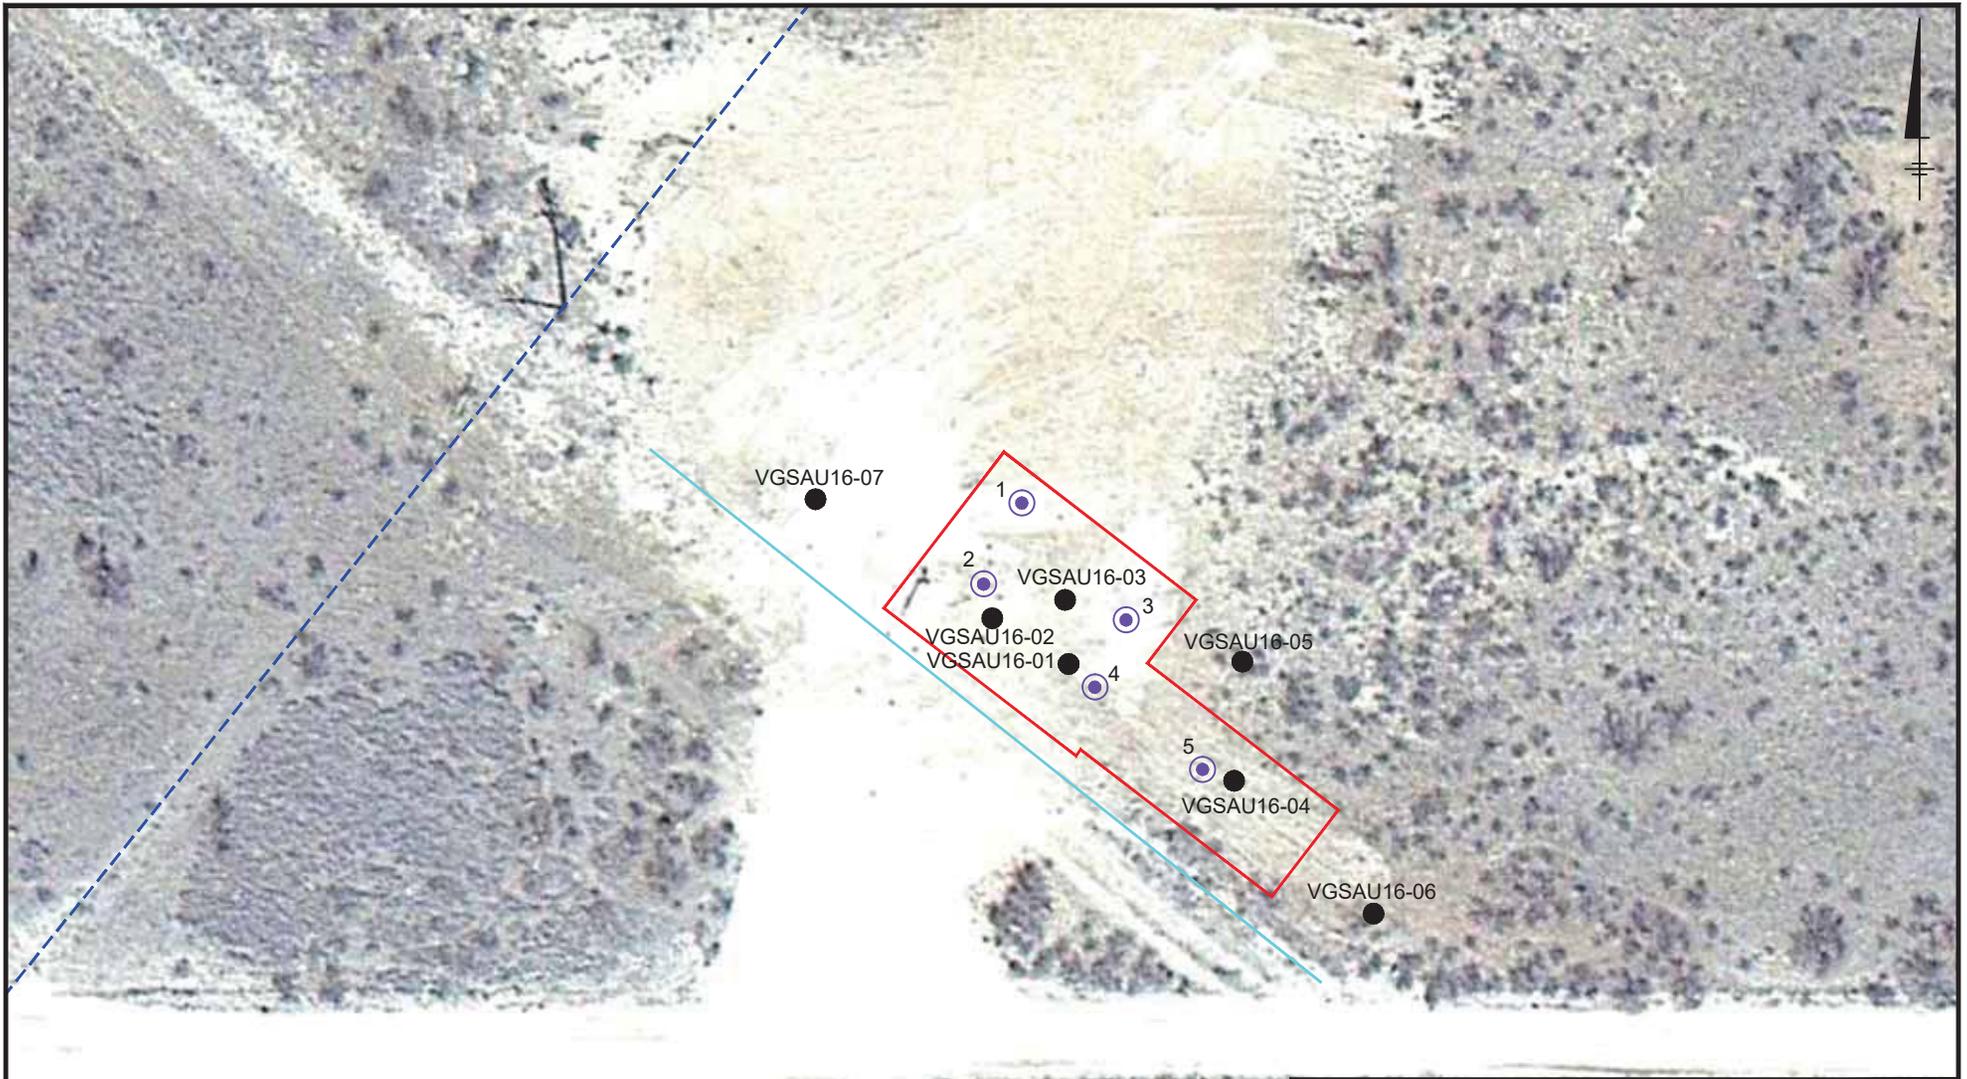
- MAY 2013 ASSESSMENT SOIL SAMPLING LOCATION
- 1 ○ OCTOBER 2011 CONFIRMATION SOIL SAMPLING LOCATION
- UNDERGROUND UTILITY LINE
- - - ABOVE GROUND UTILITY LINE
- APPROXIMATE EXTENT OF SPILL

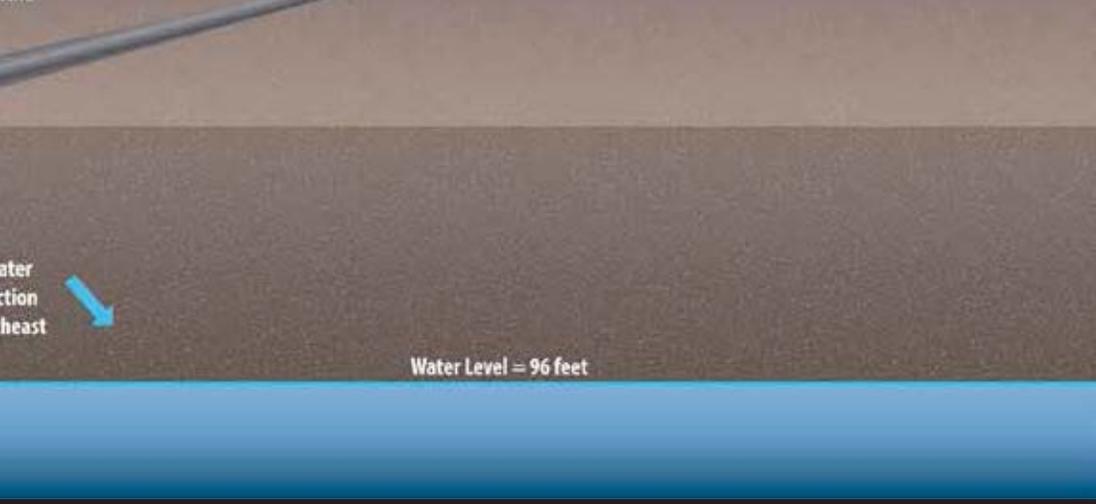
precipitation and high evapotranspiration rates. According to information obtained from the NMOSE online database, groundwater near the site is encountered at a depth of approximately 96 feet.

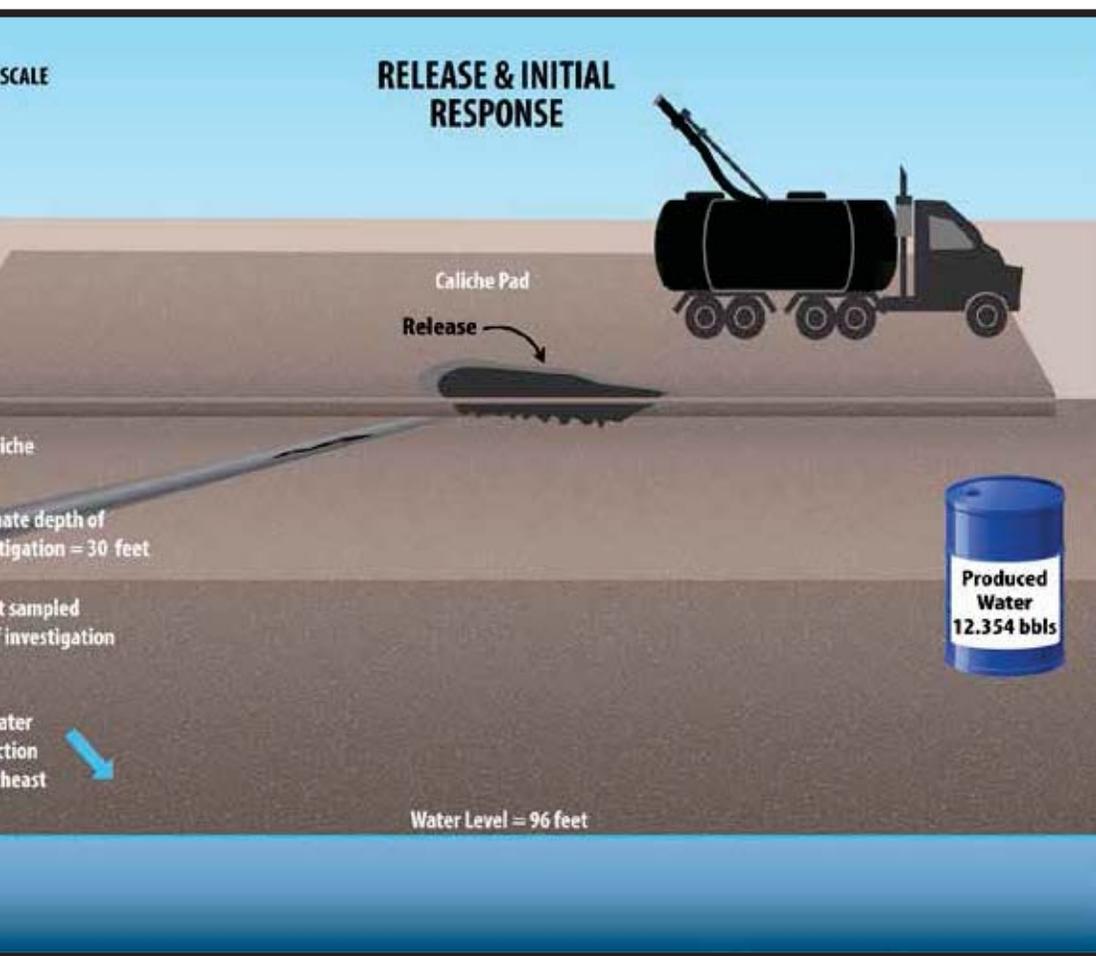
A release of approximately 12.354 bbls of produced water occurred at the site on November 10, 2011 due to a pinhole in an underground utility line. Chevron personnel from the Midcontinent Operating Unit (MCBU) stopped the release and recovered an approximately 12 bbls using a vacuum truck. Chevron MCBU personnel excavated visually impacted areas in the area to a depth of approximately 30 feet bgs and collected five discrete confirmation soil samples from the excavation. Analyte concentrations in one or more confirmation soil samples were above regulatory criteria, which prompted additional site assessment activities.

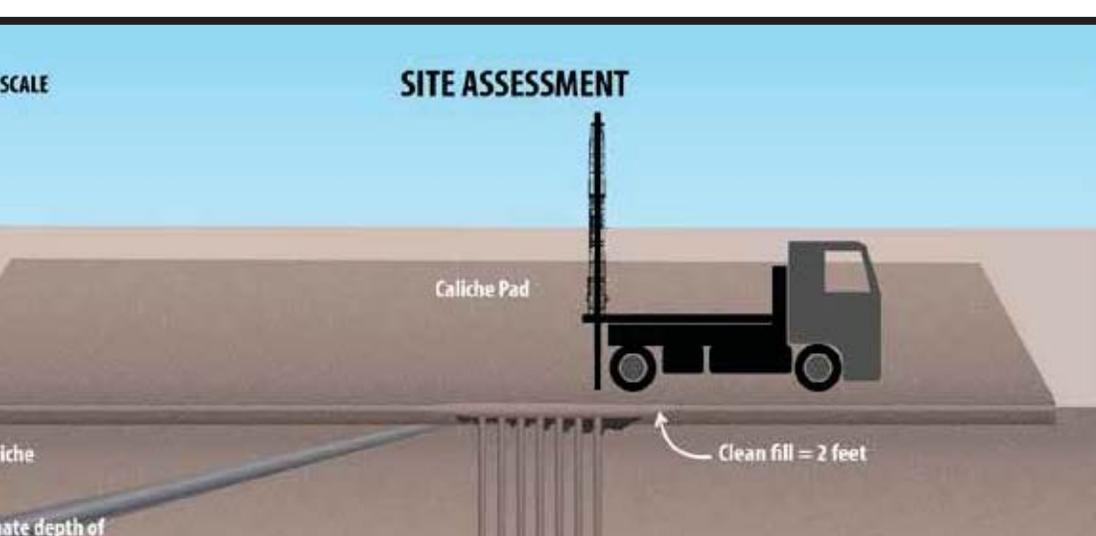
In May 2013, ARCADIS conducted site assessment activities to characterize the lateral and vertical extents of soil contamination at the site. Soil boring locations were based on the results of confirmation soil sampling completed at the site in 2011, locations of pipelines and equipment at the site, and the extent of the release as documented by Chevron personnel during the initial response activities. Analyte concentrations in soil samples collected during the 2013 assessment were reported below site-specific critical values. Assessment activities demonstrated

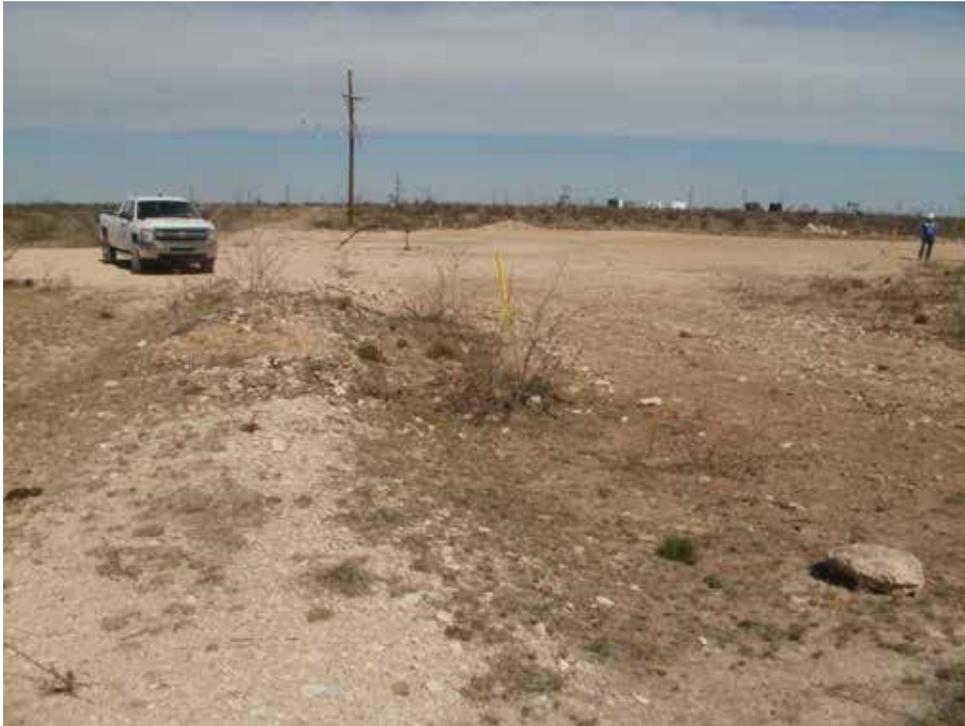
Photograph 1 – Vacuum Grayburg San Andres Unit #16; Facing Northwest

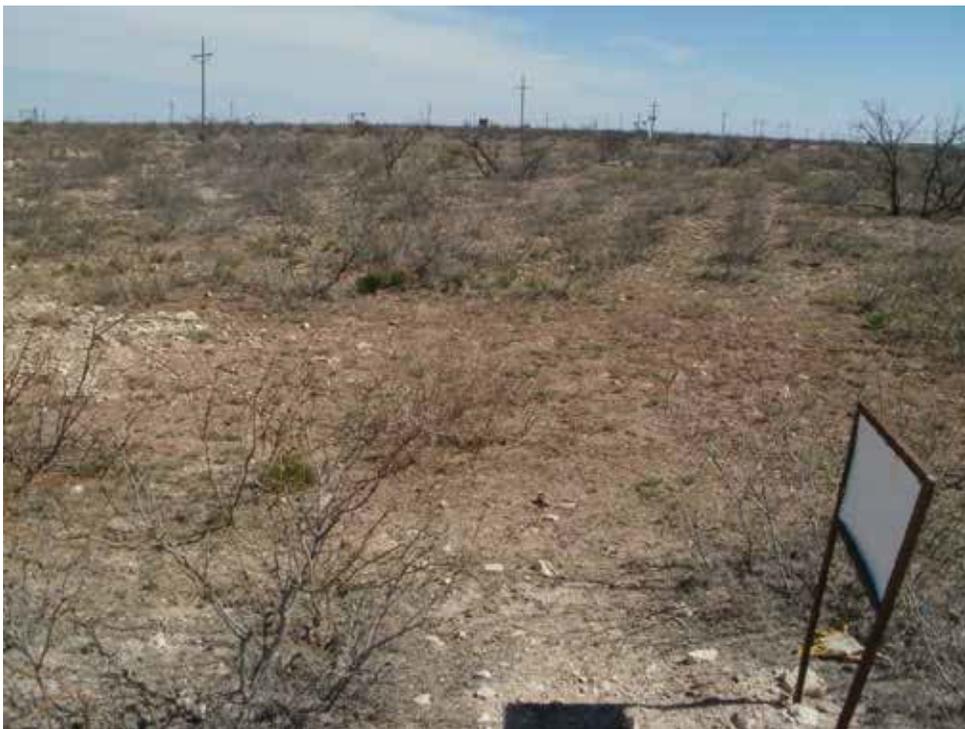
Photograph 2 – Vacuum Grayburg San Andres Unit #16 release area; Facing Northeast

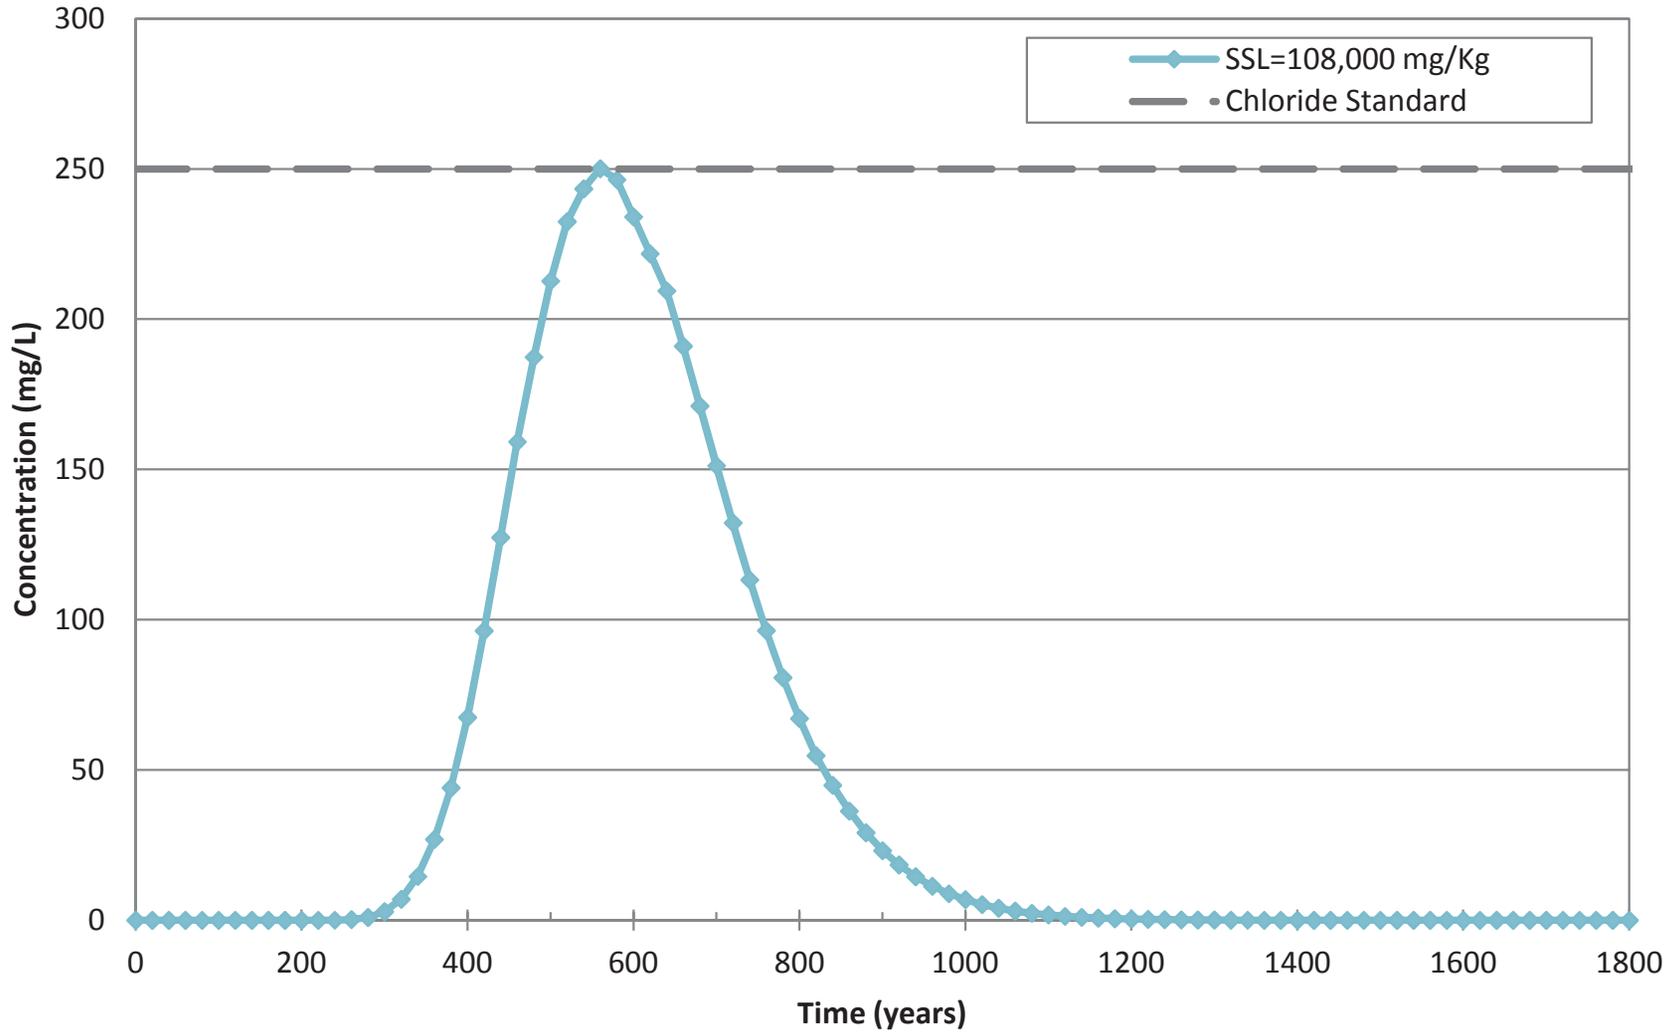
Figure 1
MULTIMED Simulated Chloride Concentration Vs Time in Groundwater
(Source = 20m, Chloride 0-1m, & Depth to Groundwater = 20m)

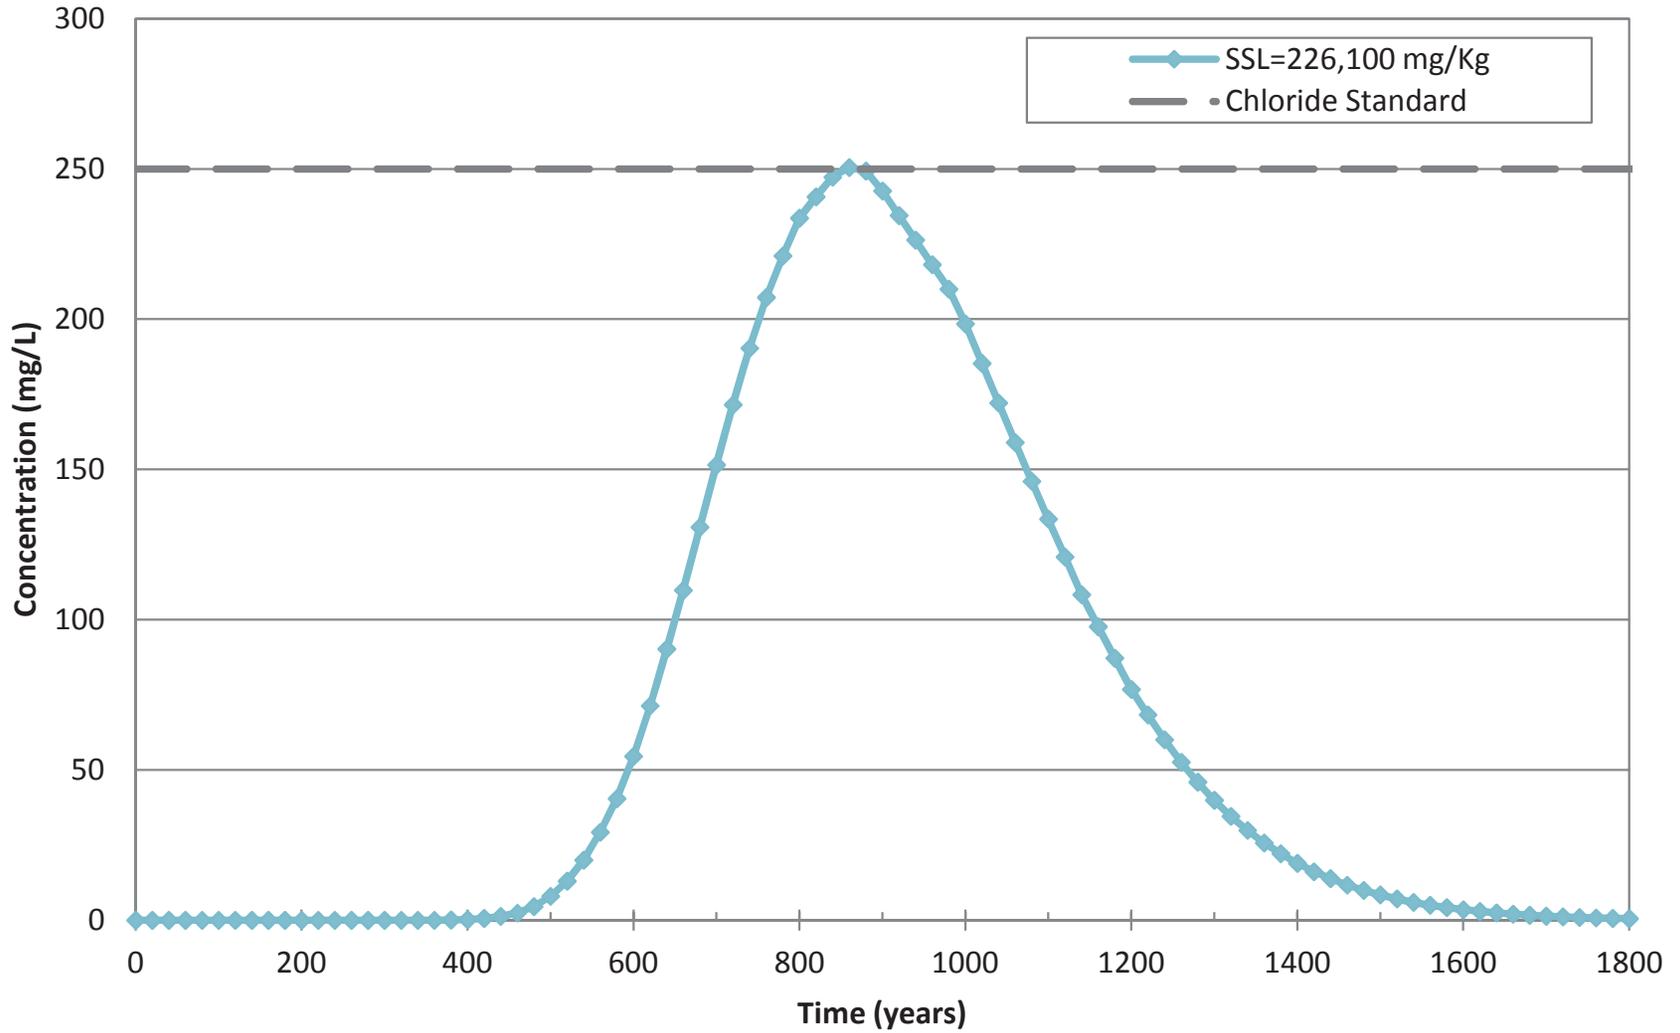
Figure 2
MULTIMED Simulated Chloride Concentration Vs Time in Groundwater
(Source = 20m, Chloride 0-1m, & Depth to Groundwater = 30.5m)

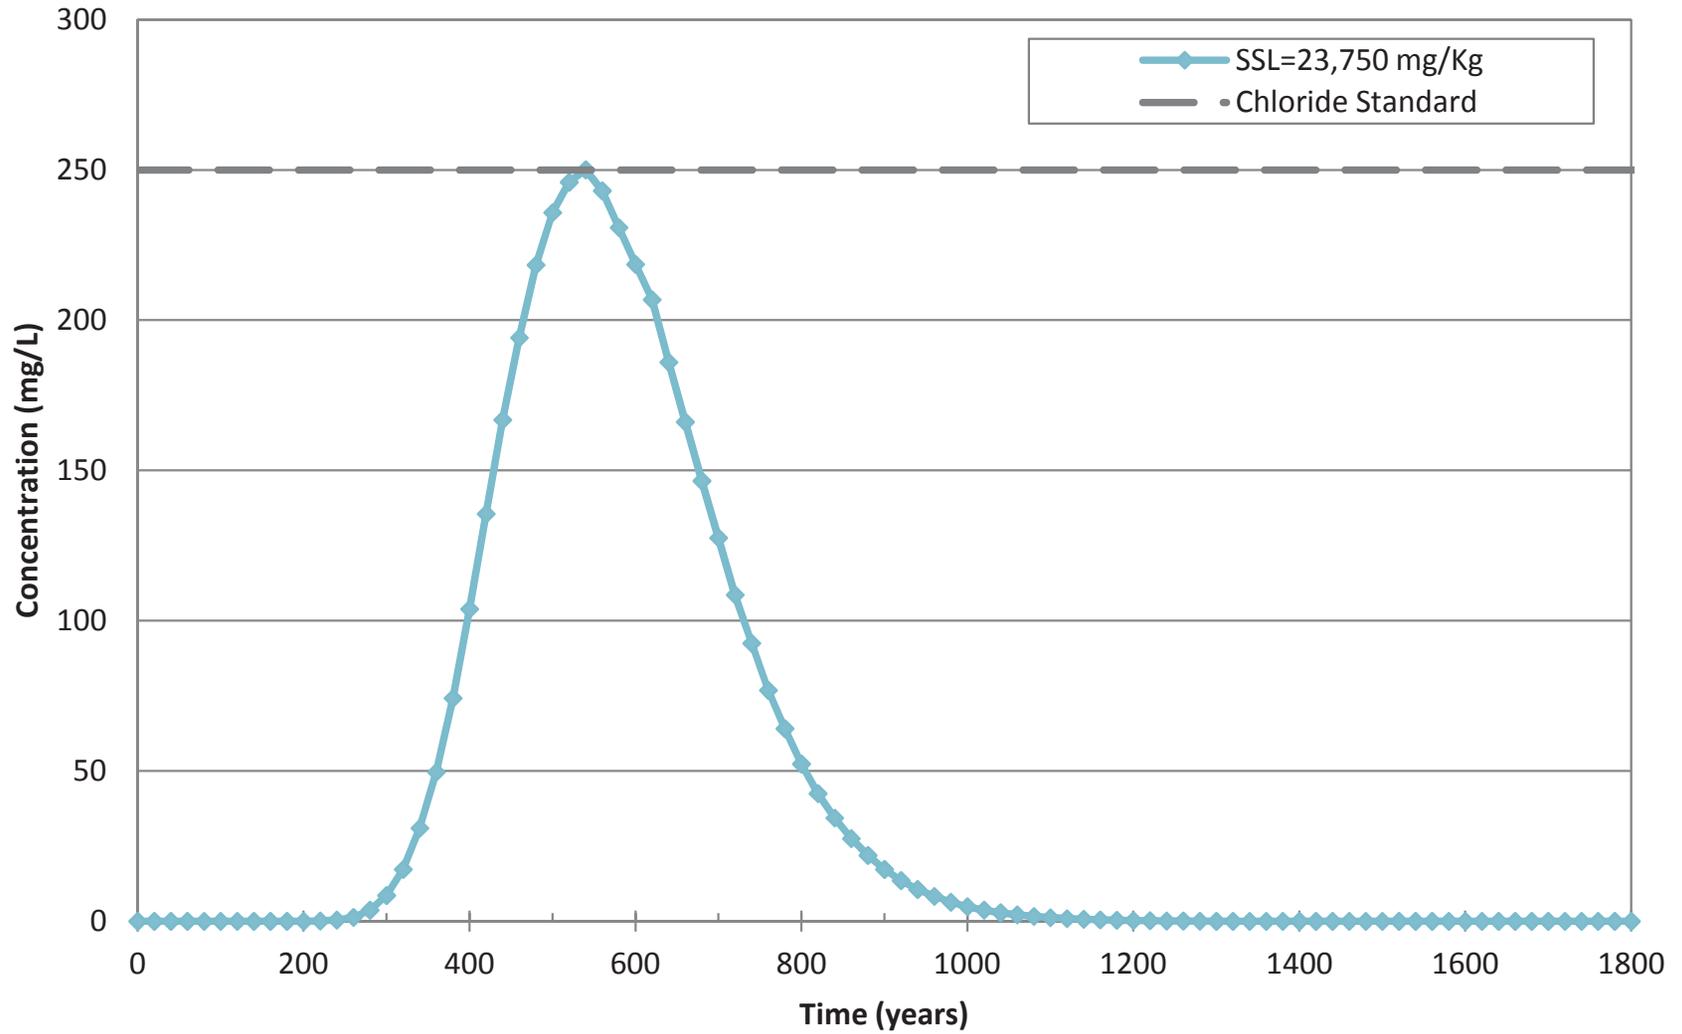
Figure 3
MULTIMED Simulated Chloride Concentration Vs Time in Groundwater
(Source = 20m, Chloride 0-3m, & Depth to Groundwater = 20m)

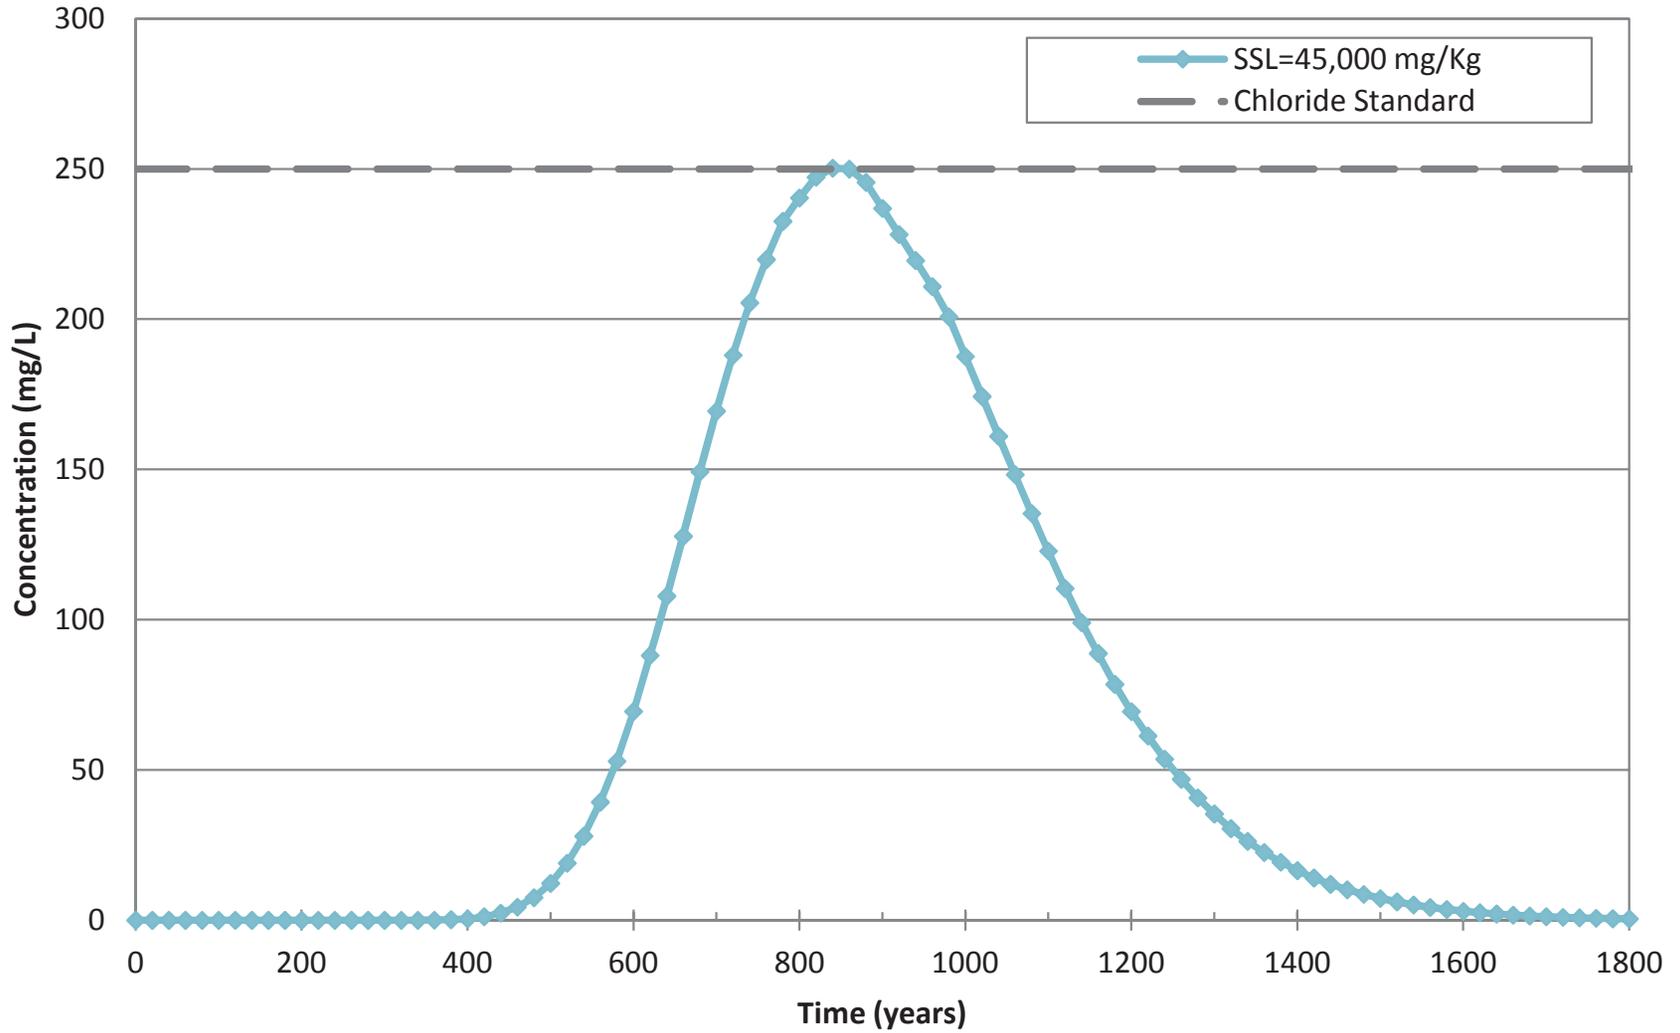
Figure 4
MULTIMED Simulated Chloride Concentration Vs Time in Groundwater
(Source = 20m, Chloride 0-3m, & Depth to Groundwater = 30.5m)

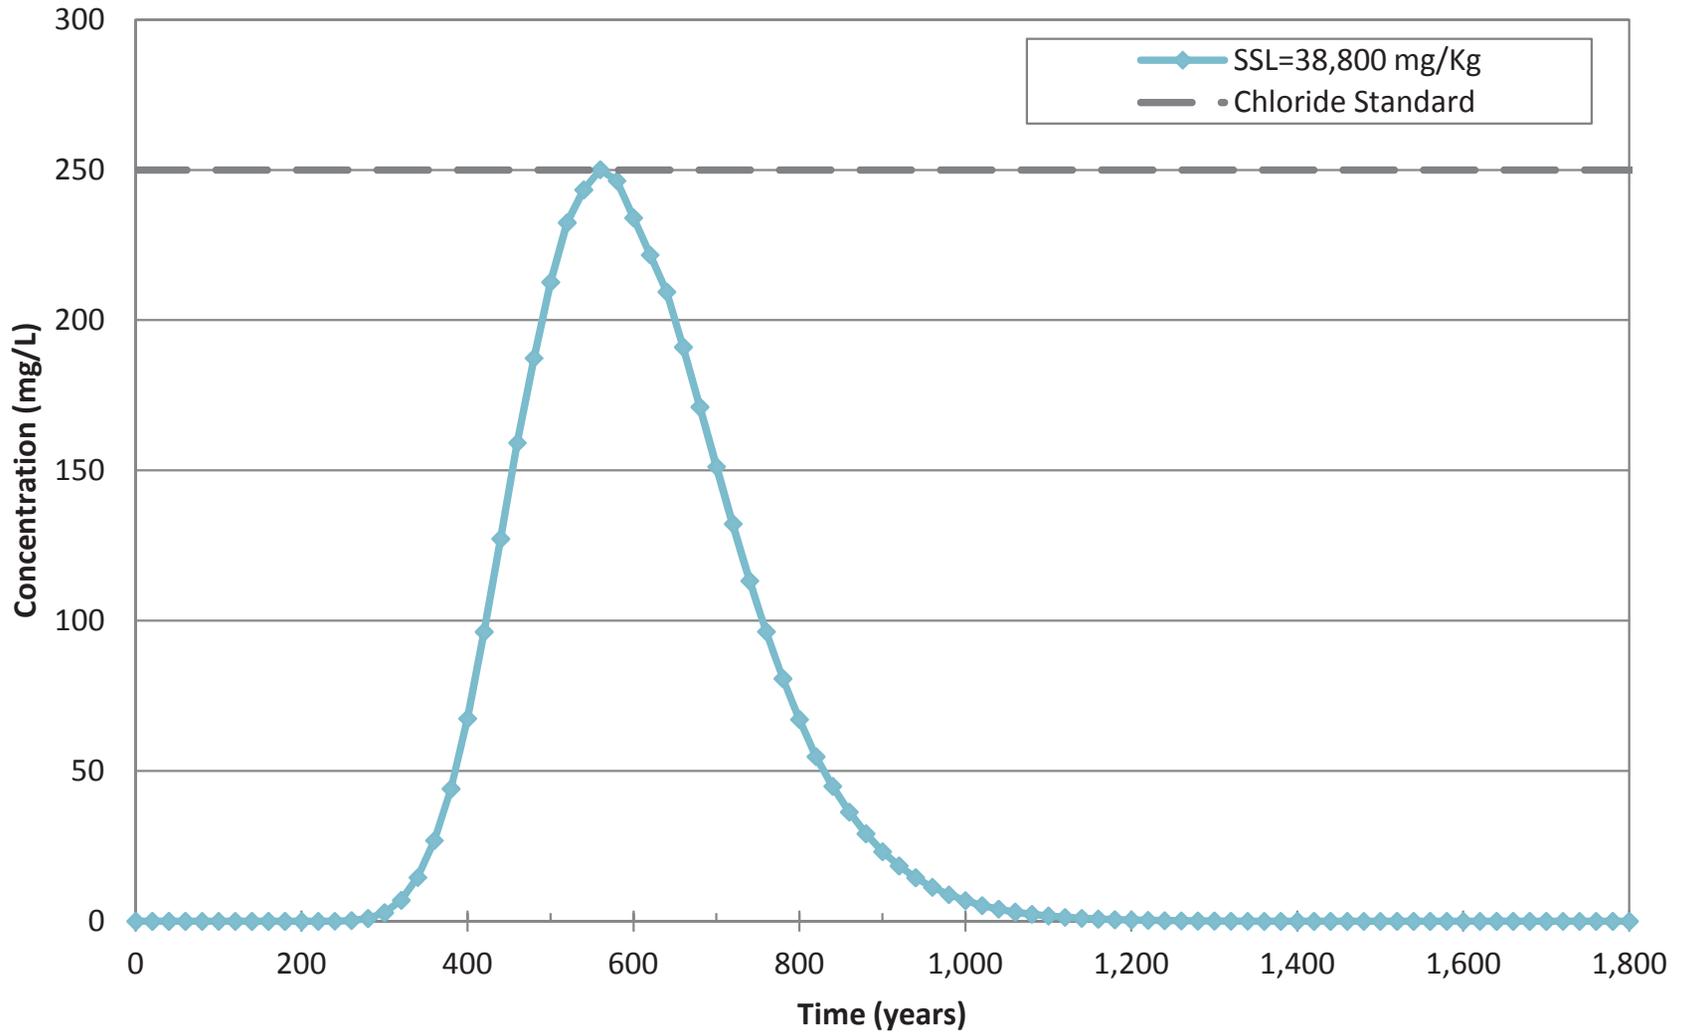
Figure 5
MULTIMED Simulated Chloride Concentration Vs Time in Groundwater
(Source = 45m, Chloride 0-1m, & Depth to Groundwater = 20m)

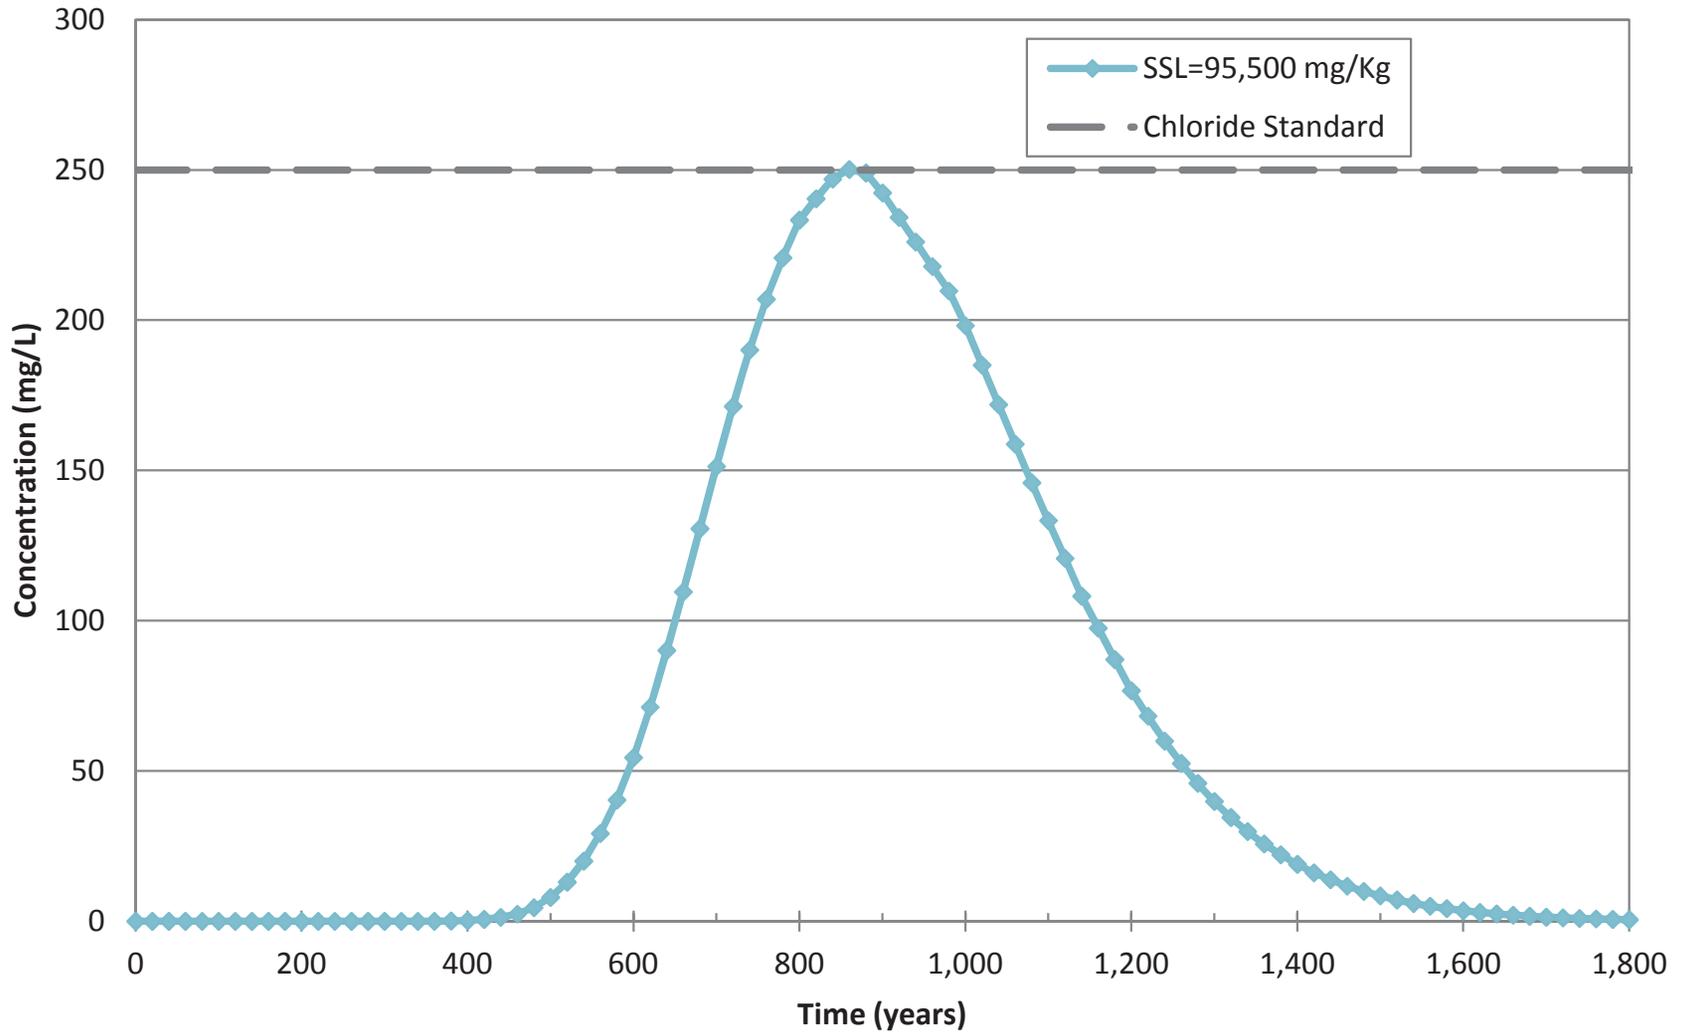
Figure 6
MULTIMED Simulated Chloride Concentration Vs Time in Groundwater
(Source = 45m, Chloride 0-1m, & Depth to Groundwater = 30.5m)

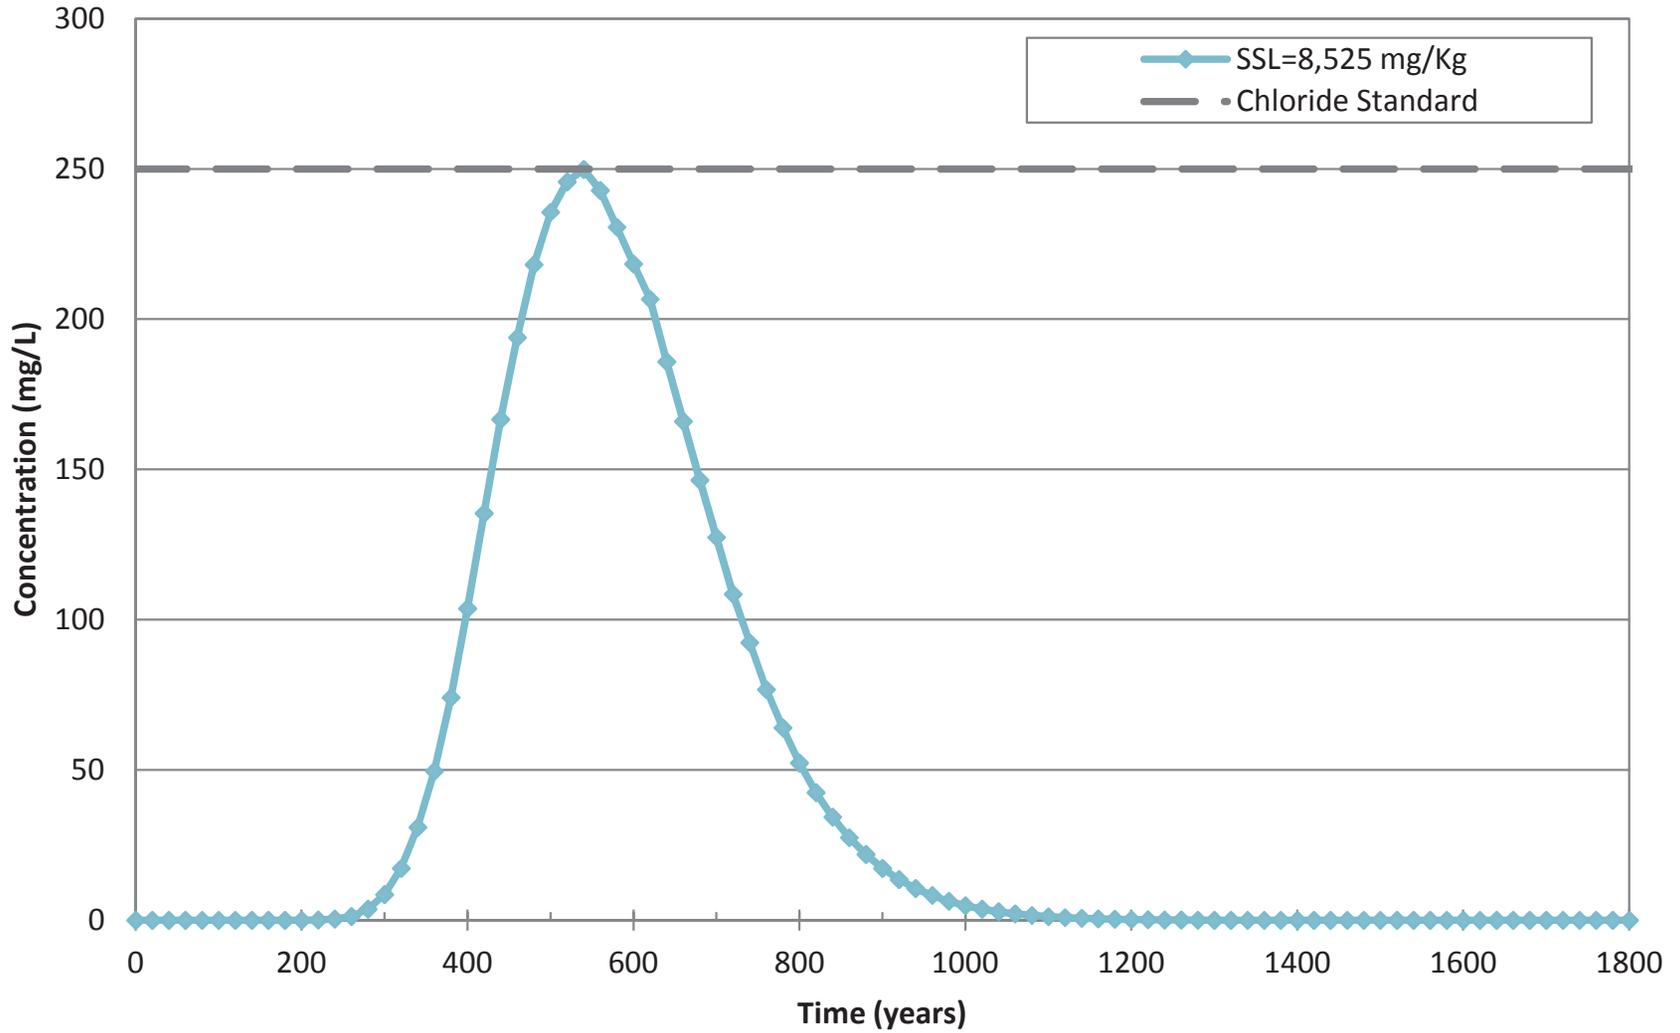
Figure 7
MULTIMED Simulated Chloride Concentration Vs Time in Groundwater
(Source = 45m, Chloride 0-3m, & Depth to Groundwater = 20m)

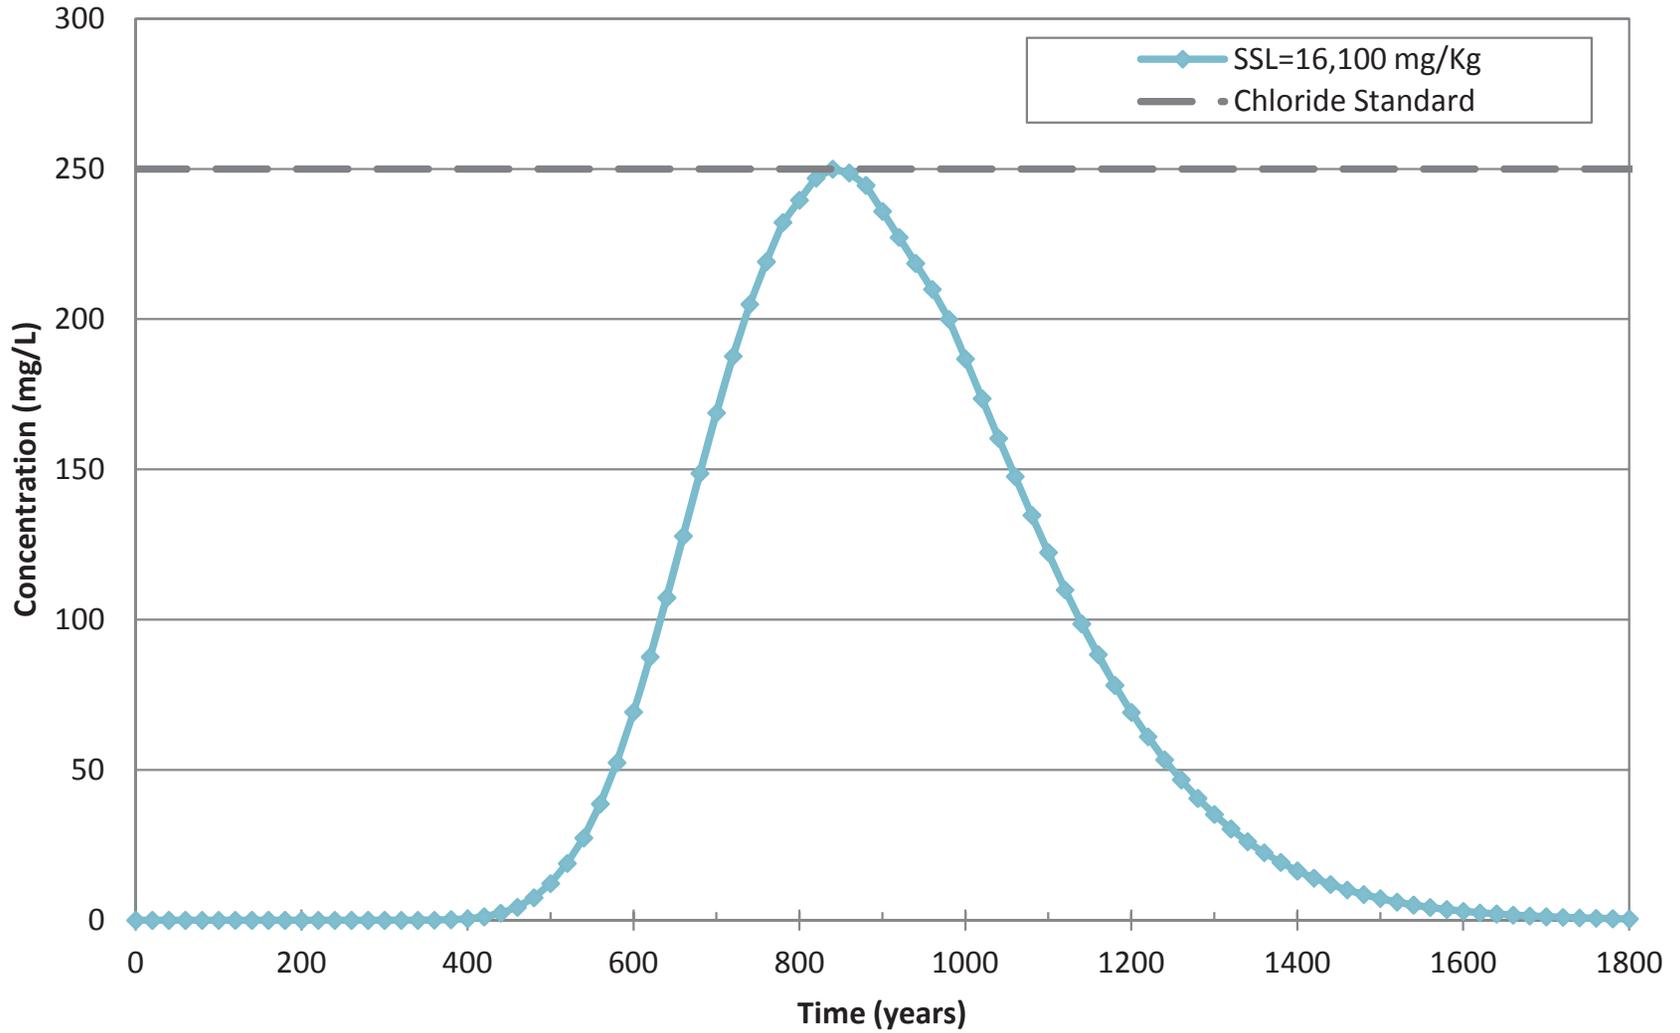
Figure 8
MULTIMED Simulated Chloride Concentration Vs Time in Groundwater
(Source = 45m, Chloride 0-3m, & Depth to Groundwater = 30.5m)
