# Closure of Release Investigation and Remedial Action Plan

Okeanos #1 SWD Flowback Line (NMOCD Reference #: 1RP-5407)

Terracon Project No. AR197105

RE: **Closure of Release Investigation and Remedial Action Plan**  
Okeanos #1 SWD Flowback Line (NMOCD Reference #: 1RP-5407)  
Unit M Section 36, T20S, R32E, Lea County, New Mexico  
Terracon Project No. AR197105

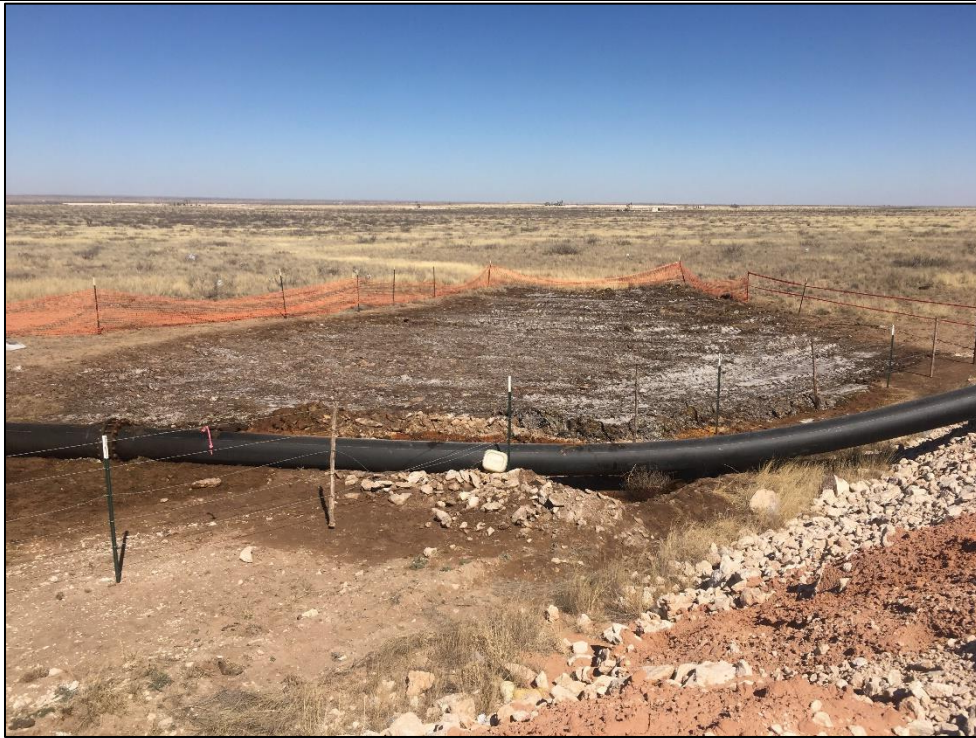
**PHOTO 1:** View of Release Origin, facing Northeast. 2/25/2019 / **TIME:** 2:11PM / **GPS:** 32.5253 -103.5211

Initial source elimination was accomplished by the Solaris foreman shutting in the leaking line and replacing the malfunctioning gasket. Solaris deployed M&J Oilfield Services (M&J), an on-site contractor, to secure the site and perform containment and site stabilization activities.

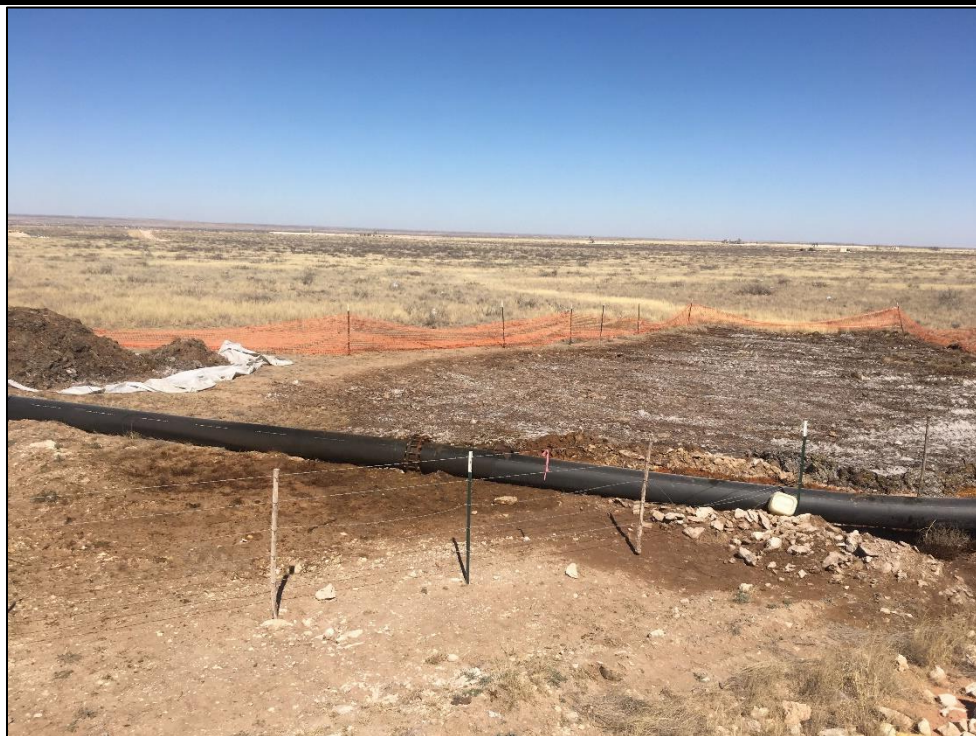
**PHOTO 2:** View of Release Origin / Stockpile, Facing North. 2/25/2019 / **TIME:** 2:11PM / **GPS:** 32.5253 -103.5211

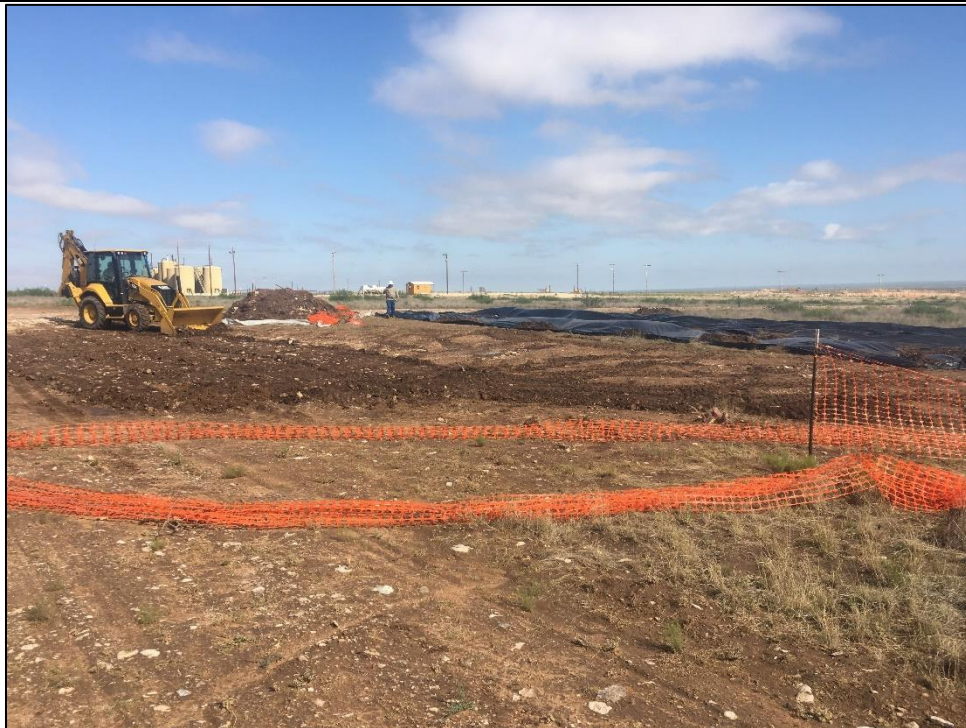
**PHOTO 14:** View of Remediation Activity, Facing West. 6/04/2019 / **TIME:** 10:01AM / **GPS:** 32.5253 -103.5207

- Based on the magnitude of chloride and hydrocarbon concentrations detected within the release margins to depths subject to NMOCD Reclamation requirements, approximately 2,000 cubic yards (cy) of chloride impacted material will be required to be excavated and disposed of at a permitted disposal facility under manifest.

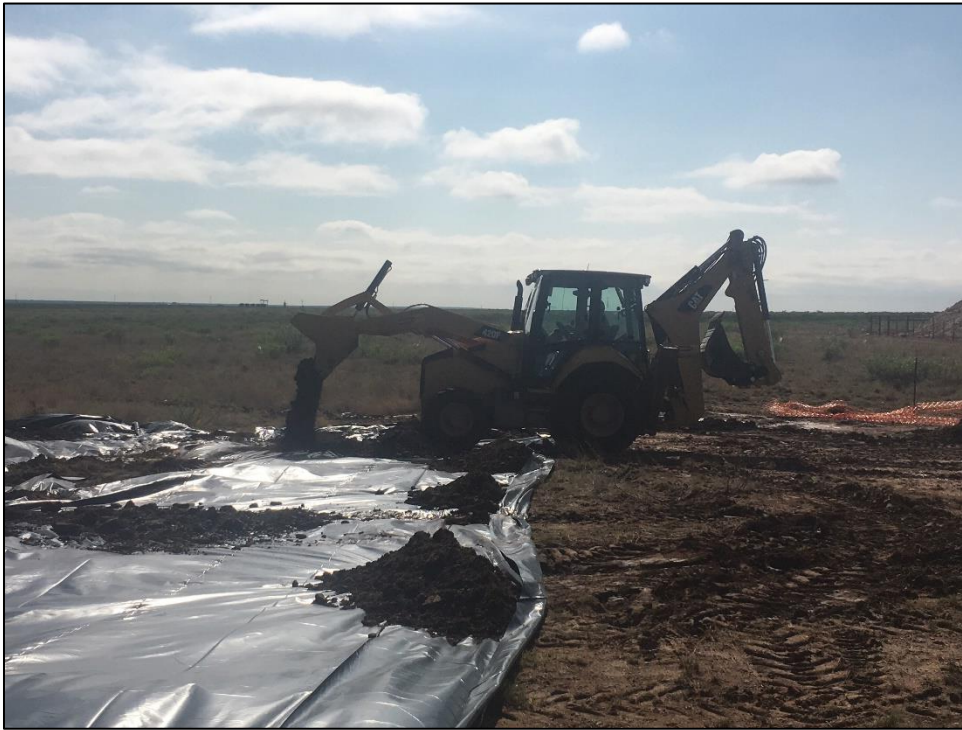
**PHOTO 15:** View of Remediation Activity, Facing East. 6/04/2019 / **TIME:** 10:04AM / **GPS:** 32.5255 -103.5211

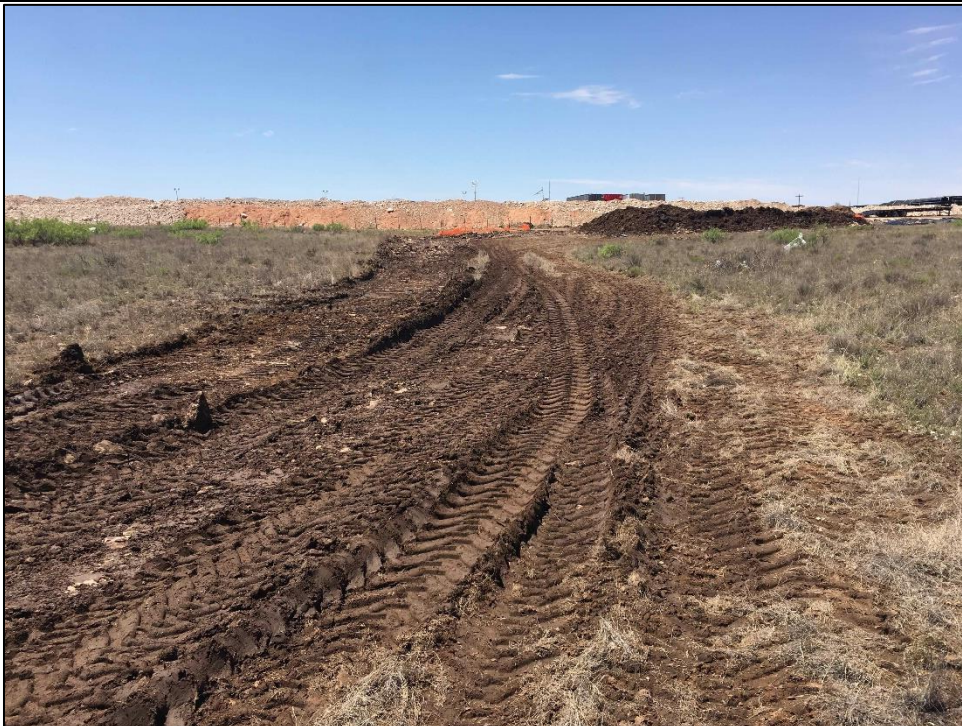
**PHOTO 16:** View of Remediation Activity, Facing South. 6/05/2019 / **TIME:** 12:20PM / **GPS:** 32.5261 -103.5206

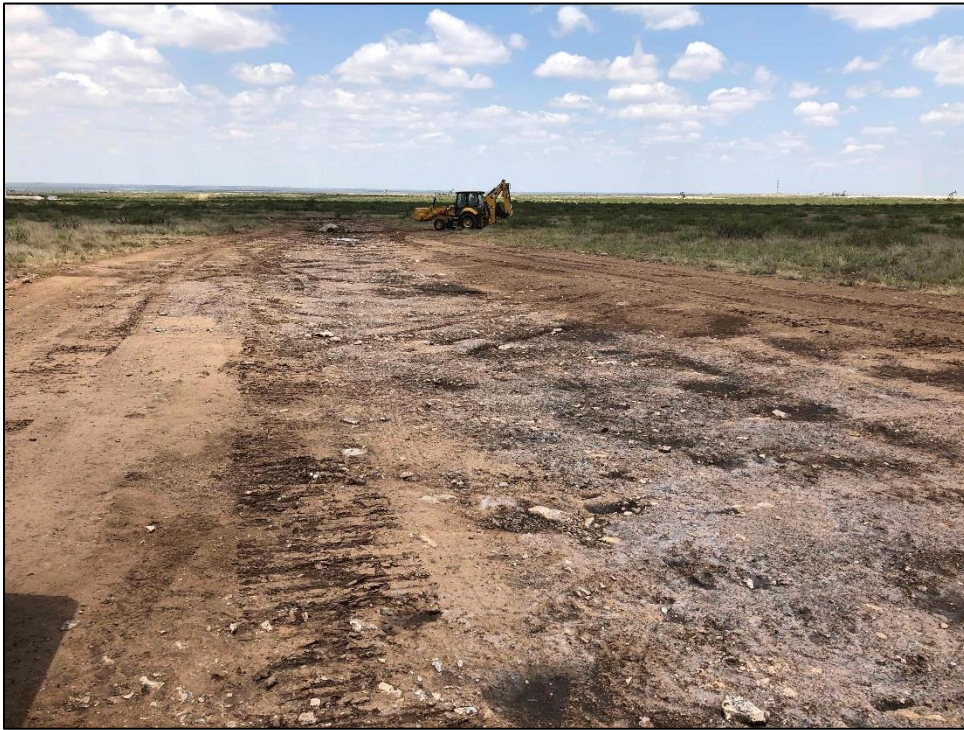
**PHOTO 33:** View of backfilling trenches, Facing North. 7/23/2019 / **TIME:** 14:42PM / **GPS:** 32.5261 -103.5206

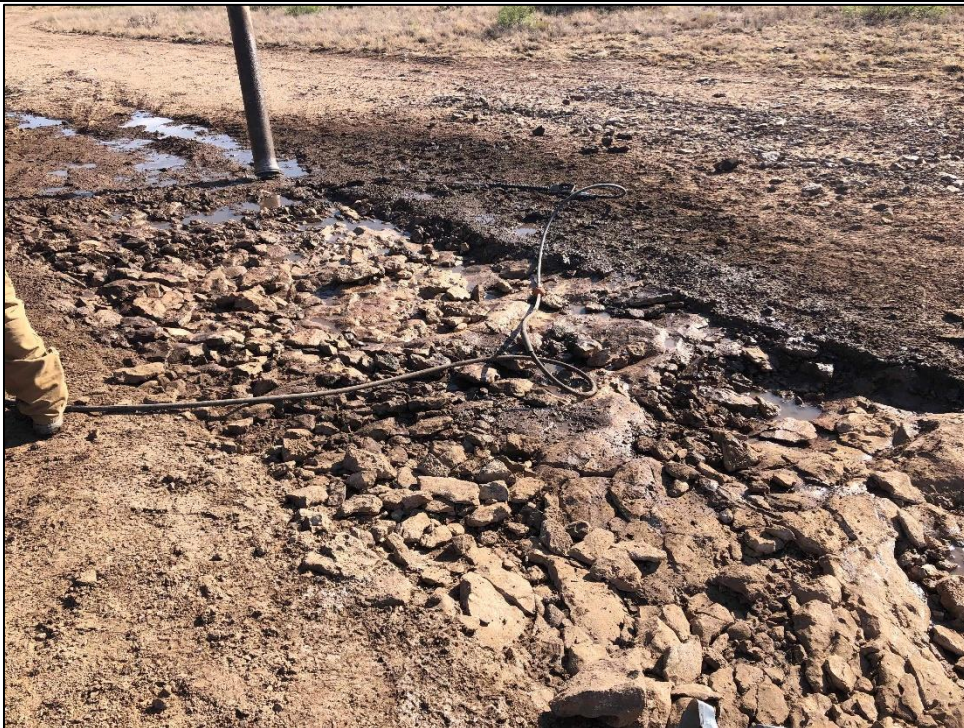
**PHOTO 34:** View of Hydro-excavation Activity, Facing North. 9/05/2019 / **TIME:** 10:20PM / **GPS:** 32.5261 -103.5206

contaminants are below the desired NMOCD RALs. Based on the proximity of the analyzed samples to this restrictive layer and the magnitude of the concentrations being elevated above 600 mg/kg but below 20,000 mg/kg, On the recommendation from Mike Bratcher with the NMOCD District 2 office in Artesia, NM, Terracon hydro-excavated the base of the excavation, hydro-vacing the restrictive feature to wash out the residual presence of chlorides at this restrictive zone to ensure that concentrations are not elevated at this restrictive interphase. Terracon included photo logs of the hydro-vacing activities with this closure report.

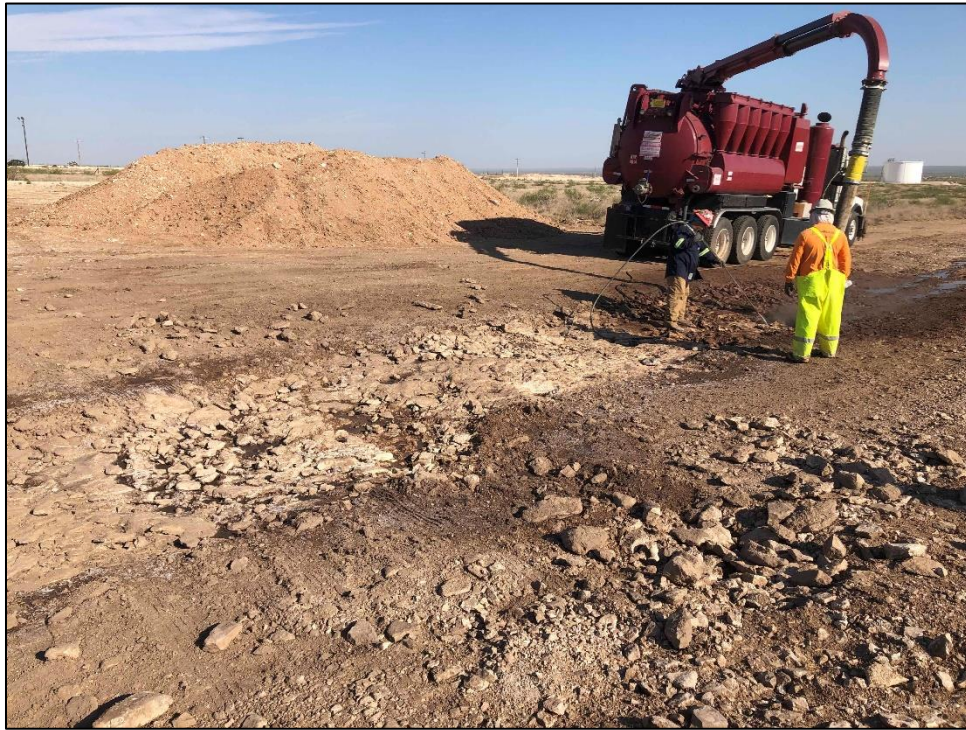
**PHOTO 35:** View of Hydro-excavation Activity, Facing West. 9/05/2019 / **TIME:** 10:40PM / **GPS:** 32.5261 -103.5206

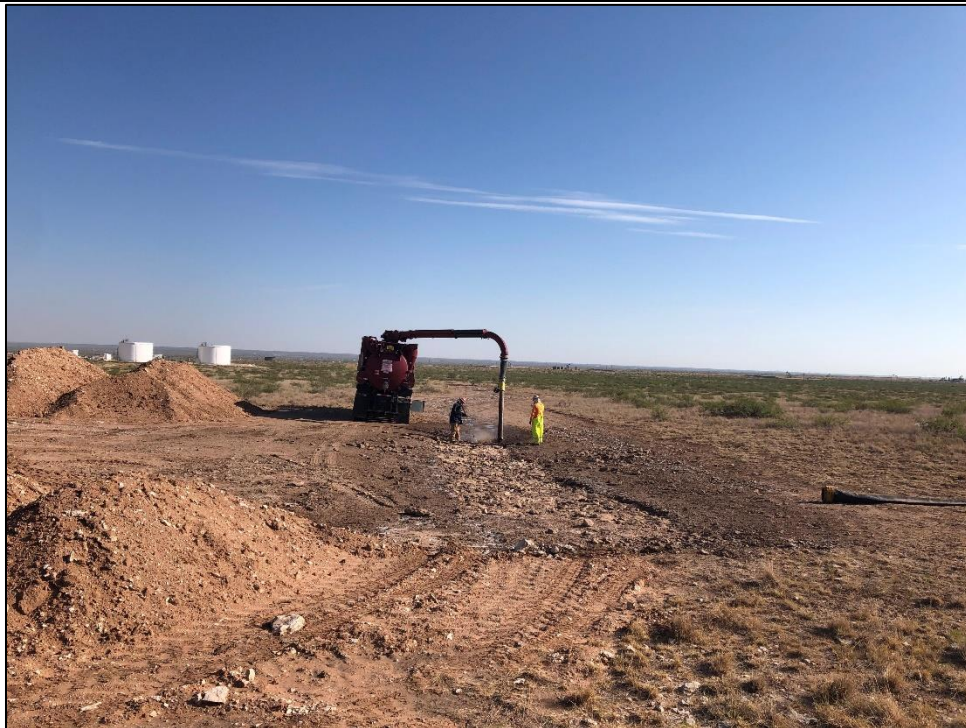
**PHOTO 36:** View of Hydro-excavation Activity, Facing North. 7/05/2019 / **TIME:** 10:30PM / **GPS:** 32.5261 -103.5206

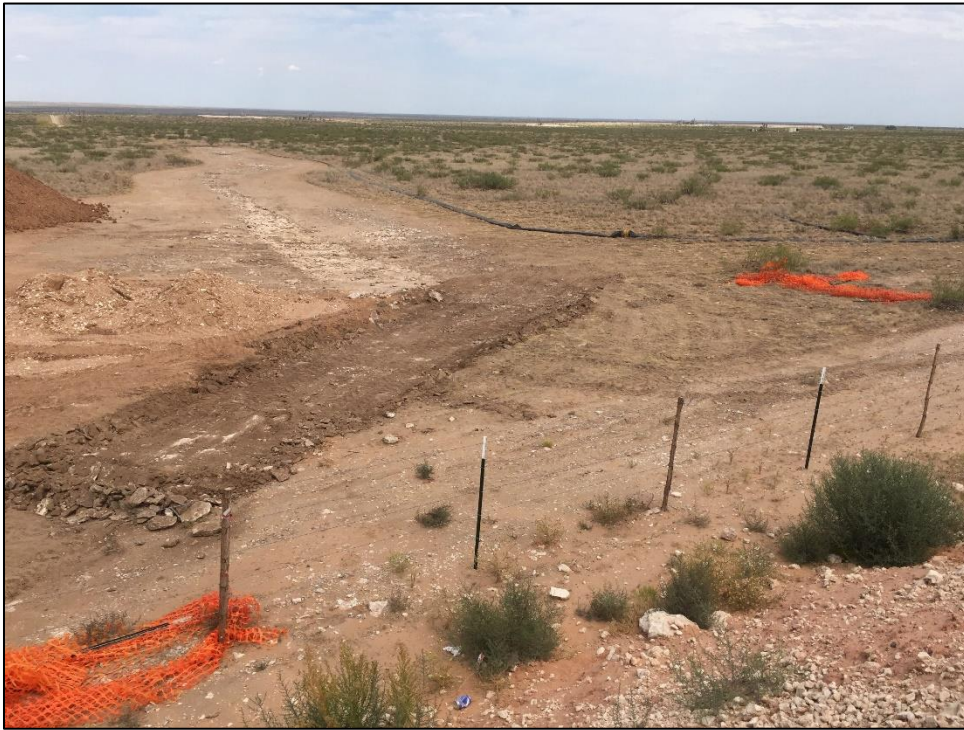
**PHOTO 37:** View of Completed Excavation, Facing Northeast. 9/20/2019 / **TIME:** 13:20PM / **GPS:** 32.5261 -103.5206

- Following excavation to restrictive layer depths, vertical and horizontal delineation samples were collected from the base and walls of the excavation to confirm the remaining levels of soil contaminants are below the desired NMOCD remediation action level (RAL).

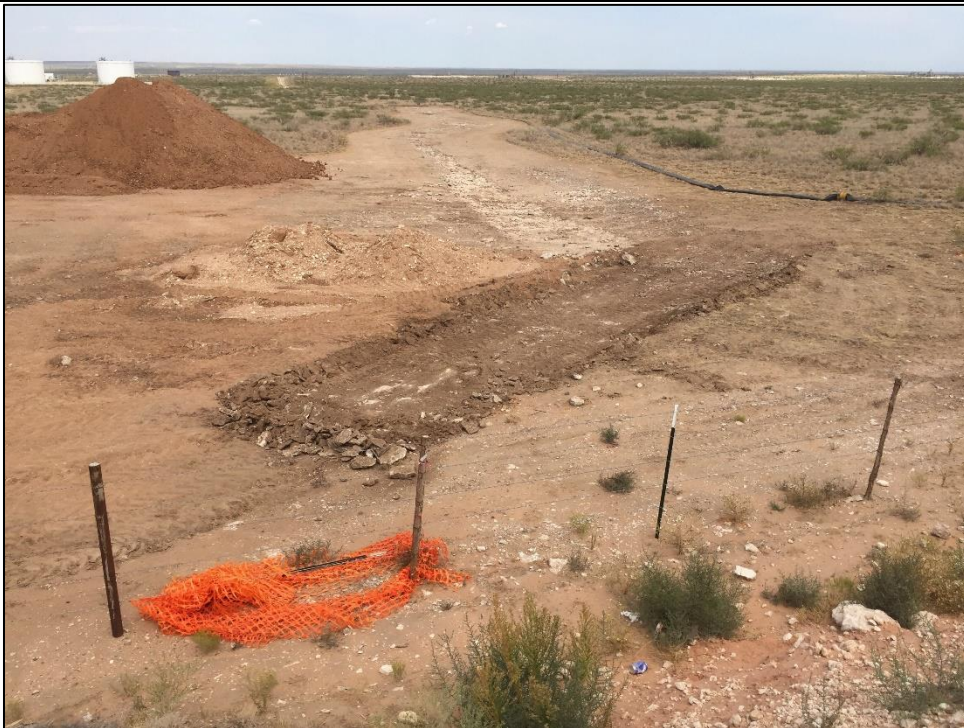
**PHOTO 38:** View of Completed Excavation, Facing North. 9/20/2019 / **TIME:** 13:19PM / **GPS:** 32.5261 -103.5206
