Soil Assessment, Remediation, and Closure Report

West Red Lake Unit #51
API# 30-015-28459 * 2RP-4660
Talon Project # 701307.106.01

Subject: **Soil Assessment and Remediation Work Plan**
West Red Lake Unit #51
API# 30-015-28459 * 2RP-4660

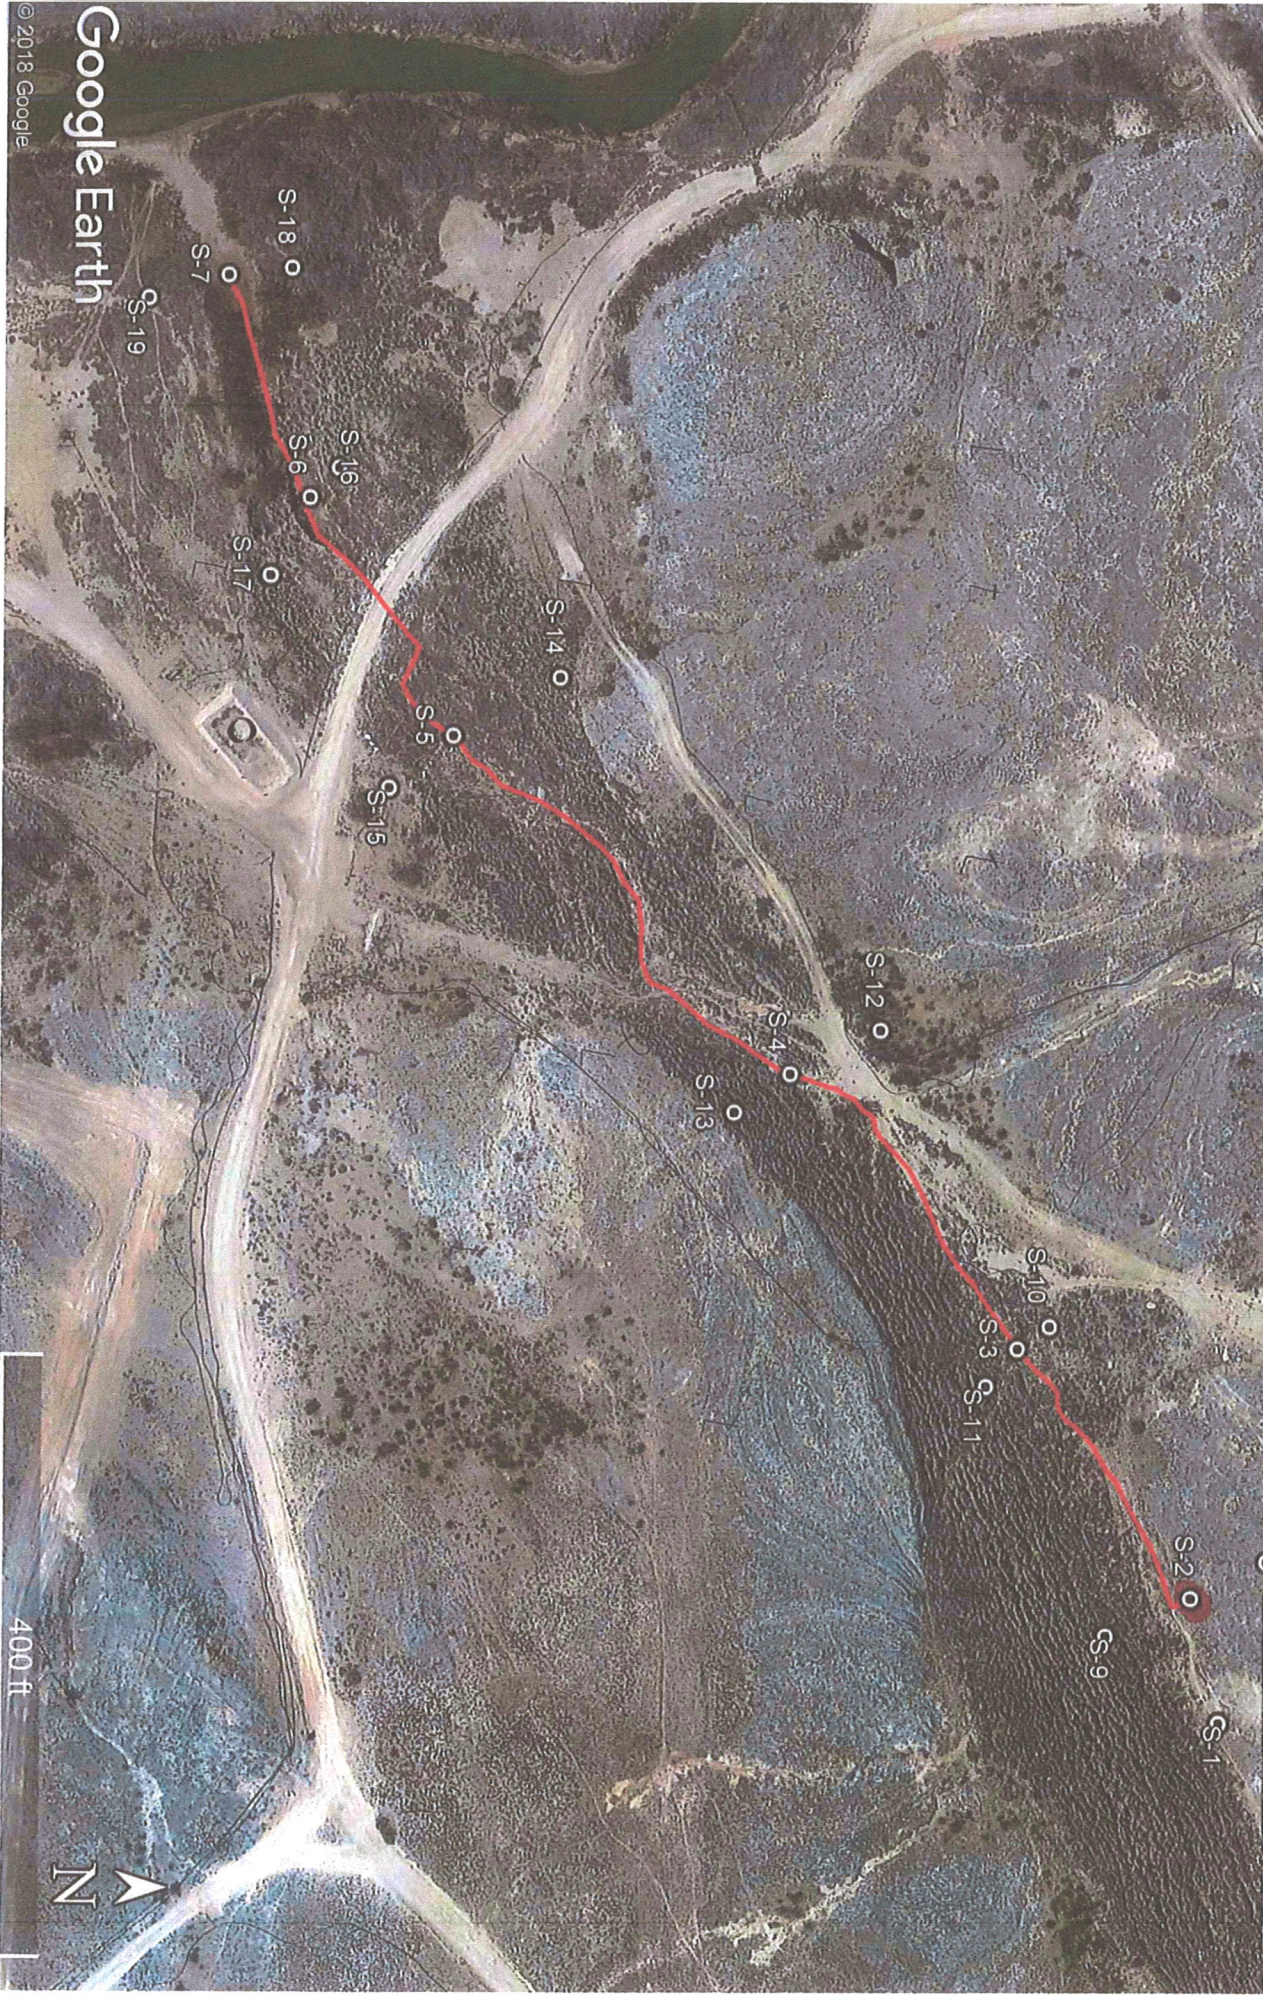
SITE PLAN

West Red Lake 51

-   Flow Path
-   Release Point
-   Sample Locations

- The flow path between sample locations S-2 through S-4, including S-7 (end of flow path) was excavated to a depth of 2-feet deep.
- The flow path between sample locations just south of S-4 through S-6 was excavated to a depth of 4-feet deep.
- It is noted that the analytical results from sample location S-1, up gradient from the release, indicate that background readings in this draw exceed NMOCD RRAL's (1330 mg/kg at 2-feet below ground surface).
