Report Type: Closure Report 2RP-5010

Site:	King Tut Federal #001H Battery				
Company:	COG Operating LLC				
Section, Township and Range	Unit E	Sec. 19	T 24S	R 32E	
Lease Number:	API No. FMAP1828468531				
County:	Eddy County				
GPS:	32.203915			-103.72301	
Surface Owner:	Federal				
Mineral Owner:					
Directions:	From the intersection of 128 and Buck Johnson Rd., go southwest on Buck Johnson Rd. for 0.43 mi., turn south onto unnamed lease Rd. and go 1.85 miles to location.

Re: Closure Report for the COG Operating, LLC, King Tut Federal #001H Battery, Unit E, Section 19, Township 24 South, Range 32 East, Eddy County, New Mexico. 2RP-5010

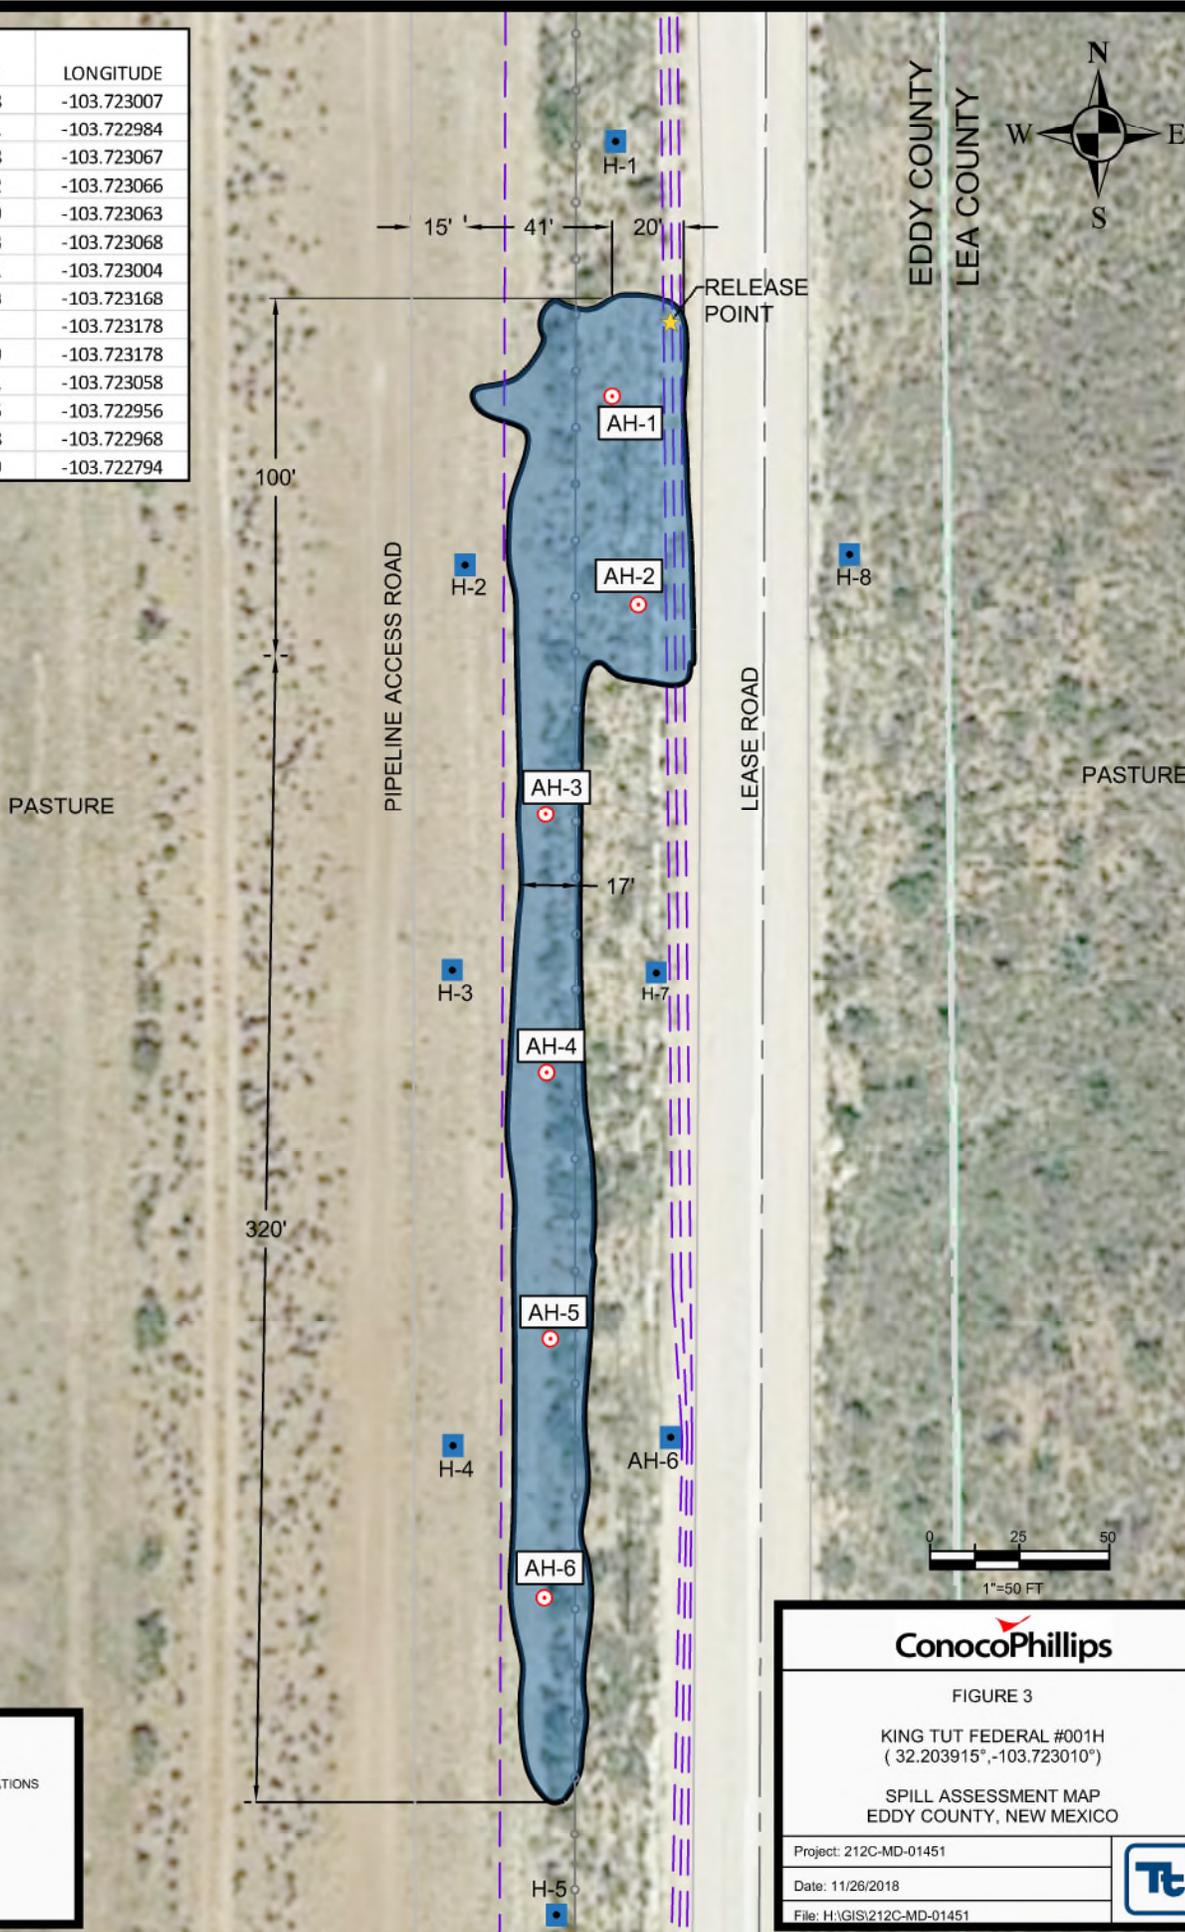
FIGURE 3

On October 15, 2018, Tetra Tech personnel were on Site to evaluate and sample the release area. A total of six (6) auger holes (AH-1 through AH-6) were installed in the release area to total depths ranging from 2-2.5' to 4-4.5' below surface. A total of eight (8) horizontal delineation samples (H-1 through H-8) were collected around the perimeter of the spill to total depths of 0-1' below surface. Soil samples were collected and submitted to the laboratory for TPH analysis by EPA method 8015 modified, BTEX by EPA Method 8021B, and chloride by EPA method 300.0. Copies of laboratory analysis and chain-of-custody documentation are included in Appendix C. The results of the sampling are summarized in Table 1. The sample locations are shown on Figure 3.

SPILL ASSESSMENT MAP
EDDY COUNTY, NEW MEXICO

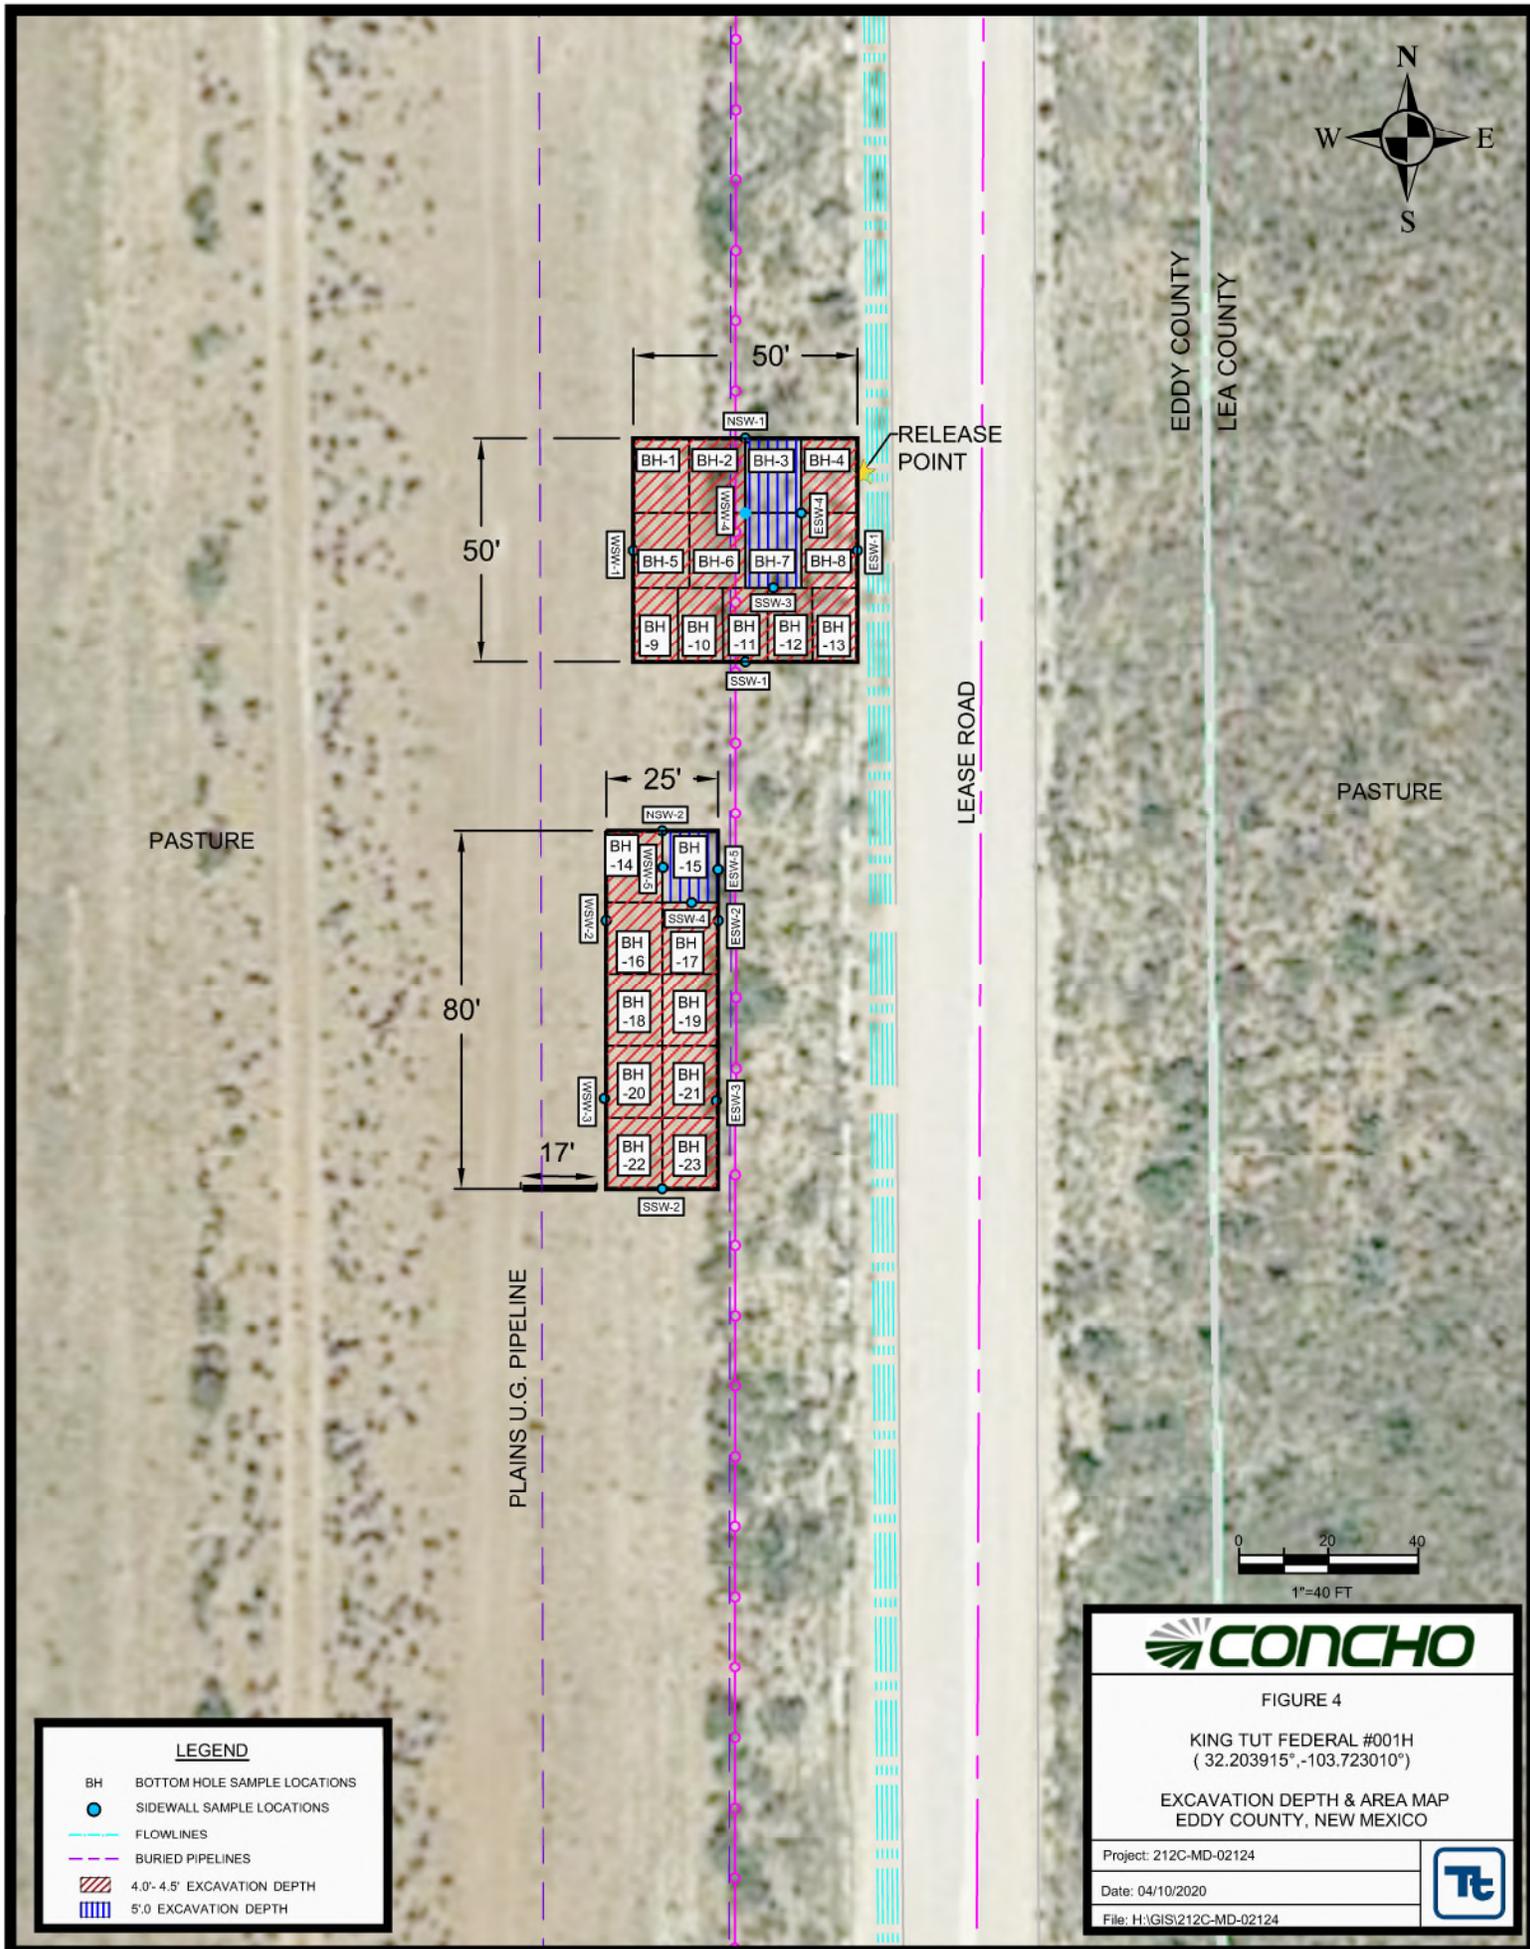
FIGURE 4

Tetra Tech personnel were onsite February 20-26, 2020, to supervise the remediation activities. The areas of auger holes (AH-1 and AH-3) were excavated to depths of 4.0'-5.0' below surface.

A total of twenty-three (23) bottom hole samples were collected (BottomHole-1 through BottomHole 23) and sixteen (16) sidewall samples (NSW-1, NSW-2, ESW-1 through ESW-5, WSW-1 through WSW-5, and SSW-1 through SSW-4) were collected every 200 square feet for documentation purposes. All collected samples were analyzed for TPH analysis by EPA method 8015 modified, BTEX by EPA Method 8021B and chloride by EPA method 300.0. Copies of laboratory analysis and chain-of-custody documentation are included in Appendix C. The results of the sampling are summarized in Table 2. The excavation depths and confirmation sample locations are shown on Figure 4.

EXCAVATION DEPTH & AREA MAP
EDDY COUNTY, NEW MEXICO

Referring to Table 2, none of the samples collected showed TPH, benzene, total BTEX and chloride above the RRALs, with the exception of BottomHole-3, BottomHole-7, and BottomHole-15, which showed chloride concentrations of 29,200 mg/kg, 23,600 mg/kg and 30,000 mg/kg, respectively. These areas were excavated to a depth of 5.0' below surface and re-sampled. All confirmation samples showed concentrations below RRALs.

Approximately 640 cubic yards of material were excavated and transported offsite for proper disposal. The area was then backfilled with clean material to surface grade.
