Release Notification

Site Name: Chimichanga 12 State Com 601 lease road	Site Type: lease road
Date Release Discovered: 4/14/2020	API# 30025466140000

Re: Release of fresh water from Chimichanga 12 State Com 601 on CR 32

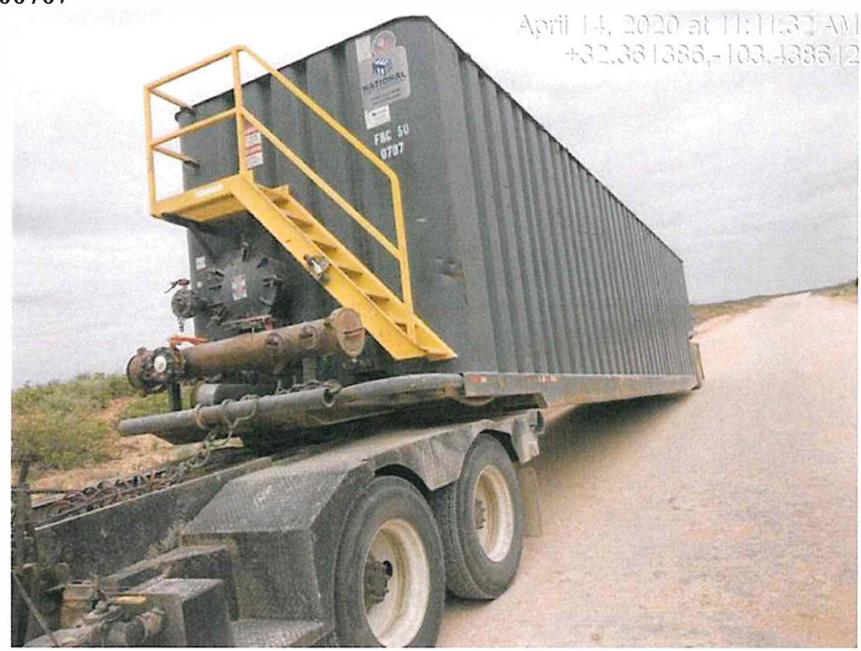
Frac Tank #FRC500707

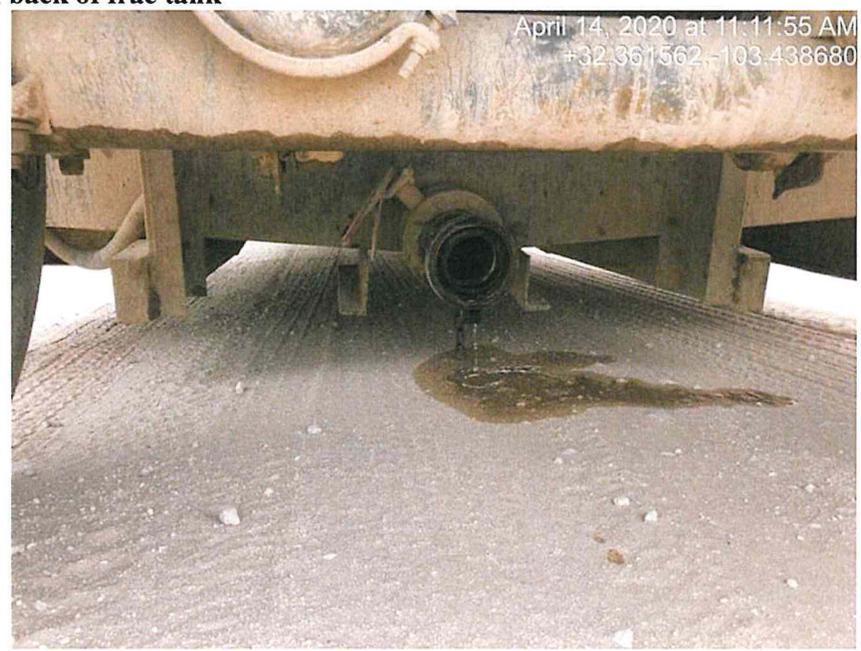
Open ball valve on back of frac tank

On April 14, 2020 a truck hauling a frac tank was noticed driving south down CR 32 west of Eunice, NM. The frac tank (#500707) was releasing fresh water from its rear ball valve (Appendix A). The substance was unknown at the time and the incident was treated as an illegal dump of produced water. The origin point of the release was located at 32.40084, -103.43481 and continued south on CR 32 for 2.87 miles (Appendix B). Initial sampling of the origin point spill area indicated that the road materials were uncontaminated. However, seven samples that were taken along the assumed path of the release were over 600mg/Kg for chlorides and 100mg/Kg for total TPH as indicated in Table 1 (Appendix C). A total of 36 samples were taken at regular intervals along the path of the release.

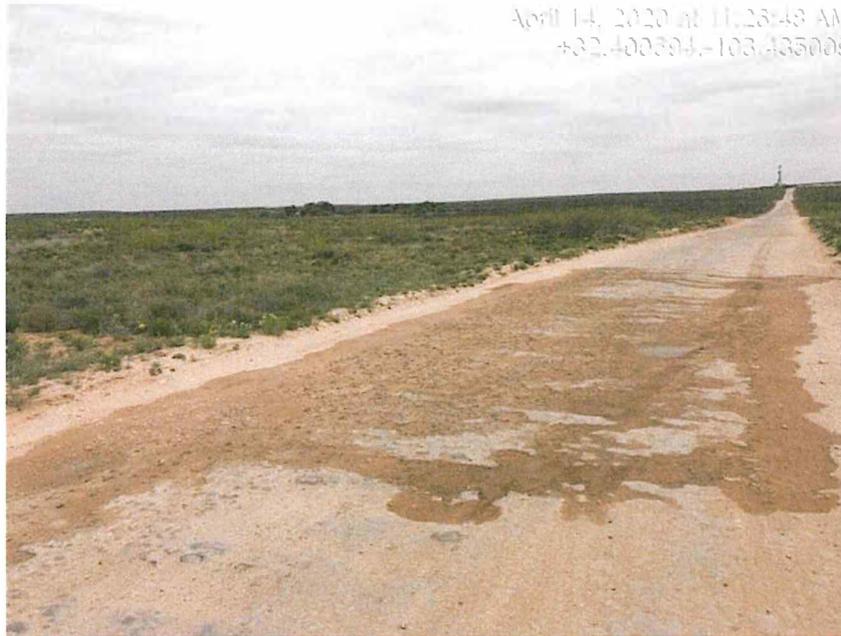
Origin of release

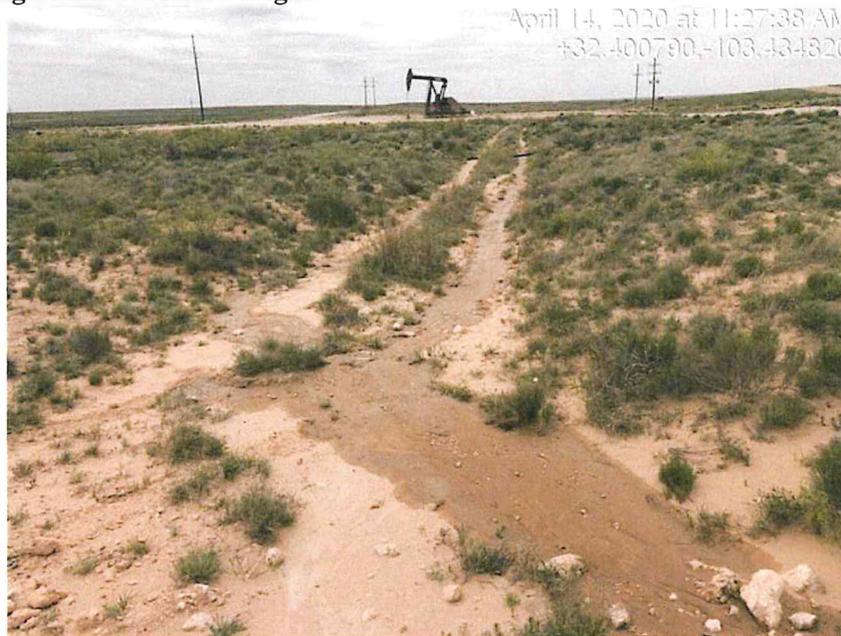
2-Track road leading South at release origin

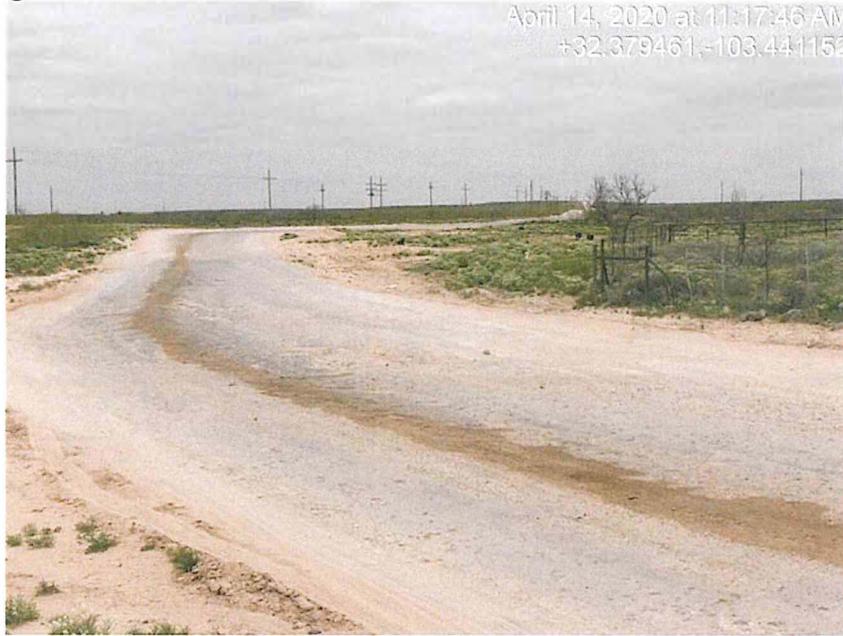
View of release along CR 32

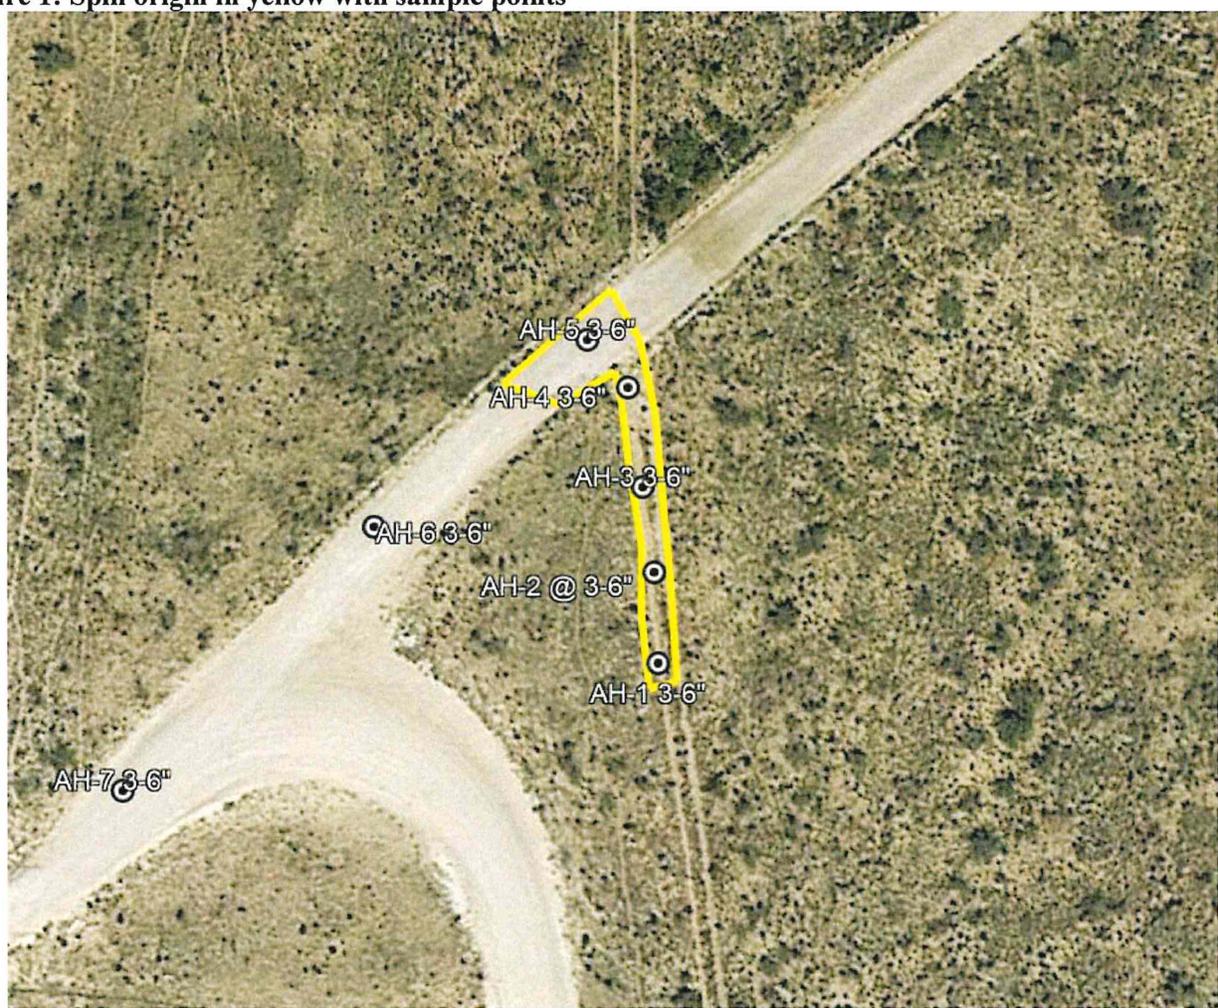
Figure 1 shows the location of the first four samples (AH1- AH4) collected on the 2 track road leading to the south and within the origin point spill area outlined in yellow. Because there was not a sample collected from the fluid released directly from the frac tank, we can use these samples as being a true representation of the released fluid due to the pristine nature of the 2-track road. This smaller road does not receive the volume of heavy traffic and higher potential for cross contamination compared to the main road. The samples analytical results is further evidence that there was not prior cross-contamination along the smaller 2-track road.

Figure 1: Spill origin in yellow with sample points

Because the majority of released fluid was in this area, we would assume to see the highest concentrations in these four samples versus other samples taken. The results in Table 1 of AH1-AH4 not only show low levels of chlorides, TPH, and BTEX, but also give credibility to the additional evidence that this was fresh water.

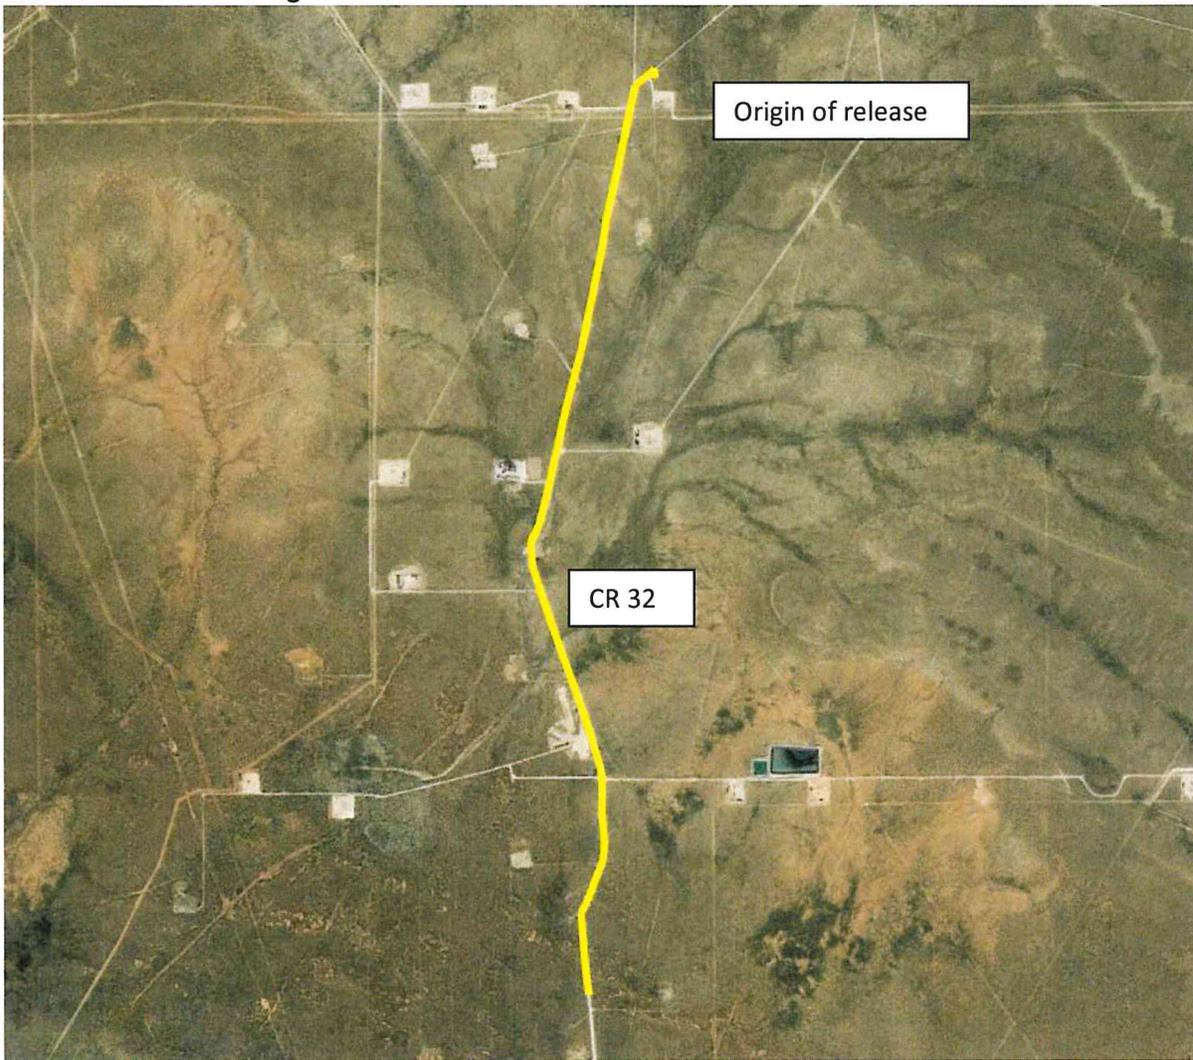
Figure 2: Path of release along CR 32 for 2.87 miles
