Closure Report

Site Name:	Red Tank 28 Federal #4
Company:	Oxy USA Inc.
Legal Description:	U/L O, Section 28, T22S, R32E
County:	Lea County, NM
GPS Coordinates:	N 32.35651° W-103.67895°

Oxy, Red Tank 28 Federal #4

Leak date: 3/15/17
Lea County, NM
AP# 30-025-36009
1RP-4658

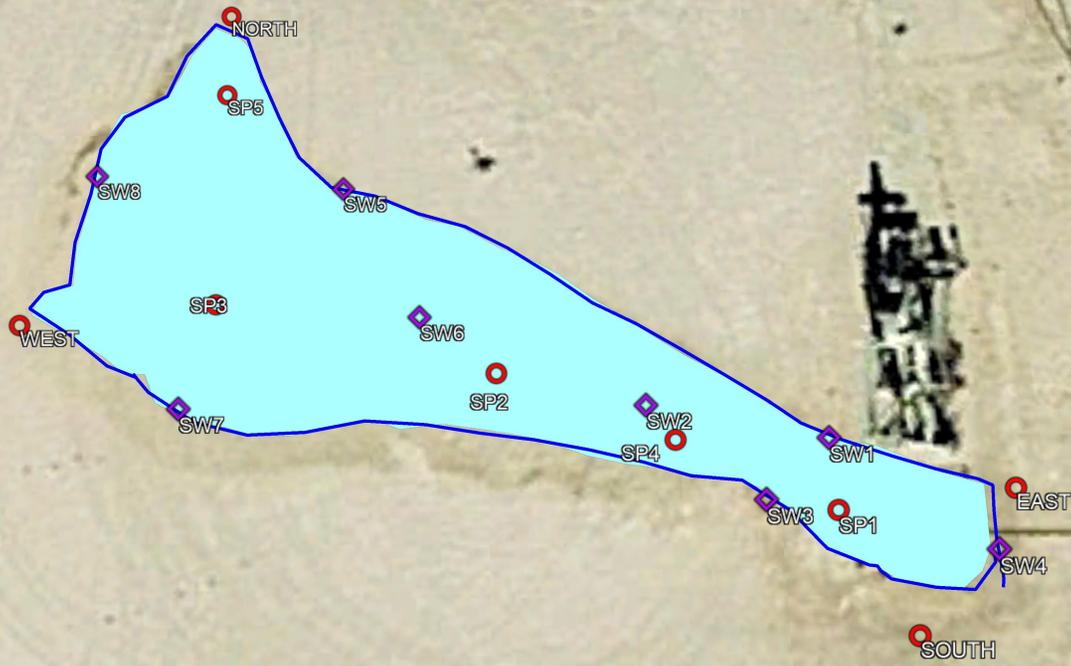
1 ft Excavation across entire leak area
-

Confirmation sample points
-

Sample points
-

Leak Area

Remediation Parameters:	Excavated the areas around SP1, SP2, and SP3 to a depth of 2 feet. No excavation was required around the areas of SP4 and SP5. Sidewall confirmation samples were taken to verify successful remediation.	
Remediation Activities:	09/27/2018 to 10/08/2018	
Plan Sent to OCD:	07/18/2017	Email from Cliff Brunson to Olivia Yu
OCD Approval of Plan:	08/02/2017	Email from Olivia Yu to Cliff Brunson
Plan Sent to BLM:	07/18/2017	Email from Cliff Brunson to Shelly Tucker
BLM Approval of Plan:	12/27/2017	Email from Shelly Tucker to Cliff Brunson

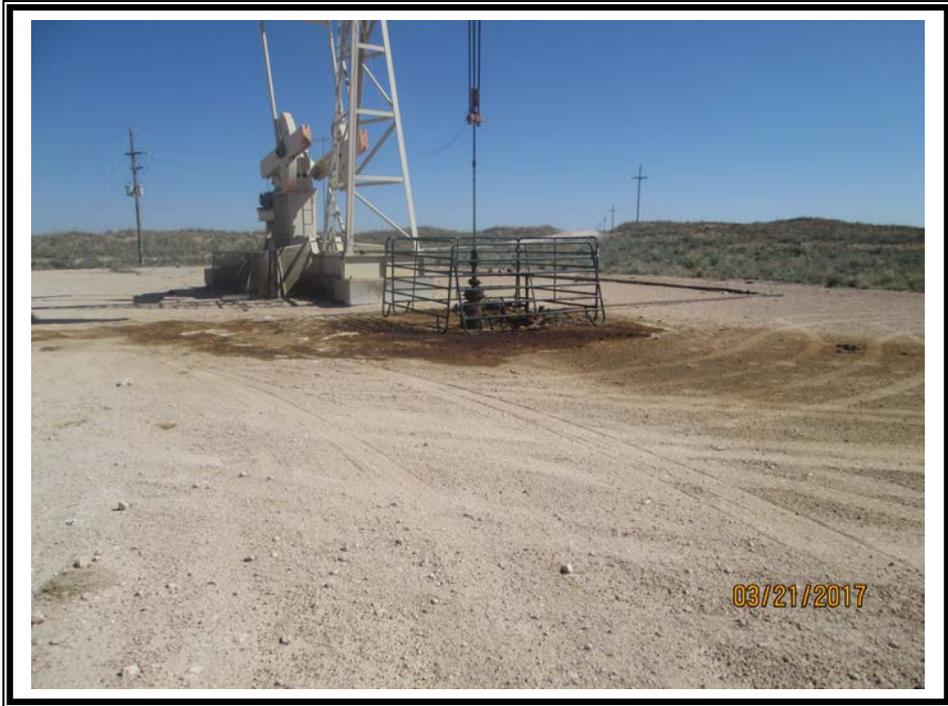
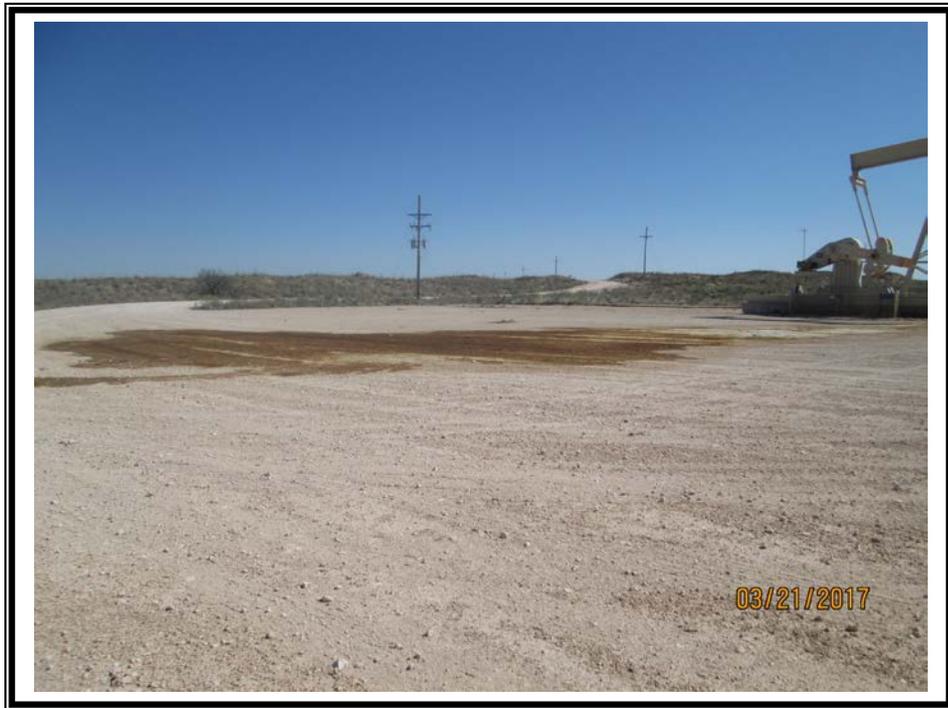
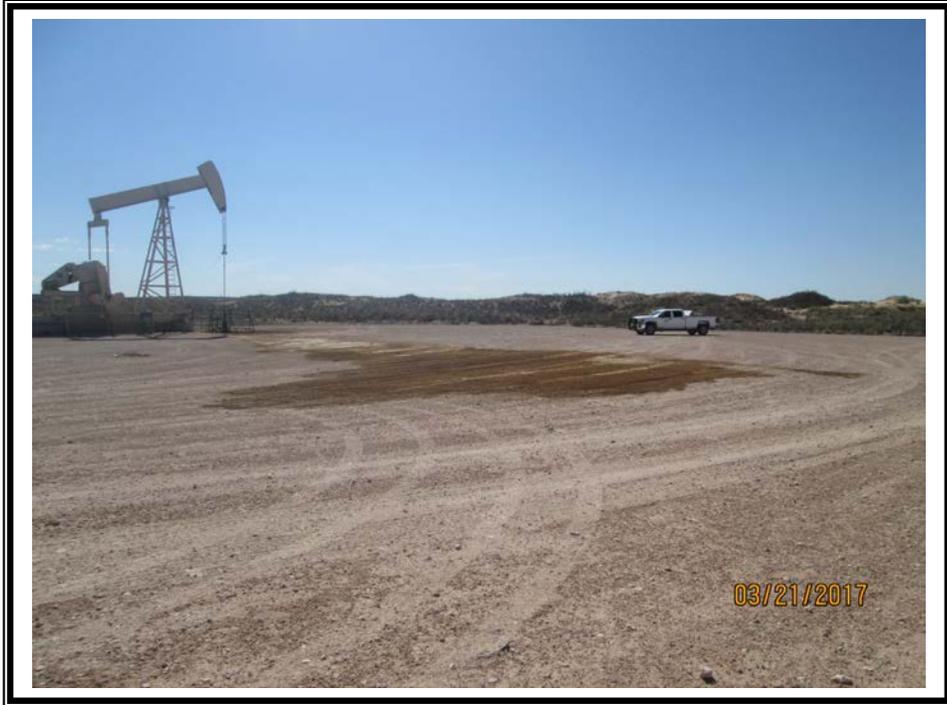
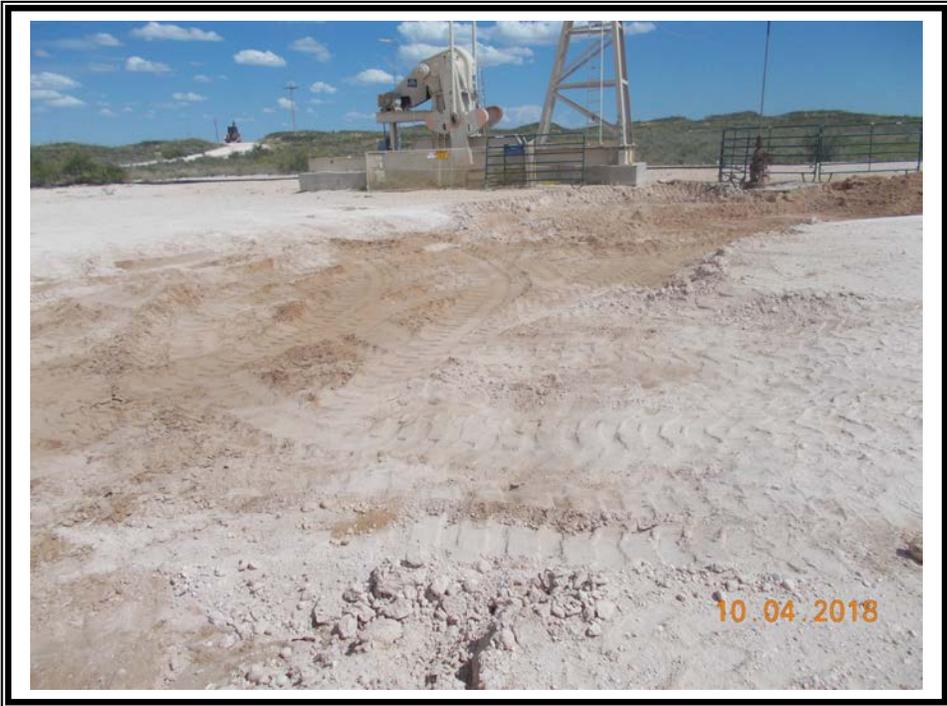
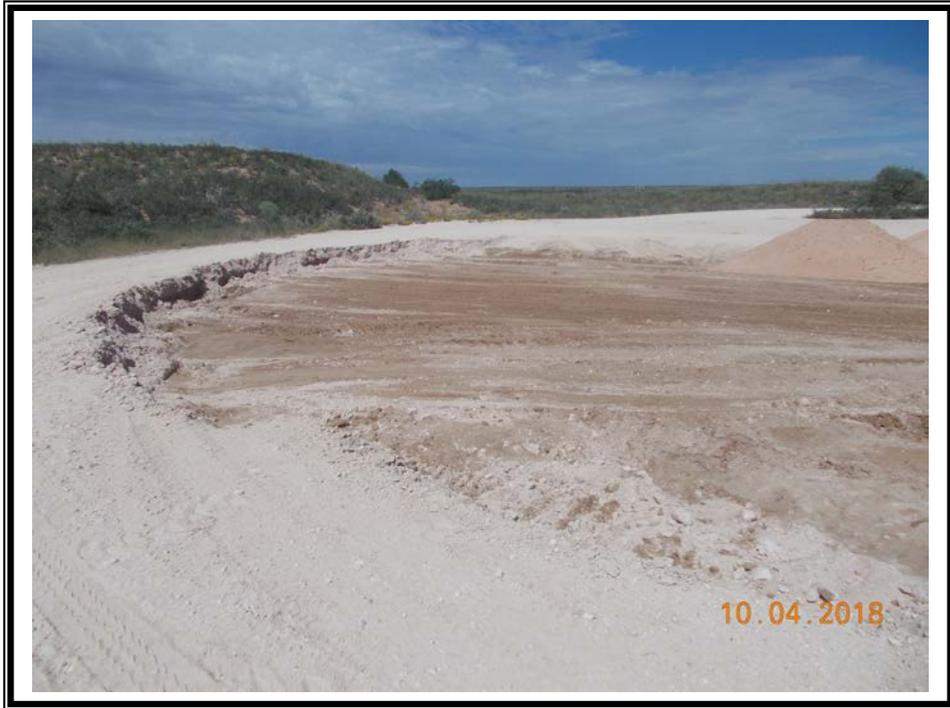
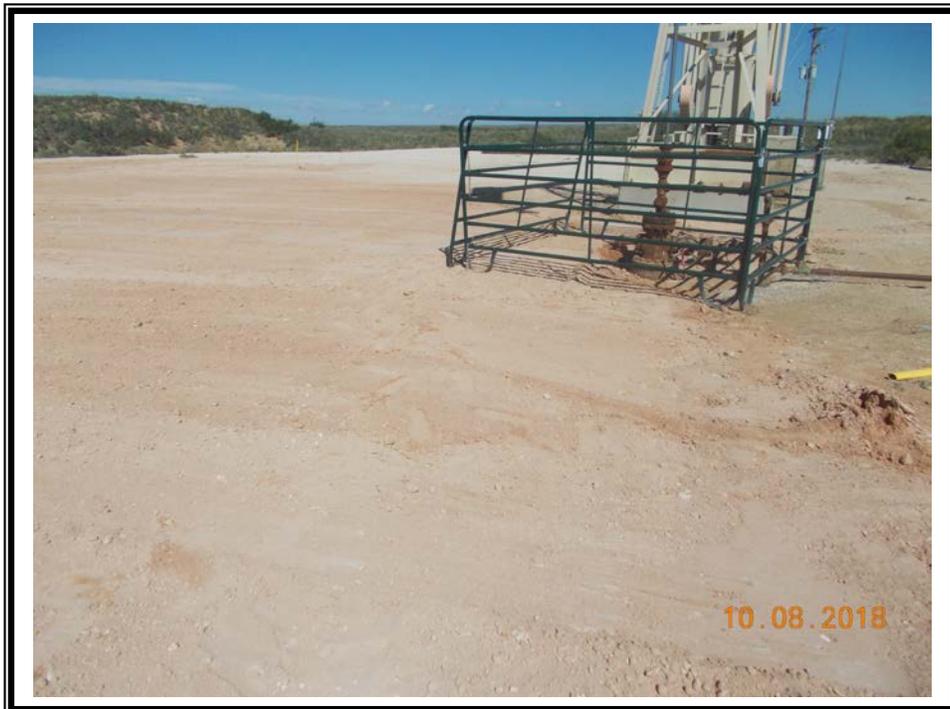
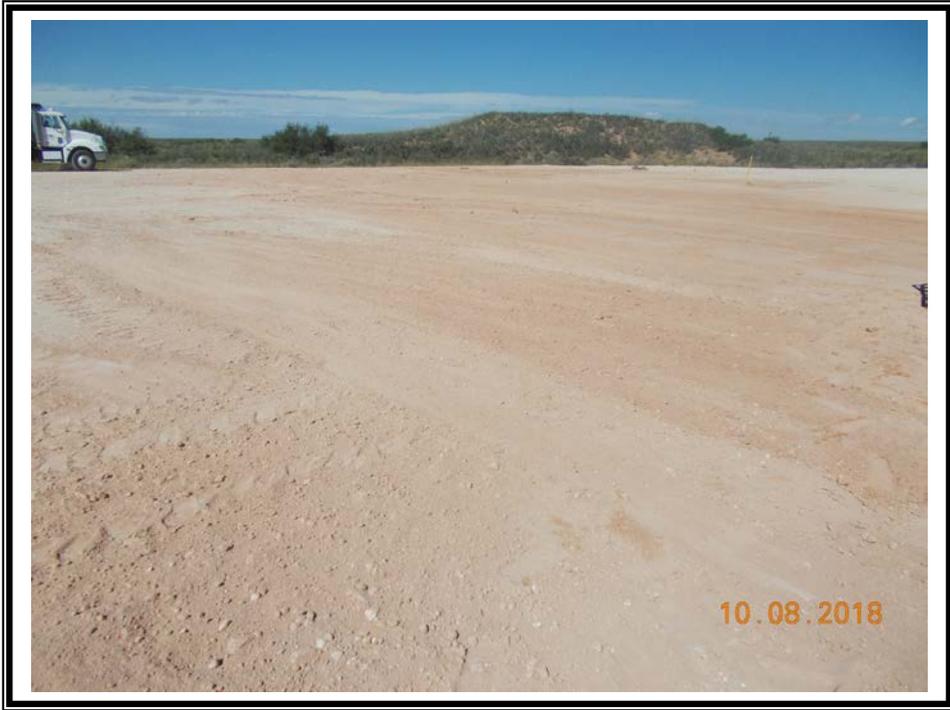
Initial C-141	Signed 03/27/2017
Final C-141	Signed 10/11/2018
Site Diagram	March 2017
Pictures	Initial visit-March 2017; Remediation September/October 2018
