July 17, 2019

Vertex Project #: 19E-00575-009

Spill Closure Report: Todd 23A Federal #029 (Section 23, Township 23 South, Range 31 East)
API: 30-015-31881
County: Eddy
Incident Report: 2RP-5401

2019 Spill Assessment and Closure
July 2019

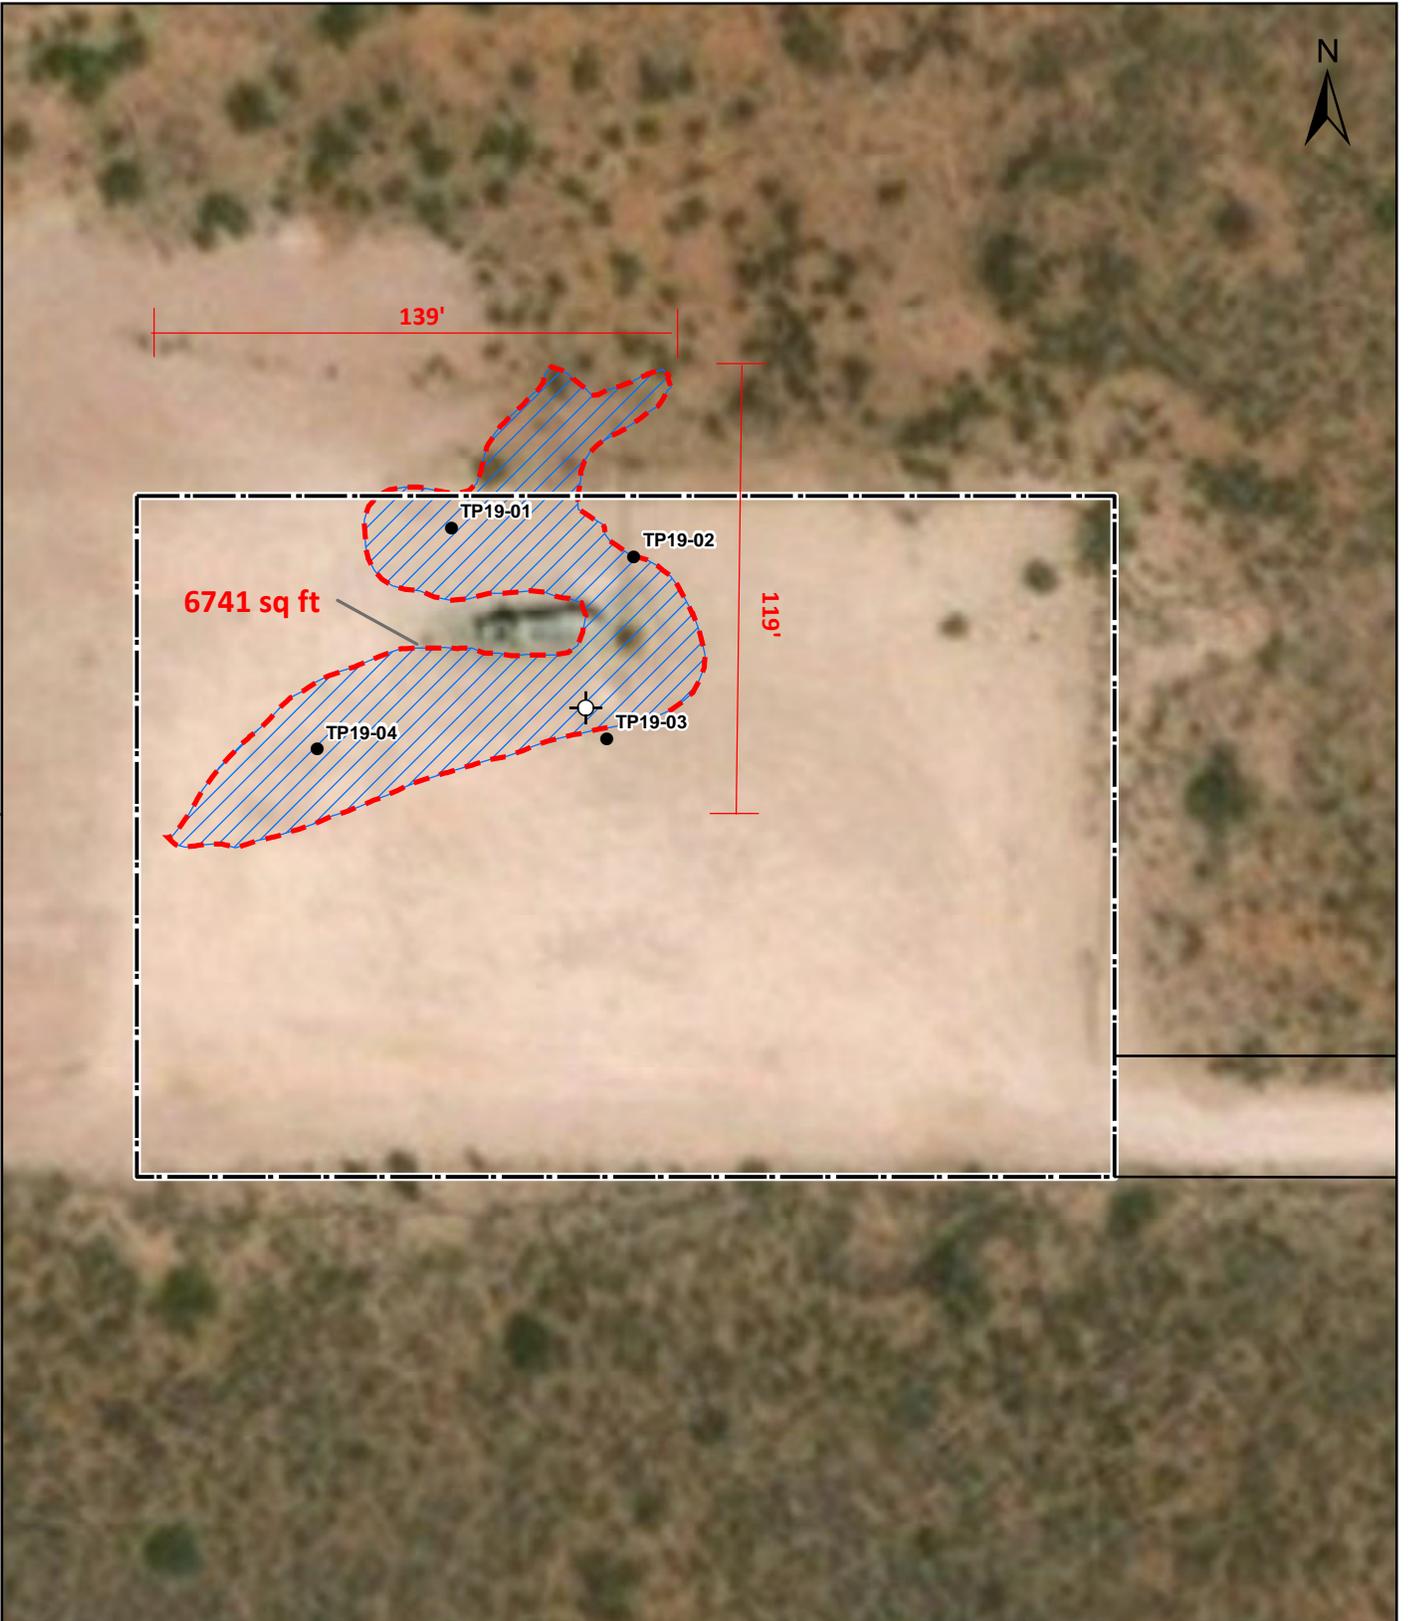
Site Schematic Excavation	
	Todd 23 A Federal 29 (Wellhead Spill)	
	DRAWN: NM	FIGURE: 2
	APPROVED: RF	
	DATE: JUL 03/19

- CONFIRMATORY SAMPLE
- ⊕ WELLHEAD
- ROAD
- WELL PAD
- ▭ SPILL AREA
- ▨ 1.0' EXCAVATED DEPTH AREA

Remediation efforts began on May 18, 2019 and was completed on May 18, 2019. Vertex personnel supervised the excavation of impacted soils. Field screening was completed on a total of four (4) sample points and consisted of analysis using a Photo Ionization Detector (volatile hydrocarbons), Dextsil Petroflag using EPA SW-846 Method 9074 (extractable hydrocarbons) and Quantabs (chlorides). Field screening results were used to identify areas requiring further remediation from those areas showing concentrations below determined closure criteria levels. Soils were removed to a depth of 0.5 feet bgs. Impacted soil was transported by a licensed waste hauler and disposed of at an approved waste management facility (Attachment 5). Field screening results are presented in Attachment 6, as well as in the DFRs in Attachment 3.

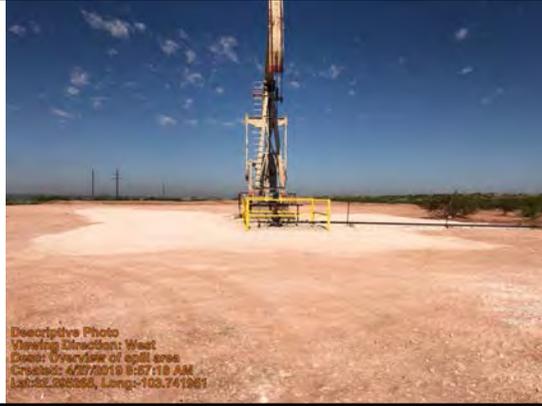
Viewing Direction: West

Overview of spill area

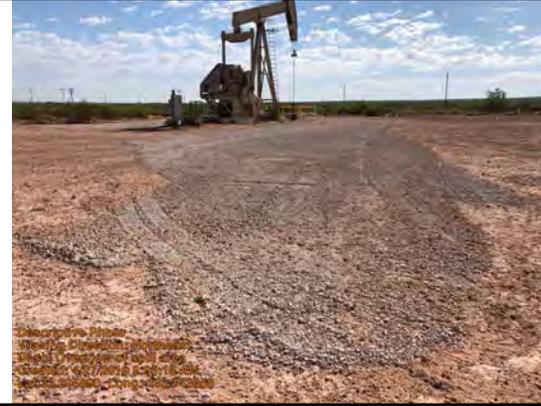
Viewing Direction: Northeast

Overview of spill area

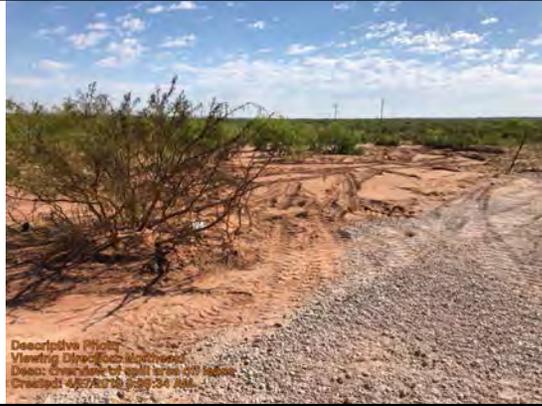
Viewing Direction: Northeast

Overview of spill area off lease

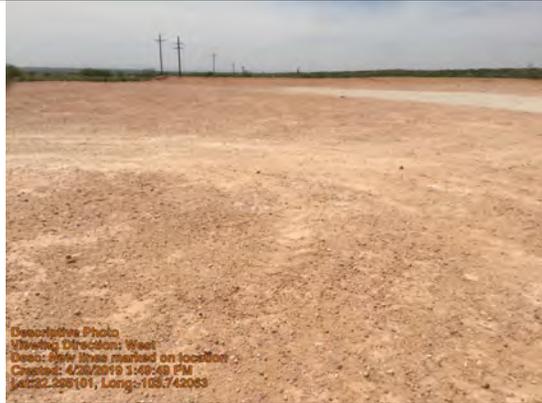
Descriptive Photo
Viewing Direction: West
Desc: New lines marked on location
Created: 4/28/2019 3:48:49 PM
Lat:32.285101, Long:-103.742063

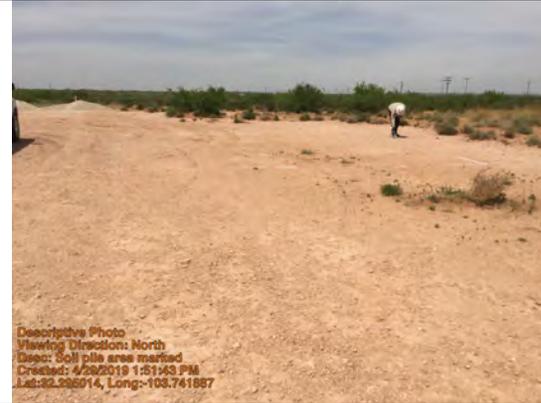
Descriptive Photo
Viewing Direction: North
Desc: Soil pile area marked
Created: 4/28/2019 1:51:43 PM
Lat:32.285014, Long:-103.741887

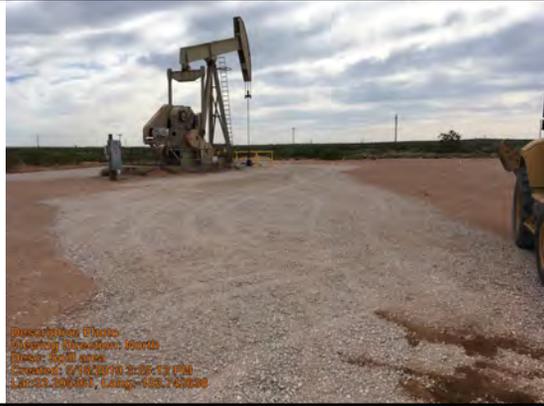
Viewing Direction: North

Spill area

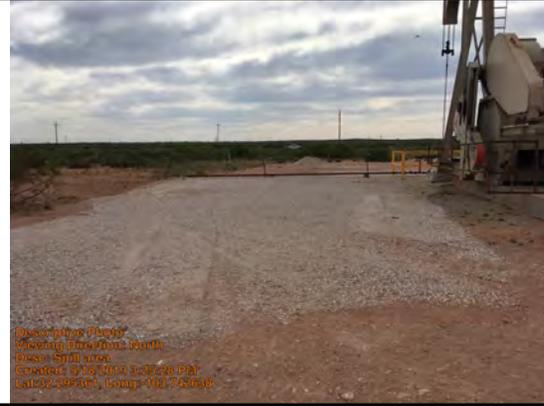
Viewing Direction: North

Spill area

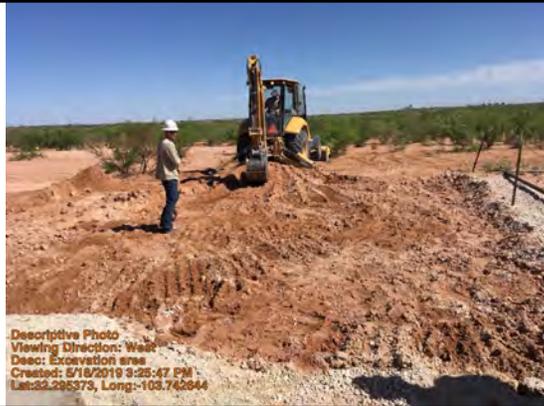
Viewing Direction: West

Excavation area

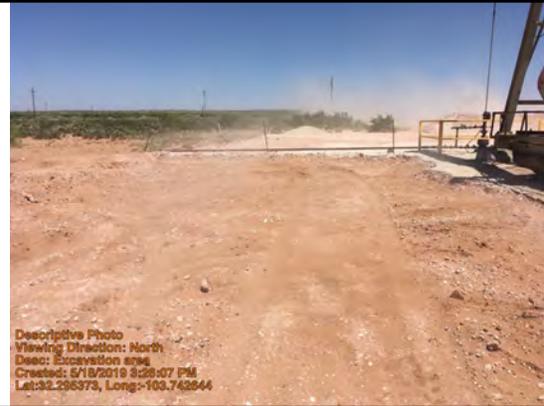
Viewing Direction: North

Excavation area

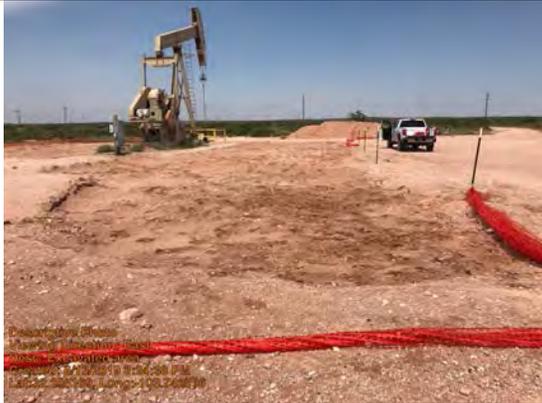
Descriptive Photo
Viewing Direction: East
Area: Excavated area
Created: 6/13/2019 3:24:39 PM
Lat:32.286496, Long:-103.749498

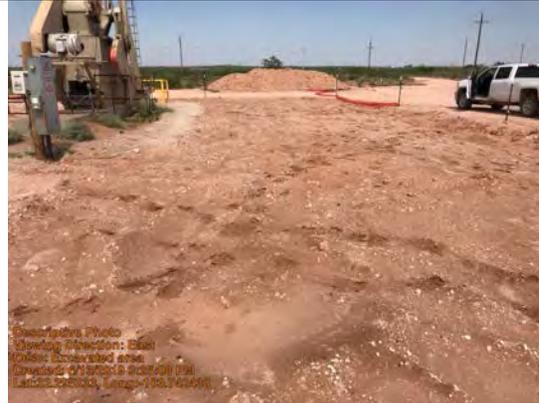
Descriptive Photo
Viewing Direction: East
Area: Excavated area
Created: 6/13/2019 3:24:41 PM
Lat:32.286496, Long:-103.749498

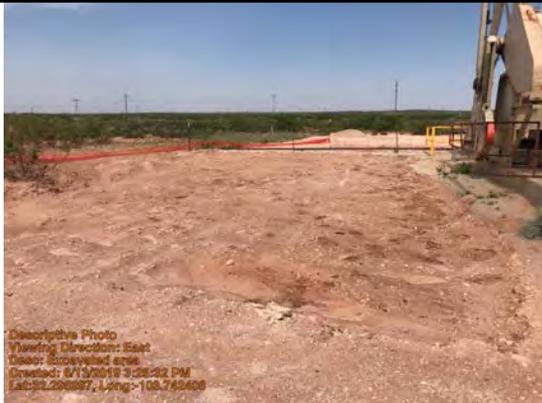
Descriptive Photo
Viewing Direction: East
Area: Excavated area
Created: 6/13/2019 3:25:22 PM
Lat:32.286497, Long:-103.749498

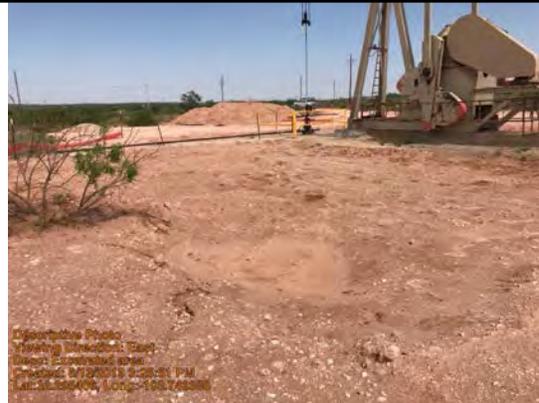
Descriptive Photo
Viewing Direction: East
Area: Excavated area
Created: 6/13/2019 3:25:31 PM
Lat:32.286496, Long:-103.749498

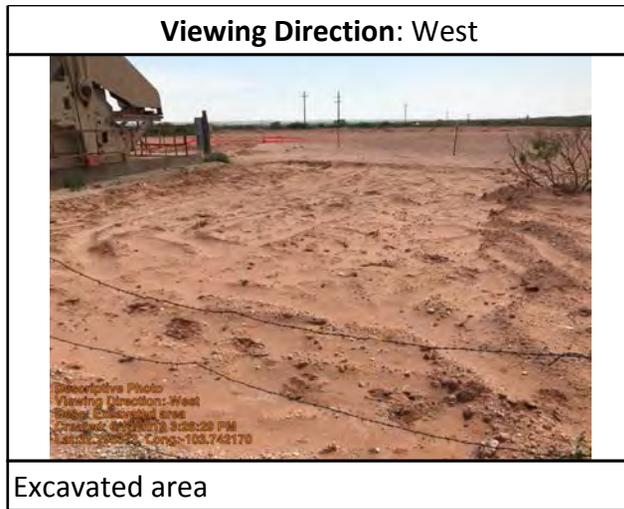
Excavated area

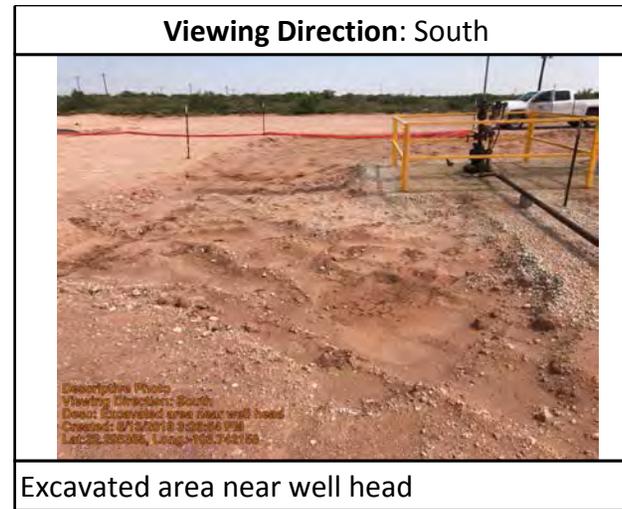
Excavated area near well head

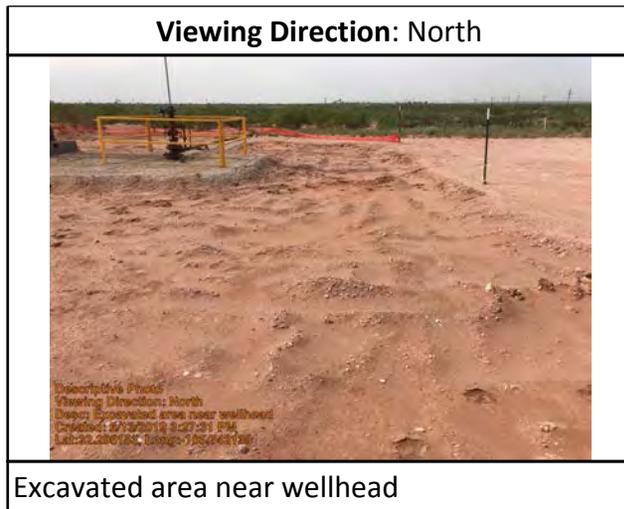
Excavated area near wellhead

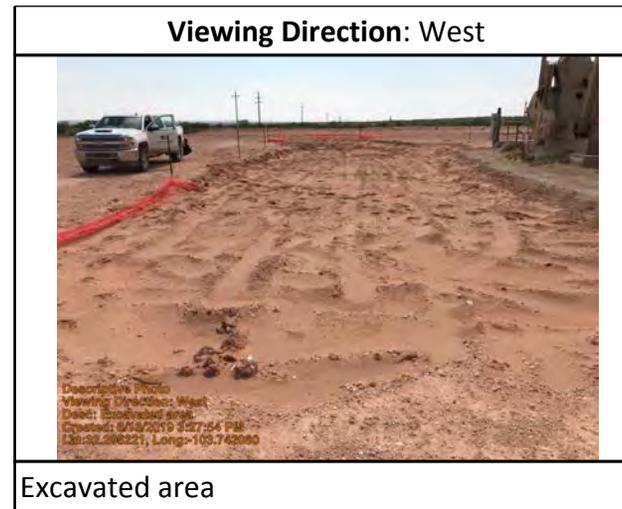
Excavated area

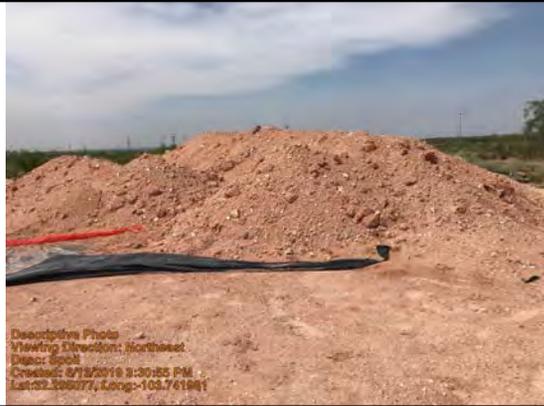
Descriptive Photo
Viewing Direction: Northeast
Descr: Spoil
Created: 6/13/2019 3:30:55 PM
Lat:22.295077, Long:-103.741991

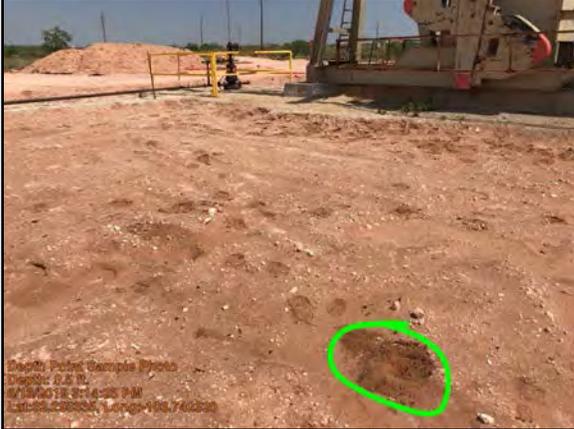
Sample Point ID: TP19-01

Depth: 0.5ft.

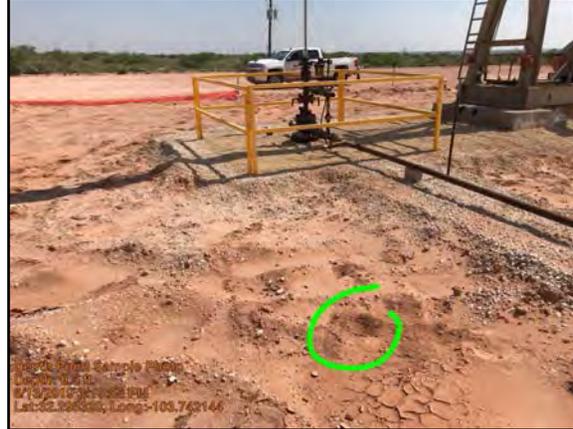
Sample Point ID: TP19-02

Depth: 0.5ft.

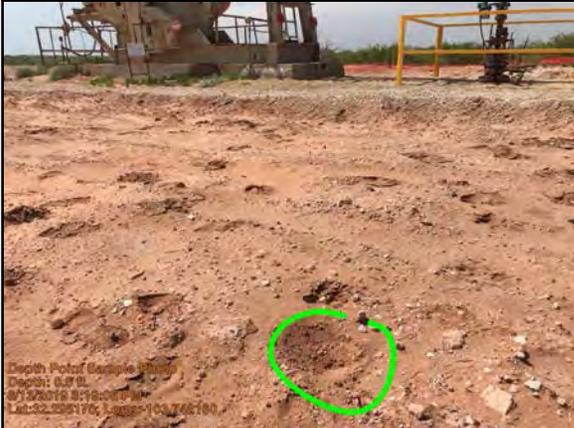
Sample Point ID: TP19-03

Depth: 0.5ft.

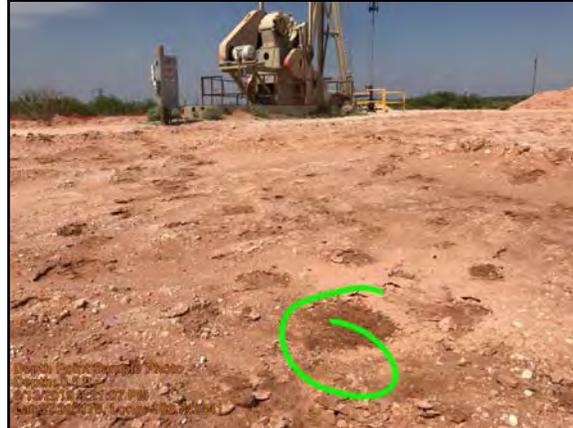
Sample Point ID: TP19-04

Depth: 0.5ft.
