**Work Plan**

**Vasquez #001**  
**RP#: 2RP-5702**  
**Incident#: NRM1932257155**  
**DOR: October 9, 2019**  
**GPS: 32.2315331 -104.0559235**  
**Unit Letter J, Section 11, Township 24 South, Range 28 East**  
**Eddy County, New Mexico**

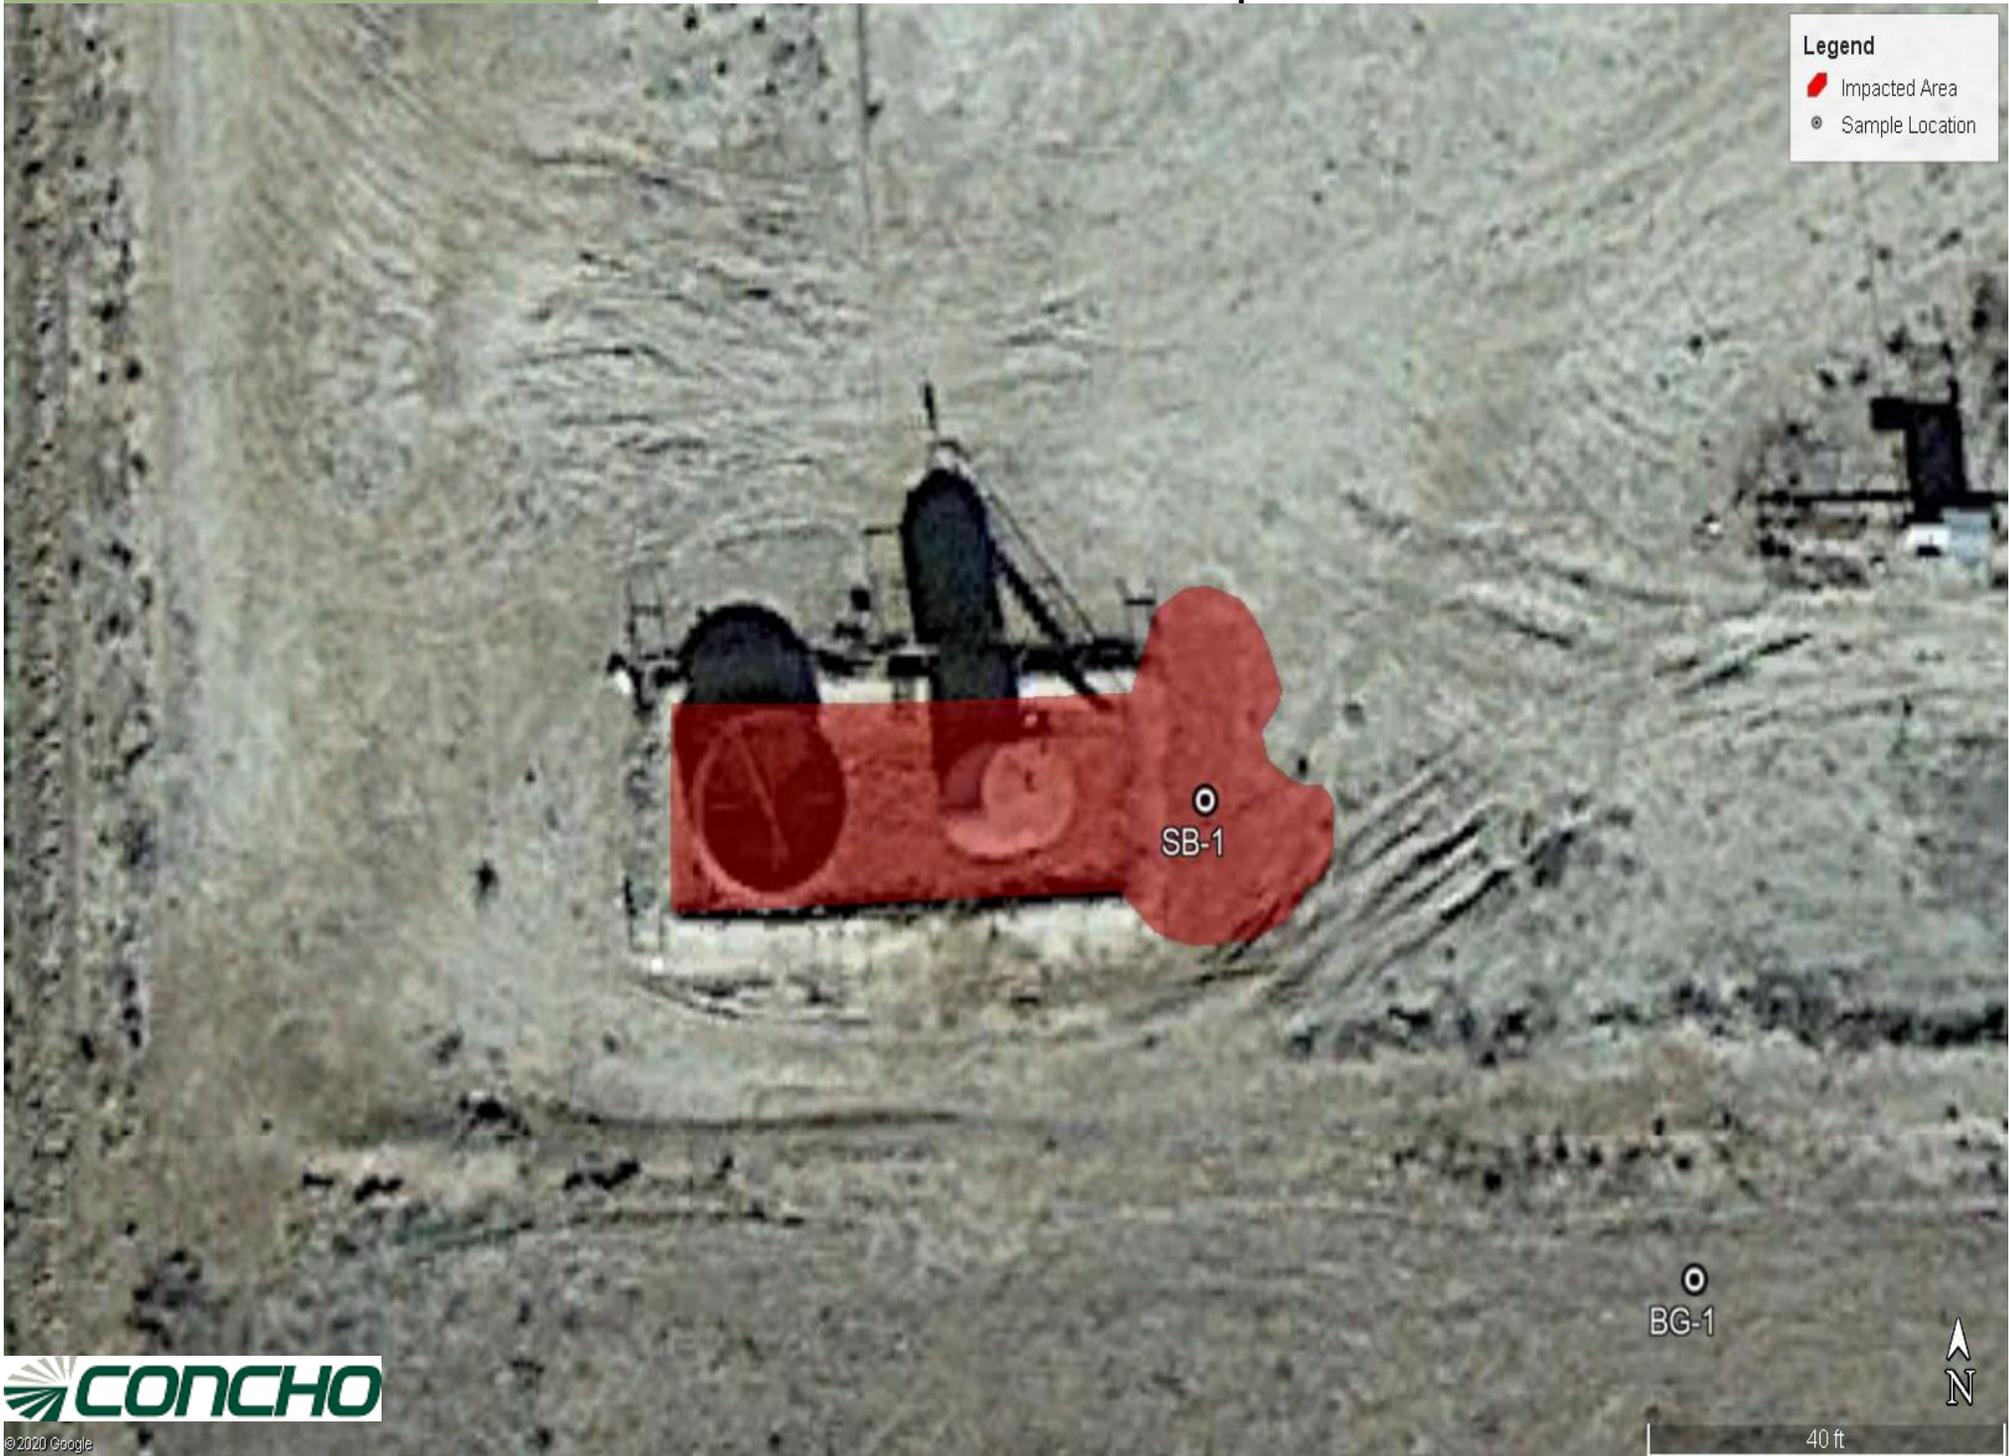
# Vasquez #001

Impacted Area
-

Sample Location

- The impacted area in the vicinity of sample location SB-1 will be excavated to a depth of three (3) feet BGS.
- Due to the production equipment the impacted area inside of the berms of the tank battery will be deferred until abandonment of the facility.
- All of the excavated material will be hauled to an NMOCD approved solid waste disposal facility.
- The excavation will be backfilled with clean “like” material and contoured to match the surrounding terrain.
