RE: Nash Draw Unit #29 modular impoundment (Atlantis system) for temporary storage of treated produced water.

**C-144 Permit Package for
Nash Draw Unit #29 -
Temporary Storage of Treated Produced
Water - Modular Impoundment
Section 13 T23S R29E Eddy County NM**

**Prepared for
XTO Energy
Midland, Texas**

**Prepared by
R.T. Hicks Consultants, Ltd.
Albuquerque, New Mexico**

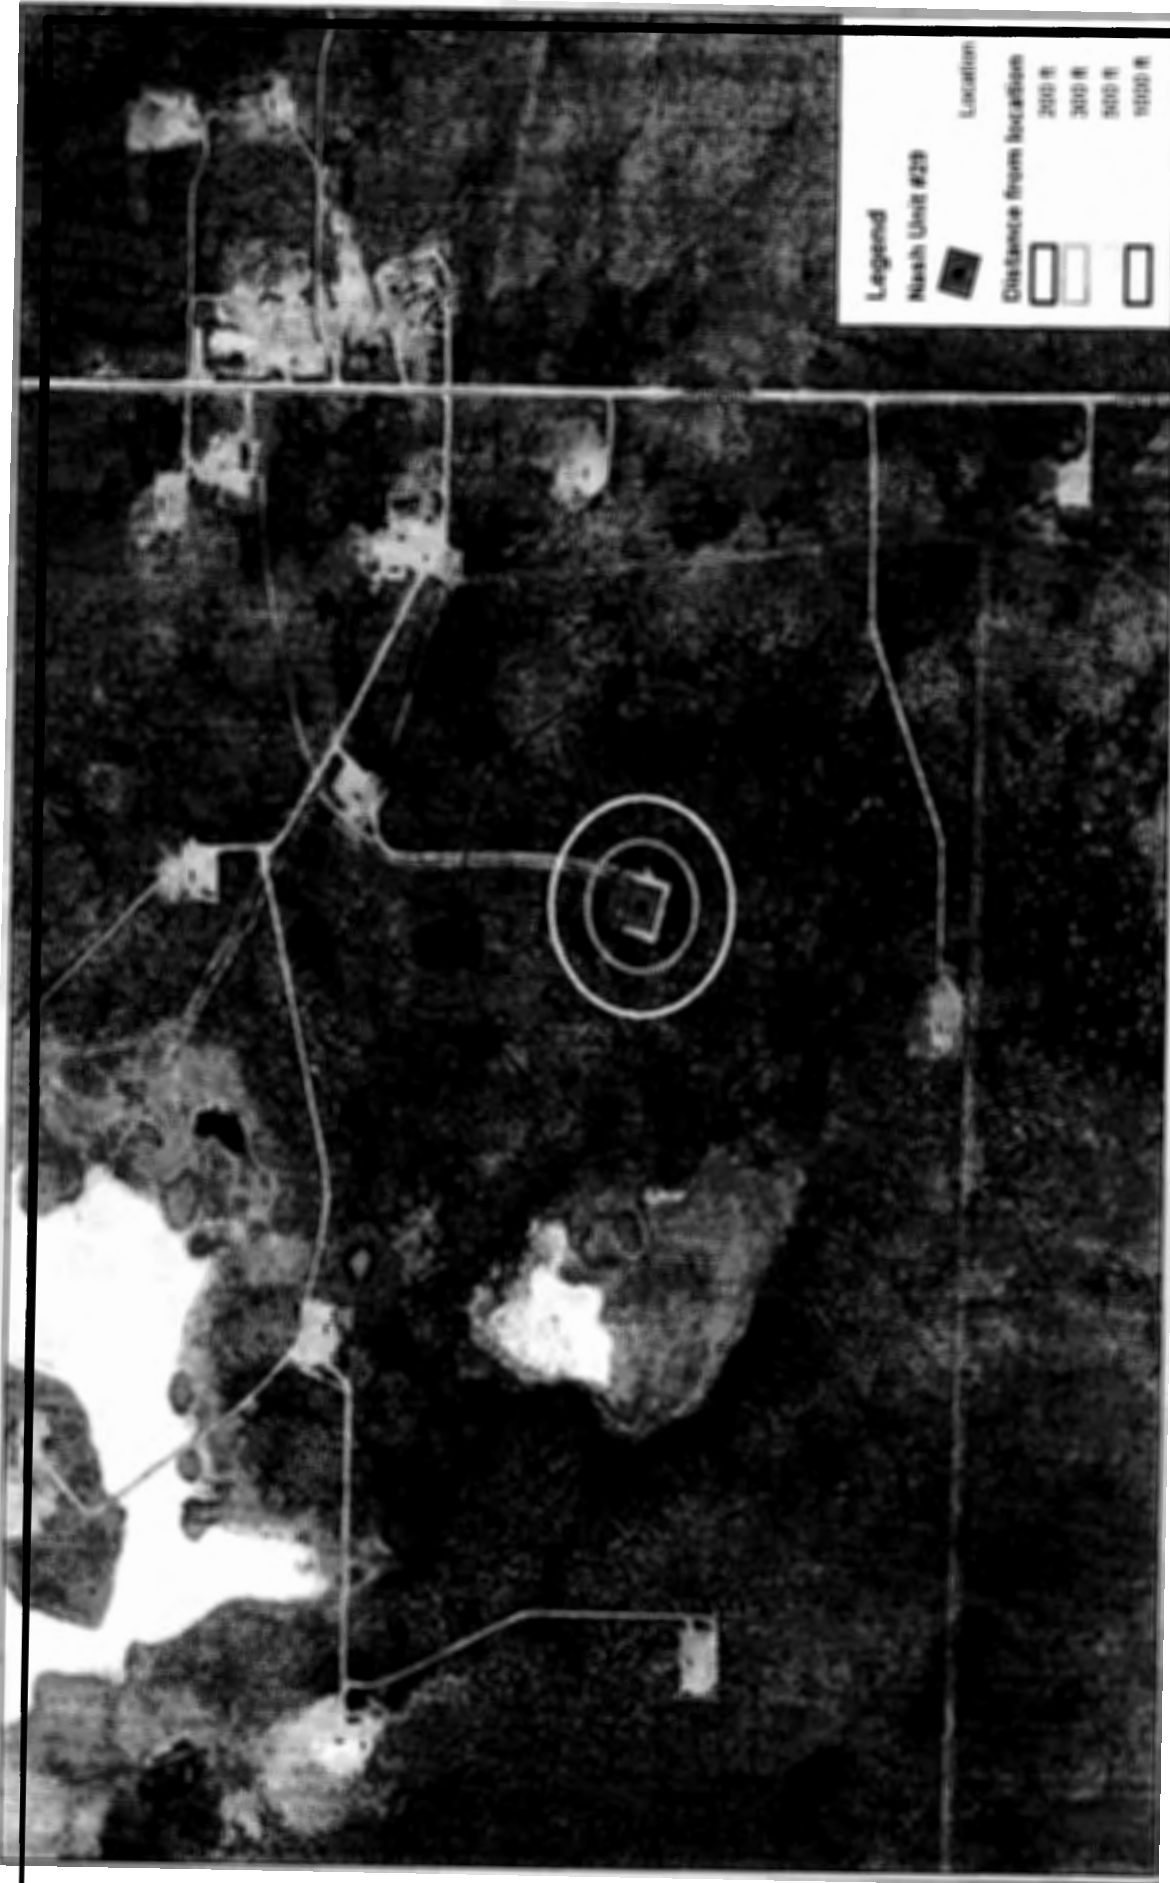
Nearby Structures

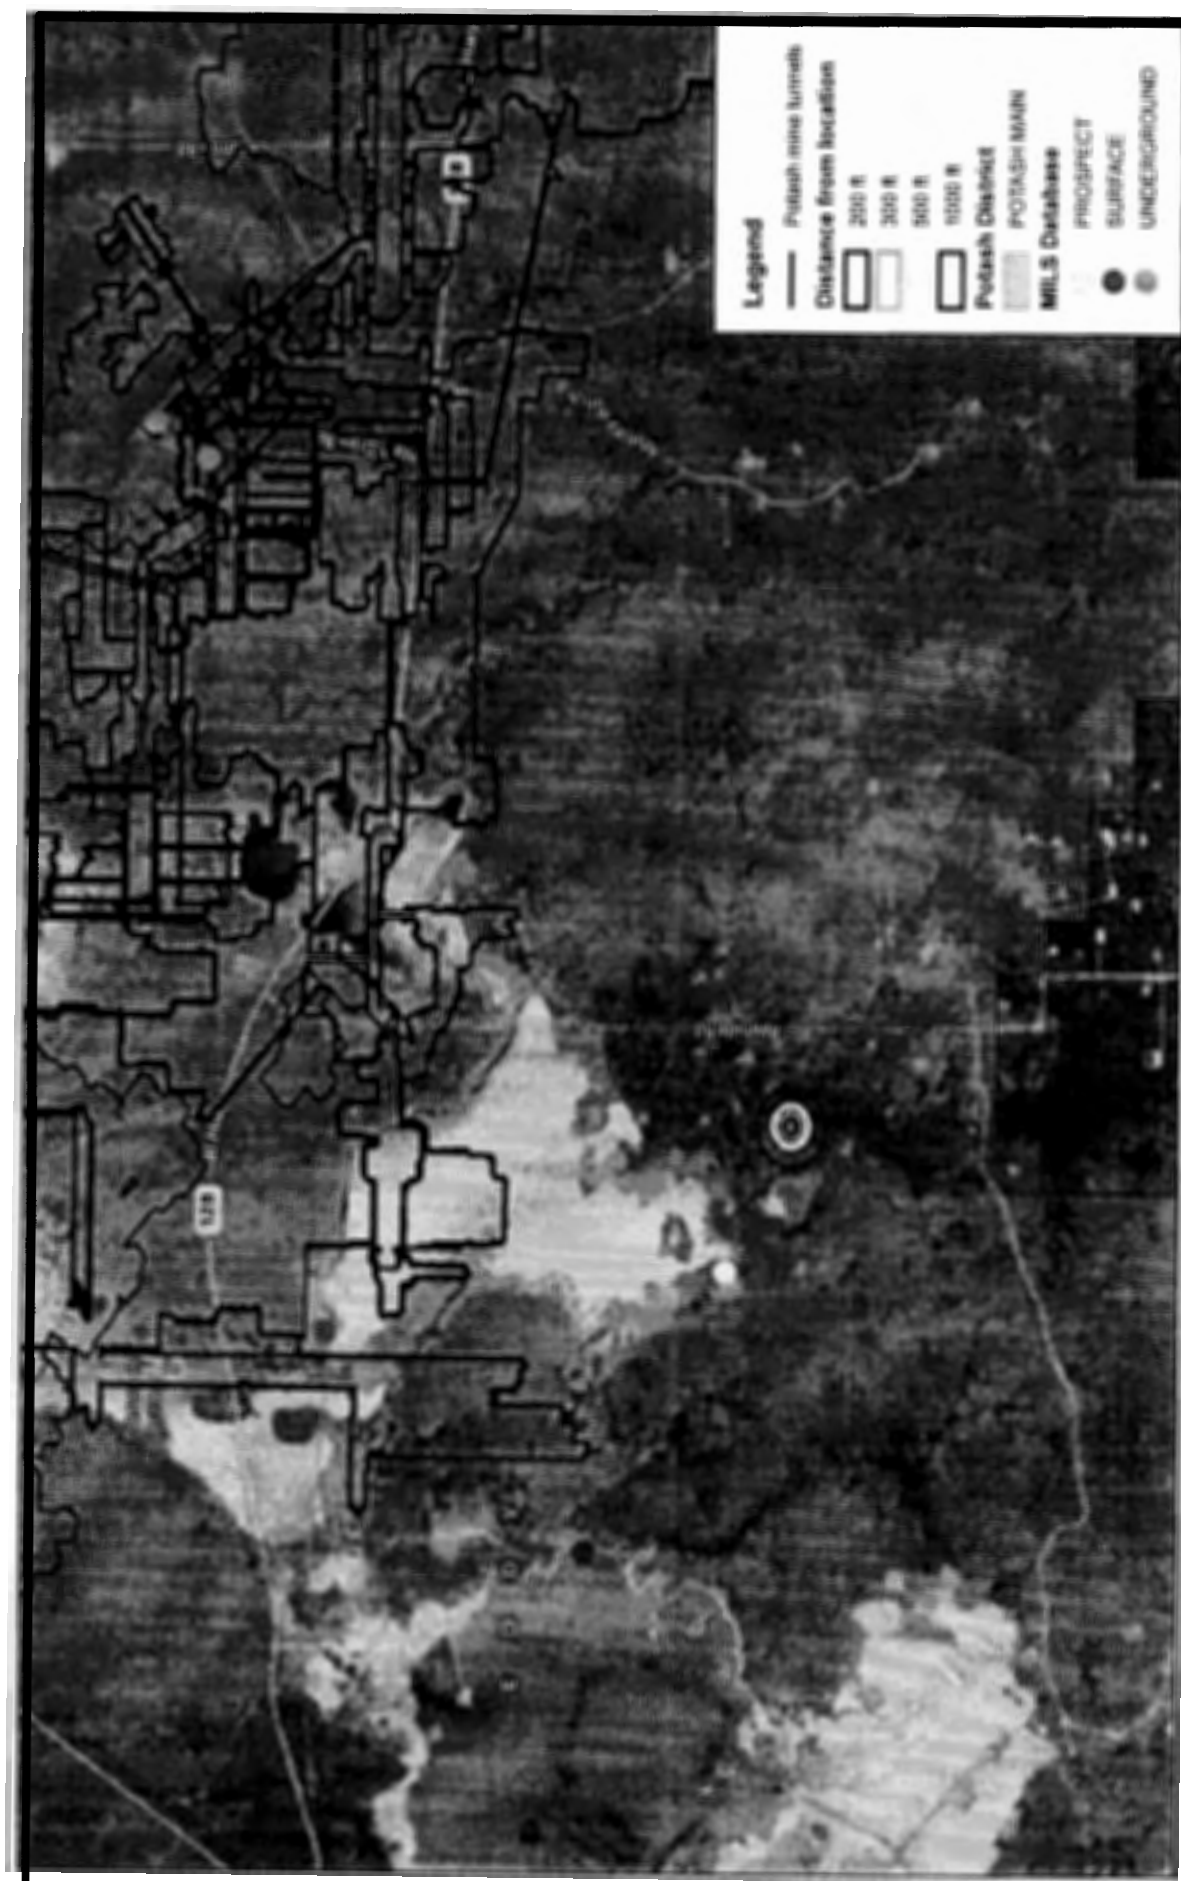
Potash tunnel source: BLM Base Map January 2012

Figure 7	Nearby Mines and Potash Tunnels	R.T. Hicks Consultants, Ltd 901 Rio Grande Blvd NW Suite F-142 Albuquerque, NM 87104 Ph: 505.266.5004
June 2012	XTO Energy: Nash Unit #29

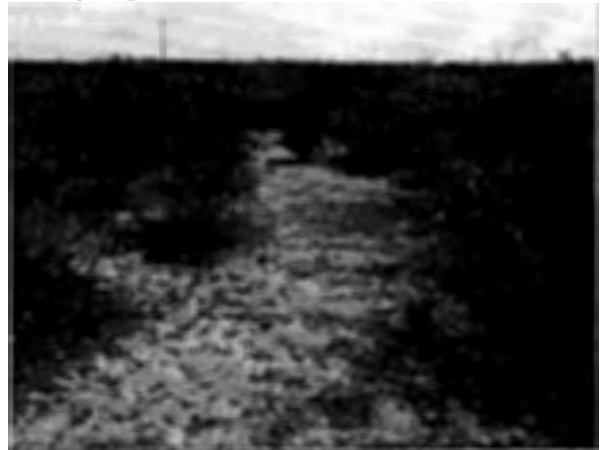
Photo 1: Photo of USDA identified intermittent stream. No definite banks and beds with visible evidence of occasional flow of water were identified.

- a. Data from the USDA’s National Hydraulic Dataset shows an intermittent stream (shown as a light blue dotted line in Figure 2) transecting the location.
- b. Site reconnaissance identified no evidence of a watercourse as defined by NMAC 19.15.2.7. Photo 1, at right, shows the location of the “intermittent stream” identified by the USDA. As shown in Photo 1, no watercourse was identified having definite banks and beds with visible evidence of the occasional flow of water.
- c. No other watercourses, water bodies, springs, or seeps exist within 200-feet of location.

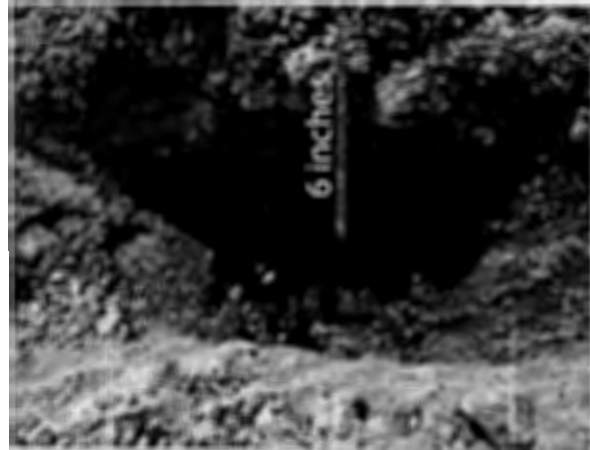
Photo 2: 6-inch caliche pad thickness. Dense clay underlies the pad.

- a. The closest potash mining tunnel is 1.5 miles north-northwest of the location. The closest surface mining location is 0.7 miles northwest. The MILS database lists the surface mine as a Prospect.
- b. The construction of the modular impoundment will not require more than 18 inches excavation into the subsurface. The existing production pad consists of 6 inches of caliche on top of very dense clay (Photo 2). We conclude the construction of the modular impoundment will not compromise the subsurface integrity.

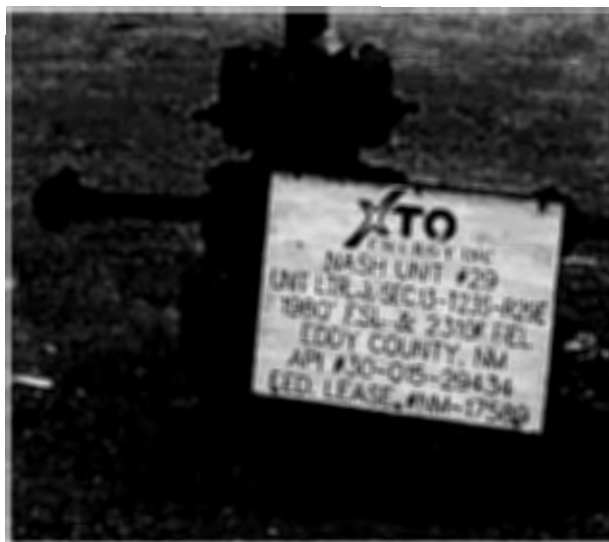
Photo 4: Sign at Nash Unit #29 to be used in conjunction with the modular impoundment.

The existing sign at Nash Unit #29 production well, which is on the same production pad as the proposed location, shall be used. Photo 4 is a photograph of

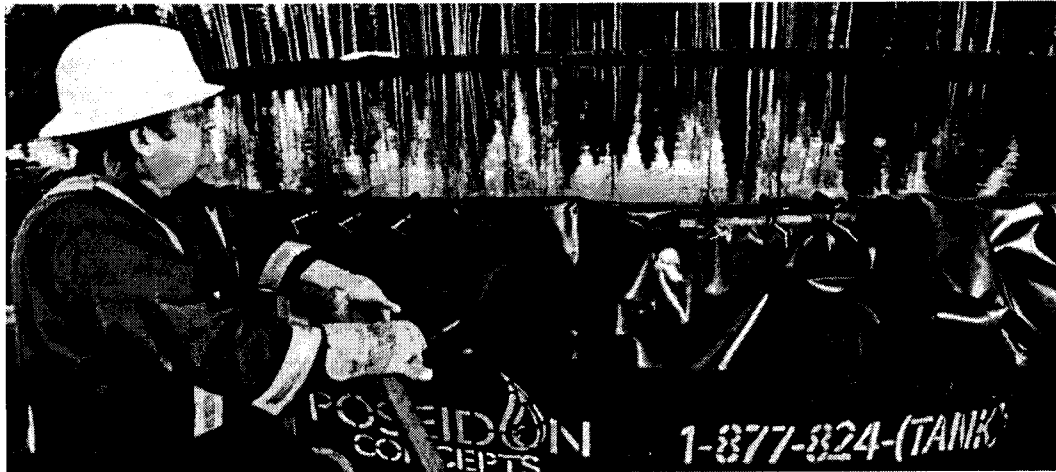
Photo 6: Clamping system holding liner in place. Spacing between clamping is 3-feet.

The 30 mil LLDPE liner is then clamped to the top of these walls leaving an extra 2 feet of liner material hanging outside of the modular impoundment to provide a safety margin (Photo 6, below).

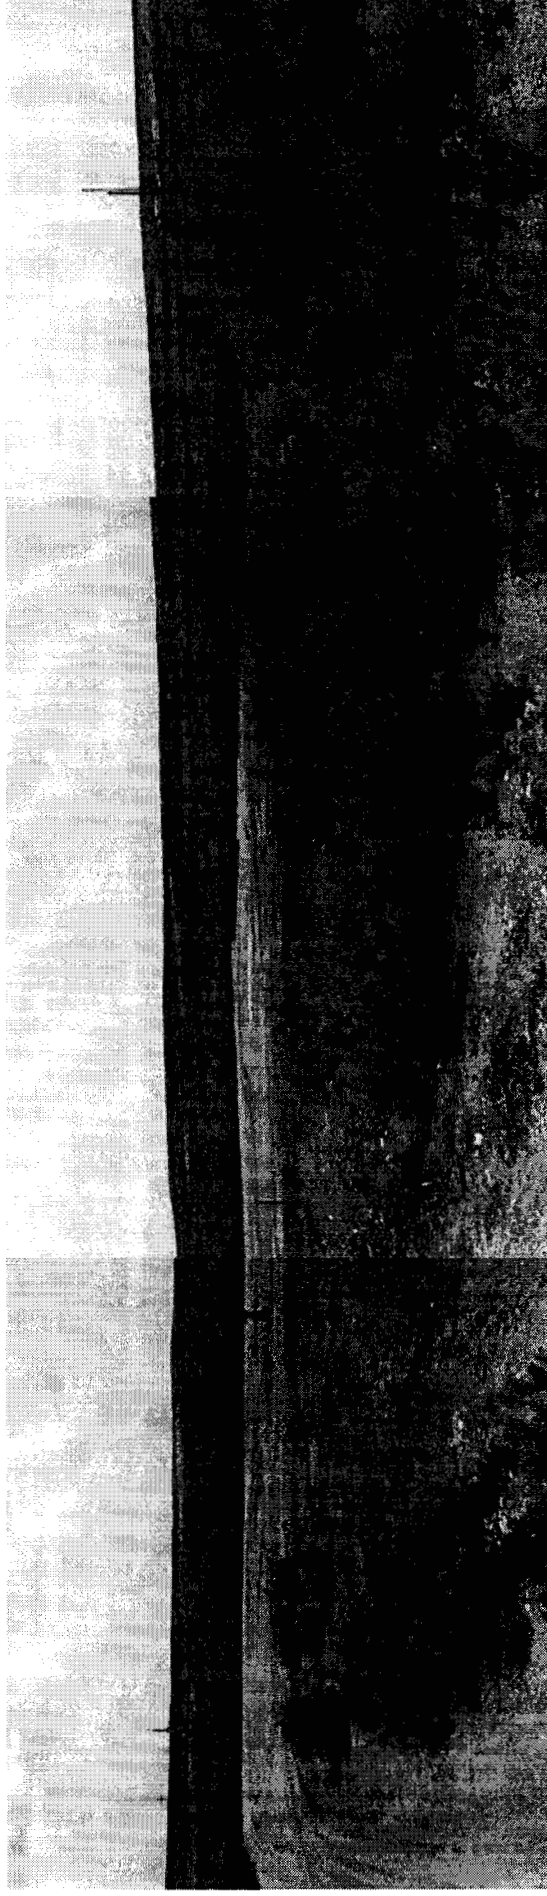
Photo-montage of Nash Unit #29 location looking south from a small rise. Temporary pit will lie on east (left) of the pad.

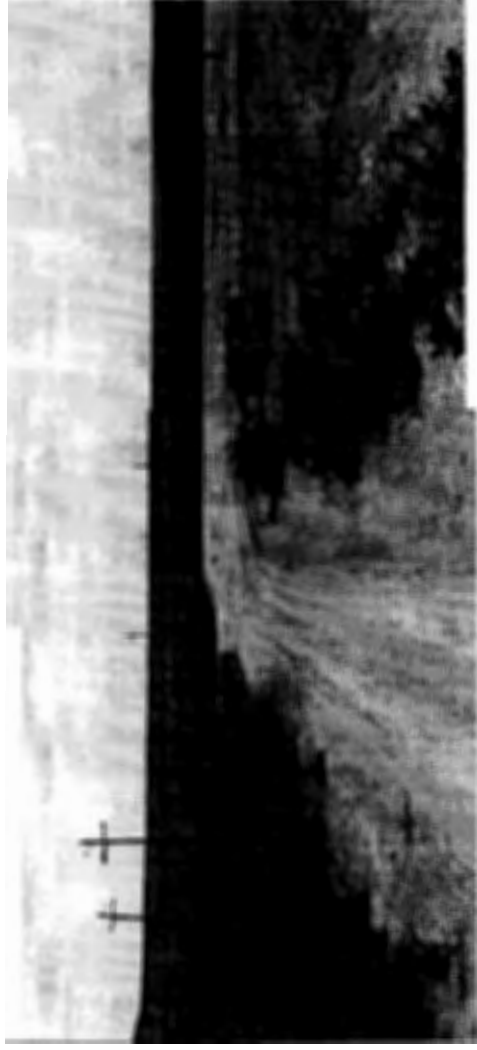
East portion of photo-montage Topography is very flat and site inspections found no evidence of a continuously-flowing arroyo on southeast portion of pad.

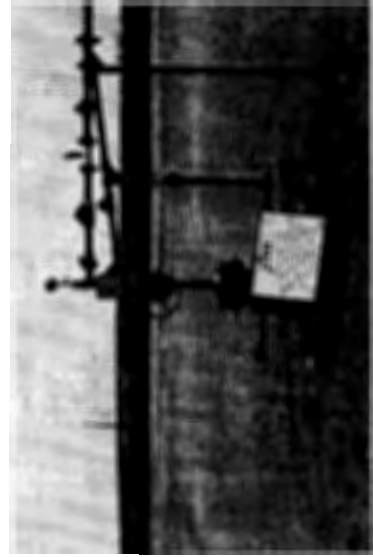
Photograph showing sign in compliance with NMOCD Rules.

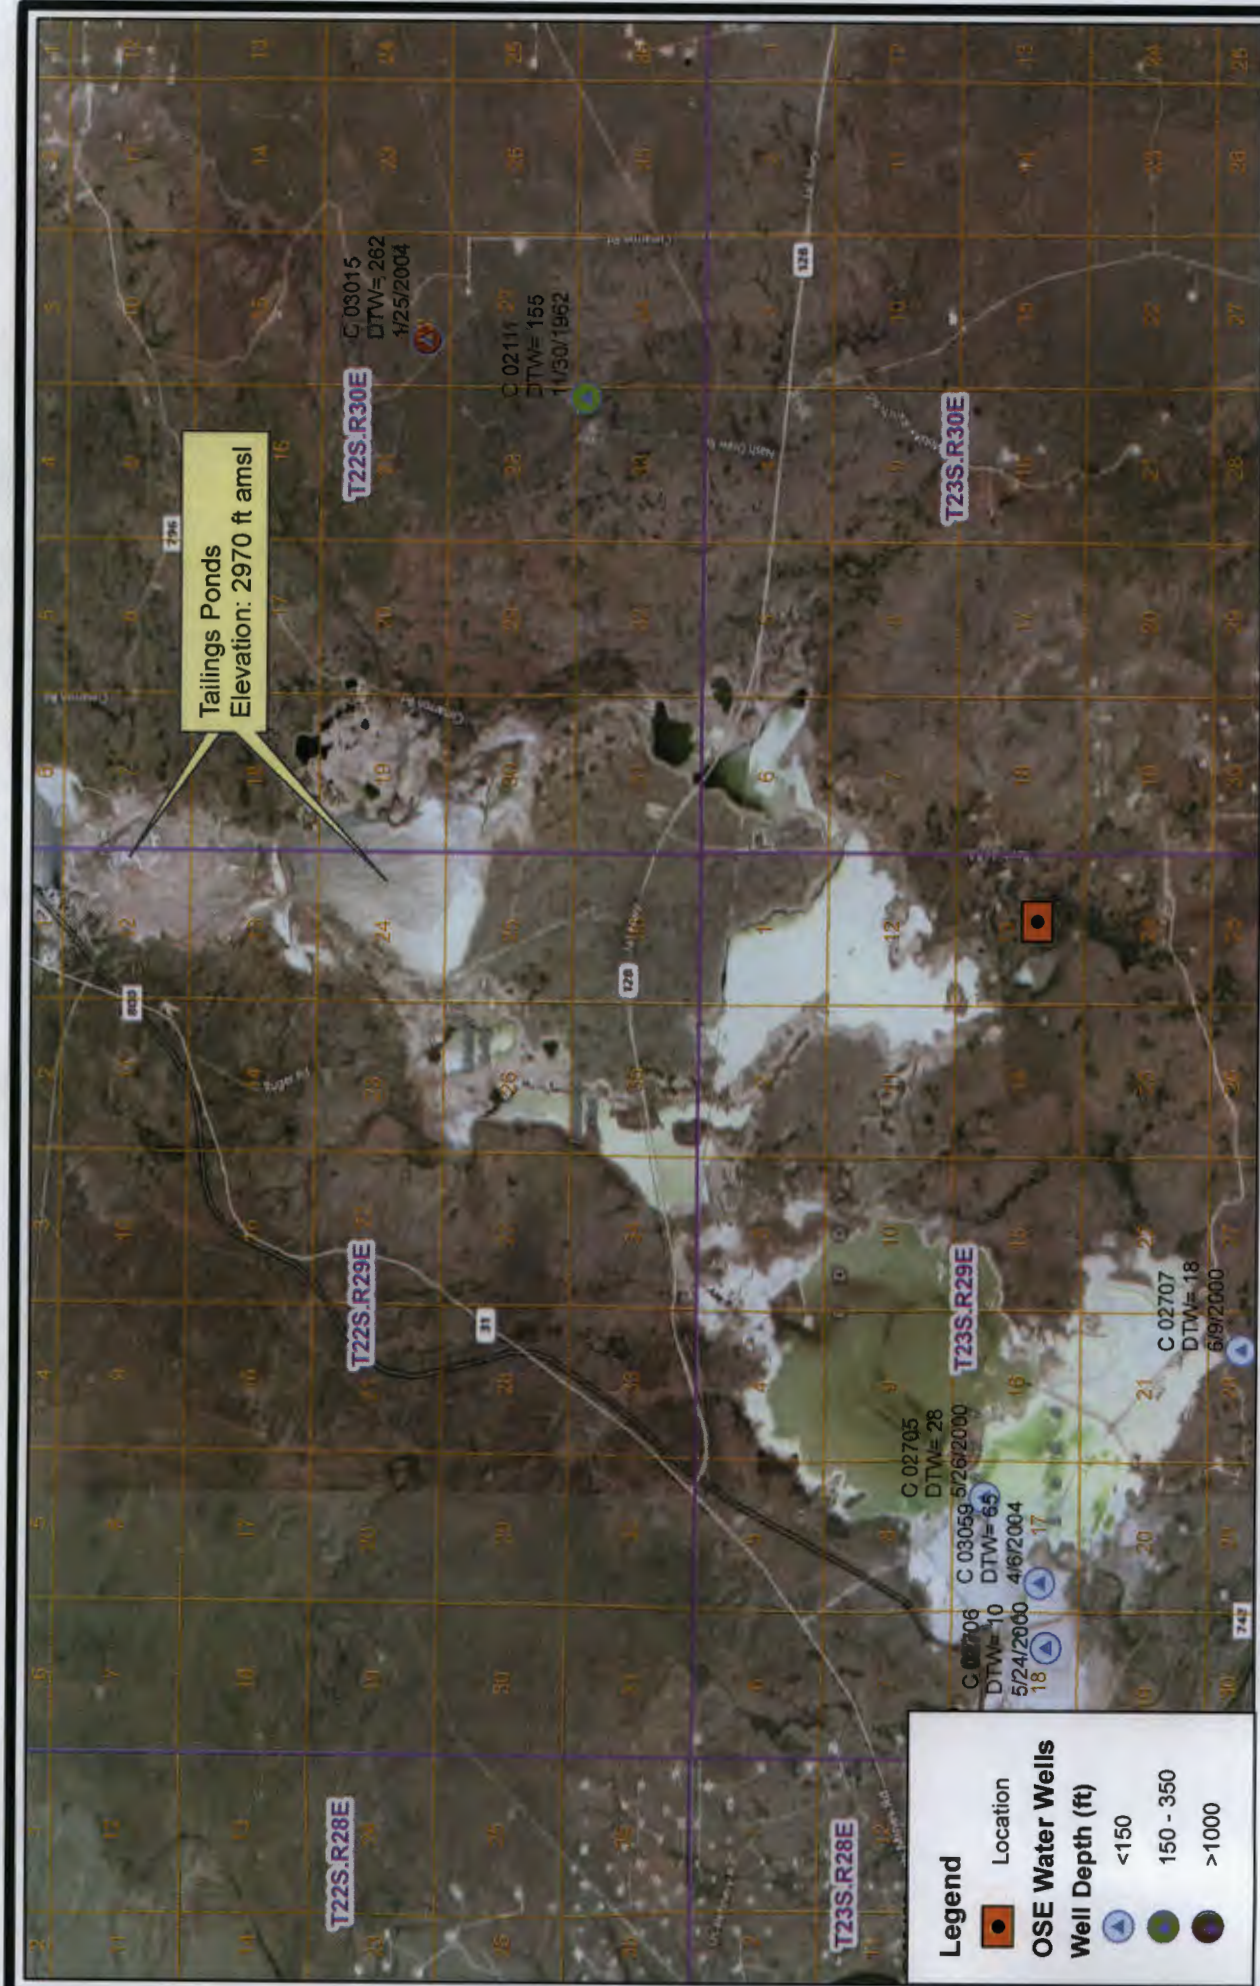
Location of Proposed Pit Relative to
 Salt Lake/Tailings Pond

The modular impoundment is located on Quaternary-Piedmont alluvial deposits (Figure 1a). The elevation at the bottom of the modular impoundment is 2,989.5 feet amsl. Underlying the alluvial deposits is the Rustler Formation that is composed of anhydrite, gypsum, interbedded sandy clay and shale, and irregular beds of dolomite. The Rustler overlies the Salado Formation.

Overlying the Rustler are Quaternary alluvial, lacustrine and piedmont deposits. Figure 1a shows that the modular impoundment lies on piedmont deposits (Qp) with playa/lacustrine deposits (Qpl) to the west and north and exposures of Rustler to the southeast and southwest.

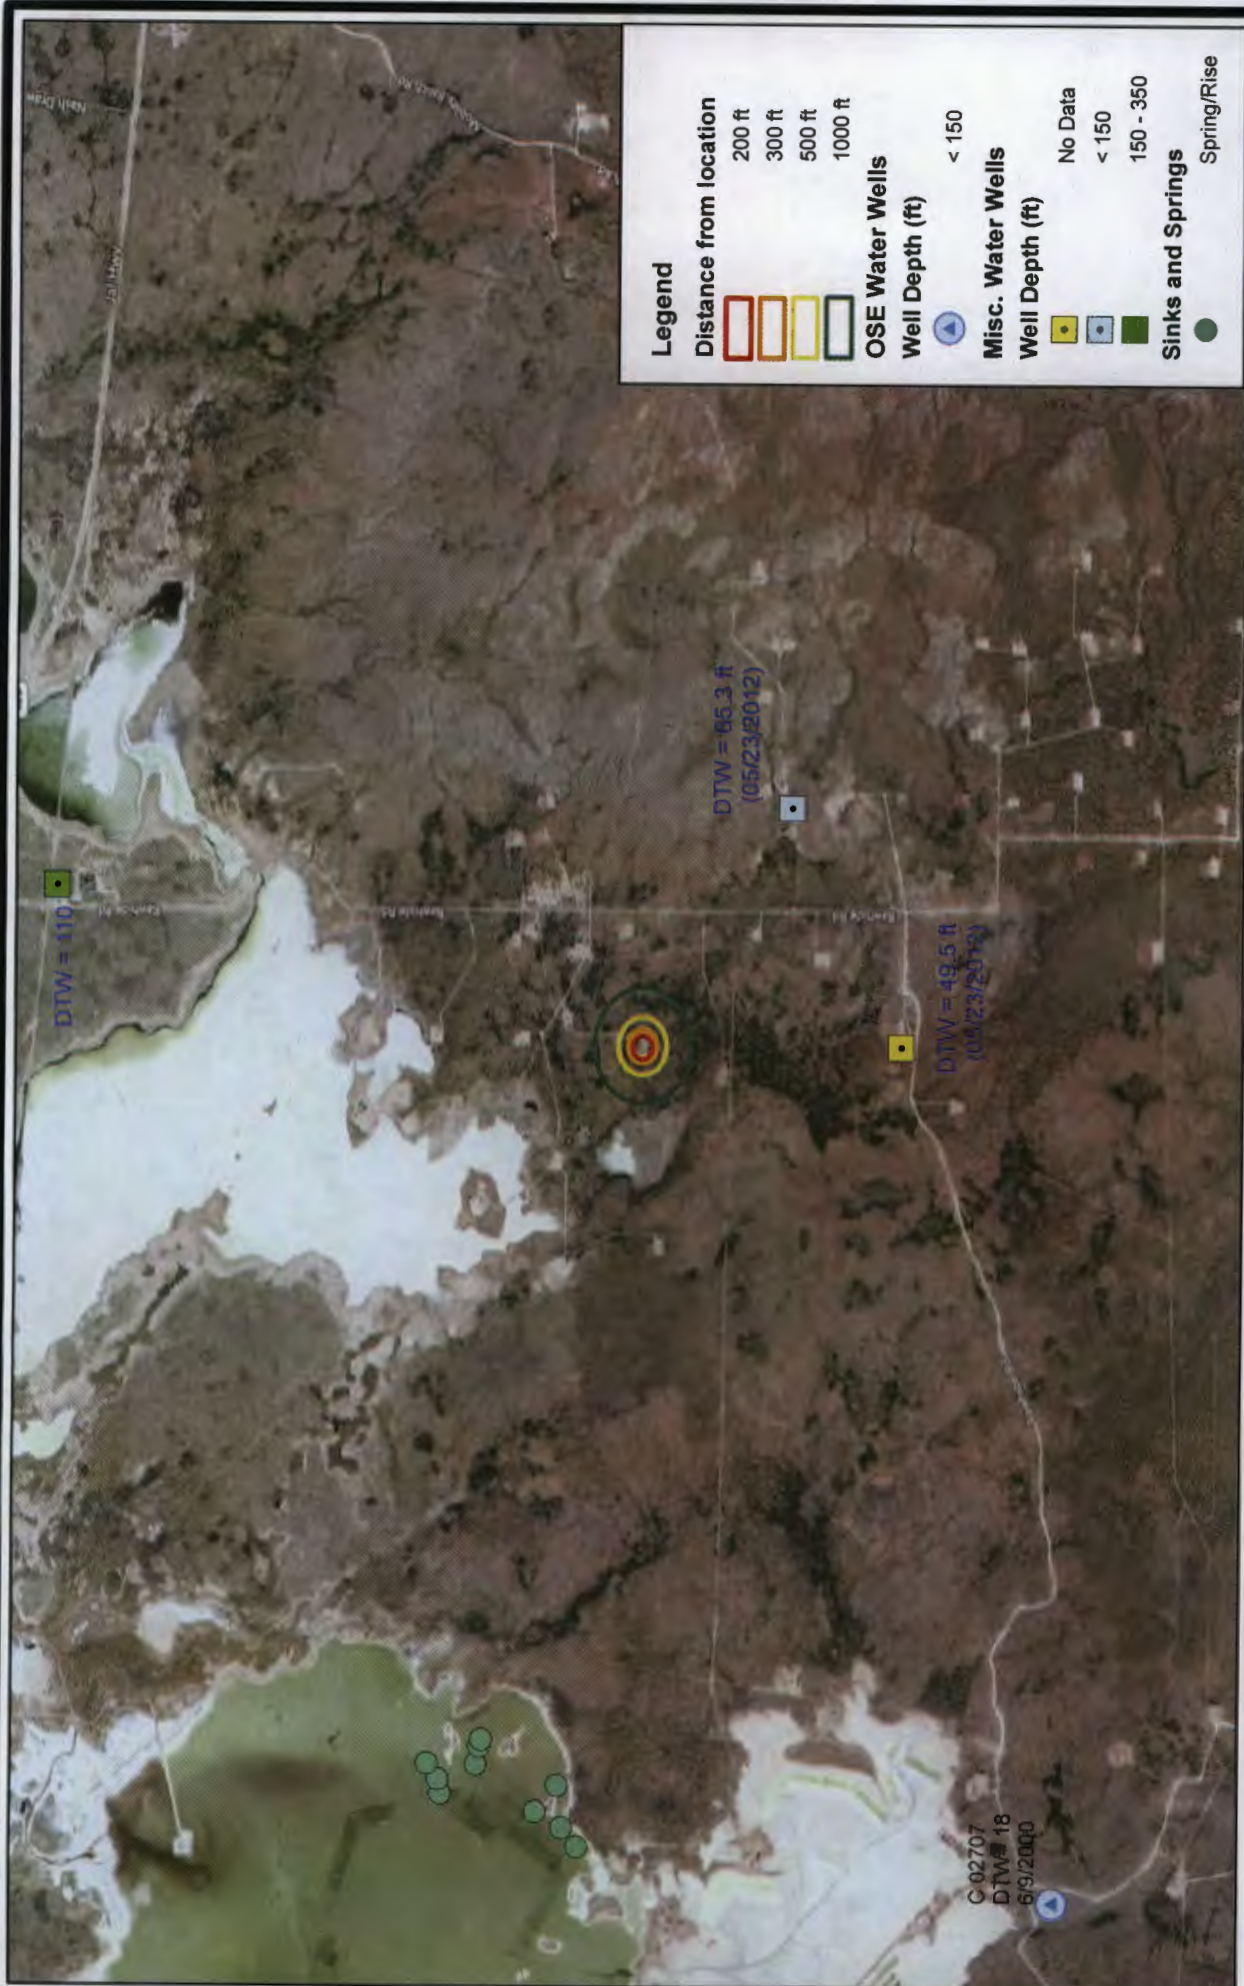
Figure 3

Nearby Fresh Water Springs or Wells

Approximately 1-mile south of the modular impoundment is a water well (WAIDS-6) listed in Go-Tech's WAIDS database. This well is listed as a stock well completed within the Rustler formation; the WAIDS database provides no total depth or depth to groundwater data. However, the WAIDS reports a chloride concentration of 54 mg/L (07/31/1997). Hicks Consultants measured the depth to groundwater on May 23, 2012 at 49.5 feet below ground surface (2,978 ft amsl).

Approximately one mile southeast of the modular impoundment, Open File Report -95³ describes a stock well (OFR95-9) completed within the Rustler formation with a depth to groundwater of 54.9 feet (10/1977) and a total well depth of 59.6 feet. The WAIDS database lists total depth of the well at 100 feet (12/10/76) with a chloride concentration of 36 mg/L. Hicks Consultants measured this well on May 23, 2012 with a depth to groundwater of 65.3 feet (2,977.7 feet amsl).

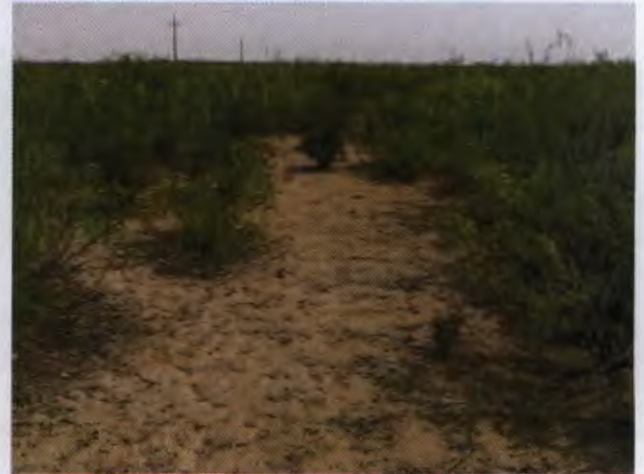
Photo 1: Photo of USDA identified intermittent stream. No definite banks and beds with visible evidence of occasional flow of water were identified.

- a. Data from the USDA’s National Hydraulic Dataset shows an intermittent stream (shown as a light blue dotted line in Figure 2) transecting the location.
- b. Site reconnaissance identified no evidence of a watercourse as defined by NMAC 19.15.2.7. Photo 1, at right, shows the location of the “intermittent stream” identified by the USDA. As shown in Photo 1, no watercourse was identified having definite banks and beds with visible evidence of the occasional flow of water.
- c. No other watercourses, water bodies, springs, or seeps exist with 200-feet of location.

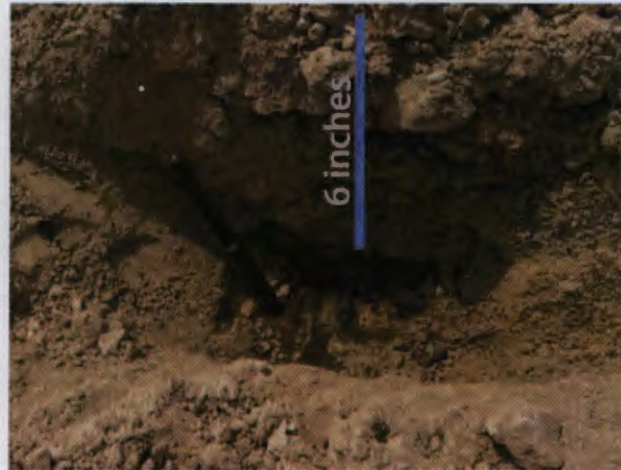
Photo 2: 6-inch caliche pad thickness. Dense clay underlies the pad.

- The closest potash mining tunnel is 1.5 miles north-northwest of the location. The closest surface mining location is 0.7 miles northwest. The MILS database lists the surface mine as a Prospect.
- The construction of the modular impoundment will not require more than 18 inches excavation into the subsurface. The existing production pad consists of 6 inches of caliche on top of very dense clay (Photo 2). We conclude the construction of the modular impoundment will not compromise the subsurface integrity.

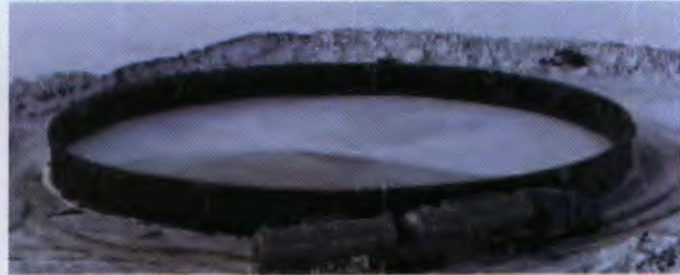
Photo 3: Example of Poseidon's fluid storage system.

XTO Energy shall construct a modular impoundment fluid storage system provided by Poseidon Concepts. The modular impoundment system model is the Atlantis⁴. Photo 3, right, is an example of Poseidon's modular impoundment. The modular impoundment shall be constructed according to manufacturer's specifications as described in Section 19.15.17.11.F, below. The modular impoundment is engineered to prevent contamination of fresh water and protect public health and the environment.

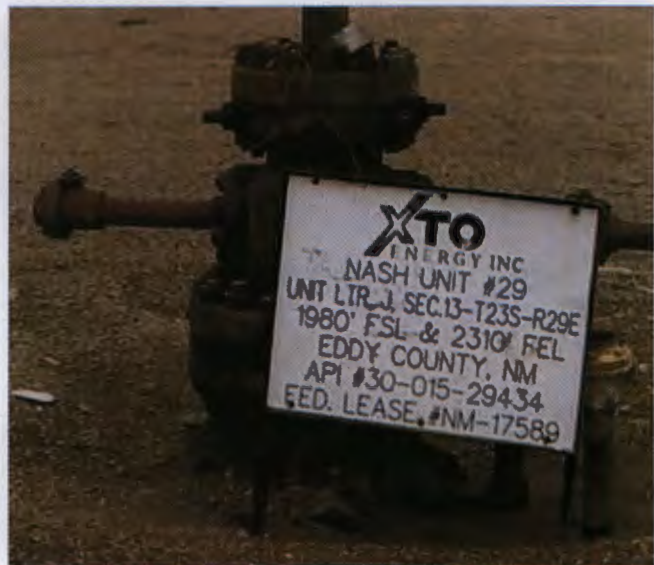
Photo 4: Sign at Nash Unit #29 to be used in conjunction with the modular impoundment.

The existing sign at Nash Unit #29 production well, which is on the same production pad as the proposed location, shall be used. Photo 4 is a photograph of

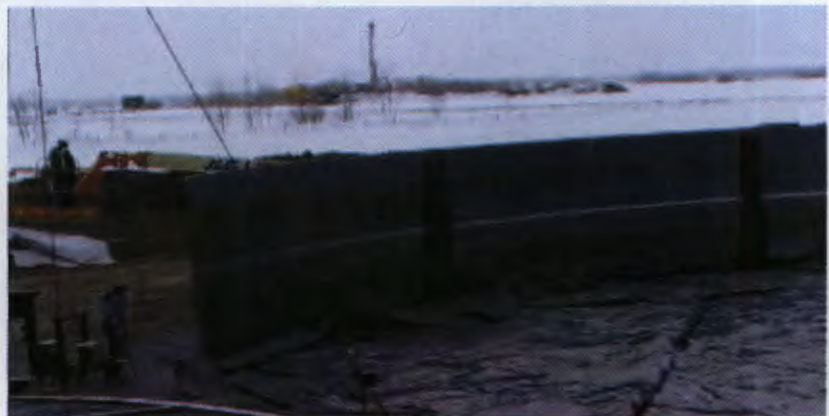
Photo 5: Interlocking panels of the modular impoundment.

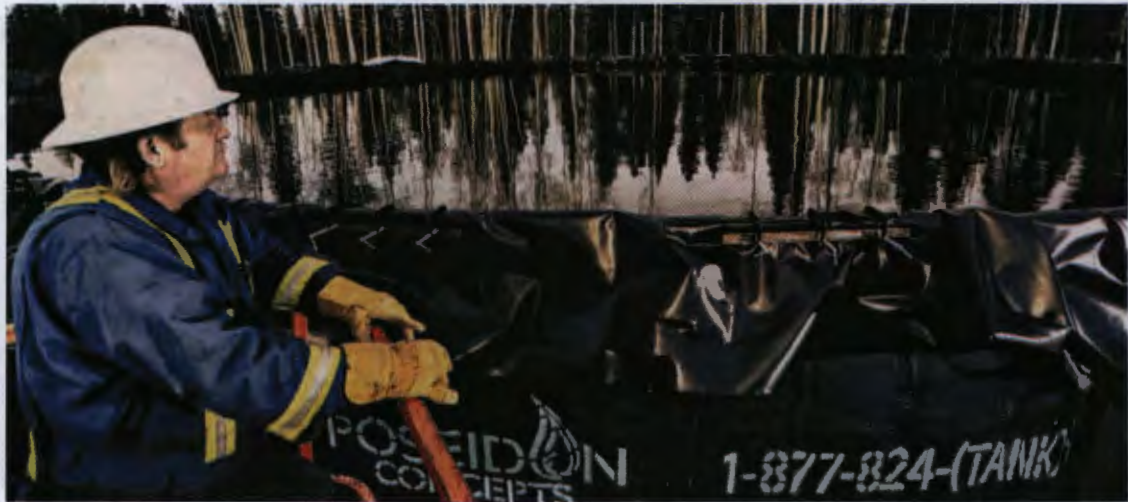
Photo 6: Clamping system holding liner in place. Spacing between clamping is 3-feet.

The 30 mil LLDPE liner is then clamped to the top of these walls leaving an extra 2 feet of liner material hanging outside of the modular impoundment to provide a safety margin (Photo 6, below).

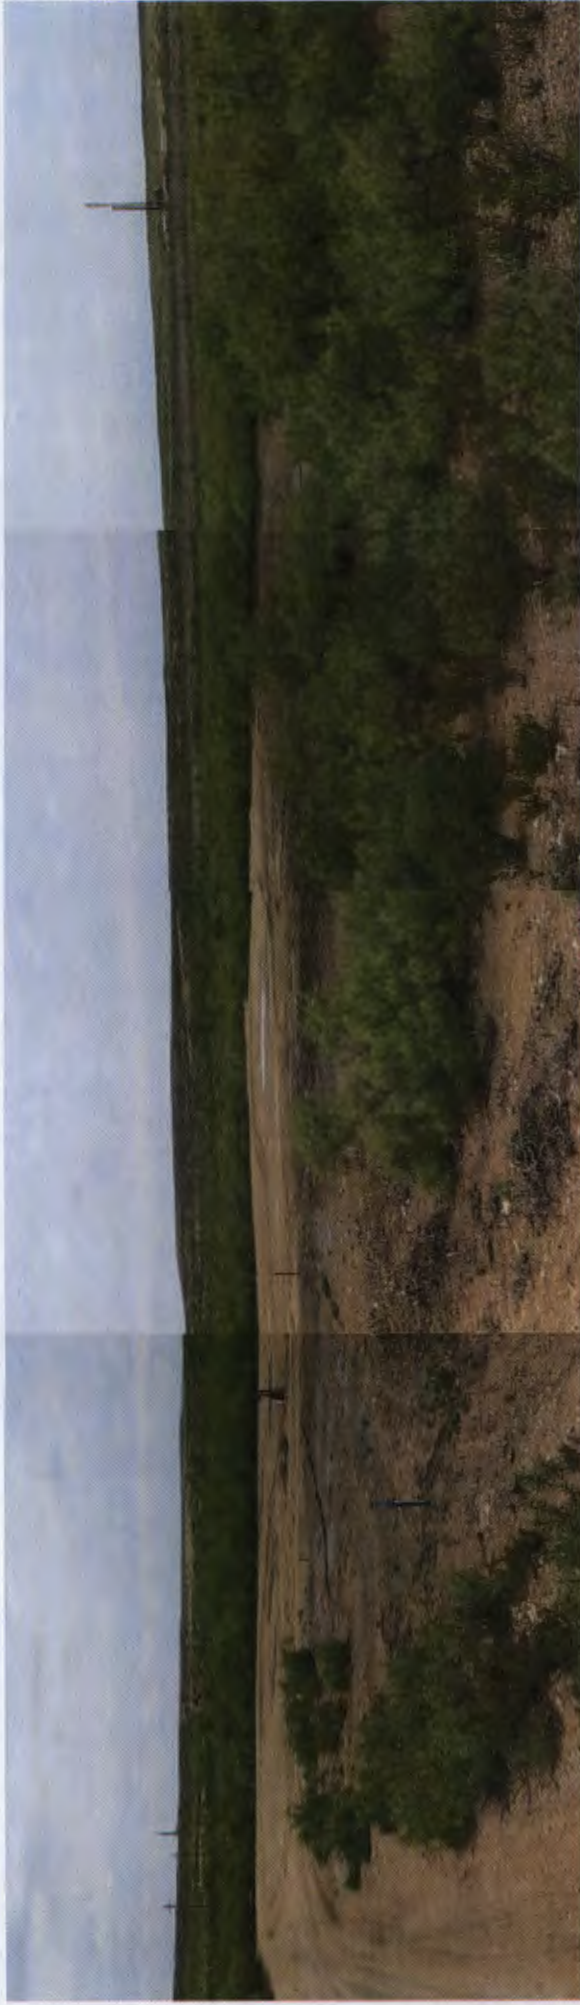
Photo-montage of Nash Unit #29 location looking south from a small rise. Temporary pit will lie on east (left) of the pad.

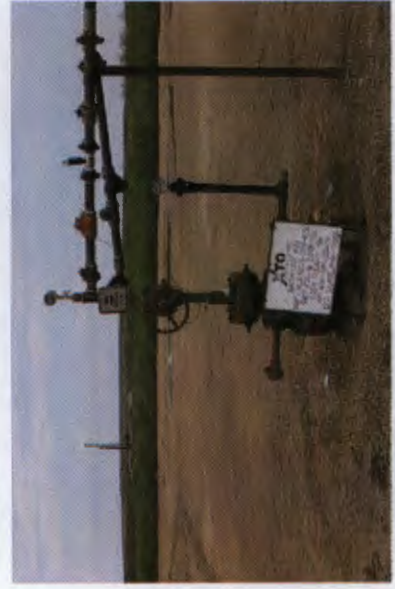
Photograph showing sign in compliance with NMOCD Rules.

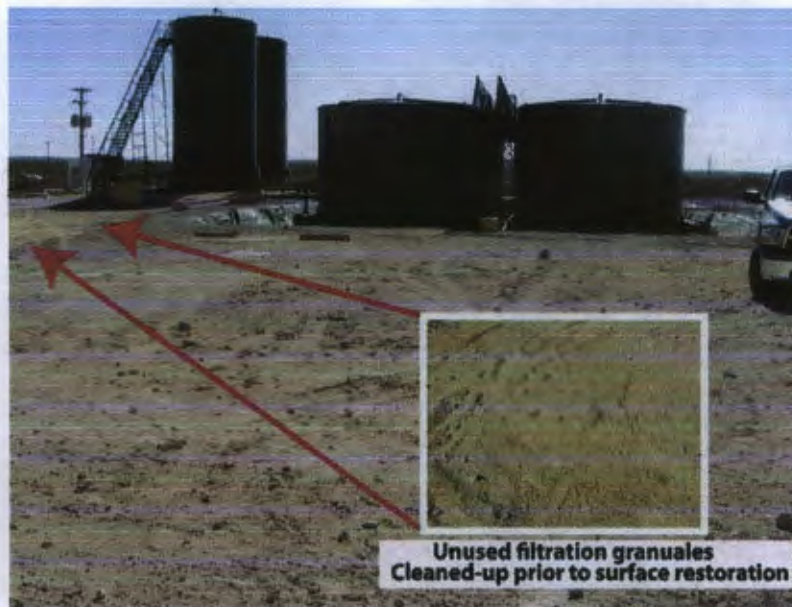
Figure 1:
Photograph of
filtration granules
used in the
CleanWave
system. The
granules were
cleaned-up prior
to surface
restoration.

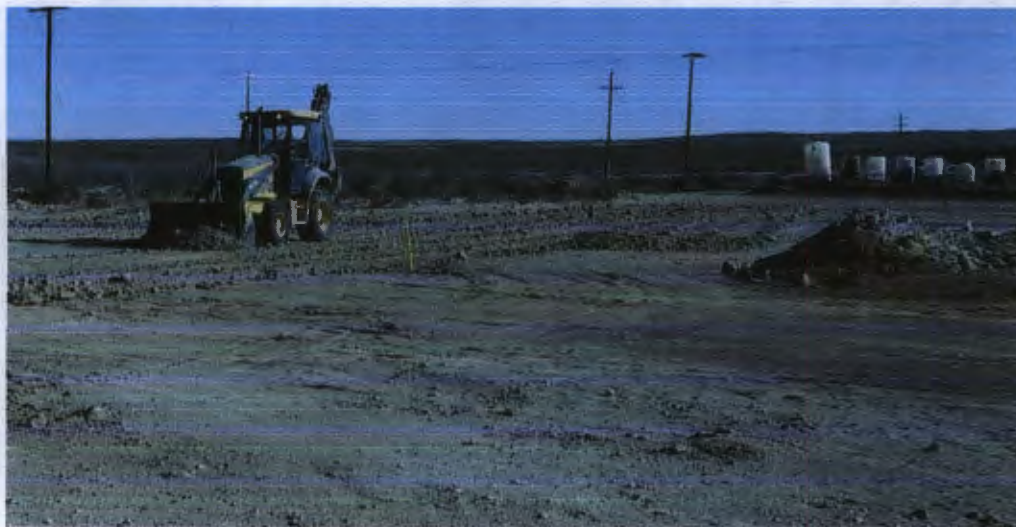
Figure 2: Grading of former containment berms. The former berms were either thin spread on location or placed around location to reinforce existing berms (Figure 3).

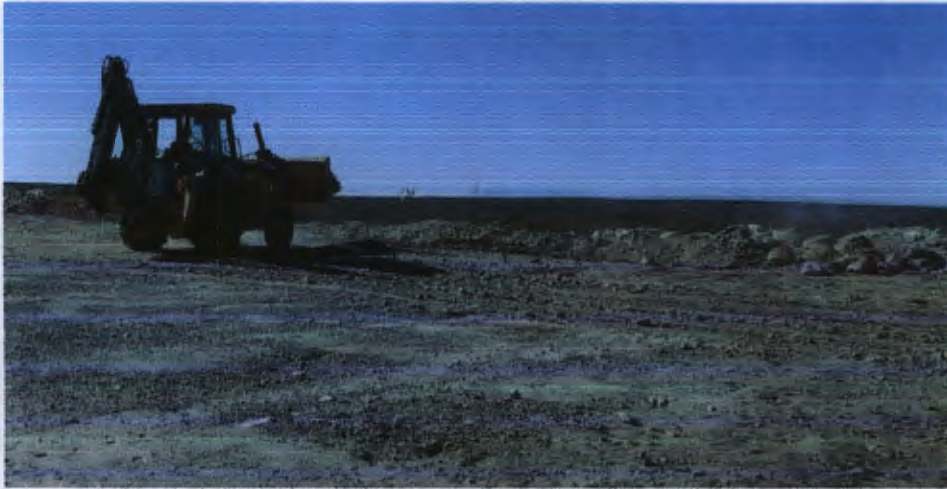
Figure 3: Re-using material from former containment berms from the CleanWave system to reinforce existing containment berms.

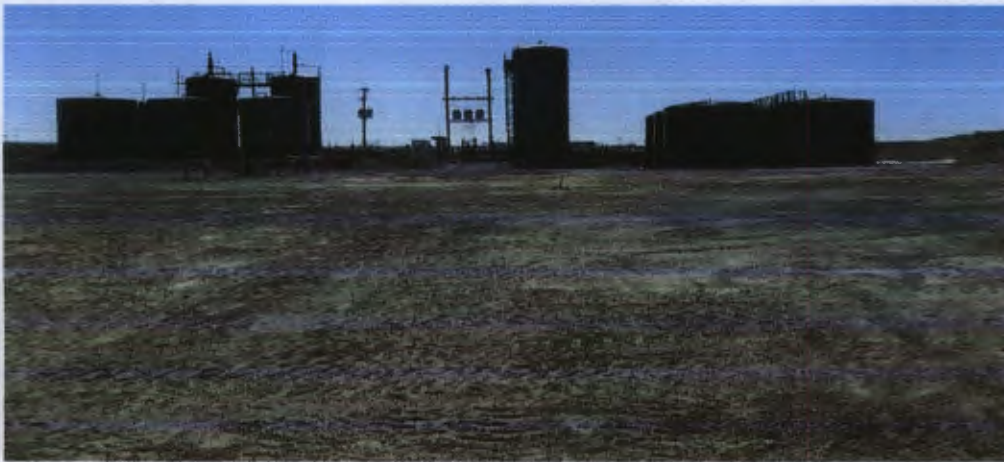
Figure 4: Location graded to pre-existing conditions. Nash Unit #4 is at left; Nash Unit #53SWD at right. Photograph is viewing south.
