# Linn Energy Turner B #95

## CLOSURE REPORT

API No. 30-015-26612

Unit Letter L, Section 20, Township 17 South, Range 31 East

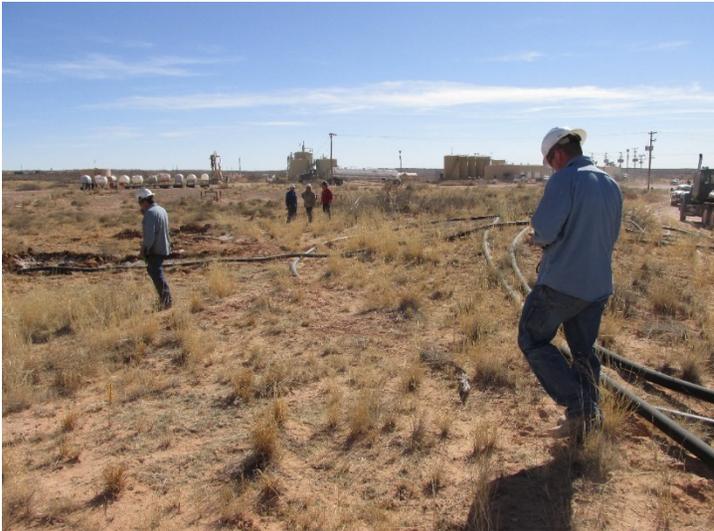
Location and spill area 2/18/14

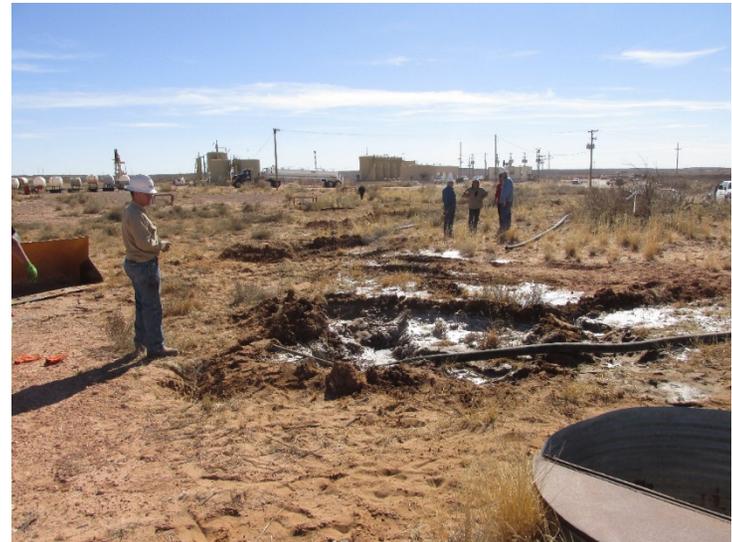
Impacted soil site 2/18/14

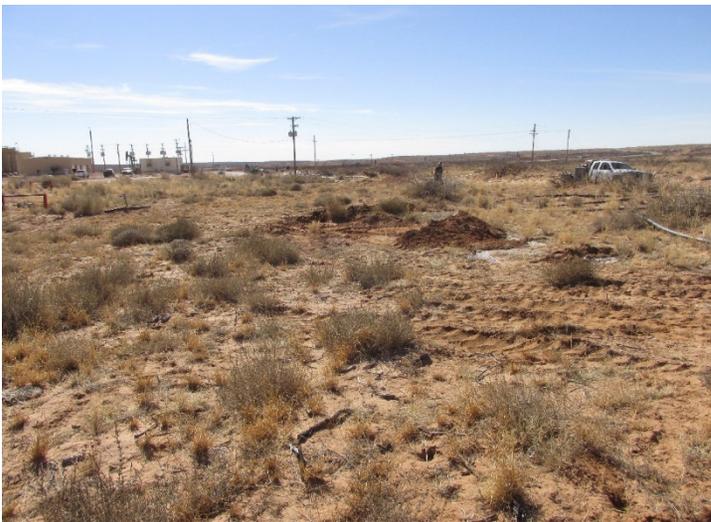
Stockpile of impacted soil for removal 2/18/14

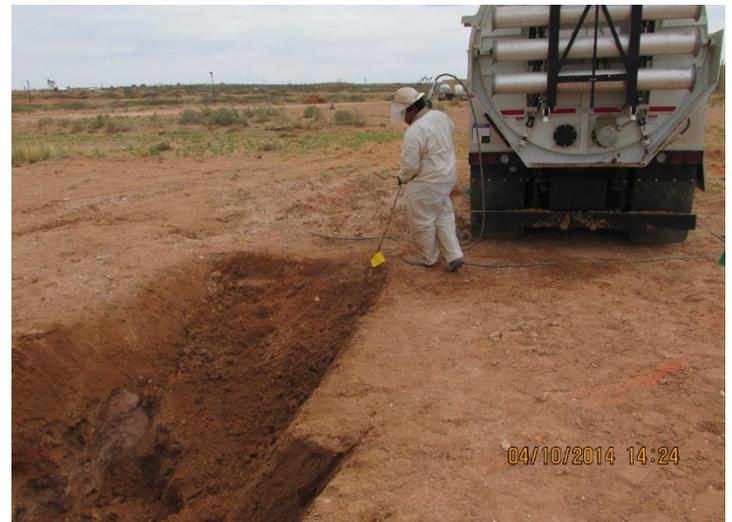
Hydro-vac of leak source 4/10/14

On April 10, 2014, DFSI contracted a hydro-vac in order to fully remediate the area around SP1 to 4ft. bgs. This was conducted due to the number of lines in this vicinity.

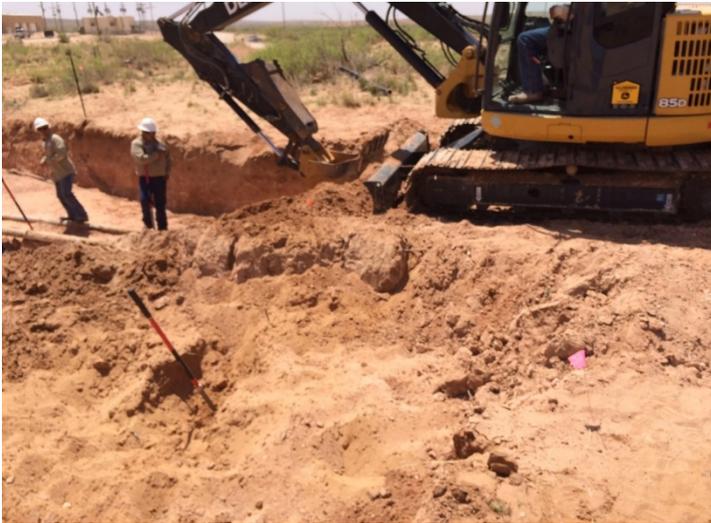
Excavation of site 4/25/14

On April 24, 2014 DFSI field personnel revisited the site in order to retrieve side wall confirmations of the excavation. Representative soil samples were retrieved at the north, south, east and west wall of the excavation in order to ascertain the vertical extent of impact, and submitted to a commercial laboratory for analyses. The results returned acceptable levels of chloride, in that chloride was <1460 mg/kg, BTEX was <.300, GRO DRO was non-detect.

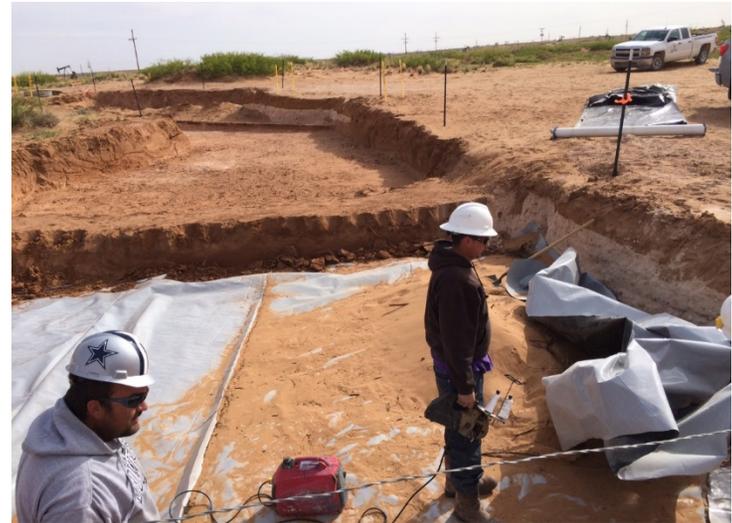
Installation of liner 5/1/14

On May 01, 2014 the excavation of the impacted area was complete. A 20mil. liner was installed at SP1, SP5 and SP6 respectively prohibiting downward migration of vadose zone. All impacted soils were removed to an NMOCD approved facility. The lined excavation was then backfilled with fresh topsoil contouring to the site, and preparation of surface conducive to seeding.

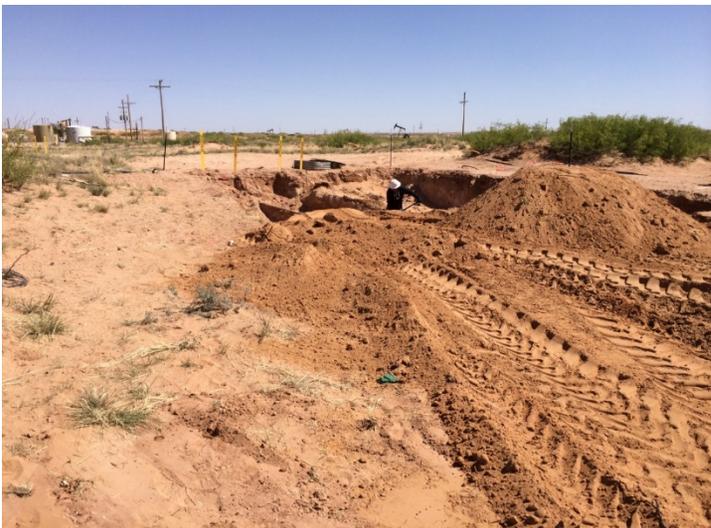
Backfilling of lined area 5/2/14

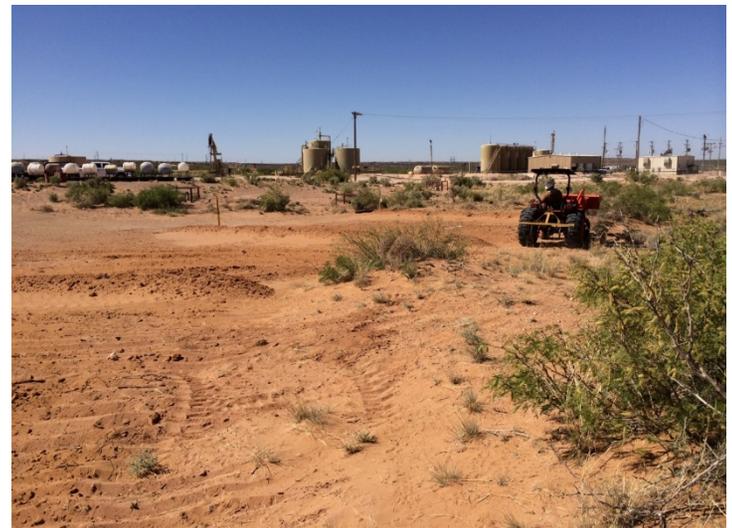
Site at completion of tilling and seeding 5/6/14

On May 06, 2014 DFSI personnel tilled and seeded the site with 100lbs of native vegetation and seed mixture promoting vegetation and providing an infiltration barrier. Photographs of site activities can be viewed in Appendix II.

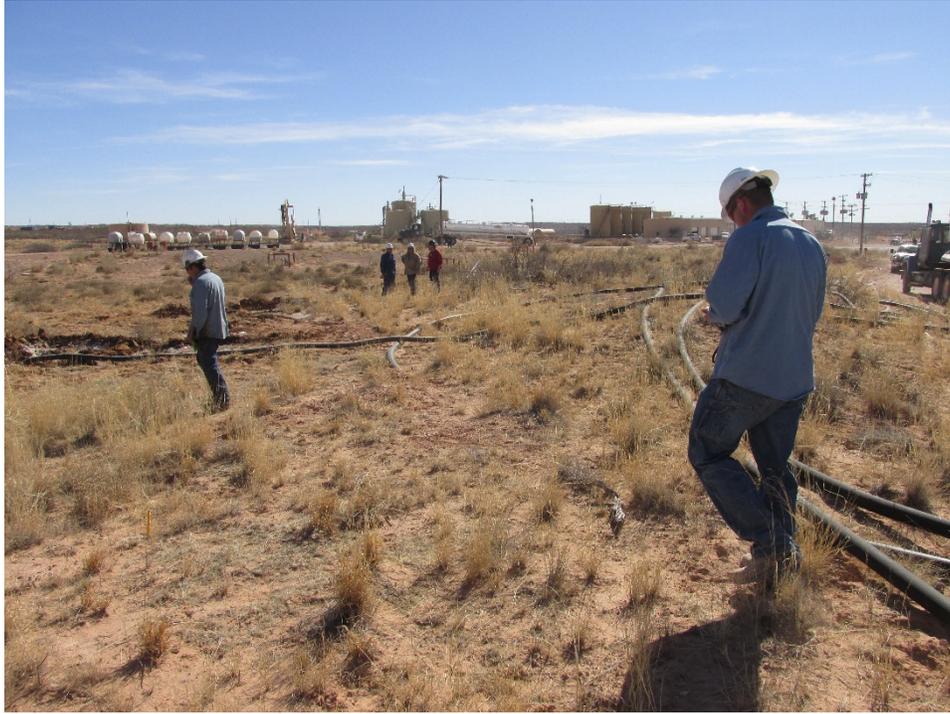
Location and spill area 02/18/14

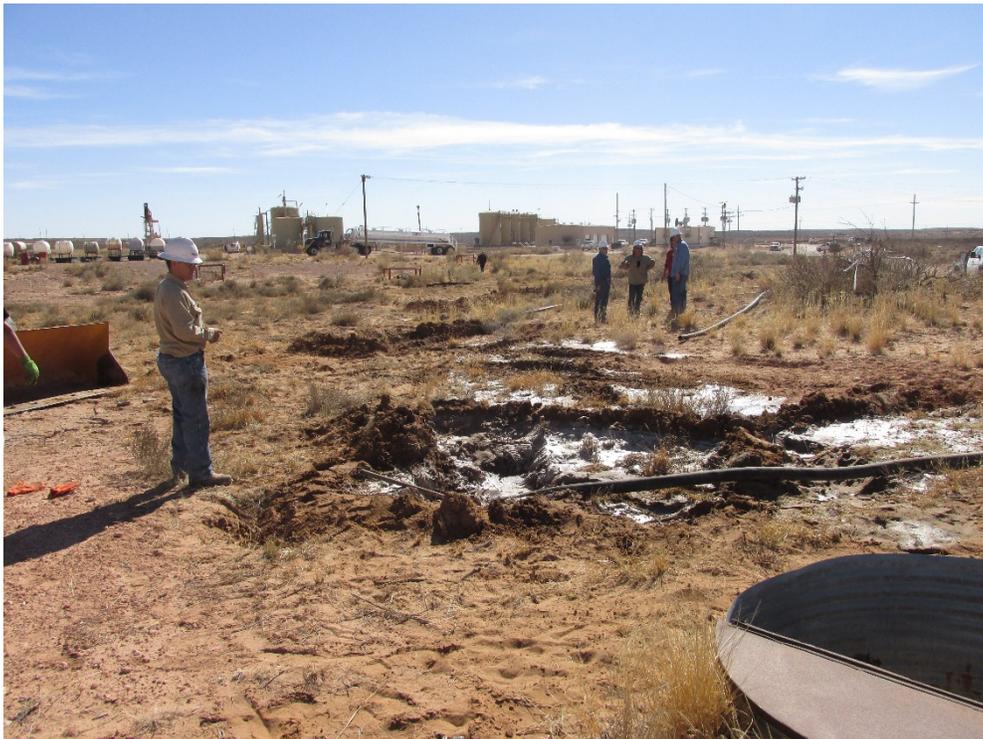
Impacted soil site 02/18/14

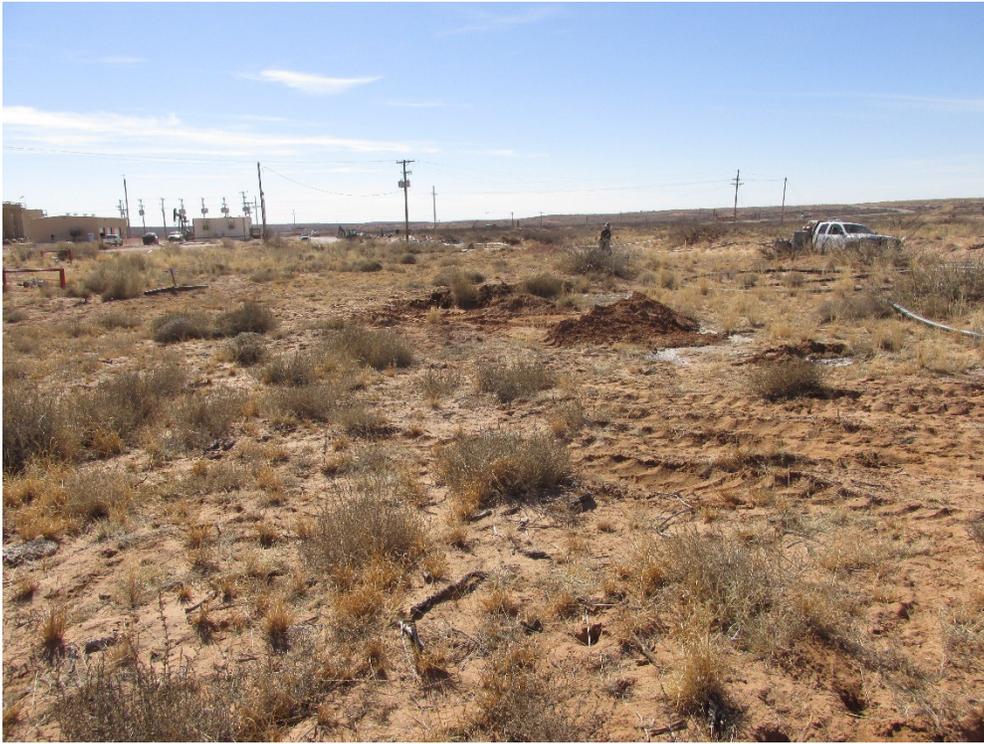
Stockpile of impacted soil for removal 02/18/14
