Report Type: Closure Report

Site:	Poptart 12 Federal #4H					
Company:	COG Operating LLC					
Section, Township and Range	Sec 12	T 19S	R 31E			
Lease Number:	API-30-015-39712					
County:	Eddy County					
GPS:	32.68048° N			103.82900° W		
Surface Owner:	Federal					
Mineral Owner:						
Directions:	From the intersection of CR 222 HWY 360, travel NORTH on CR 222f or apprx. 11.2 miles to the intersection of CR 22 and CR 249. Turn SOUTHEAST onto two track and continue for 2.2 miles to unlocked gate, continue for additional 0.5 miles, turn North 100 ft to location.

Re: Closure Report for the COG Operating LLC., Poptart 12 Federal #4H Tank Battery, Unit D, Section 12, Township 19 South, Range 31 East, Eddy County, New Mexico.

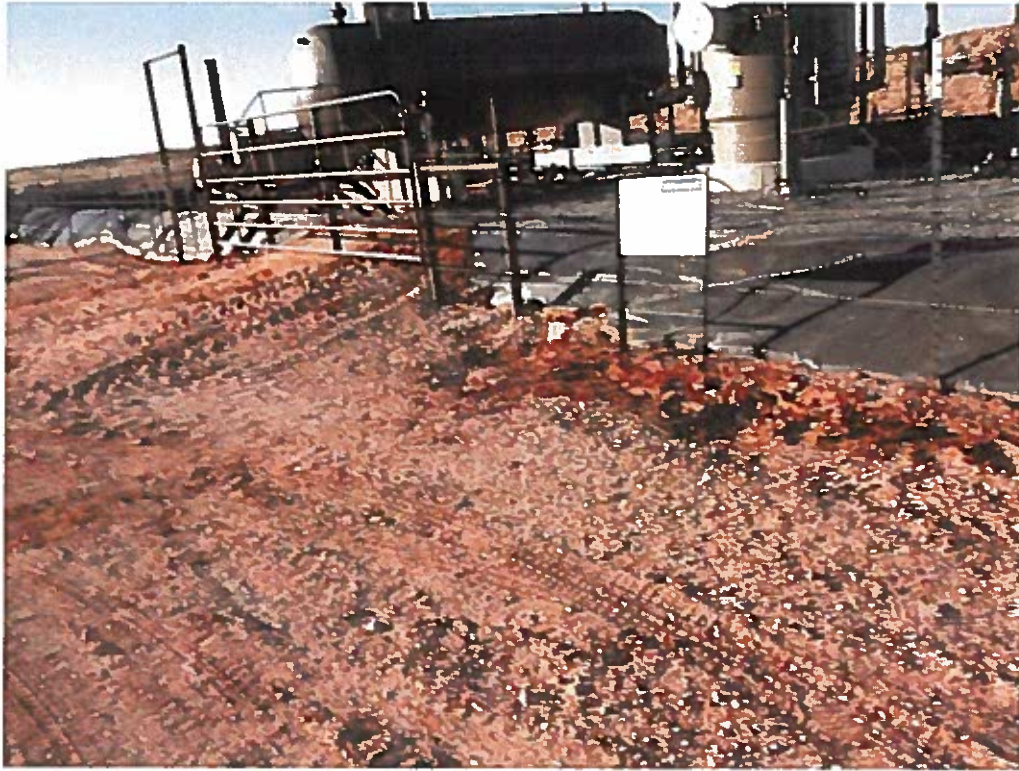
Referring to Table 1, none of the samples exceeded the RRAL for TPH and BTEX. Elevated chloride concentrations were detected in all of the auger holes. Auger hole (AH-2) was vertically defined and declined to 48.4 mg/kg at 2-2.5' below surface. The areas of AH-1 and AH-3 were not vertically defined, with bottom auger hole samples of 3,290 mg/kg at 4-4.5' and 1,160 mg/kg at 0-1', respectively.

View North – Area of AH-1

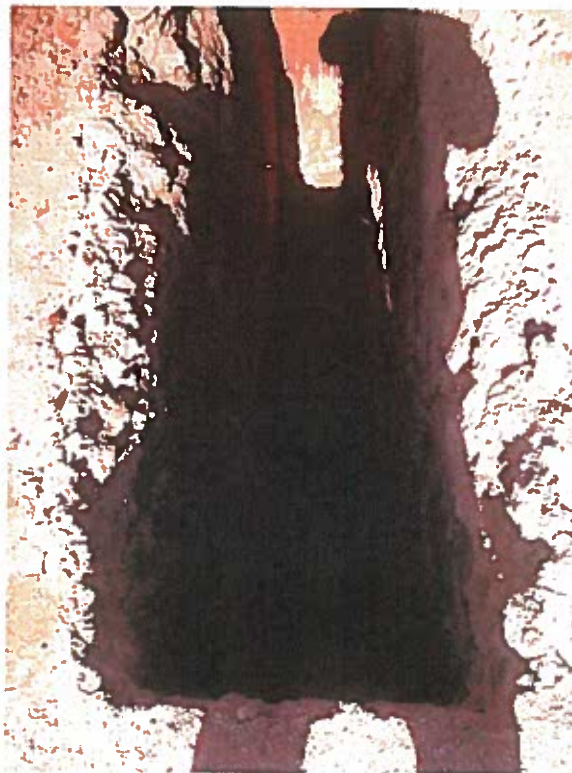
Prior to excavation of the soils, Tetra Tech installed backhoe trenches (T-1 and T-2) in the areas of AH-1 and AH-3 to define extents and confirm the detected chloride concentrations in the soils. The areas of T-1 (AH-1) and T-2 (AH-3) showed elevated chloride bottom samples of 2,120 mg/kg and 1,170 mg/kg at 10' below surface and were not vertically defined.

Typical Trench

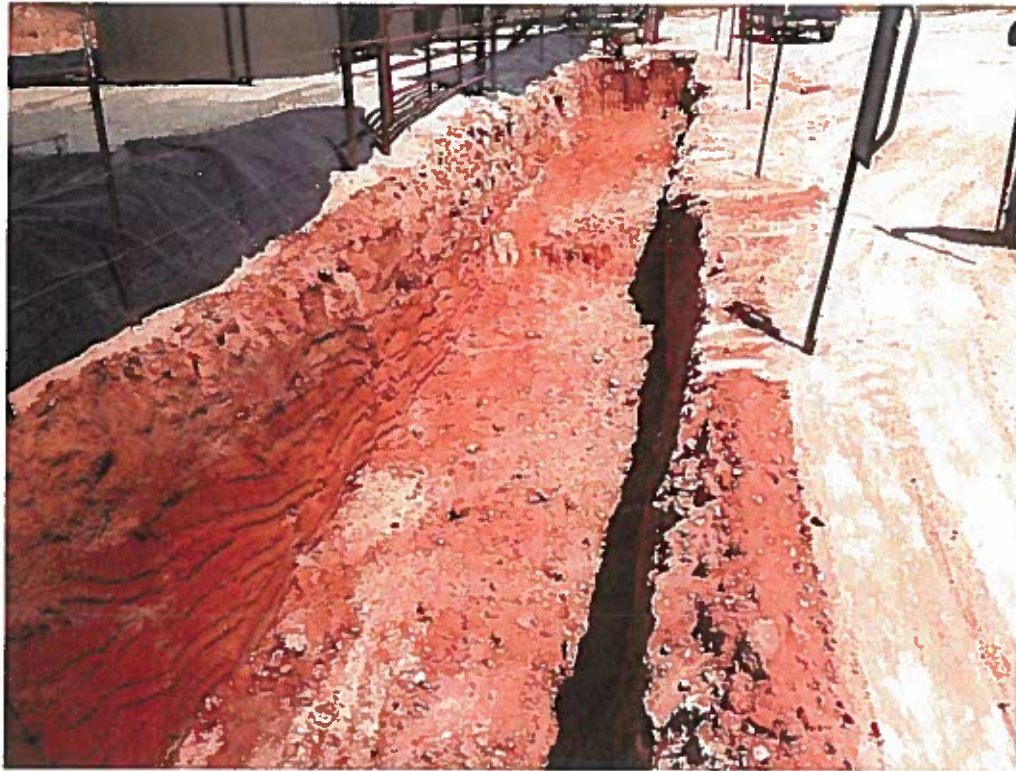
View East – Excavated area of AH-1

Auger hole (AH-2) was excavated to approximately 2.0' below surface. Based on the field data, the areas of auger holes (AH-1 and AH-3) were excavated 4.5' below surface and placed a clay material to cap area and prevent further migration of contaminants left in place. Confirmation samples were taken in the areas of each auger hole. The area of auger hole (AH-1) showed chloride concentrations of 608 mg/kg, 400 mg/kg, and 112 mg/kg at the North Sidewall, West Sidewall, and South Sidewall; respectively. The area of auger hole (AH-2) showed chloride concentrations of 1,790 mg/kg, 48.0 mg/kg, and 32.0 mg/kg at the North Sidewall, South Sidewall, and Bottom hole; respectively. The North Sidewall could not be excavated any further due to the equipment in the area. The area of auger hole (AH-3) showed chloride concentrations of 528 mg/kg, 16.0 mg/kg and 592 mg/kg at the North Sidewall, South Sidewall, and East Sidewall; respectively. Once the areas were excavated to the appropriate depths, the excavations were backfilled with clean soil to grade, and approximately 98 cubic yards of excavated material was hauled to proper disposal.

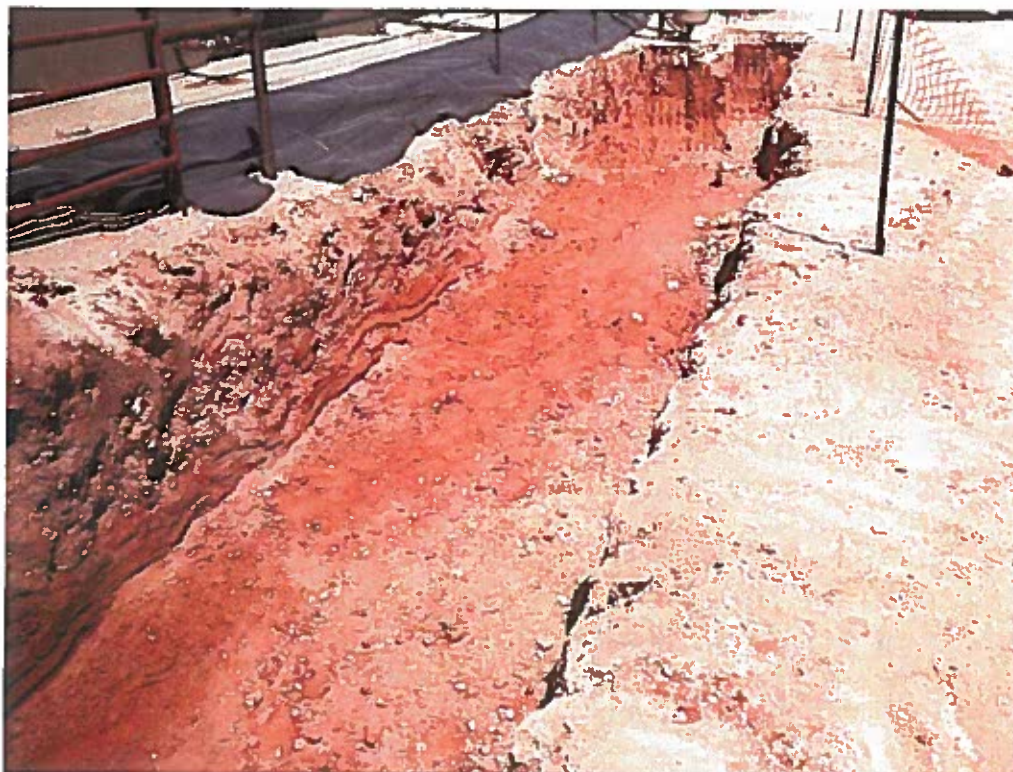
View East – Excavated area of AH-2 and AH-3

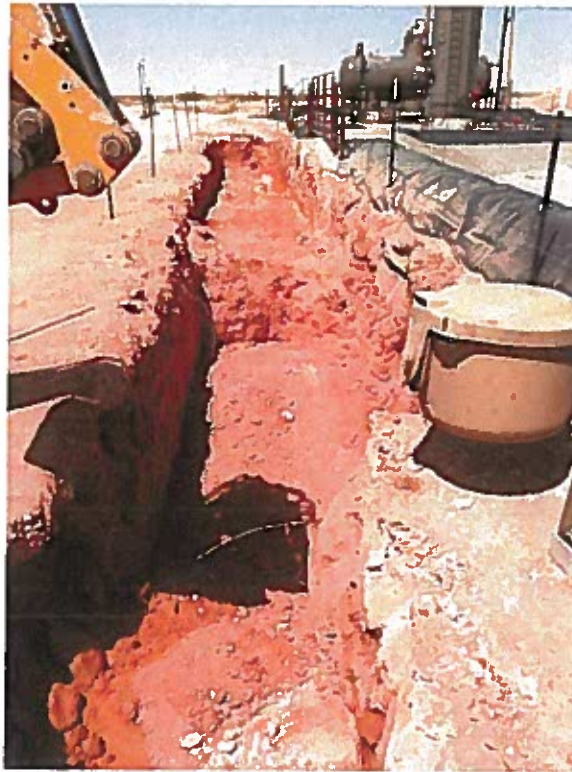
View West – Clay lined area of AH-3

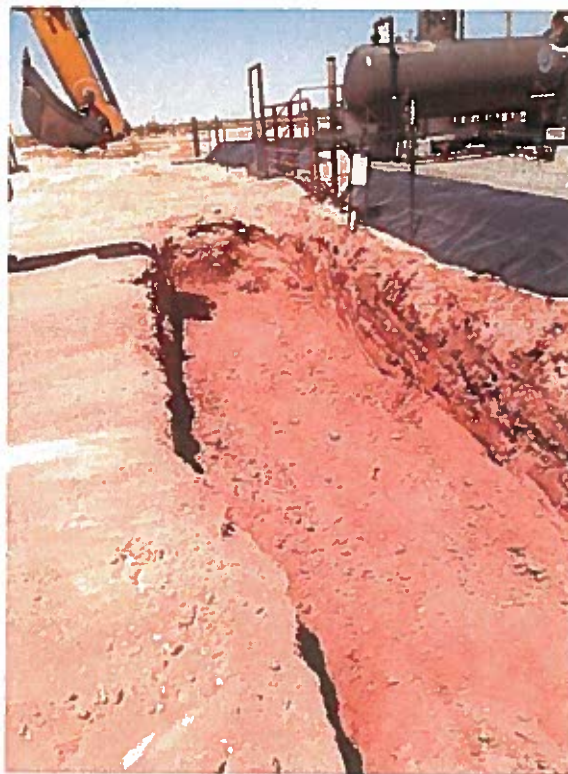
View West – Clay lined area of AH-1

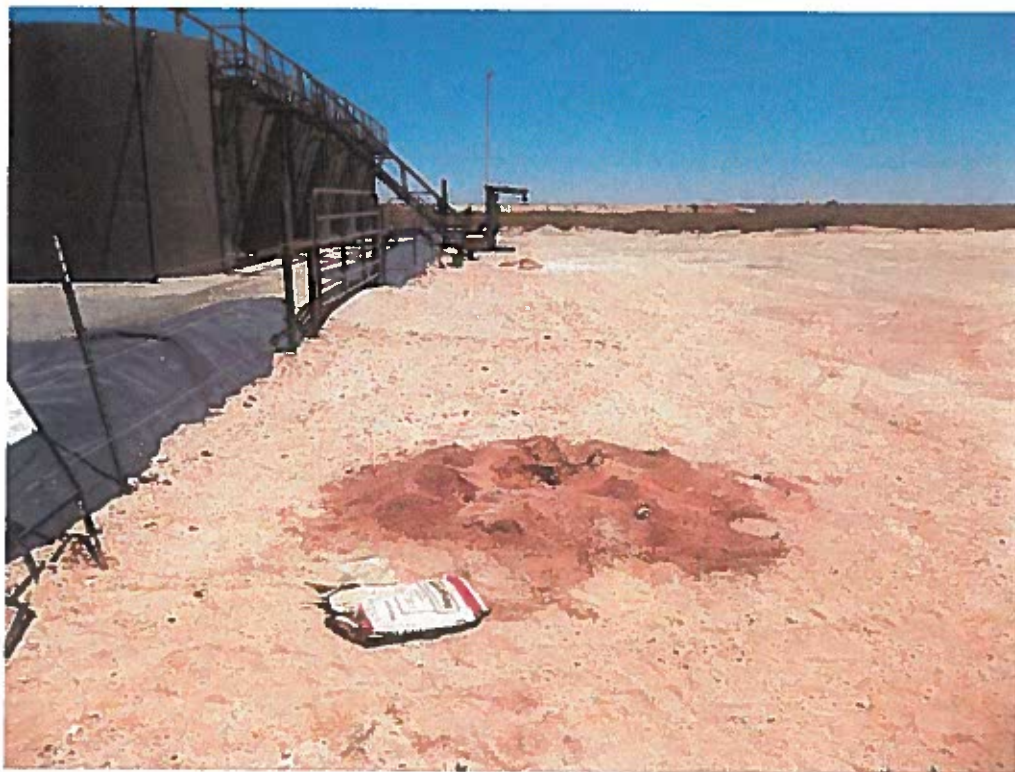
On May 14, 2014, Tetra Tech installed two (2) boreholes (BH-1 and BH-2) in order to vertically define the chloride impact in the areas of AH-1 and AH-3. The area of BH-2 (AH-3) showed a chloride high of 1,620 mg/kg at 6'-7' below surface, which significantly declined with depth to 147 mg/kg at 29'-30' below surface.

The chloride impact in the area of BH-1 (AH-1) was not vertically defined. The area showed a chloride spike at 39'-40' below surface of 3,720 mg/kg, which began to decline to 2,260 mg/kg at 49'-50' below surface. Deeper samples were not collected due to the sandy formation which collapsed the borehole. Based on the reported depth to groundwater (greater than 300'), limited impacted area and clay cap, the area does not appear to be an environmental concern.

View East – Areas of BH-1 and BH-2
