## **CLOSURE REPORT**

**BOPCO, LP**  
**POKER LAKE UNIT #303H**  
**Eddy County, New Mexico**  
**Unit Letter "N", Section 4, Township 25 South, Range 31 East**  
**Latitude 32.155387 North, Longitude 103.784570 West**  
**NMOCD Reference #2RP-2374**

RE: Final Closure Report  
Bopco – Poker Lake Unit #303H  
UL-N, Section 4, Township 25 South, Range 31 East  
Eddy County, New Mexico  
NMOCD Reference # 2RP 2374

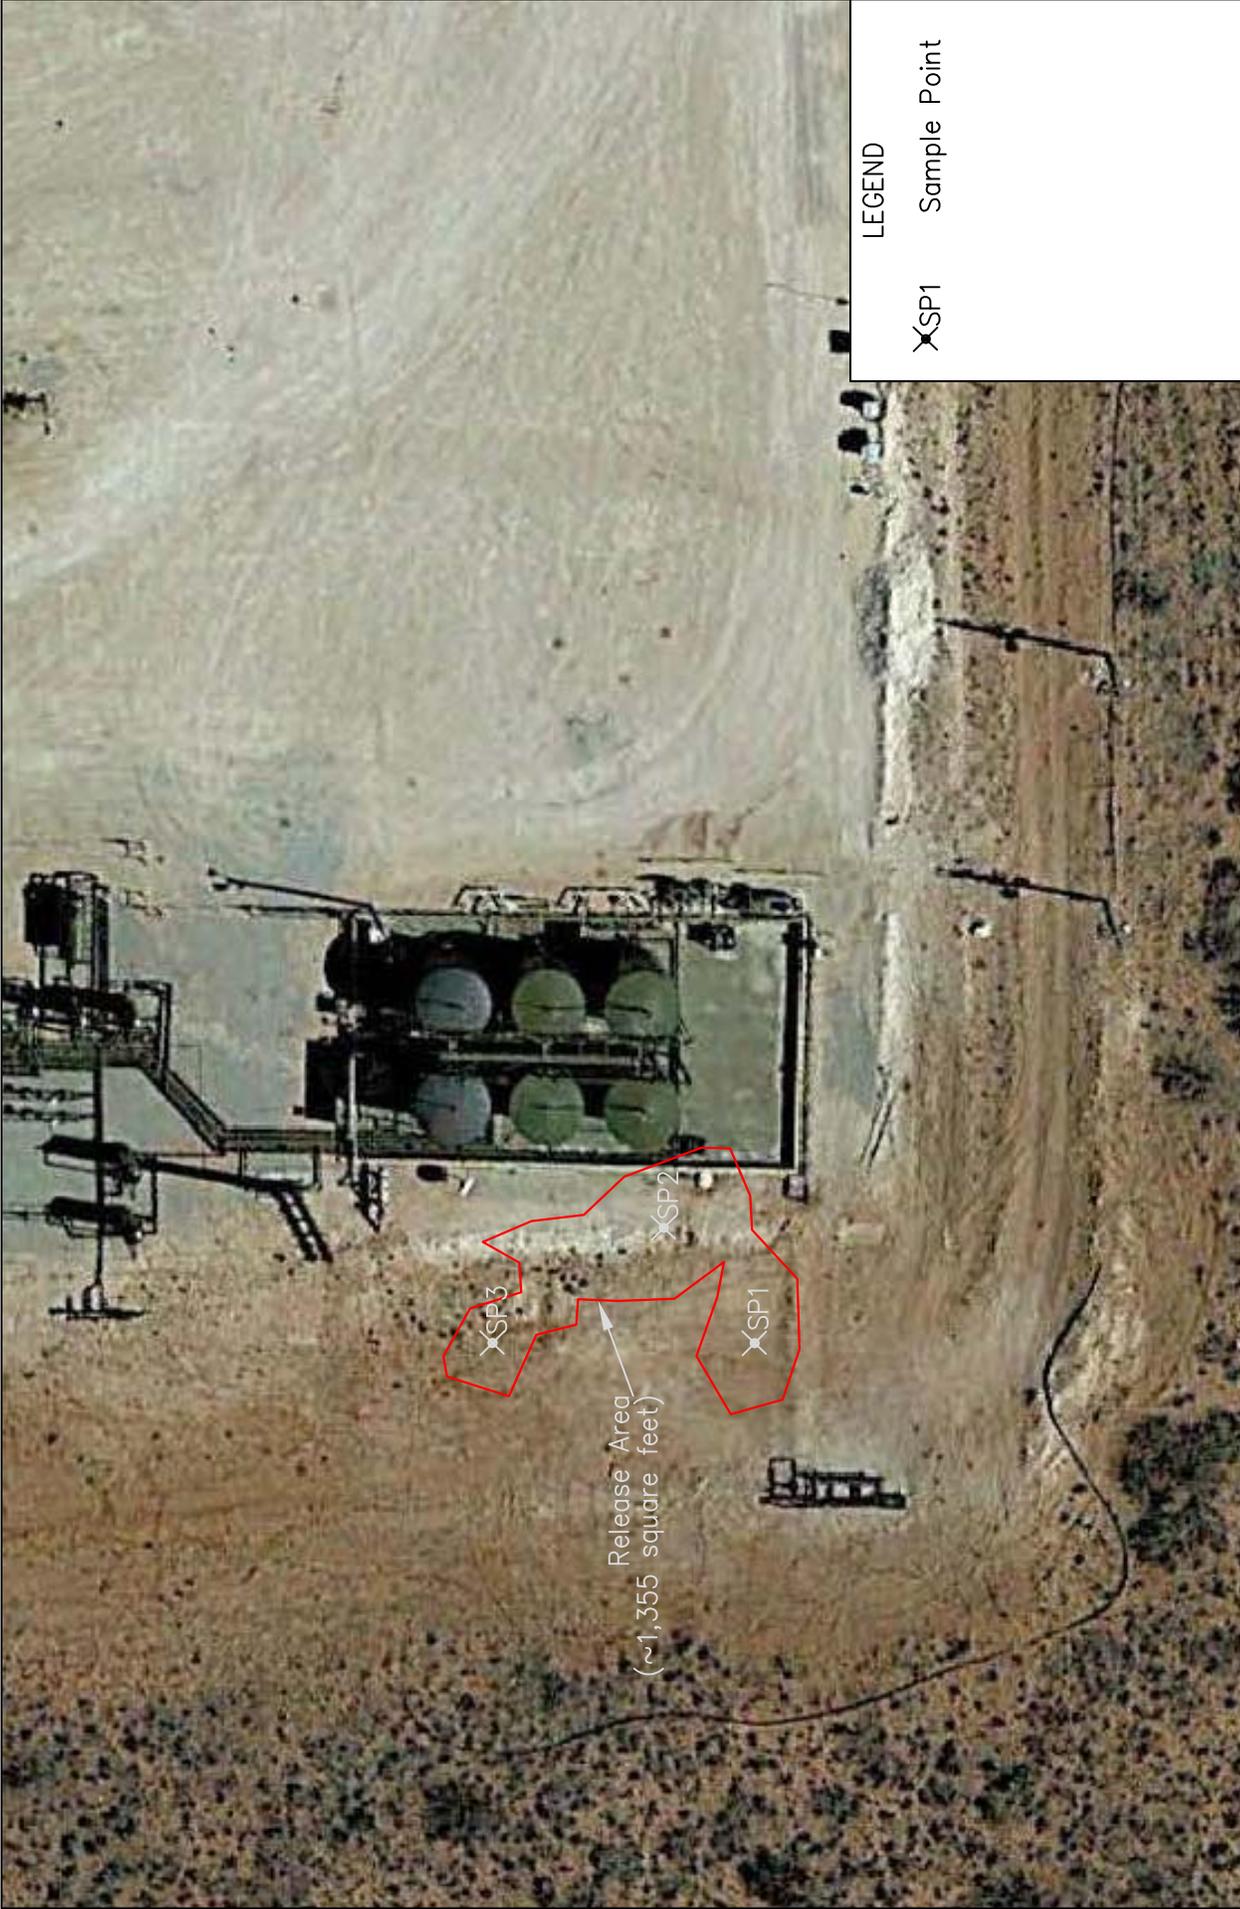
Figure 3  
 Site/Sample Map  
 Bopco, L.P.  
 Poker Lake Unit #303H

EPI personnel mobilized on the site on July 17, 2014 to collect soil samples via sample trenches to determine the vertical extent of contamination. A total of twenty (20) soil samples were collected from three (3) sample points and sent to Cardinal Labs in Hobbs, New Mexico, for testing. Laboratory analytical results indicate the excavation is void of Chloride concentrations in excess of NMOCD Recommended Remedial Action Levels (RRALs) of 1,000 mg/Kg. Laboratory analytical results indicate the excavation contains concentrations of Benzene, BTEX, and TPH in excess of NMOCD RRALs of 10 mg/Kg, 50 mg/Kg, and 5,000 mg/Kg, respectively, to a depth of four (4) feet in the area of SP1, three (3) feet in the area of SP2, and five (5) feet in the area of SP3 (reference *Figure 3* and *Table 2*).

On August 20, 2014 EPI personnel mobilized on the location to locate and hand dig around buried pipelines. From September 2 – 15, 2014 approximately 874 cubic yards of contaminated material were excavated and transported to Lea Land for disposal. The release area was excavated to approximately five (5) feet bgs, removing constituent contamination above NMOCD RRALs.

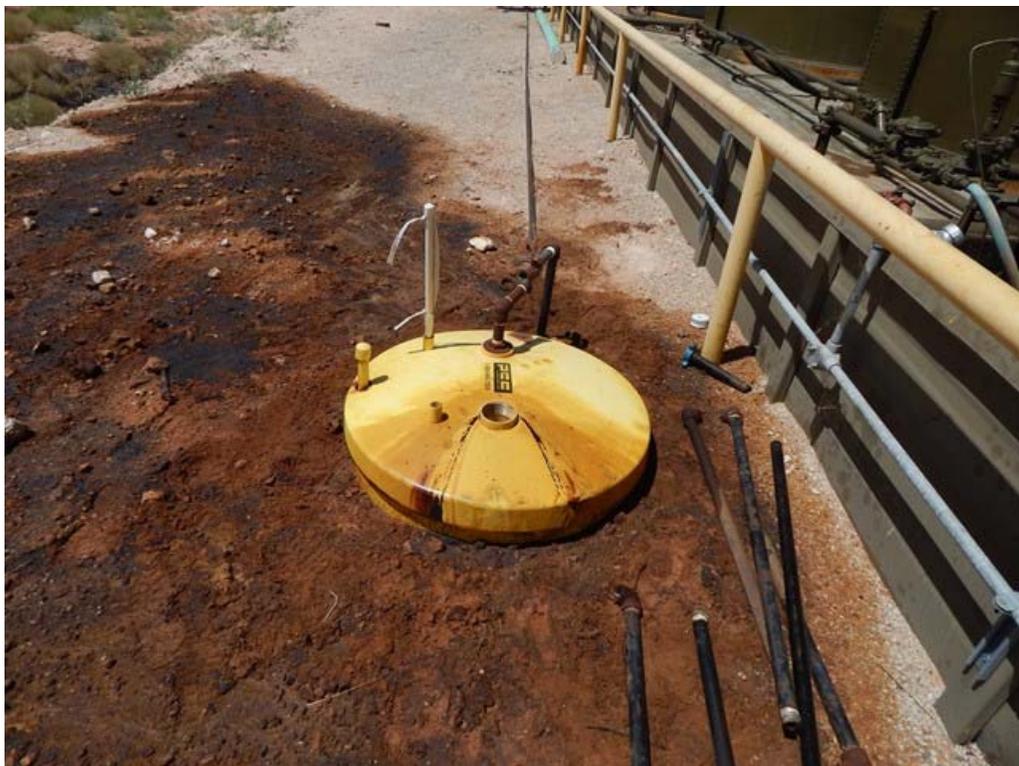
A valve was left open on the circulating pump to the sump suction line causing the sump to overflow. The spill impacted approximately 1,355 sq. ft. of mostly pasture area. The free standing fluid was recovered, the stained soil was left as is pending remediation.

Photograph #2 – Point of release

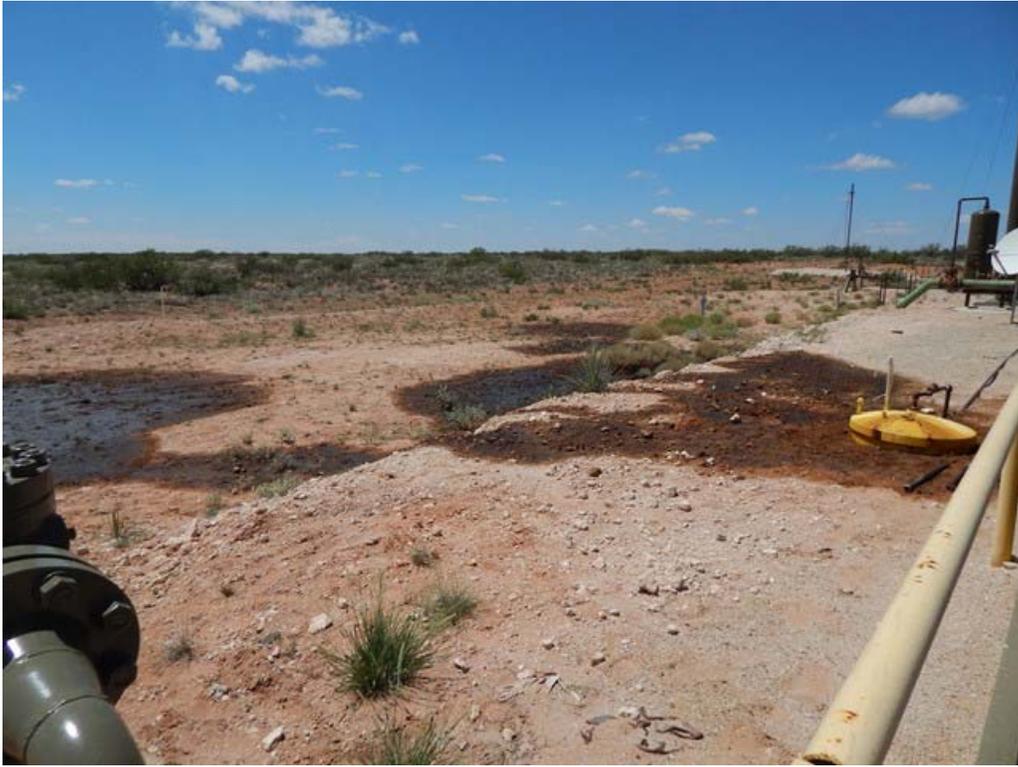
Photograph #3 – Looking northerly across release area

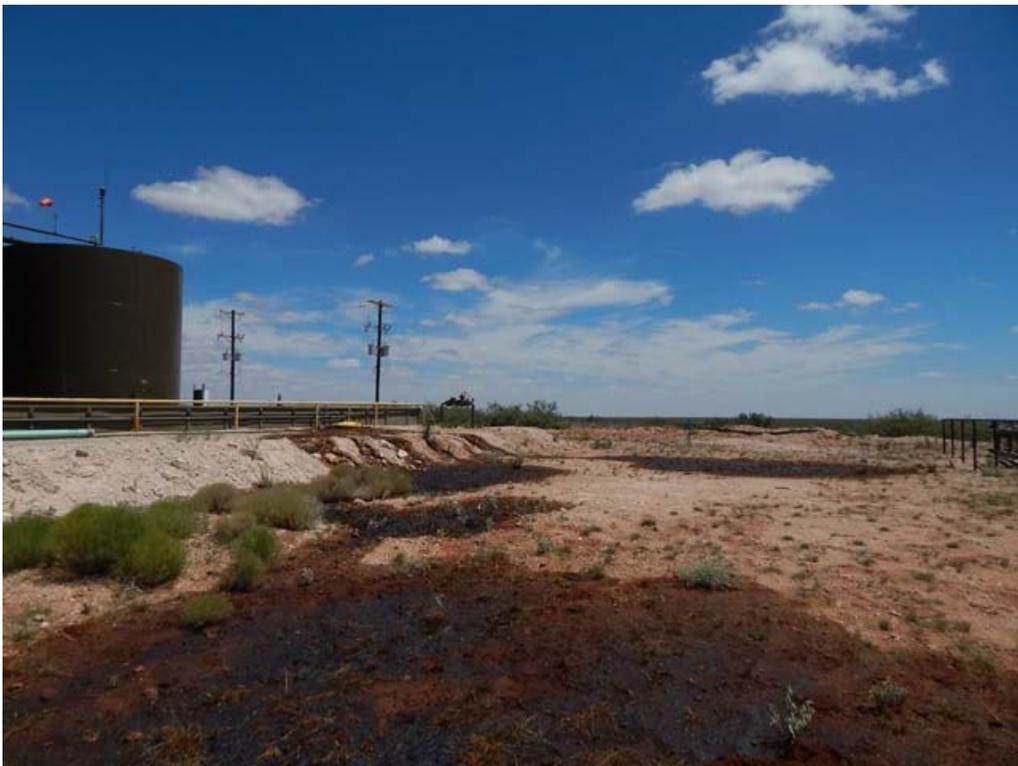
Photograph #4 – Looking southerly across release area

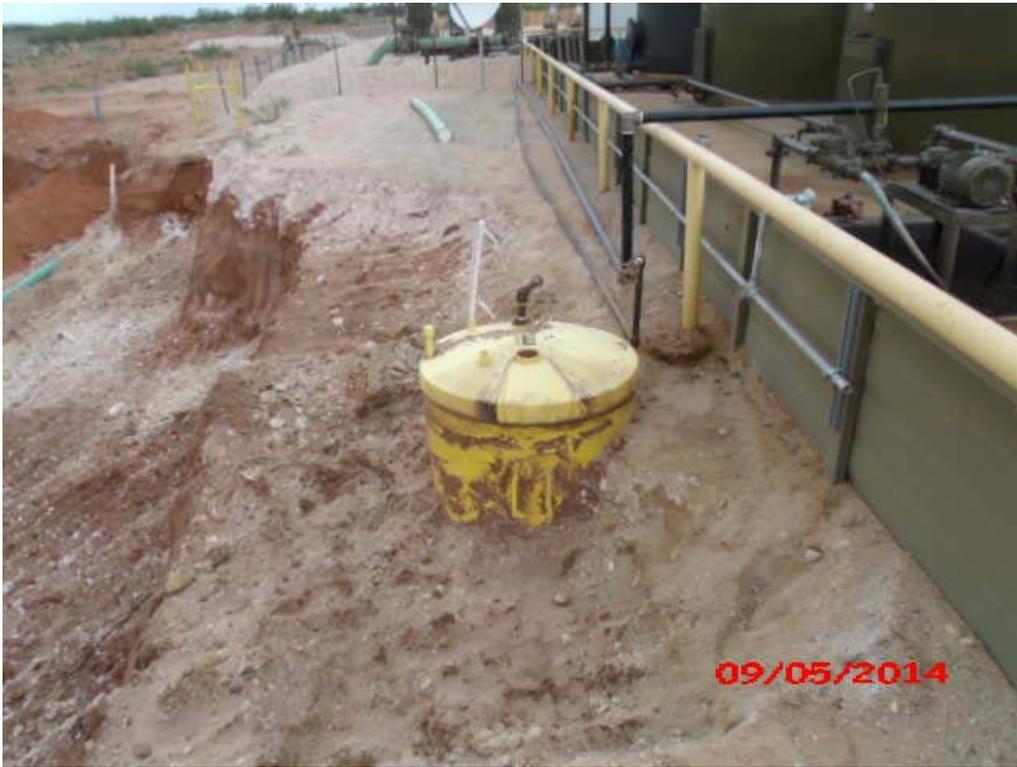
Photograph #5 – Excavated area around release point

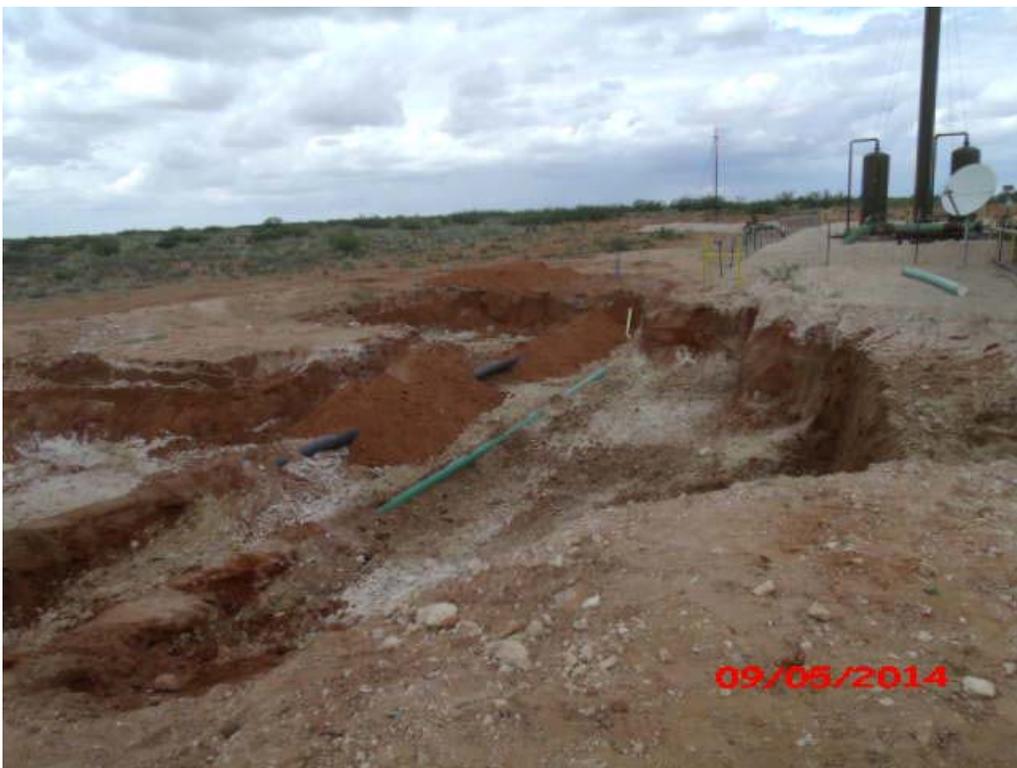
Photograph #6 – Northerly view of excavation

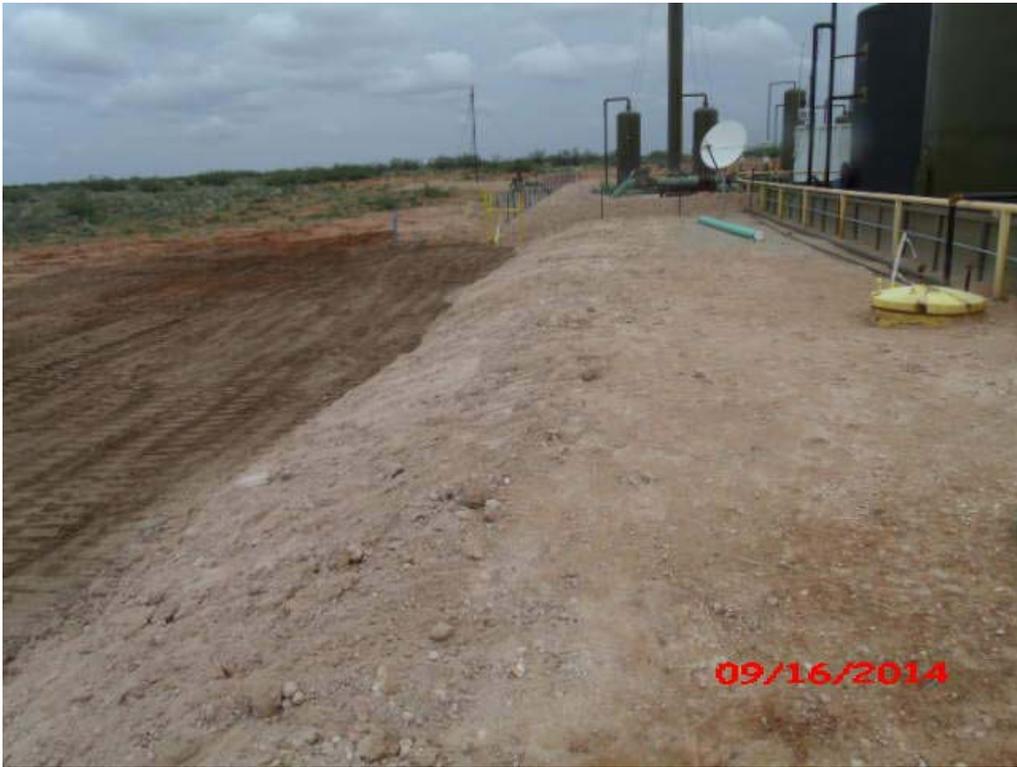
Photograph #7 – Backfilled area

From September 15 - 16, 2014 the excavation was backfilled with approximately 336 cubic yards of caliche and 504 cubic yards of topsoil. The entire disturbed area was then contoured to blend with existing pad to protect against wind/water erosion.

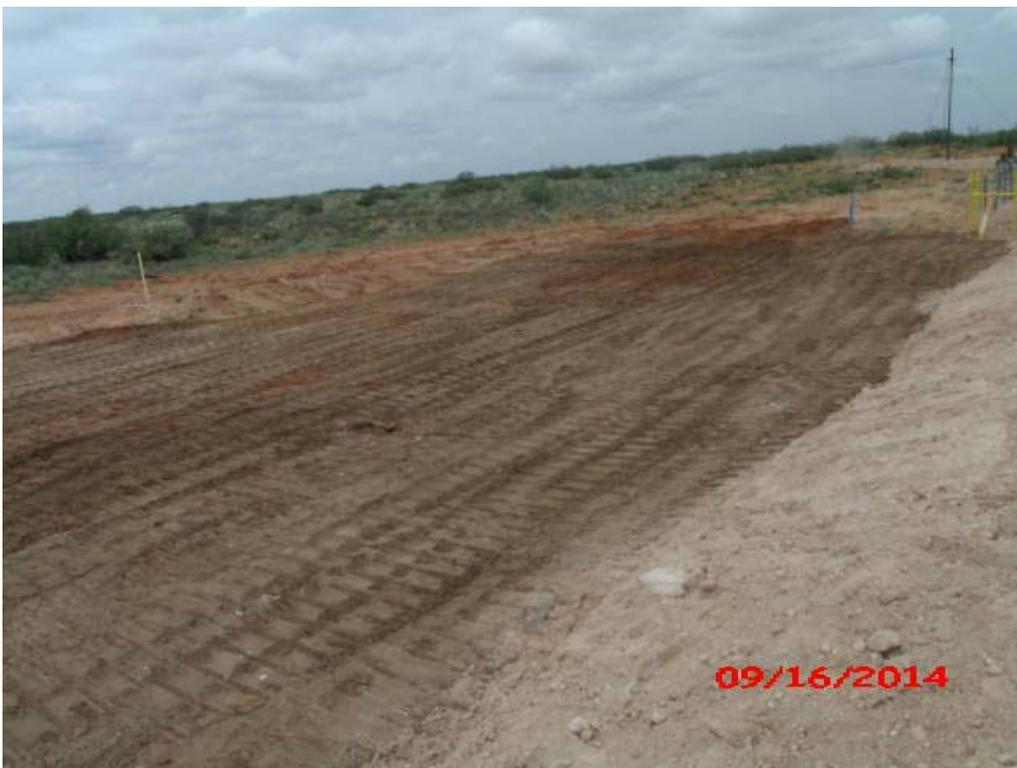
Photograph #8 – Backfilled area
