## **REMEDIATION SUMMARY AND SITE CLOSURE REQUEST**

**BOPCO, LP  
POKER LAKE UNIT #59 TANK BATTERY  
Eddy County, New Mexico  
Unit Letter "F" (SE/NW), Section 17, Township 24 South, Range 30 East  
Latitude 32.219106° North, Longitude 103.908567° West  
NMOCD Reference #2RP-2217**

**November 2014**

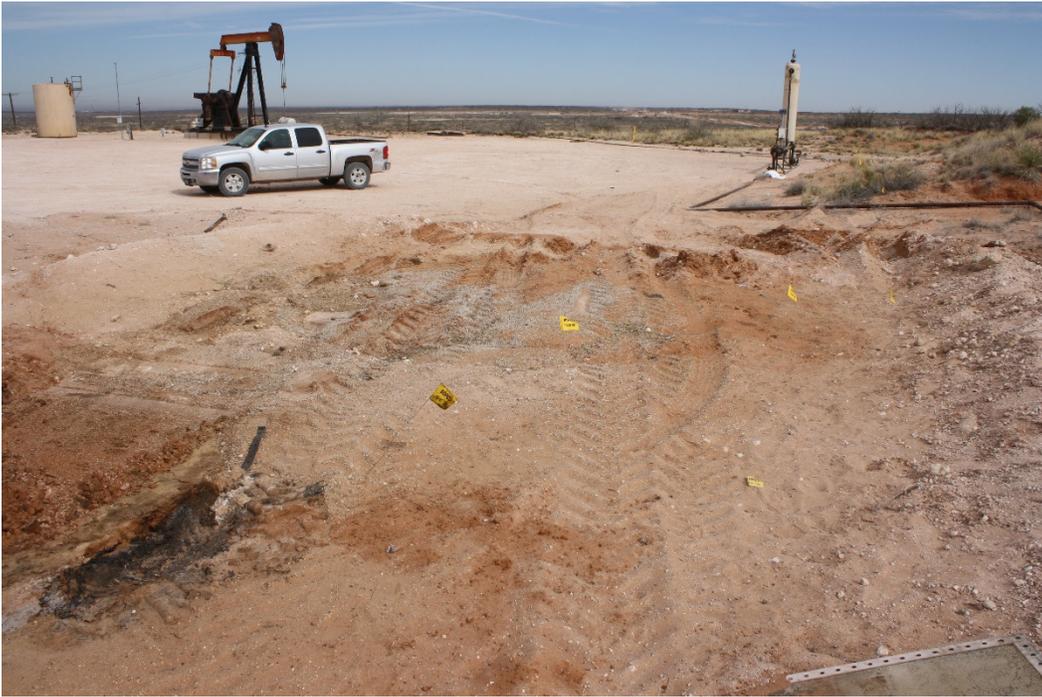
Photograph of the stained area beneath the former production tank at the PLU #59 Tank Battery.

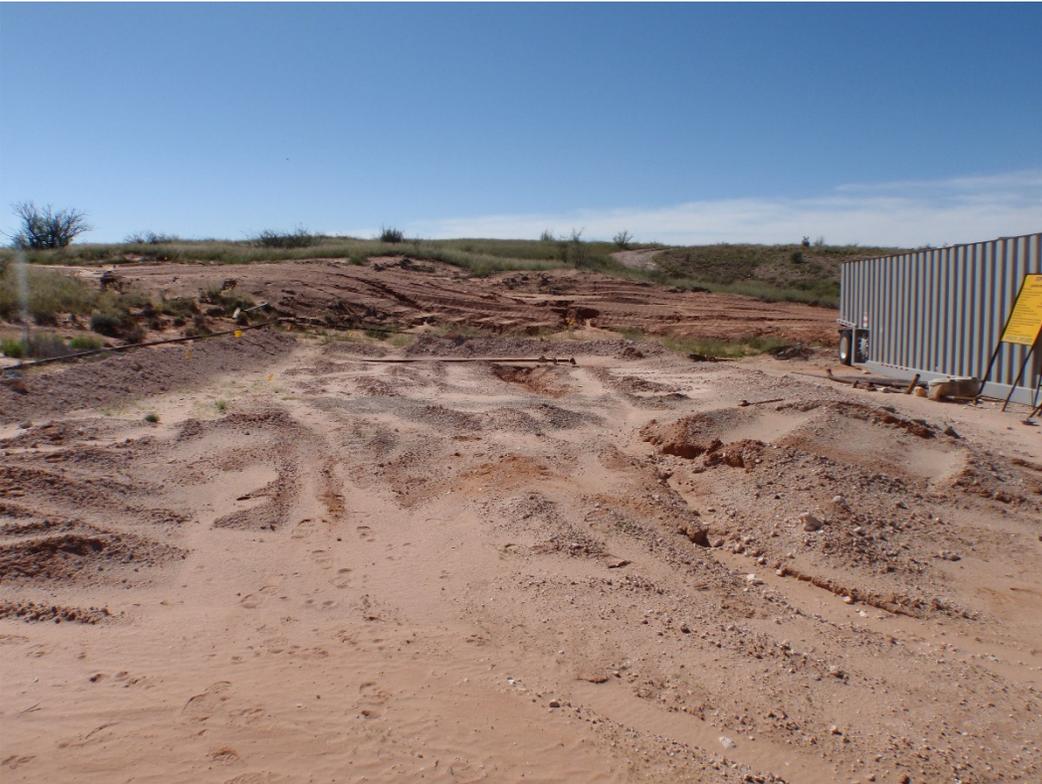
Photograph of the affected area beneath the former production tank at the PLU #59 Tank Battery.

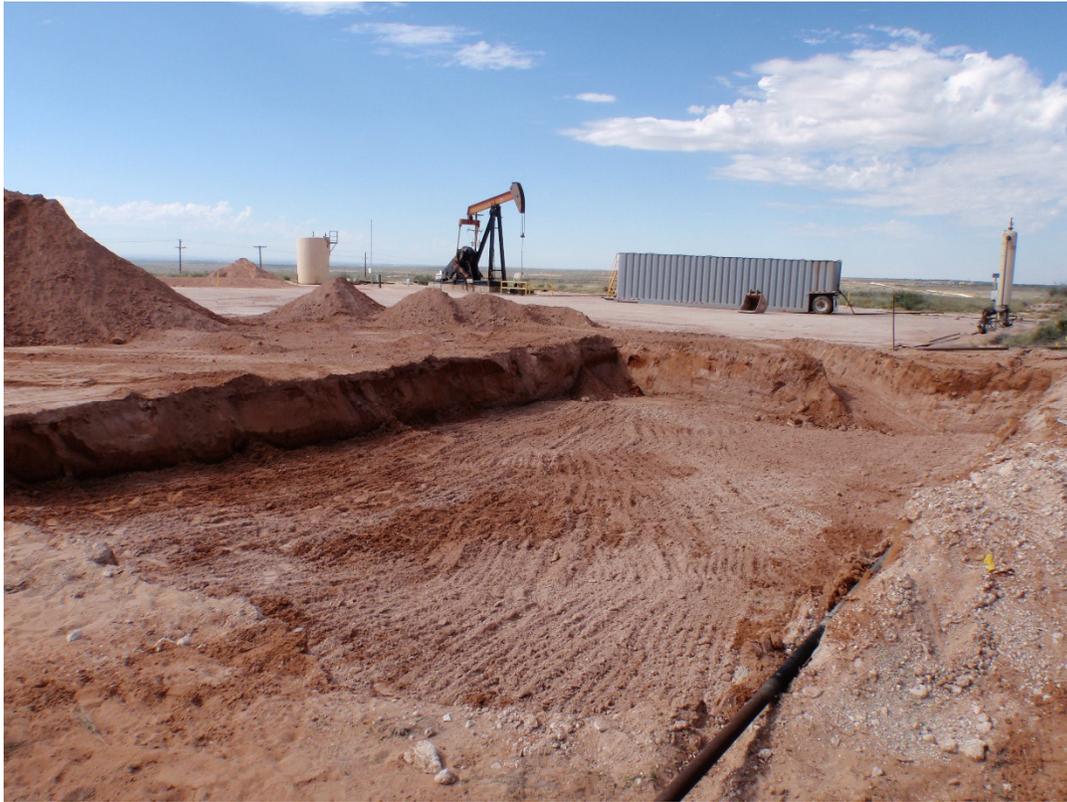
Photograph of excavation activities at the PLU #59 Tank Battery.

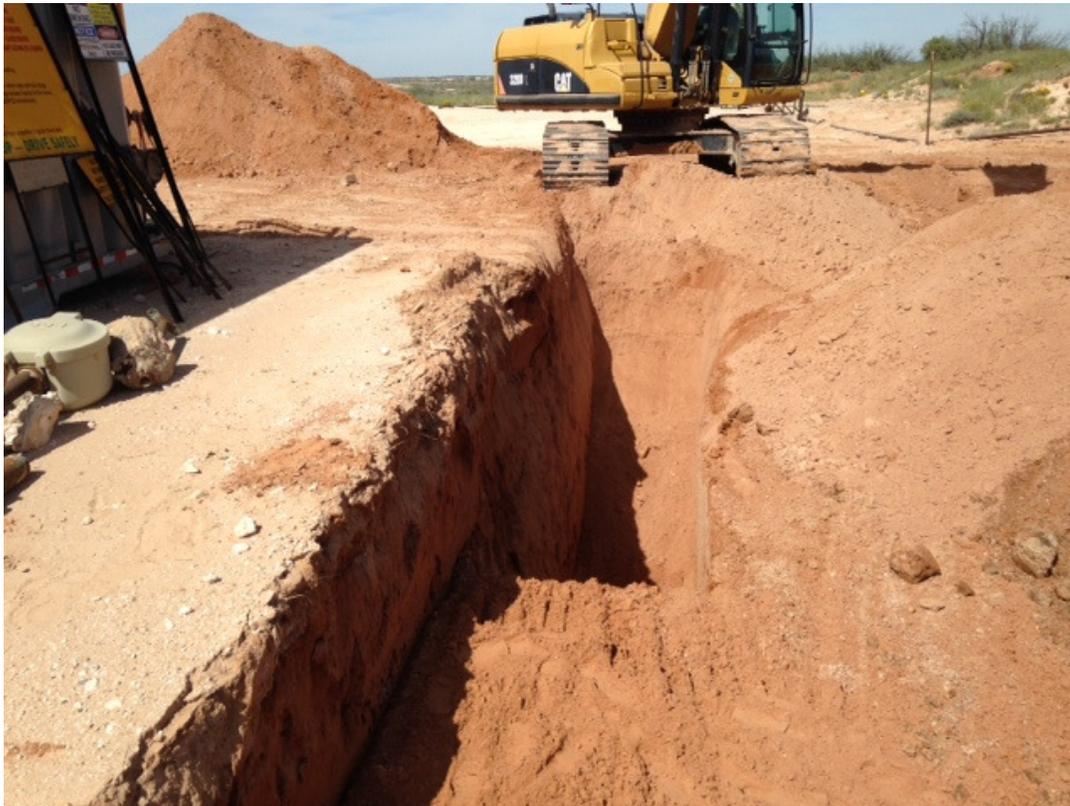
Photograph of excavation activities at the PLU #59 Tank Battery.

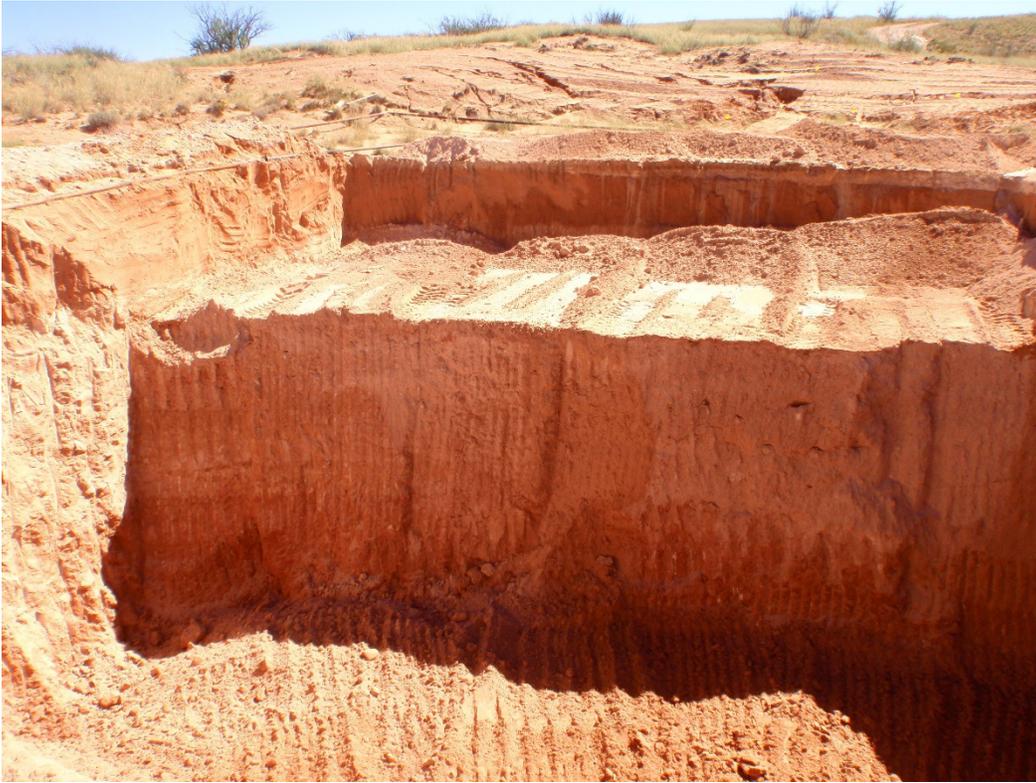
Photograph of excavation activities at the PLU #59 Tank Battery.

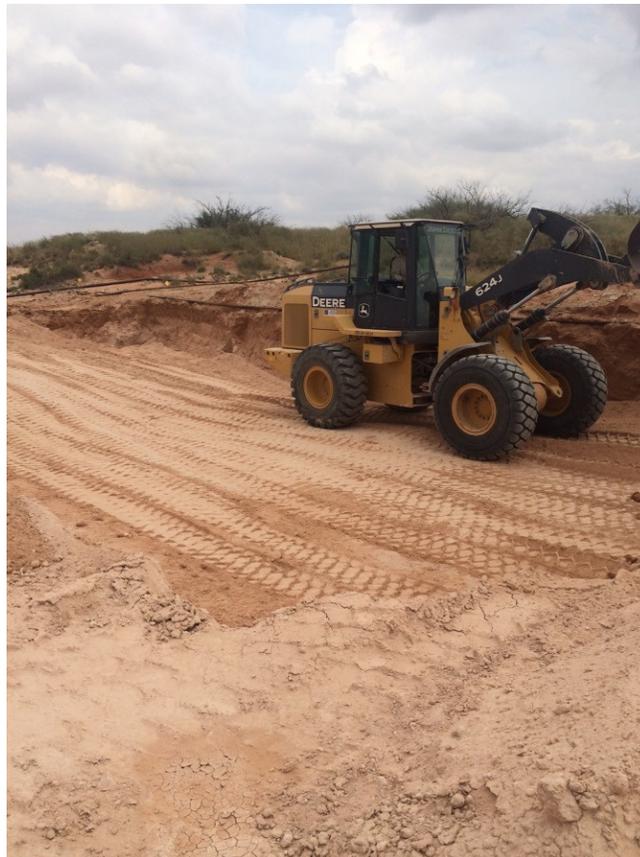
Photograph of backfilling activities at the PLU #59 Tank Battery.

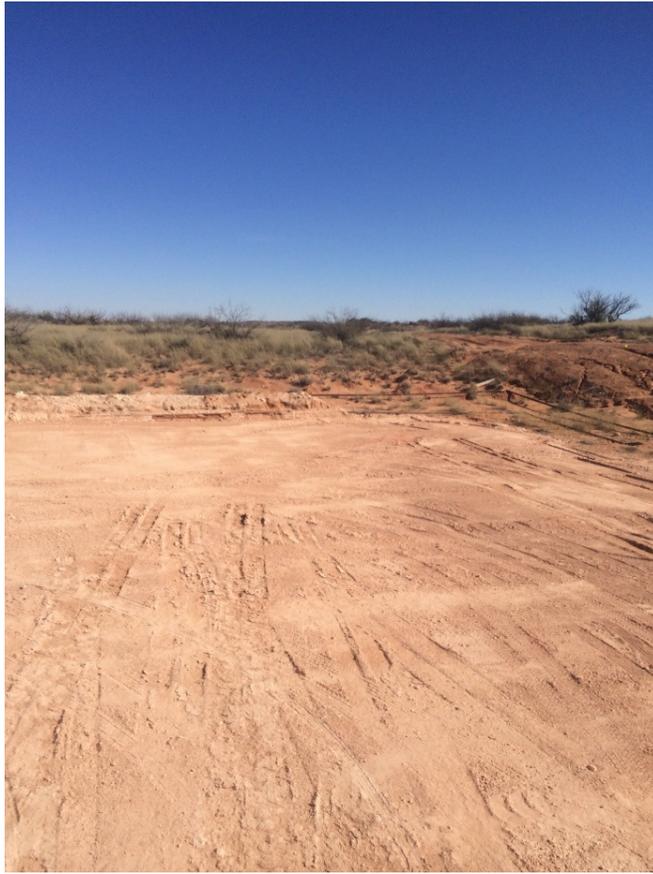
Photograph of the PLU #59 Tank Battery release site after remediation activities.

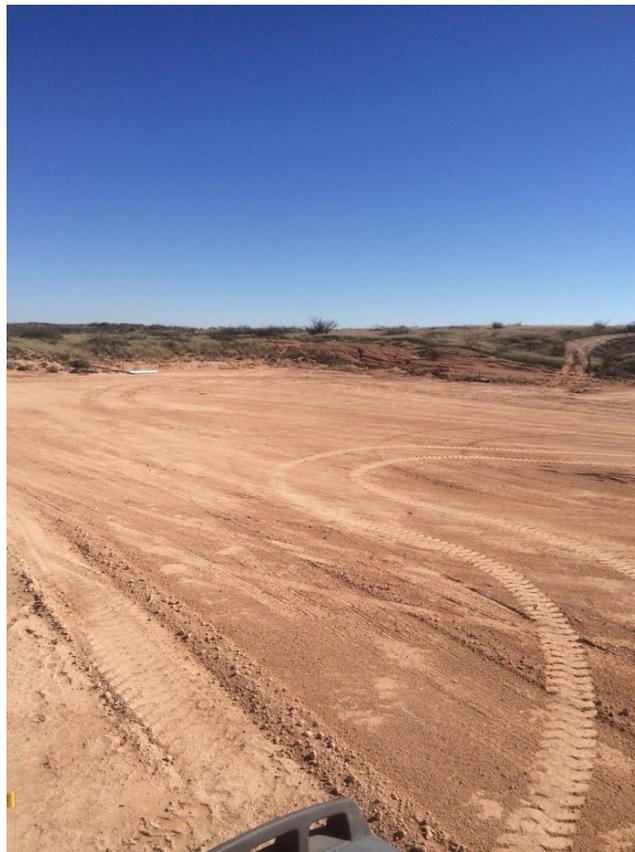
Photograph of the PLU #59 Tank Battery release site after remediation activities.
