**Re: Michalada Federal #3-D
30-015-35157
Sec. 3, T22S-R25E
Eddy County, NM**

COG Operating LLC would like to submit for your consideration the enclosed work plan for the above captioned well. The plan is in response to the C-141 Initial report dated October 13, 2014.

Michalada Federal #3-D

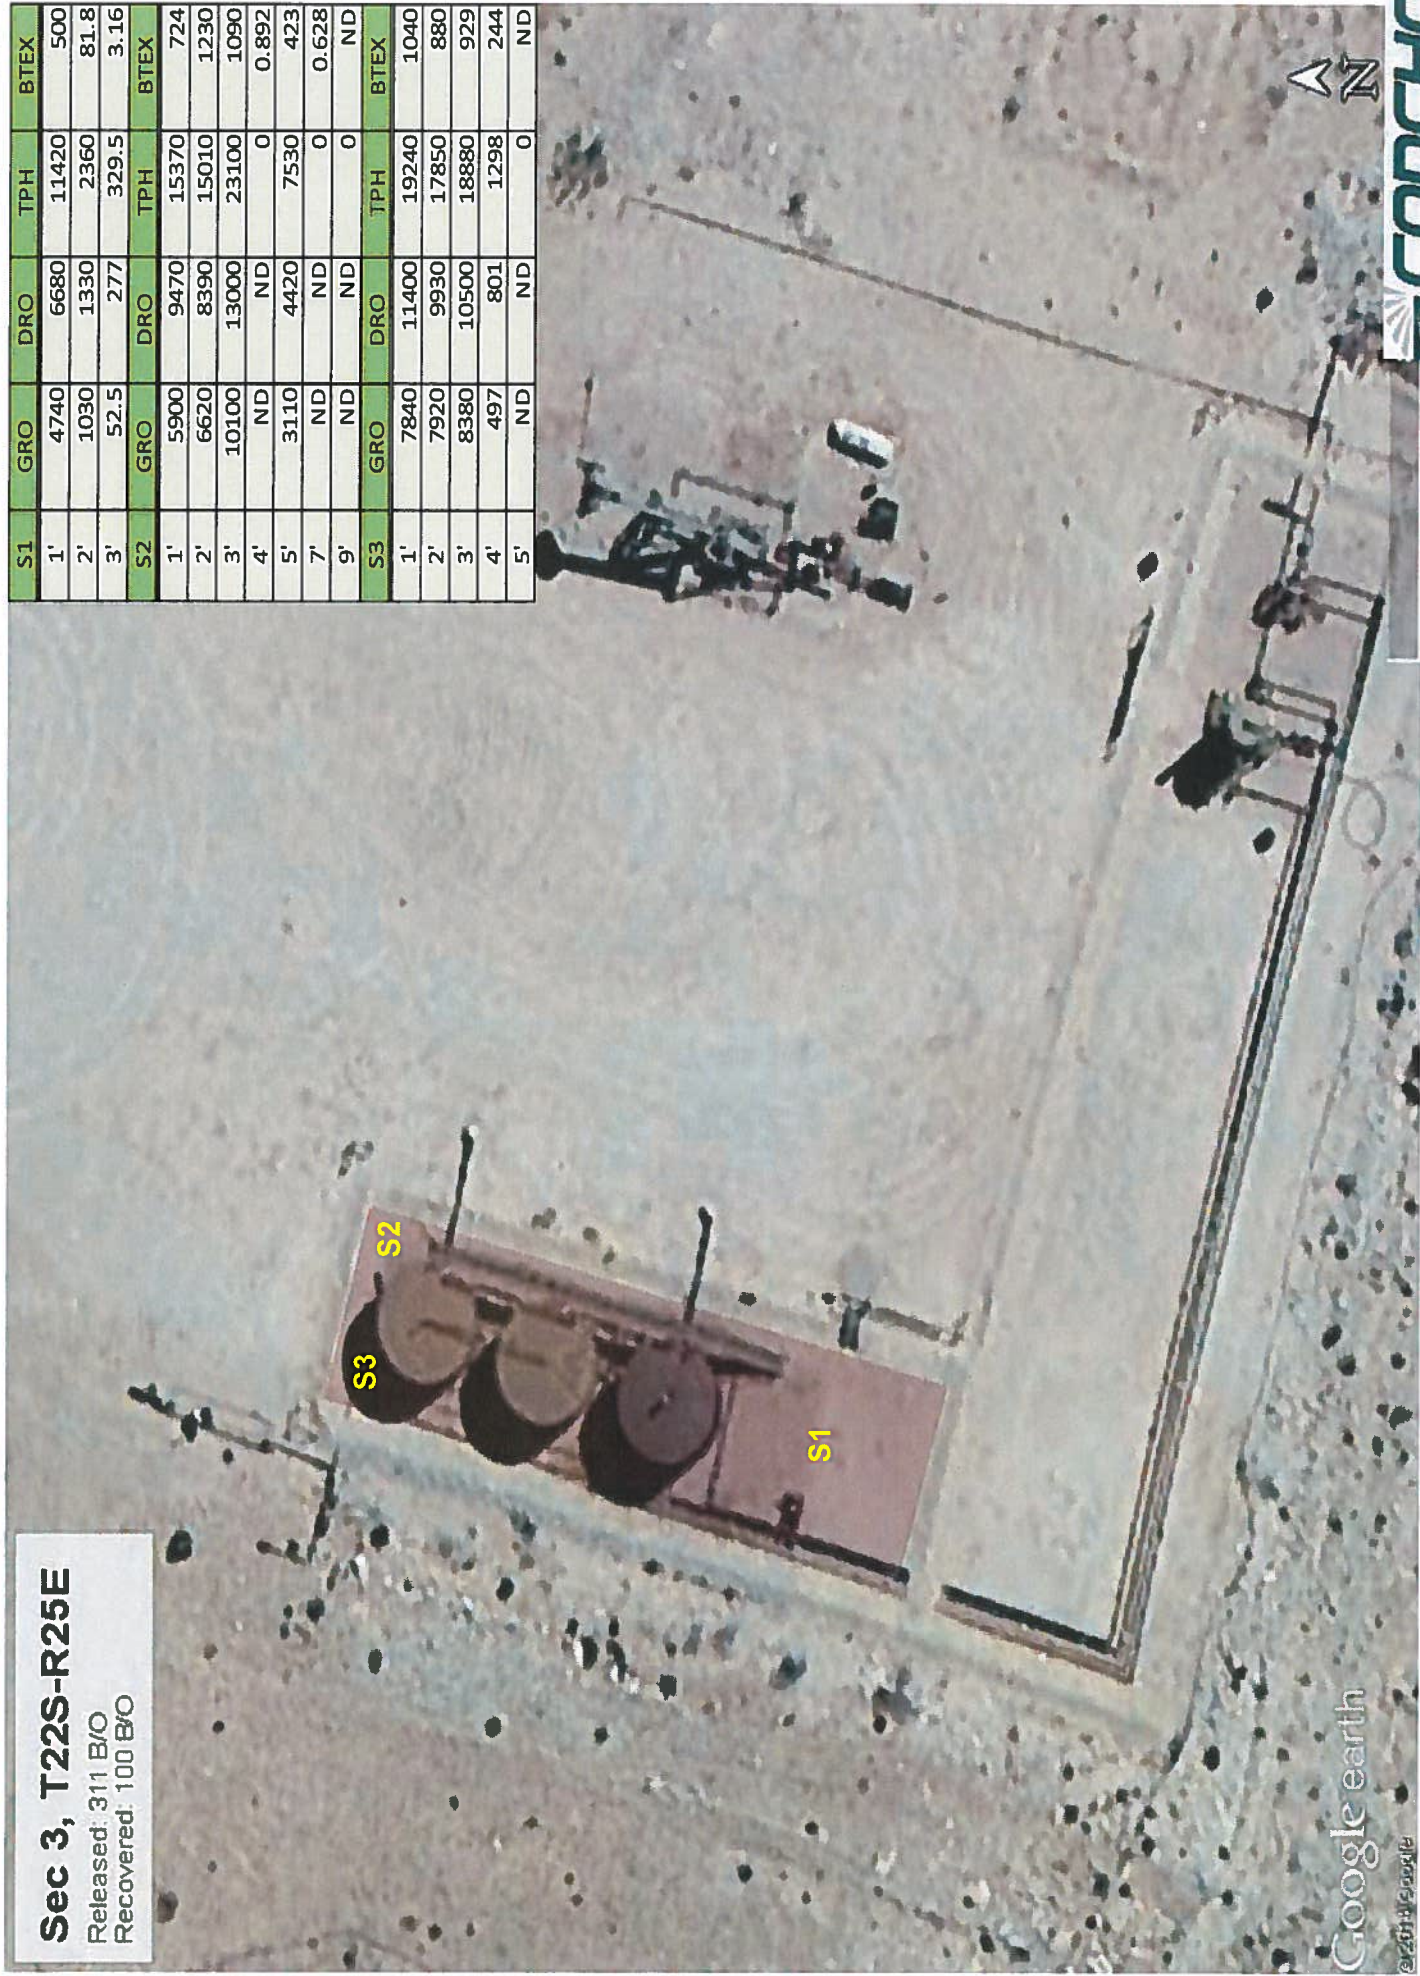
Sample points S1, S2, and S3 were selected based on the most practical sampling points within the existing infrastructure of the battery. The attached Site Diagram depicts the approximate location of the sample points chosen along with a Sample Summary Table which summarizes the included Analytical Results. S2 and S3 were chosen because of the close proximity to the initial point of release.

Sample results show TPH and BTEX levels to be above RRAL's for the sample points chosen at different depths. S1 results show elevated levels to a depth of 1'. S2 results

show elevated levels to a depth of 5' with 4' showing numbers below RRAL's. S3 results show elevated levels to a depth of 4'. Depths below these elevated points fall below RRAL's in accordance to the limits set in the NMOCD Guidelines of Remediation of Leaks, Spills, and Releases (1993).

Released: 311 B/O
Recovered: 100 B/O

S1	GRO	DRO	TPH	BTEX
1'	4740	6680	11420	500
2'	1030	1330	2360	81.8
3'	52.5	277	329.5	3.16
S2	GRO	DRO	TPH	BTEX
1'	5900	9470	15370	724
2'	6620	8390	15010	1230
3'	10100	13000	23100	1090
4'	ND	ND	0	0.892
5'	3110	4420	7530	423
7'	ND	ND	0	0.628
9'	ND	ND	0	ND
S3	GRO	DRO	TPH	BTEX
1'	7840	11400	19240	1040
2'	7920	9930	17850	880
3'	8380	10500	18880	929
4'	497	801	1298	244
5'	ND	ND	0	ND

COG Operating LLC proposes the excavation of the following sample areas:

S1 - Excavate the impacted 2' of material.

S2 - Excavate the impacted 6' of material

S3 - Excavate the impacted 4.5' of material.
