**November 11<sup>th</sup>, 2014**

**RE: Termination Request  
Burnett Oil Co – Gissler A 46 (2RP-2241)  
UL/A sec. 23 T17S R30E  
API No. 30-015-41544**

Burnett Oil Co. (Burnett) has retained Rice Environmental Consulting and Safety (RECS) to address potential environmental concerns at the above-referenced site.

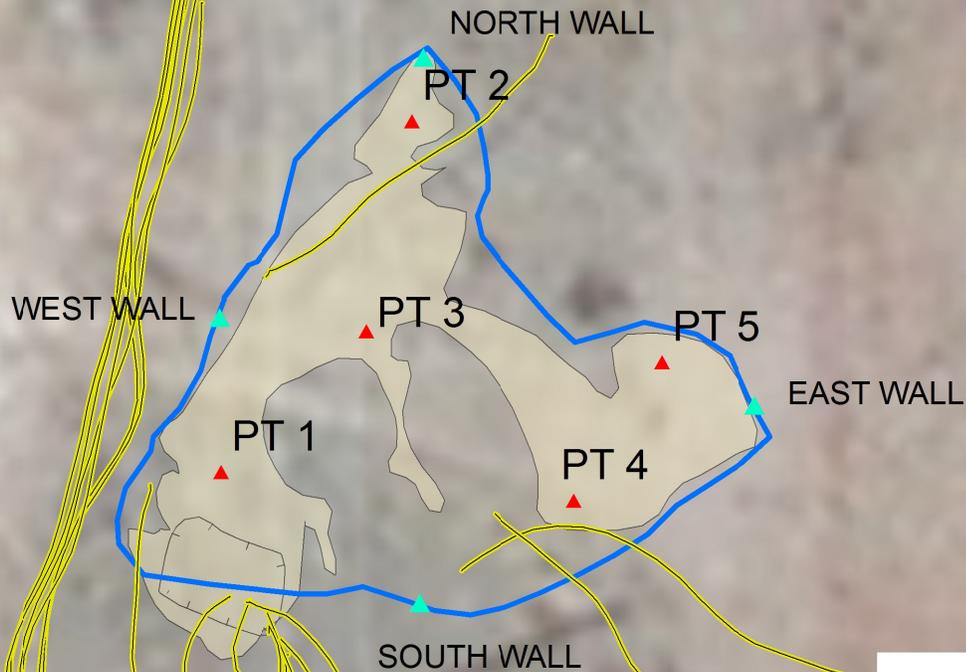
Figure 1

# Excavation Data

Scrape at 1.5 ft

CI-	PID	GRO	DRO	B	T	E	X	BTEX
5 point composite	320	8.4	<10	30.6	<0.05	<0.05	<0.05	<0.15	<0.3

CI-	PID	GRO	DRO	B	T	E	X	BTEX
North Wall	16	1.3	<10	<10	<0.05	<0.05	<0.05	<0.15	<0.3
South Wall	464	0.5	<10	<10	<0.05	<0.05	<0.05	<0.15	<0.3
East Wall	32	1.4	<10	12.7	<0.05	<0.05	<0.05	<0.15	<0.3
West Wall	<16	5.7	<10	<10	<0.05	<0.05	<0.05	<0.15	<0.3

Corrective actions began at the site on April 11<sup>th</sup>, 2014. The release area was scraped to a depth of 1.5 ft bgs (Figure 1). A total of 156 cubic yards of contaminated soil was taken to a NMOCD approved facility for disposal. At the base of the scrape a 5 point bottom composite was taken and sent to a commercial laboratory for analysis (Appendix B). The 5 point bottom composite

returned a laboratory chloride reading of 320 mg/kg, a DRO reading of 30.6 mg/kg and GRO and BTEX readings of non-detect. Final grab samples were taken from the walls of the excavation and sent to a commercial laboratory for analysis. The north wall returned a laboratory chloride reading of 16 mg/kg, the south wall returned a laboratory chloride reading of 464 mg/kg, the east wall returned a laboratory chloride reading of 32 mg/kg and the west wall returned a laboratory chloride reading of non-detect. GRO, DRO and BTEX returned values of non-detect, except for the DRO value from the east wall, which returned a value of 12.7 mg/kg.

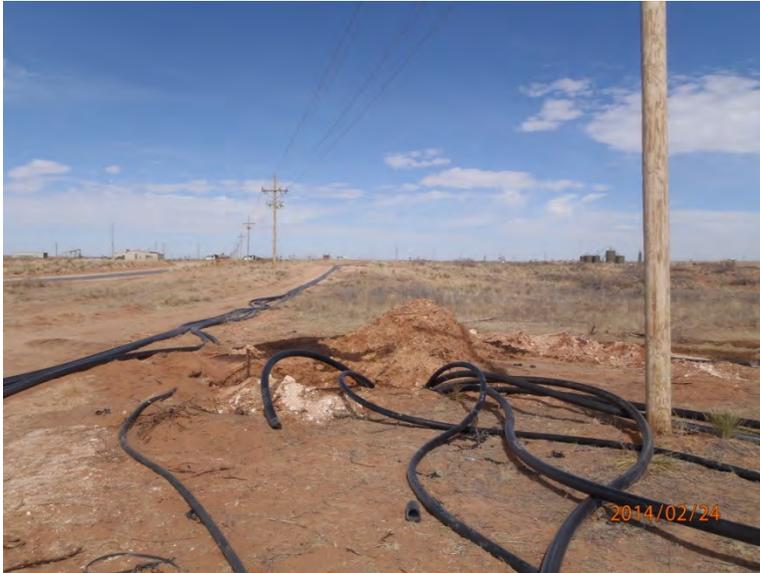
Initial site photo, facing east

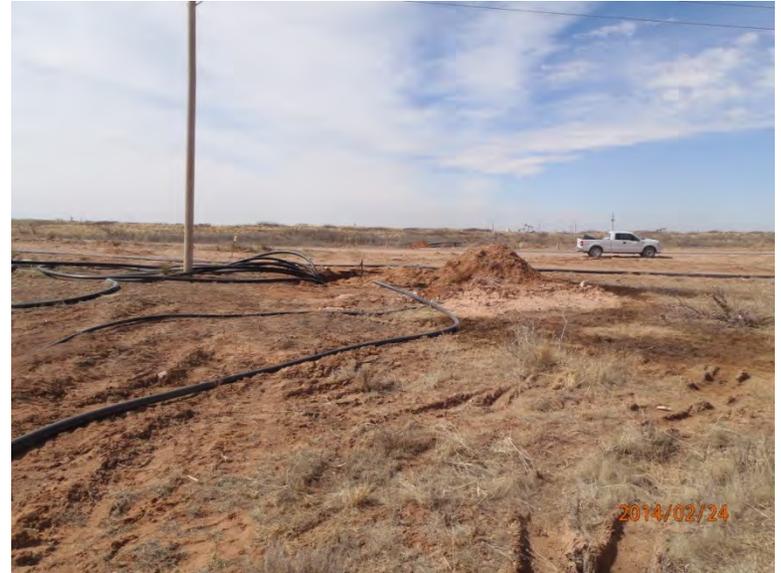
Initial site photo, facing west

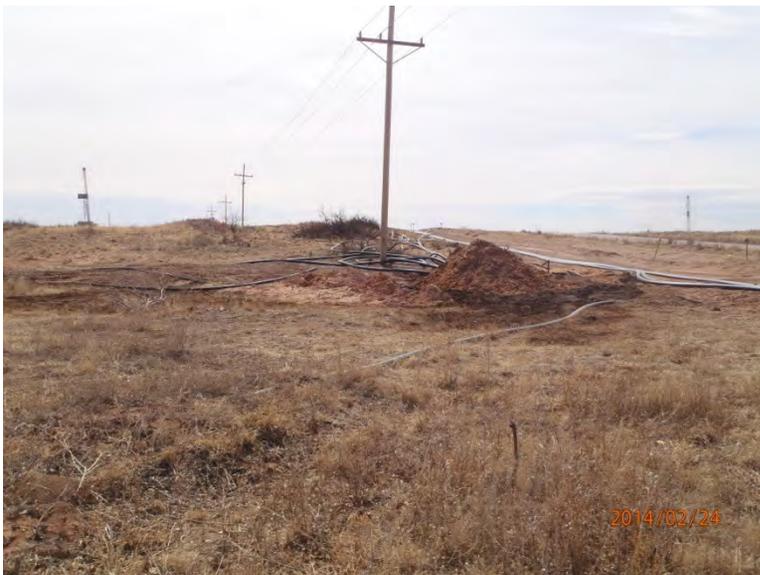
Initial site photo, facing south

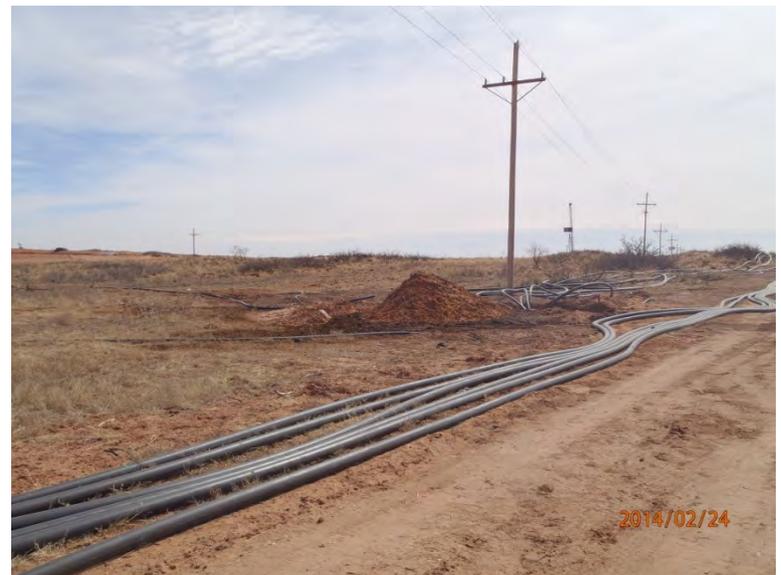
Initial site photo, facing southeast

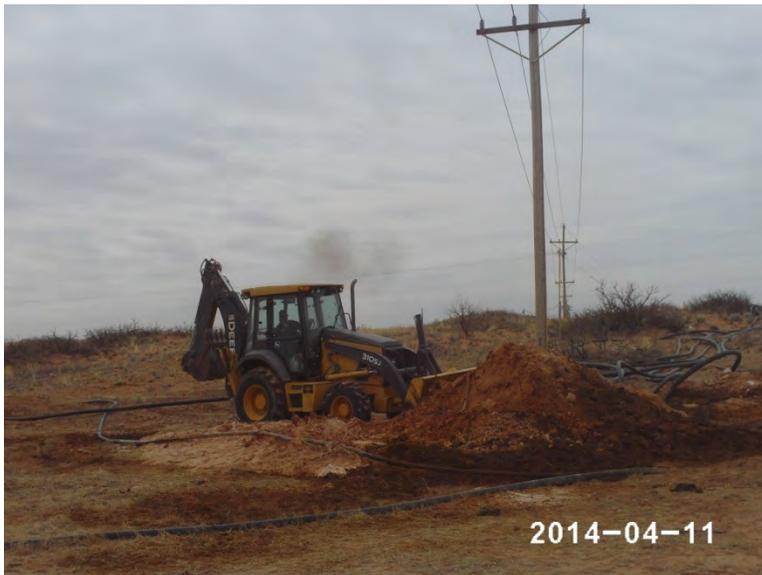
Removing extant soil pile, facing southeast 4/11/14

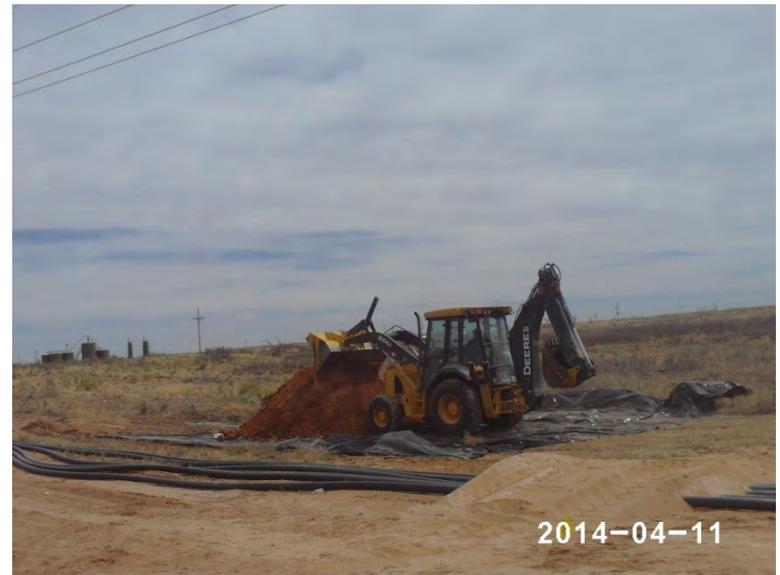
Place soil pile on plastic, facing northeast 4/11/14

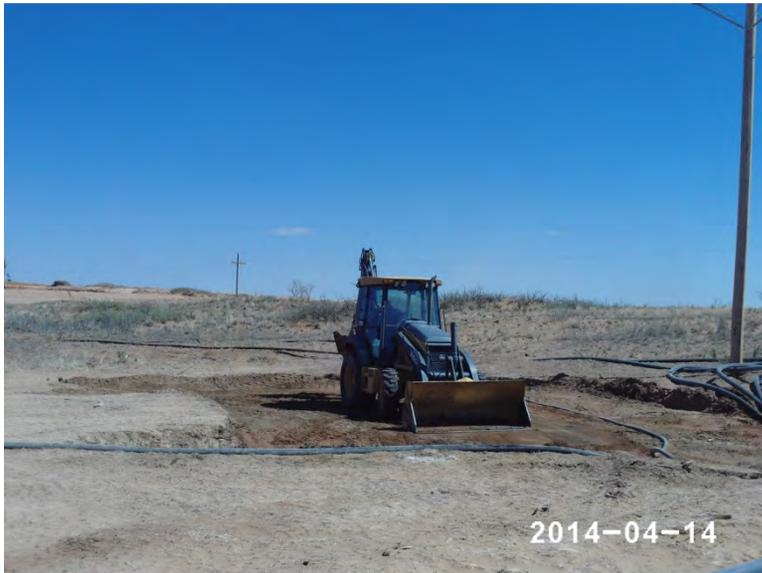
Scraping site down 1 ft bgs, facing east 4/14/14

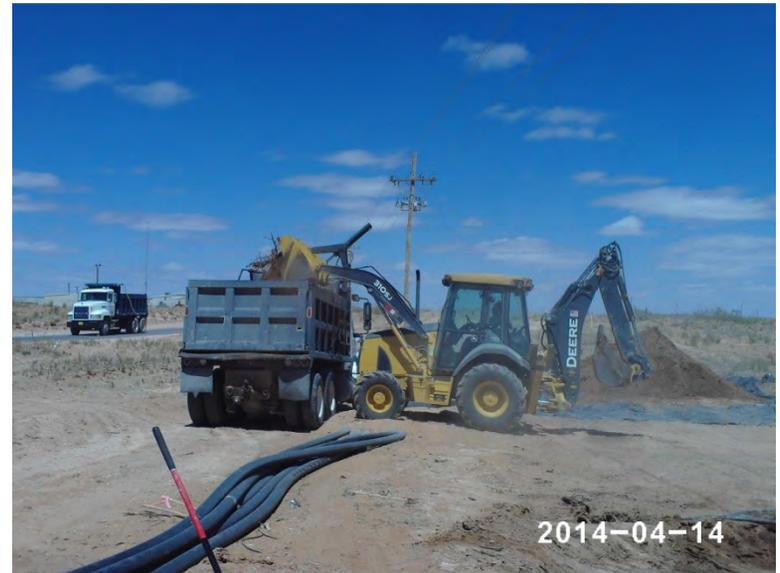
Exporting soil, facing north 4/14/14

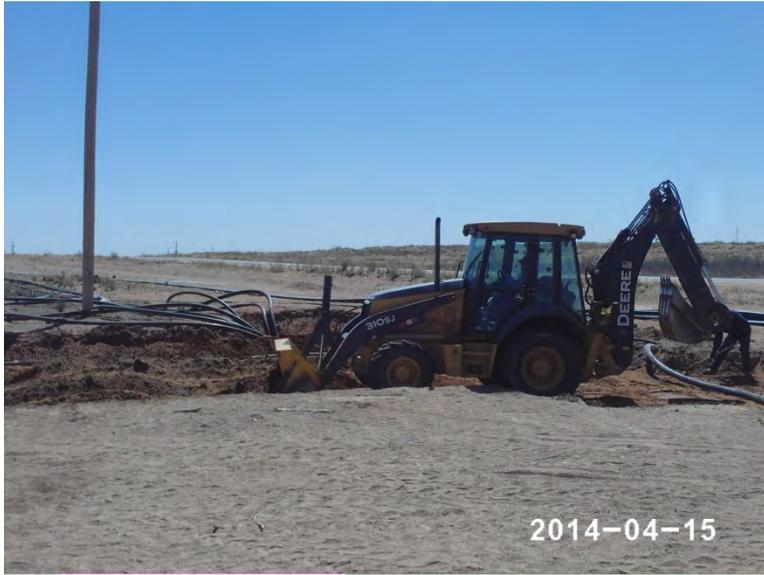
Scraping site down to 1.5 ft bgs, facing southwest  
4/15/14

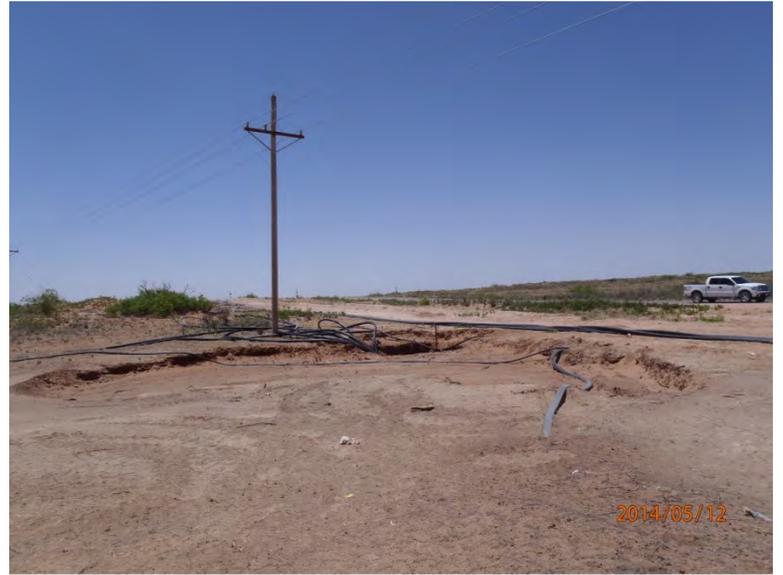
Scrape completed, facing southwest  
5/12/14

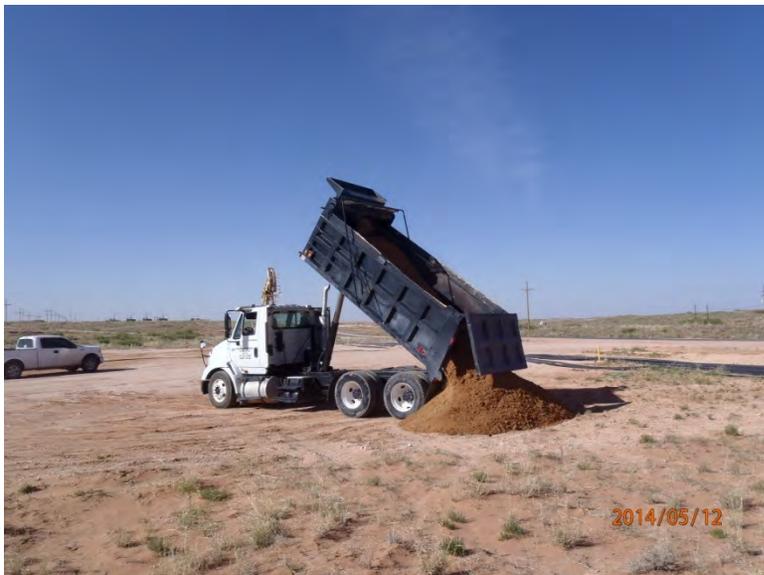
Importing top soil, facing southwest  
5/12/14

BLM approved the site to be backfilled on May 15<sup>th</sup>, 2014. A total of 252 cubic yards of top soil was imported to the site to serve as backfill. A 5 point composite of the imported top soil was taken to a commercial laboratory and returned a chloride reading of non-detect. The scrape was backfilled with the imported soil and contoured to the surrounding location. On May 21<sup>st</sup>, 2014, the site was seeded with LPC mix and the seed was raked into the soil.

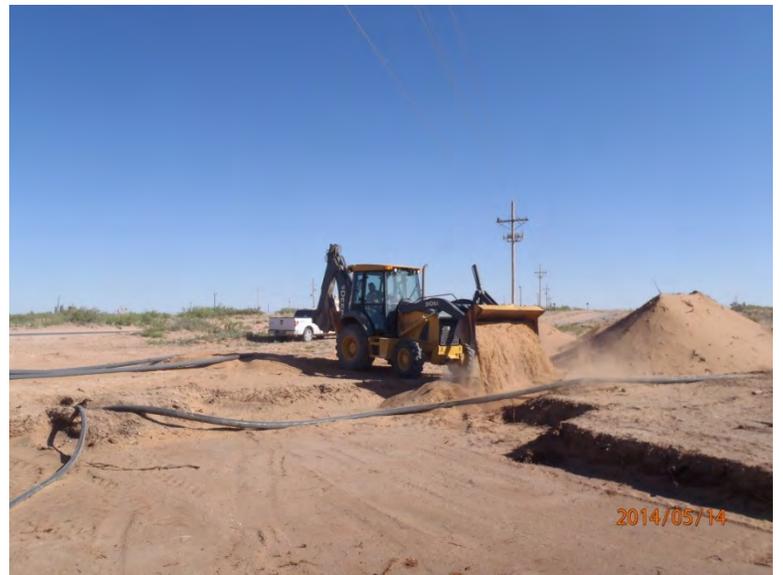
Backfilling site, facing northwest  
5/14/14

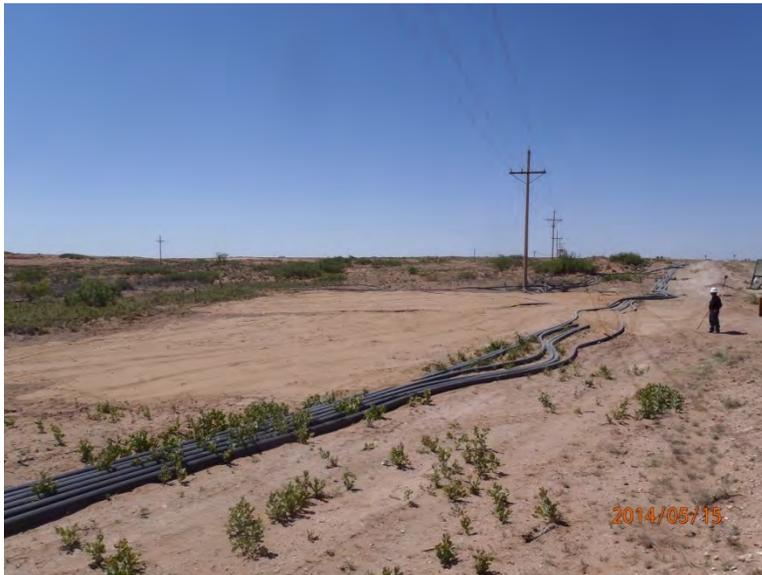
Backfilling completed, facing southeast 5/15/14

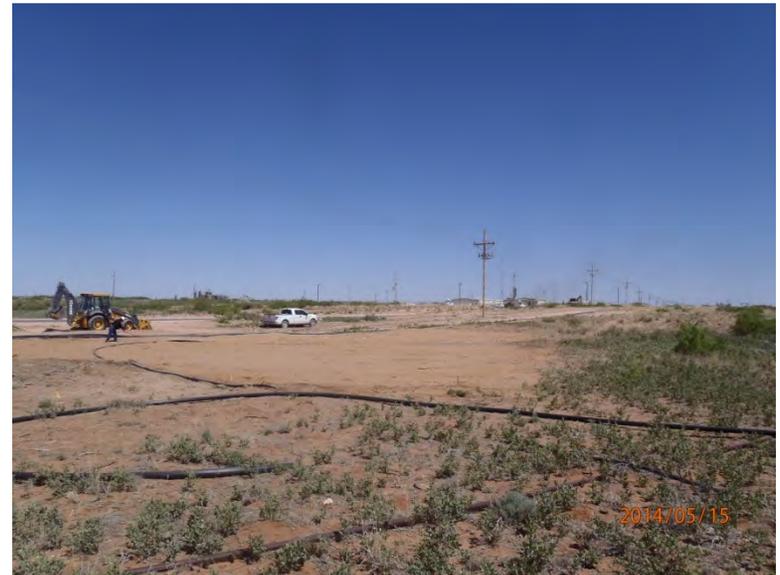
Backfilling completed, facing northwest 5/15/14

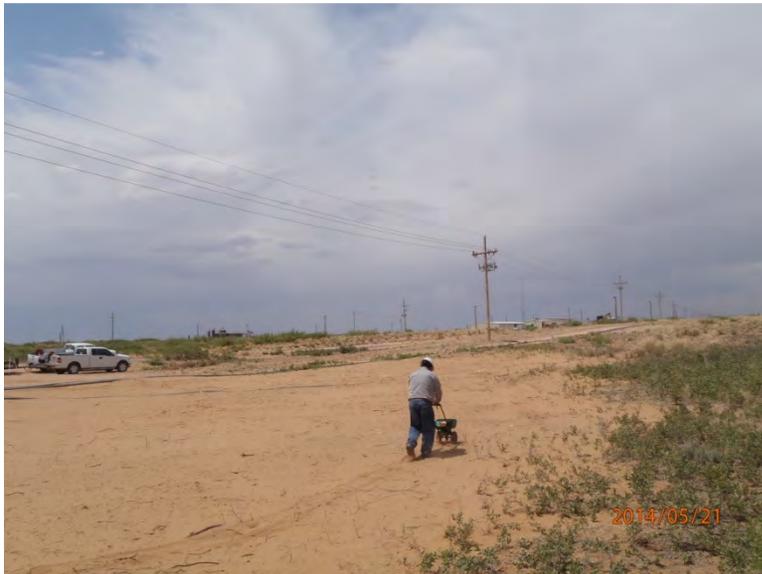
Seeding site with LPC mix, facing northwest 5/21/14

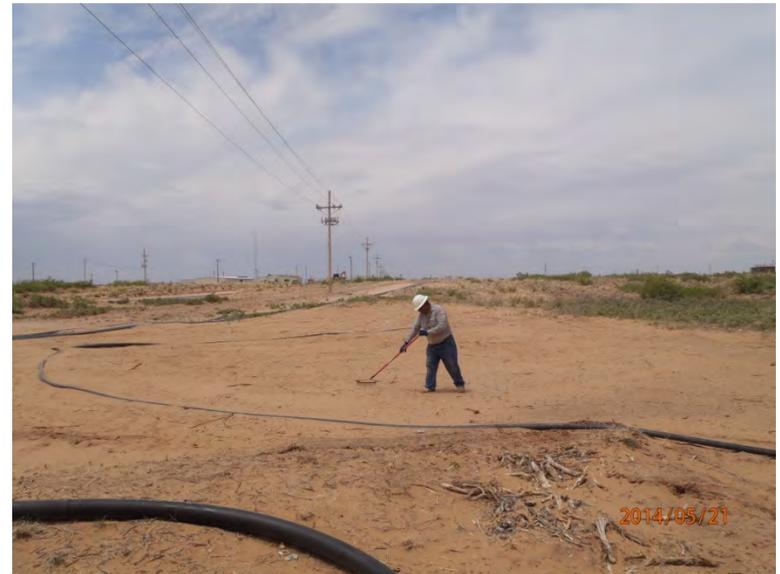
Raking seed into the soil, facing north 5/21/14

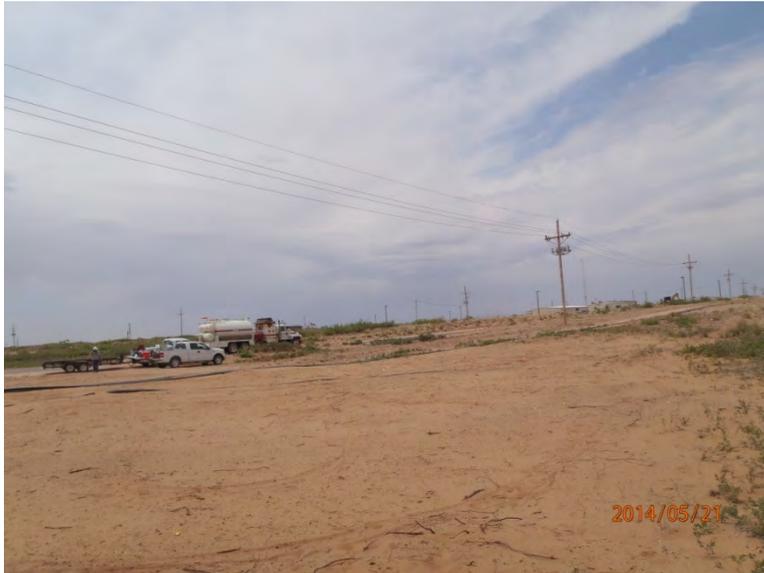
Site completed, facing northwest

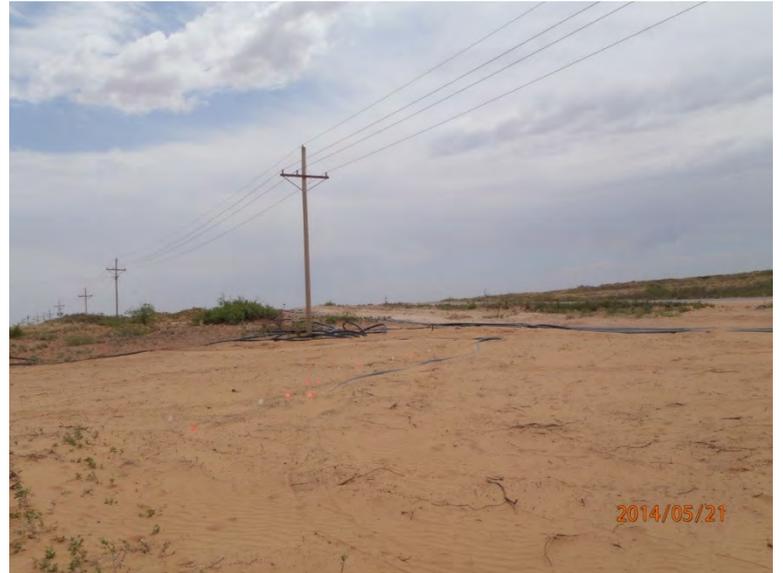
Site completed, facing southwest
