## **CLOSURE REPORT**

**BOPCO, L.P.**  
**Poker Lake Unit #276**  
**Eddy County, New Mexico**  
**Unit Letter "G", Section 13, Township 24 South, Range 29 East**  
**Latitude 32.219375 North, Longitude 103.935907 West**  
**NMOCD Reference #2RP-2600**

RE: Final Closure Report  
Bopco – Poker Lake Unit #276  
UL-G, Section 13, Township 24 South, Range 29 East  
Eddy County, New Mexico  
NMOCD Reference # 2RP 2600

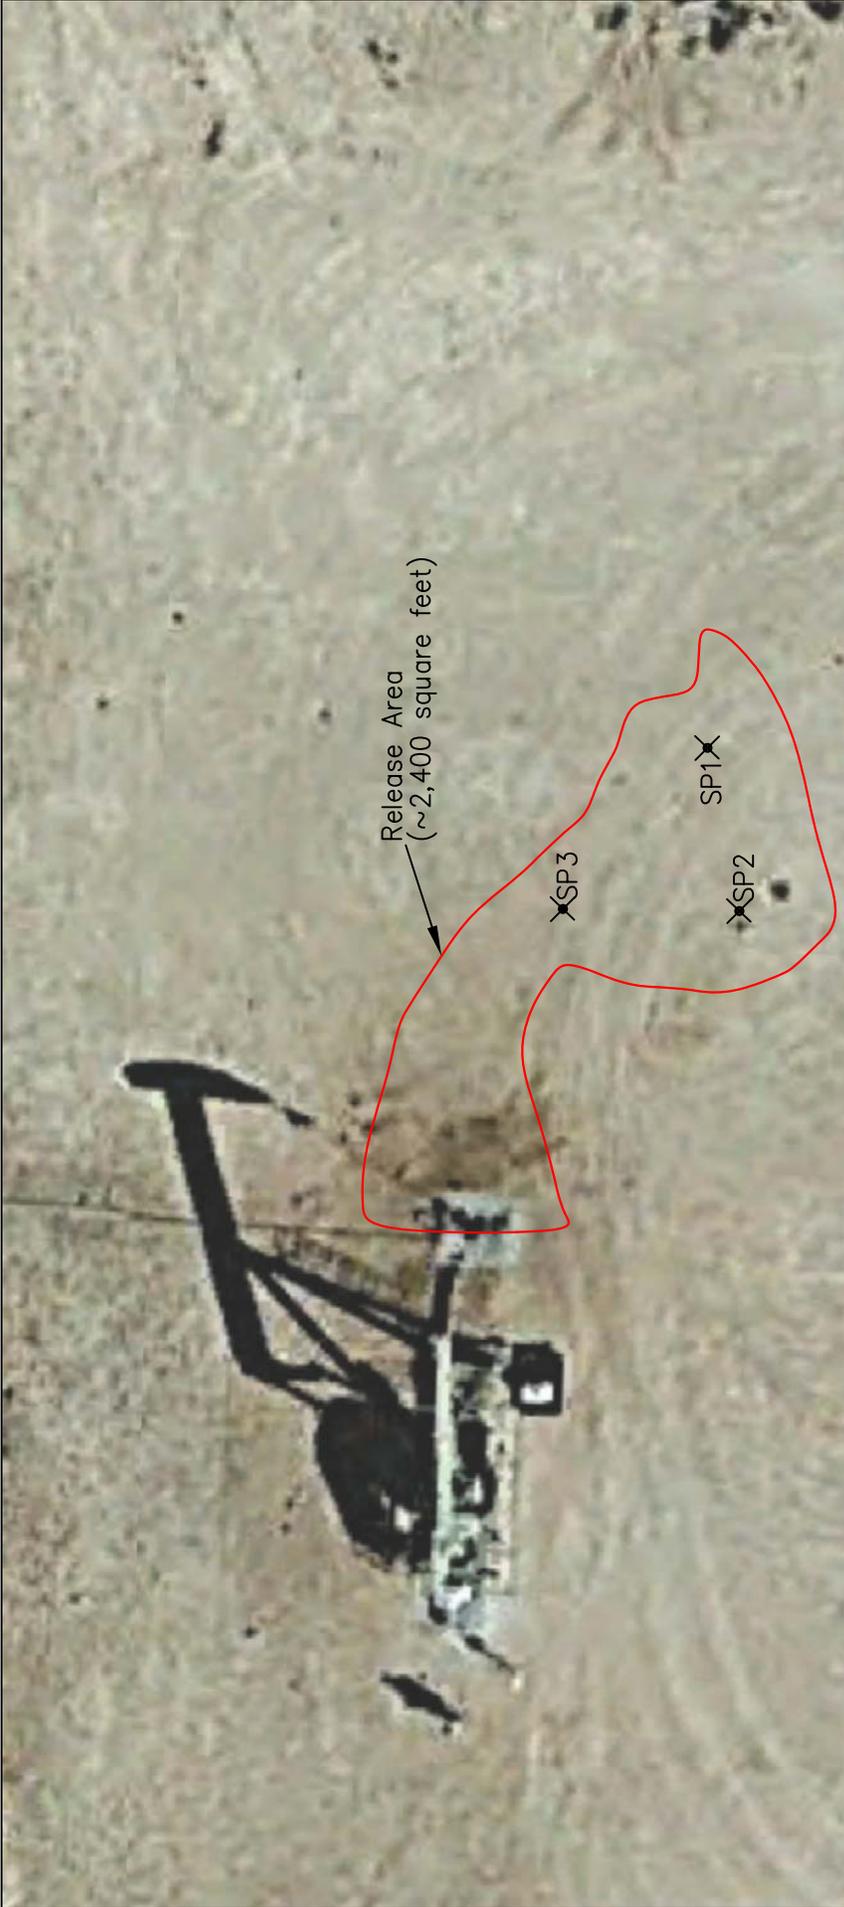
Figure 3  
Site/Sample Map  
Bopco, L.P.  
Poker Lake Unit #276

EPI personnel mobilized on the site on December 2, 2014 to collect soil samples via hand auger to determine the vertical extent of contamination. A total of twelve (12) soil samples were collected from three (3) sample locations. On December 4, 2014 one (1) additional deeper soil sample was collected from sample point SP3; all samples were sent to Cardinal Labs in Hobbs, New Mexico, for testing. Laboratory analytical results indicate the excavation is void of Benzene, BTEX, TPH, and Chloride concentrations in excess of NMOCD Recommended Remedial Action Levels (RRALs) of 10 mg/Kg, 50 mg/Kg, 5,000 mg/Kg, and 1,000 mg/Kg, respectively, in the area of SP1. Laboratory results indicate the area around SP2 to be void of Benzene, BTEX and TPH concentrations in excess of NMOCD RRALs. Chloride concentrations exceed NMOCD RRALs in the area of SP2 at surface level only. Laboratory results indicate the area of SP3 to be void of Benzene and BTEX concentrations in excess of NMOCD RRALs while TPH concentrations exceed NMOCD RRALs at surface level only, and Chloride concentrations exceed NMOCD RRALs at surface level and again between four (4) and six (6) feet bgs (reference *Figure 3* and *Table 2*).

Release Area  
(~2,400 square feet)

From November 17 - 26, 2014 the release area was excavated to a depth of one (1) foot bgs in the areas of SP1 and SP2; SP3 was excavated to a depth of two (2) feet bgs. Approximately 101.8 tons of contaminated soil was excavated and hauled to a state approved facility for disposal.

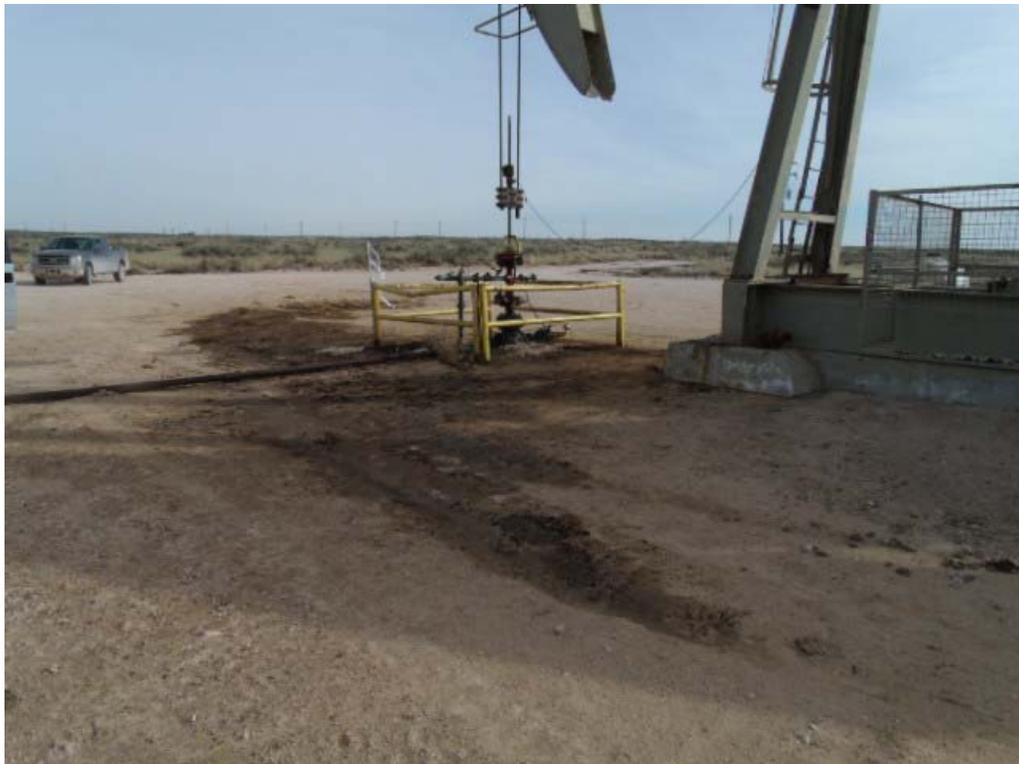
Photograph #2 – Looking across release area

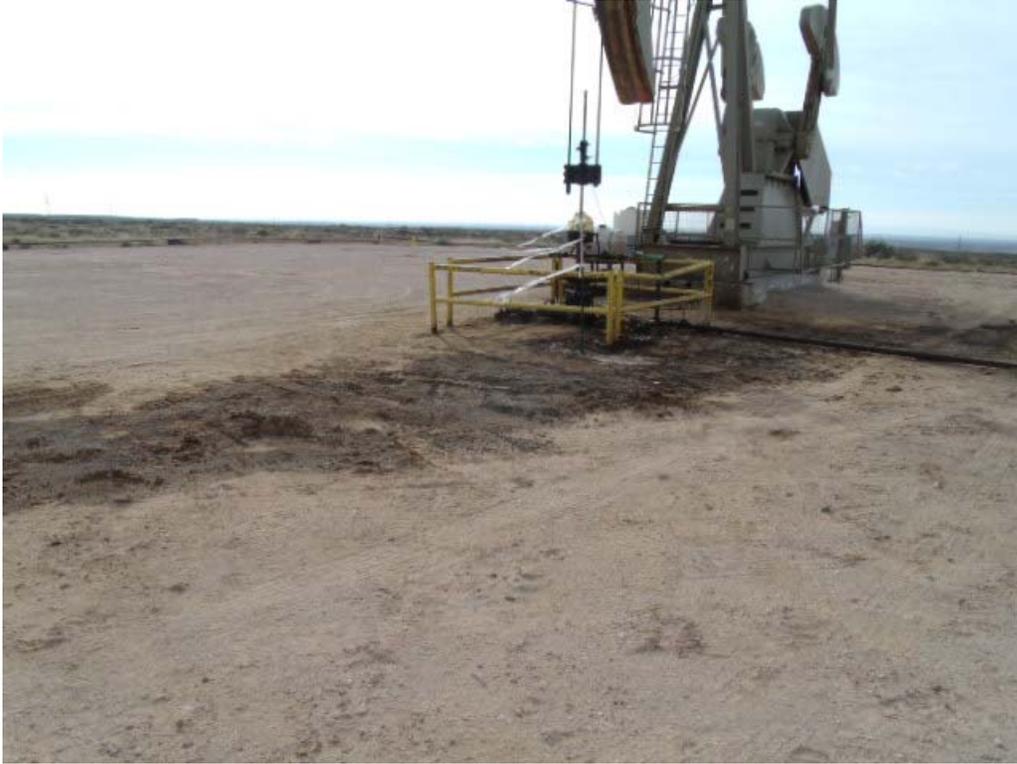
Photograph #3 – Looking across release area

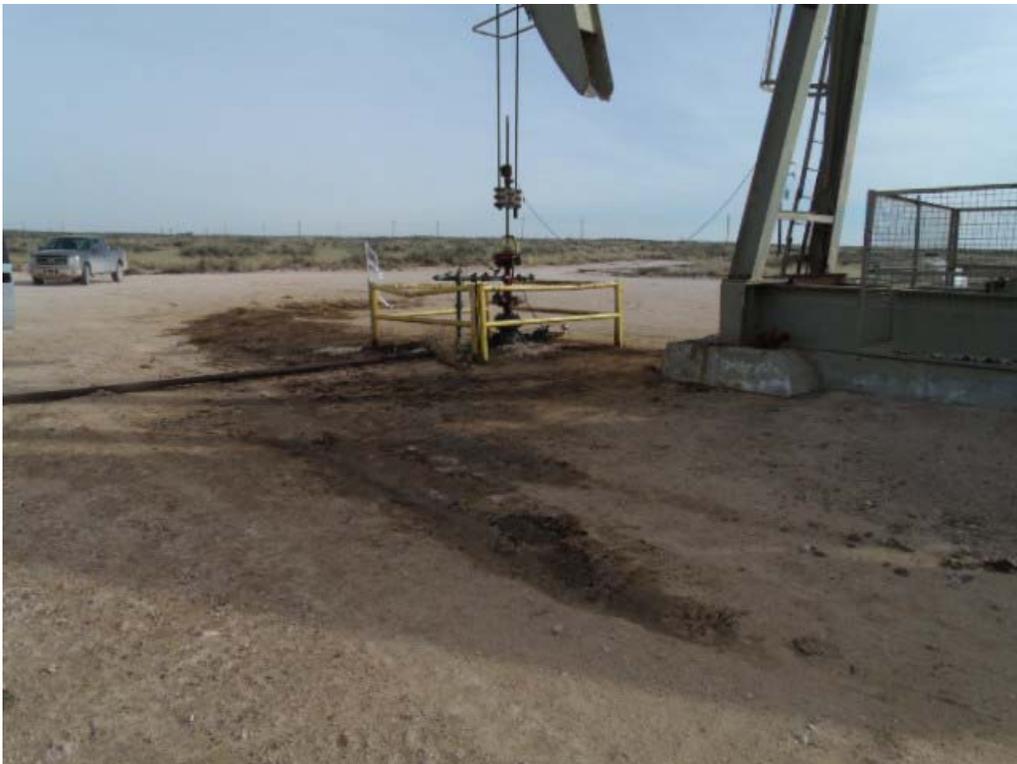
Photograph #4 – Looking across release area

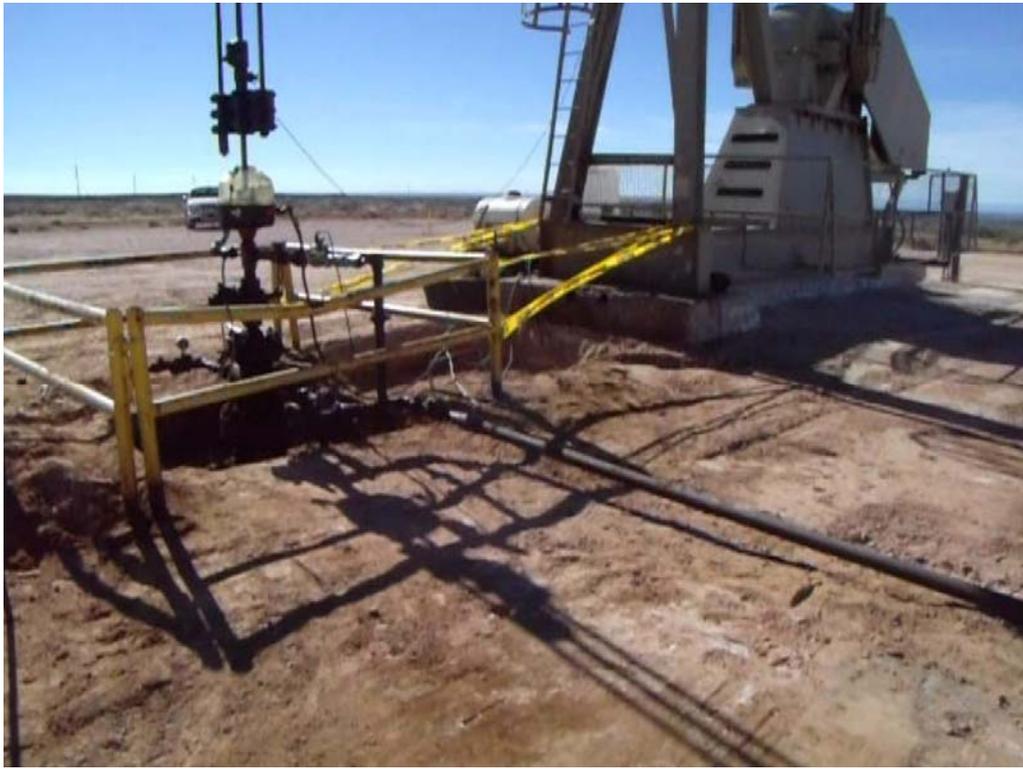
Photograph #5 – Excavated area

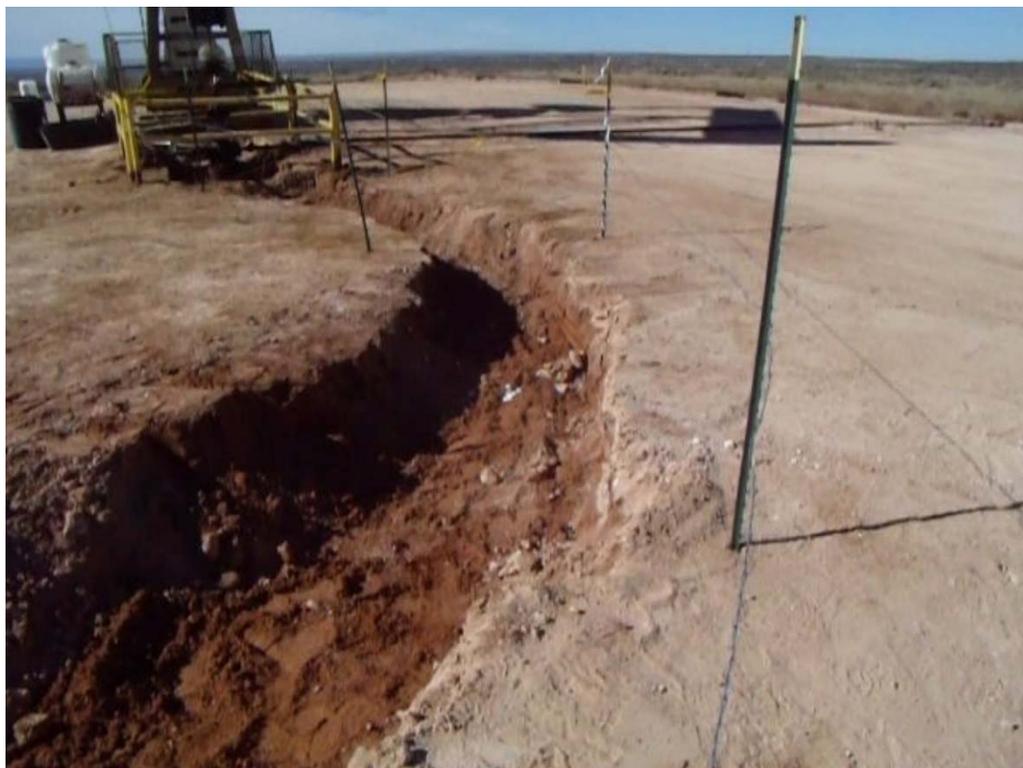
Photograph #6 – Excavated area

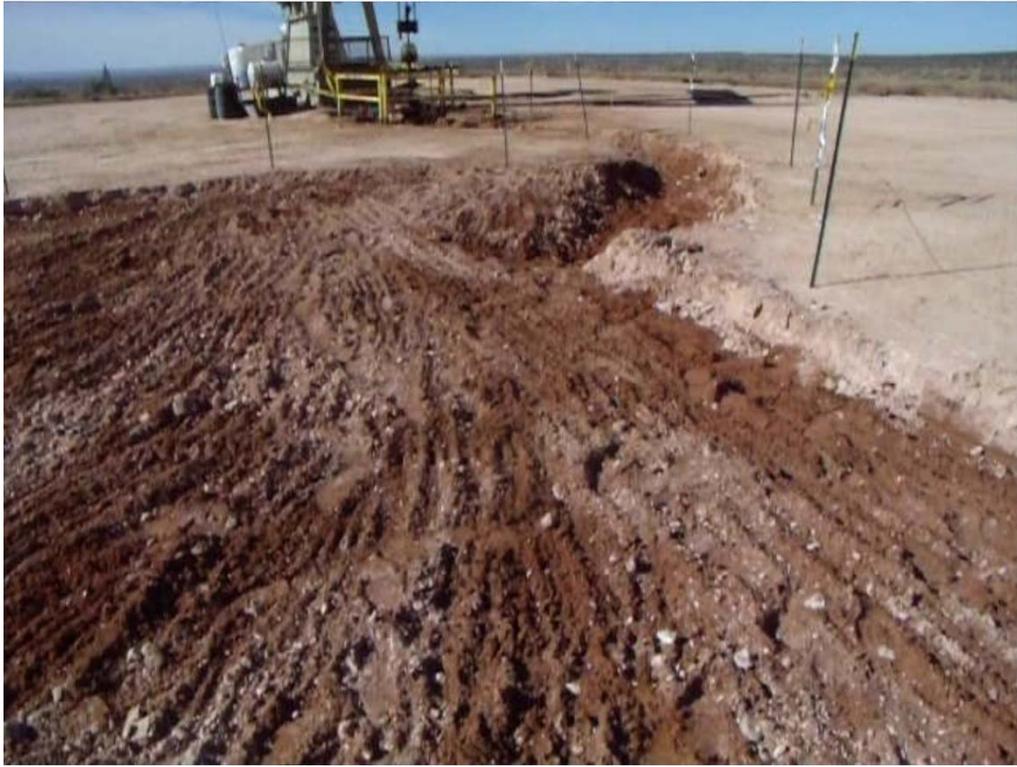
Photograph #7 – Excavated area

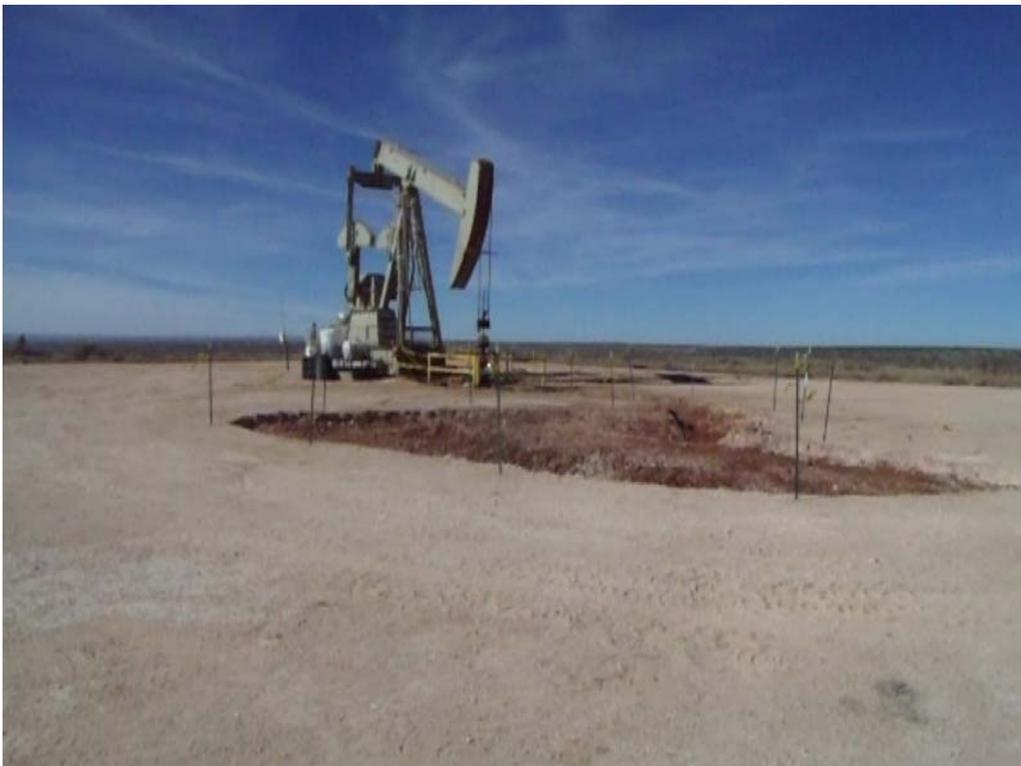
Photograph #8 – Excavated area

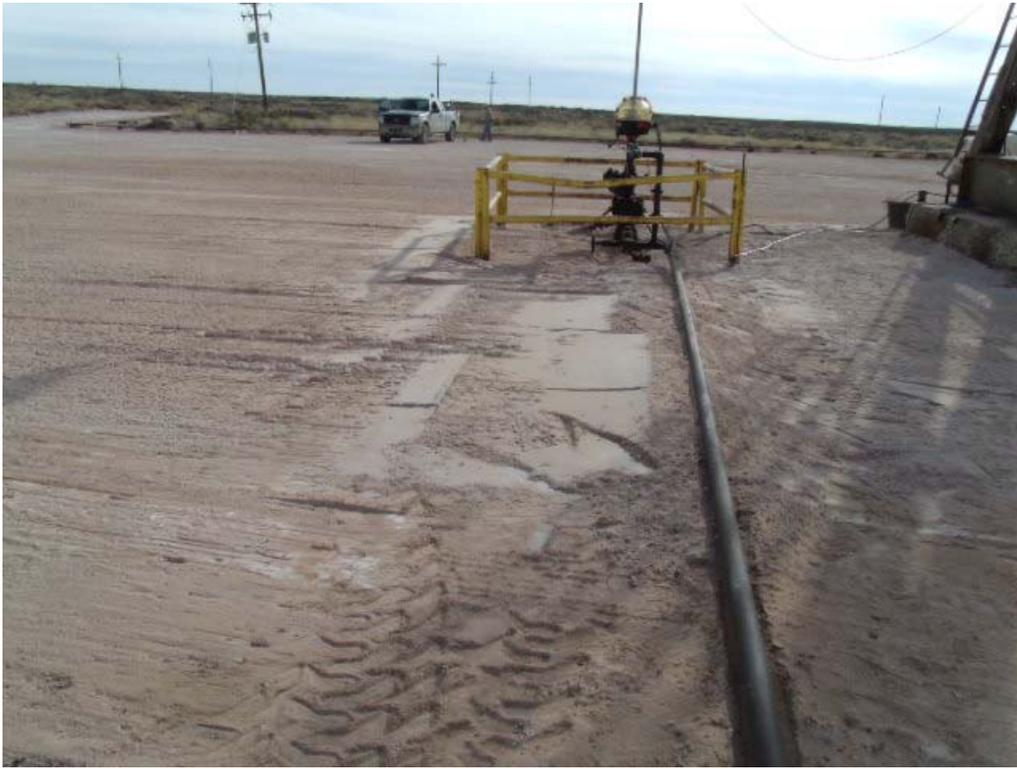
Photograph #9 – Backfilled area

The excavation was backfilled with approximately 101.8 tons of clean soil free of rocks, clumps or deleterious material. The entire disturbed area was then contoured to blend with existing pad area and protected against wind/water erosion.

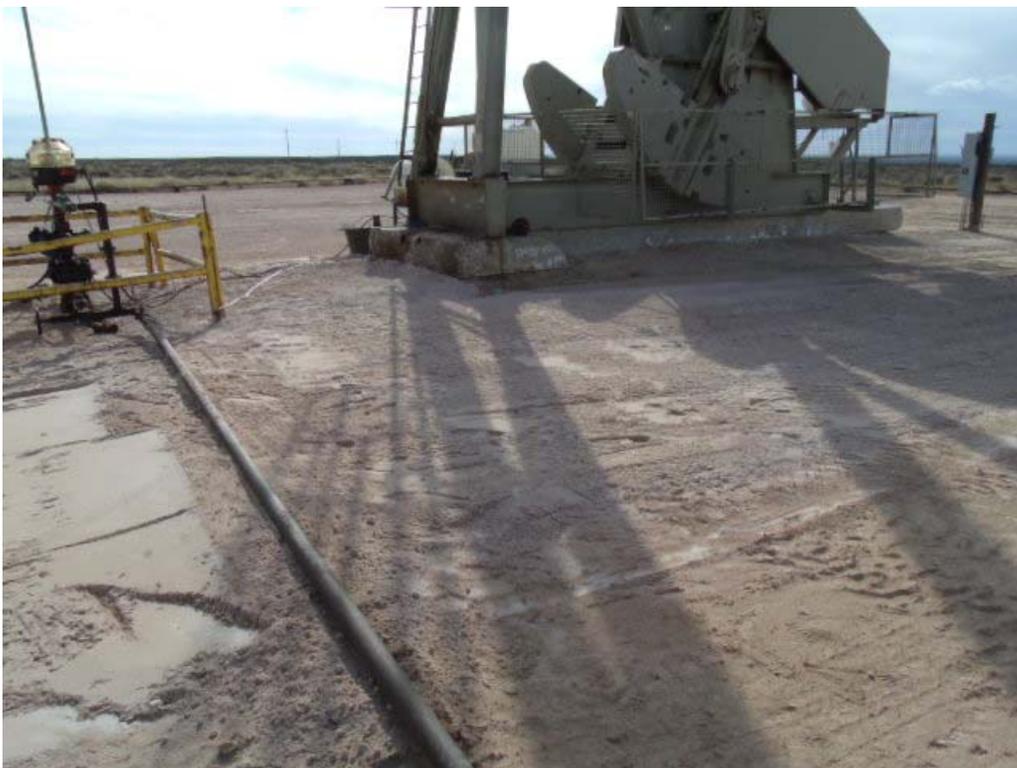
Photograph #10 – Backfilled area

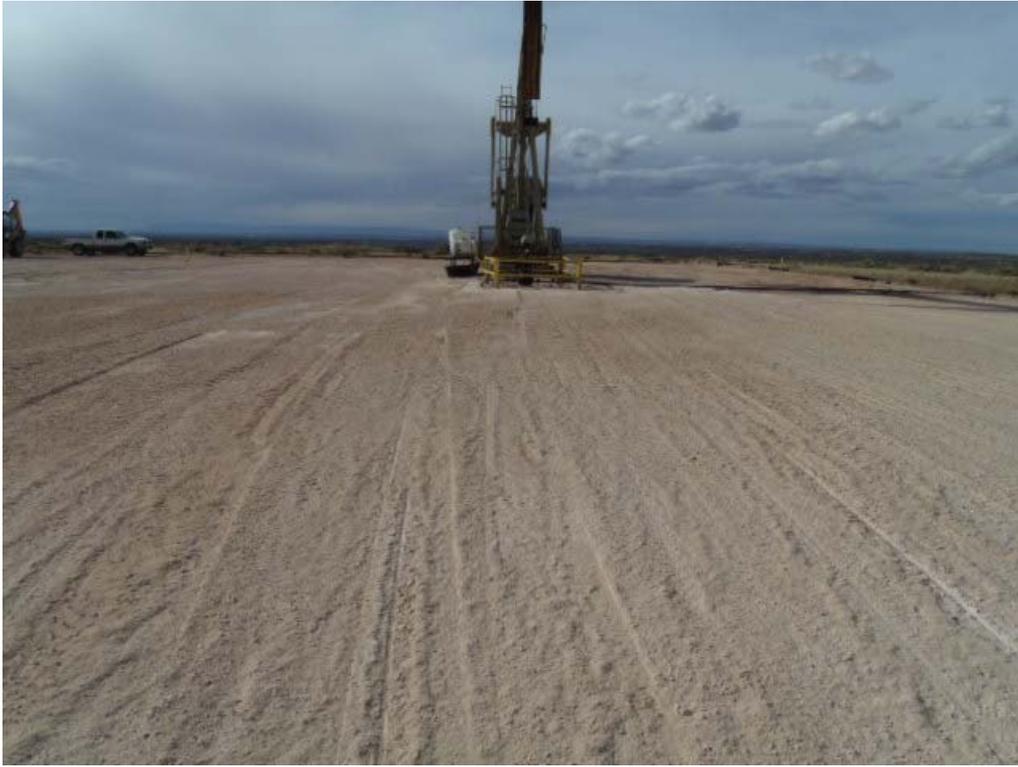
Photograph #11 – Backfilled area

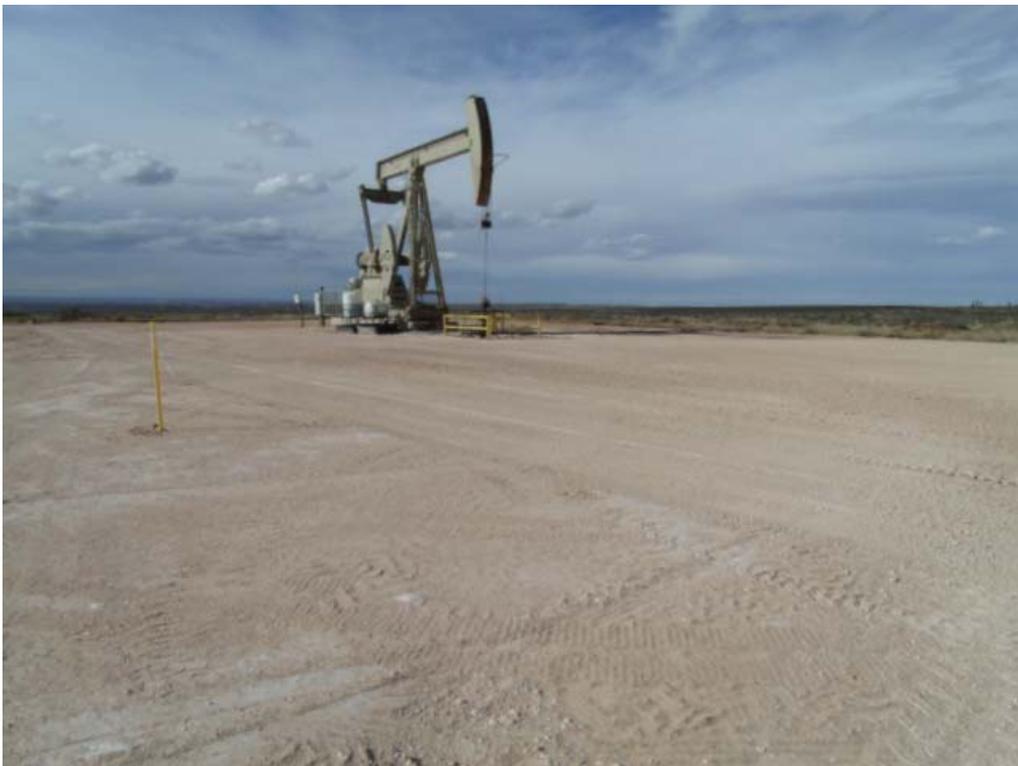
Photograph #12 – Backfilled area
