CLOSURE REPORT

BOPCO, L.P.
Poker Lake Unit #50
Eddy County, New Mexico
Unit Letter "B", Section 4, Township 25 South, Range 31 East
Latitude 32.164930 North, Longitude 103.780630 West
NMOCD Reference #2RP-1728; #2RP-2251

RE: Final Closure Report
Bopco – Poker Lake Unit #50
UL-B, Section 4, Township 25 South, Range 31 East
Eddy County, New Mexico
NMOCD Reference #'s 2RP 1728, 2RP 2251

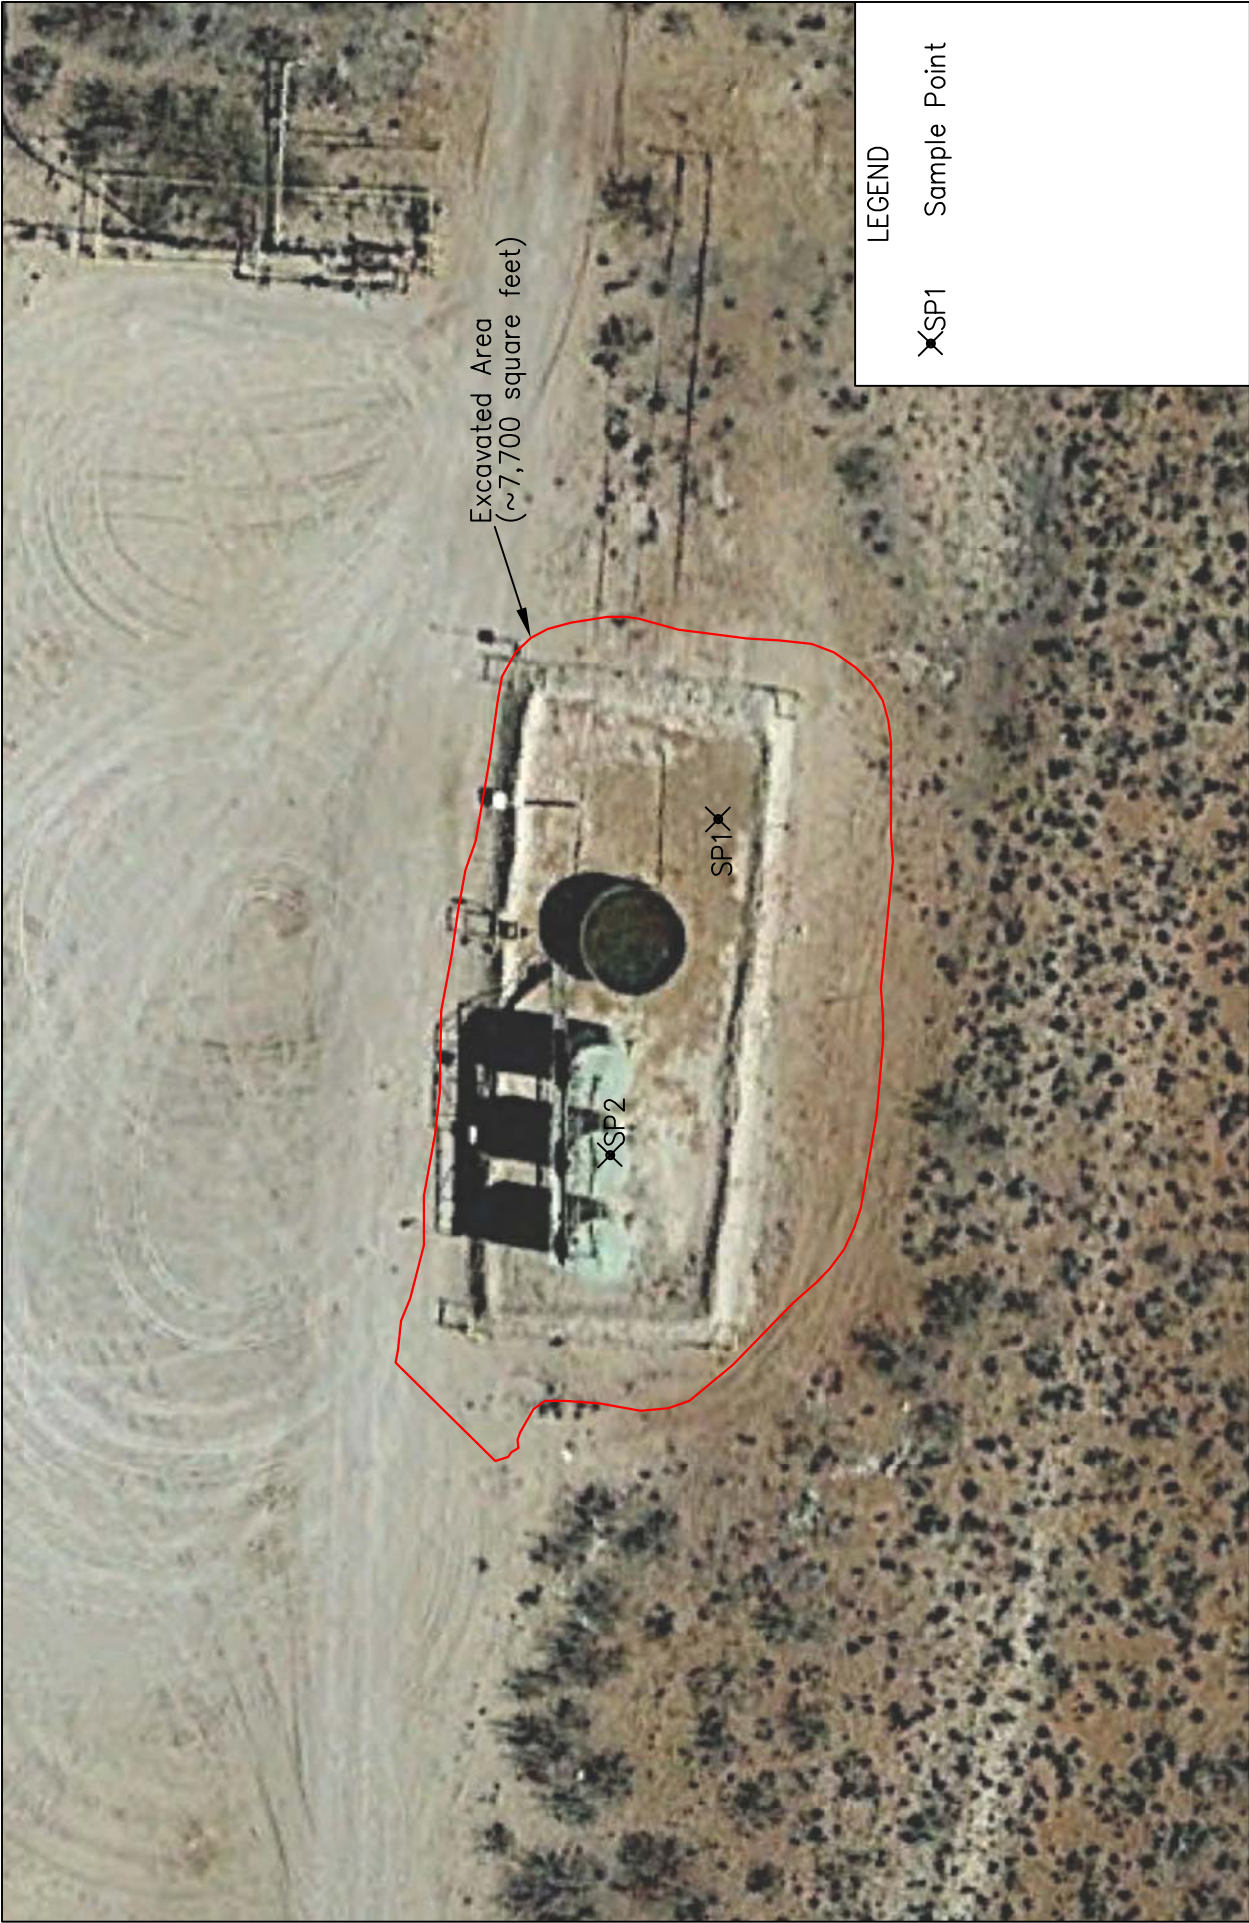
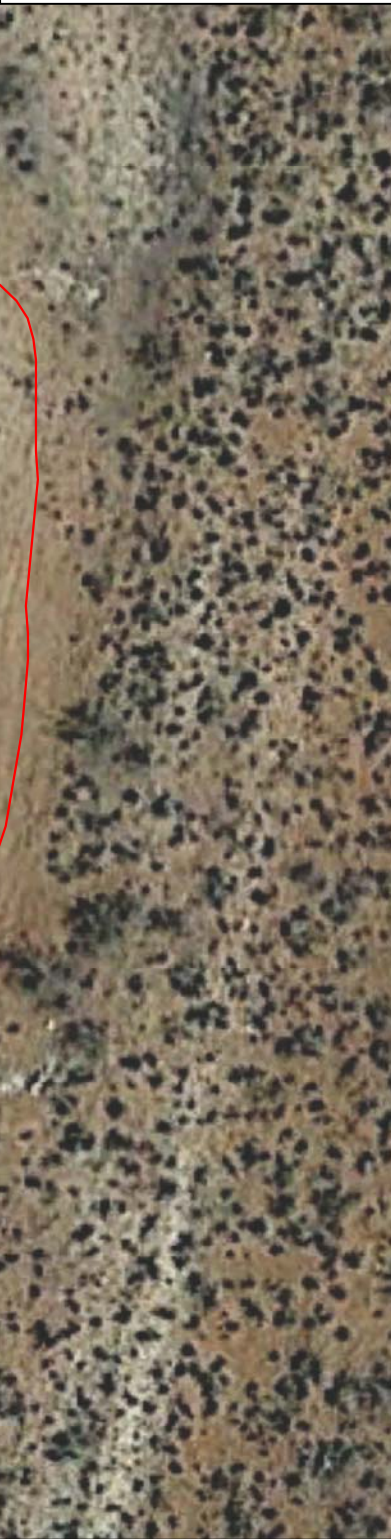
<p>Eddy County, New Mexico NW 1/4 of NE 1/4, Sec. 4, T25S, R31E N 32° 9' 52.81" W 103° 46' 50.42" Elevation: 3,445 feet amsl</p>		<p>Figure 3 Site/Sample Map Bopco, L.P. Poker Lake Unit #50</p>	
<p>DWG By: D Dominguez December 2014</p>		<p>REVISED:</p>		<p>N</p>

EPI personnel mobilized on the site on November 3, 2014 to collect soil samples via excavator to determine the vertical extent of contamination. A total of fourteen (14) soil samples were collected from two (2) sample locations. On November 10, 2014 seven (7) additional deeper soil samples were collected from the sample points. On November 25, 2014 three additional deeper samples were collected from SP1; all samples were sent to Cardinal Labs in Hobbs, New Mexico, for testing. Laboratory analytical results indicate the excavation is void of Benzene, BTEX, and TPH concentrations in excess of NMOCD Recommended Remedial Action Levels (RRALs) of 10 mg/Kg, 50 mg/Kg, and 5,000 mg/Kg, respectively. Laboratory results indicate Chloride concentrations do not exceed NMOCD RRALs of 1,000 mg/Kg in the area of SP2, however, in the area of SP1 Chloride concentrations exceed NMOCD RRALs to a depth of twenty-three (23) feet bgs (reference *Figure 3* and *Table 2*).

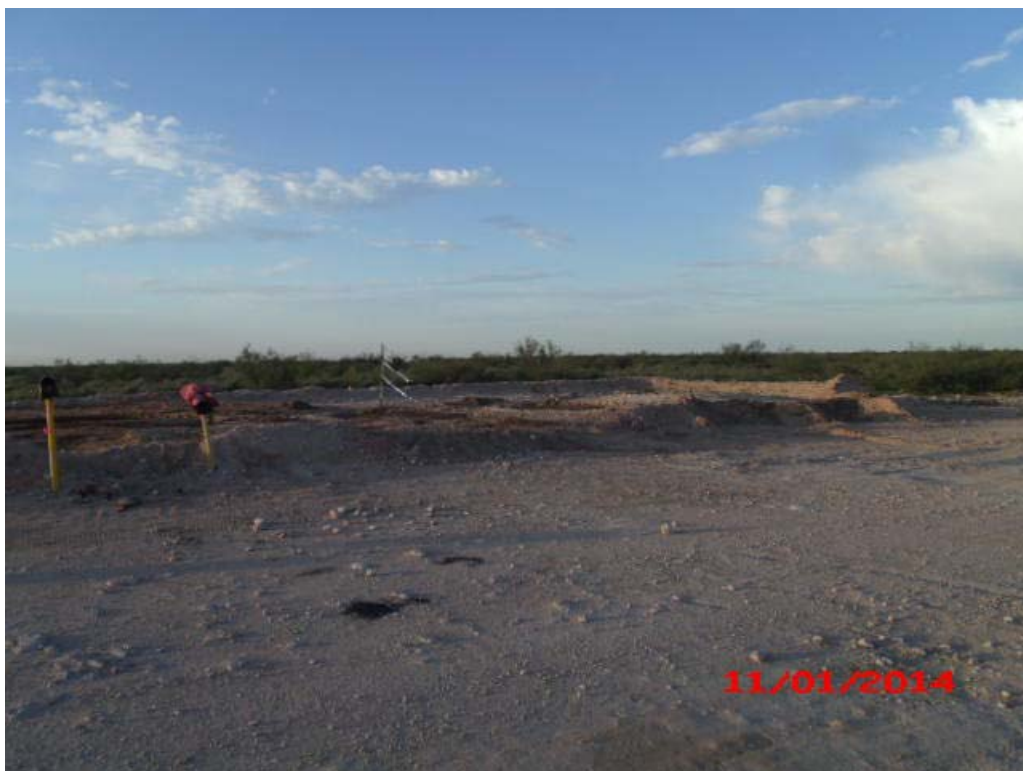
Photograph #2 – Area after tank battery removal

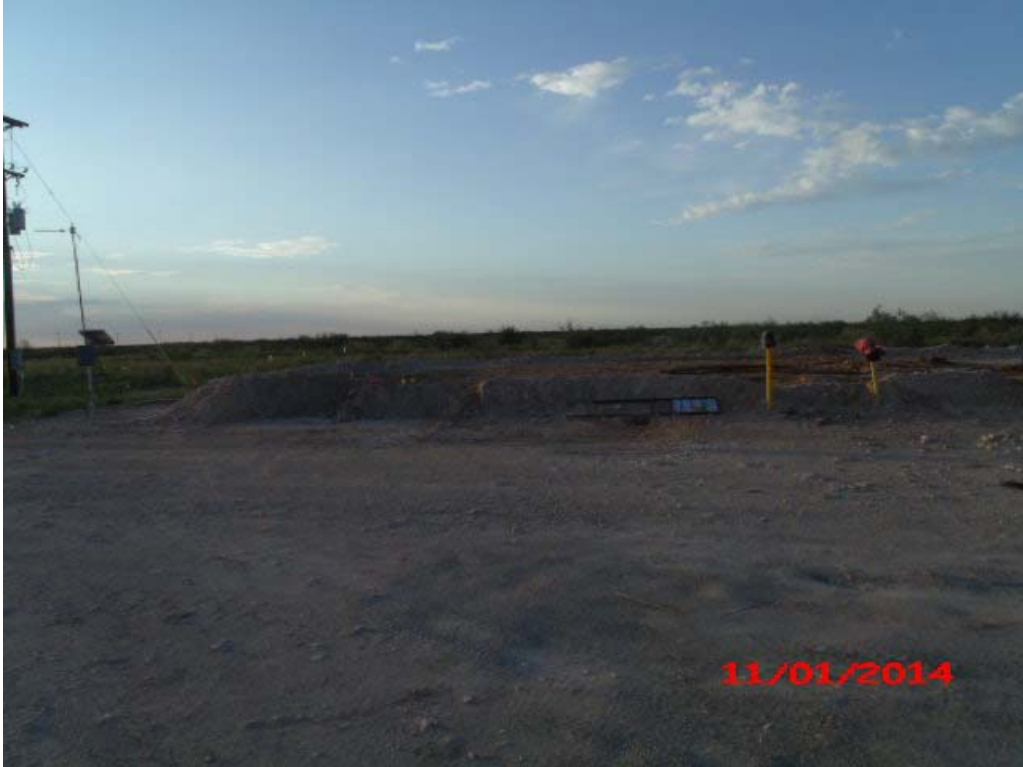
Photograph #3 – Area after tank battery removal

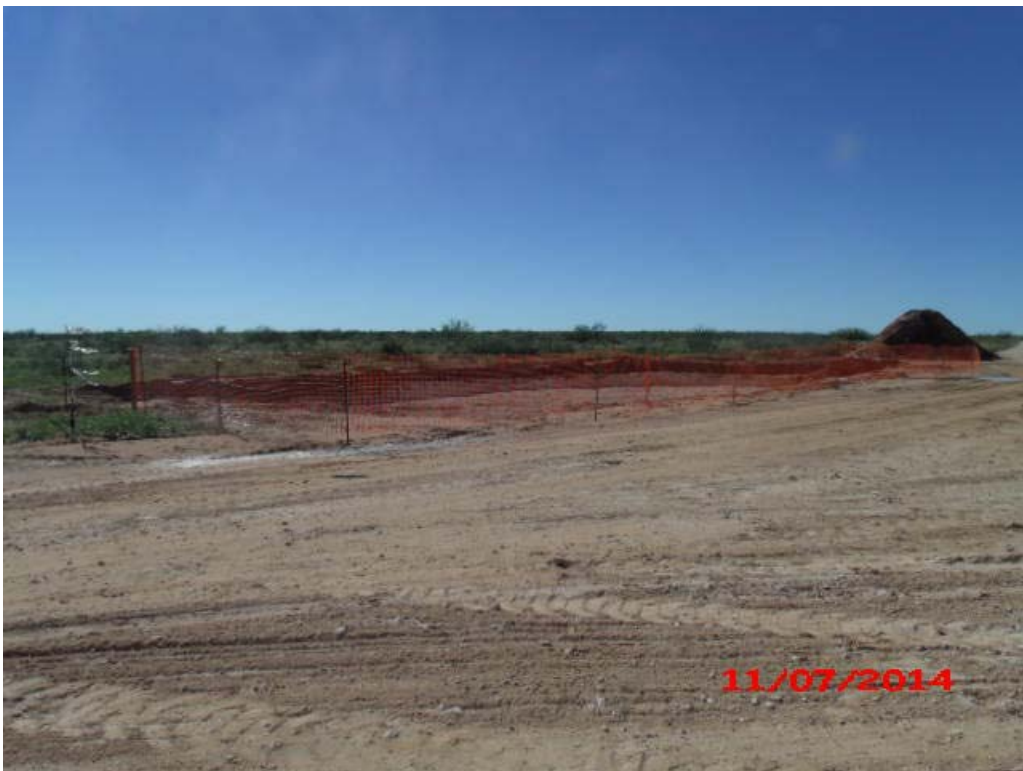
Photograph #4 – Excavated area

The release area was excavated to a depth of five (5) foot bgs with approximately 2,141 cubic yards of contaminated soil excavated and hauled to a state approved facility for disposal.

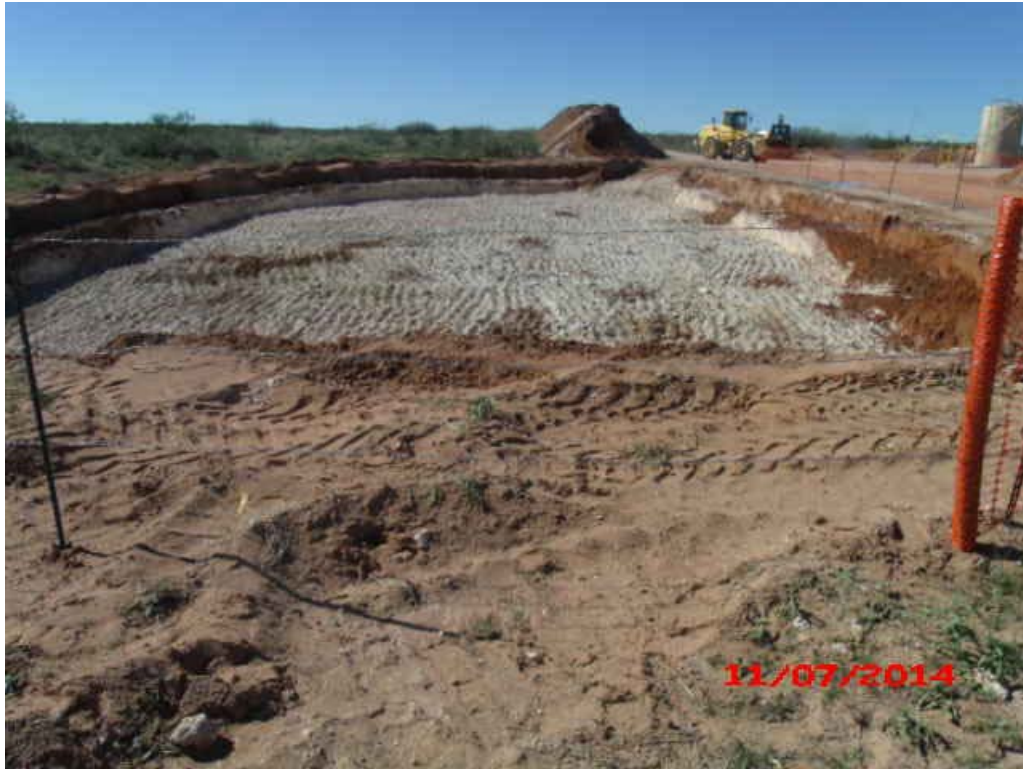
Photograph #5 – Excavated area

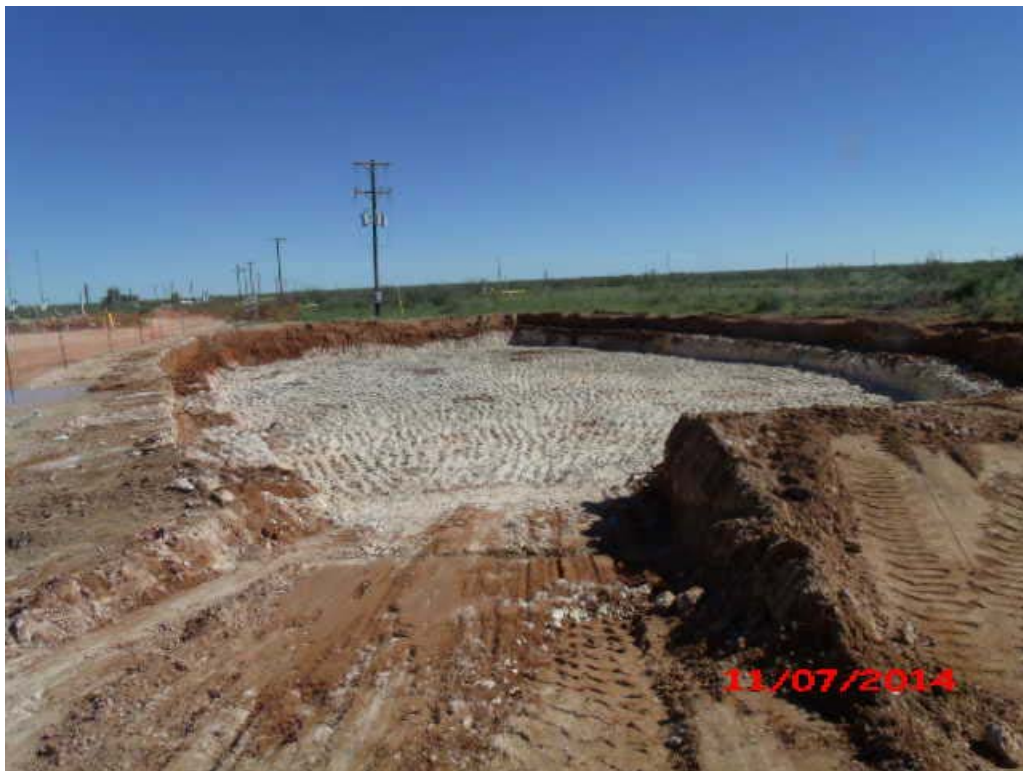
Photograph #6 – Excavated area

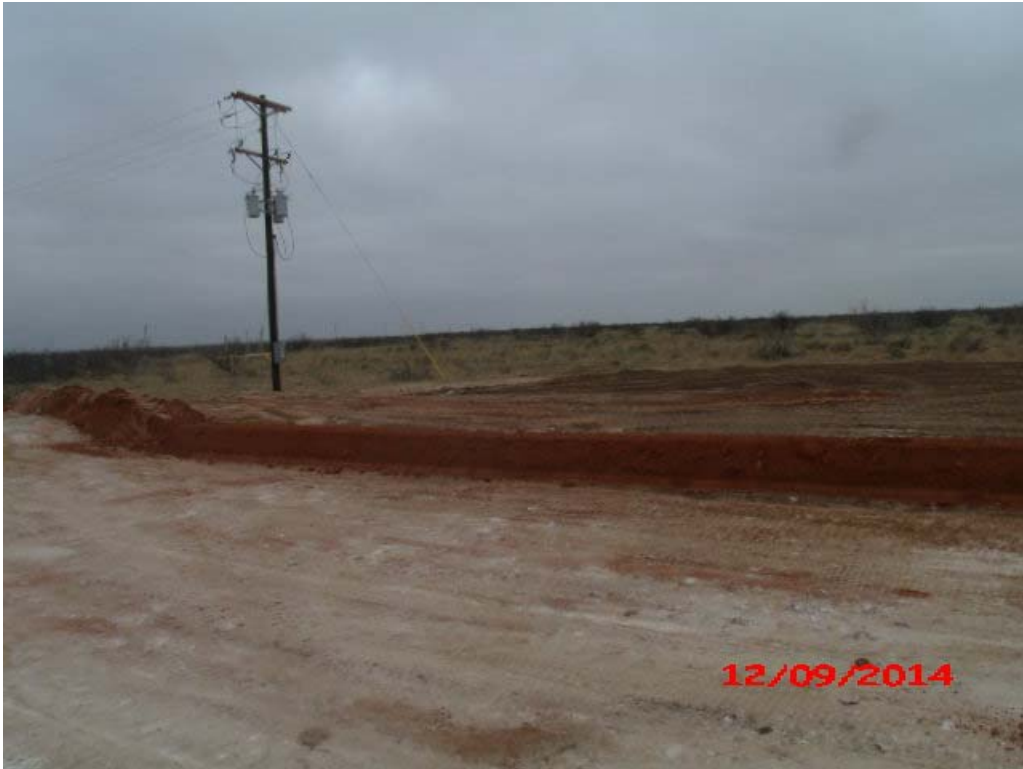
Photograph #7 – Backfilled area

The excavation was backfilled with approximately 2,141 cubic yards of clean soil free of rocks, clumps or deleterious material. The entire disturbed area was then contoured to blend with existing pasture area and protected against wind/water erosion. On December 10, 2014 the area was seeded with an approved seed mix and watered.

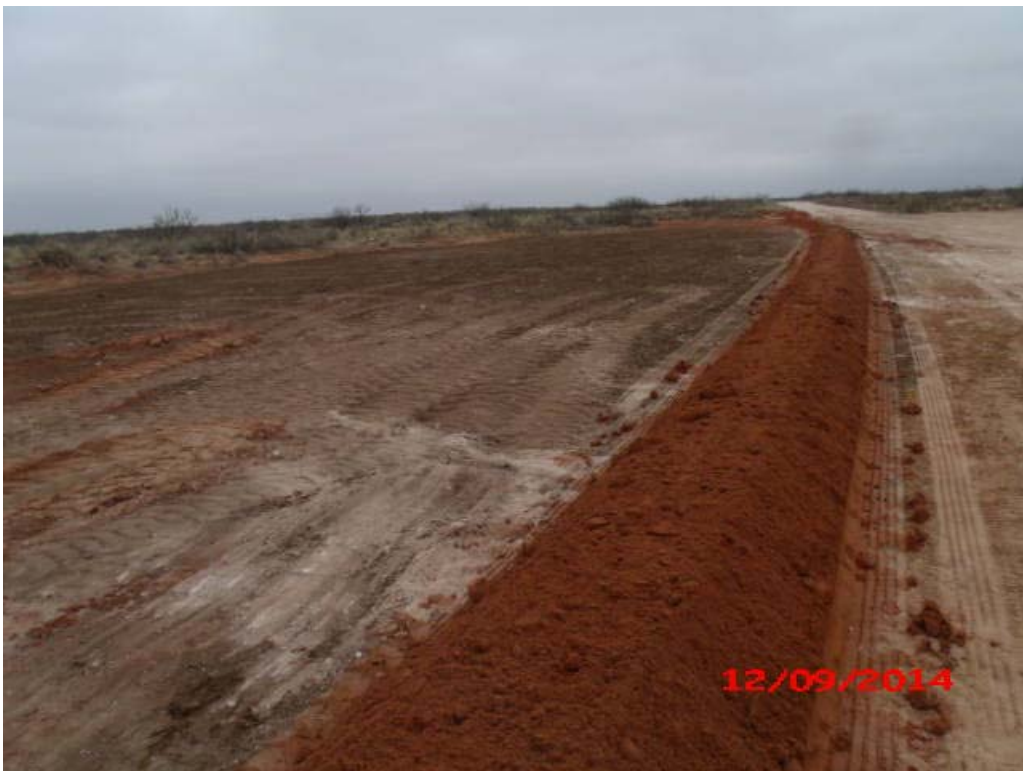
Photograph #8 – Backfilled area

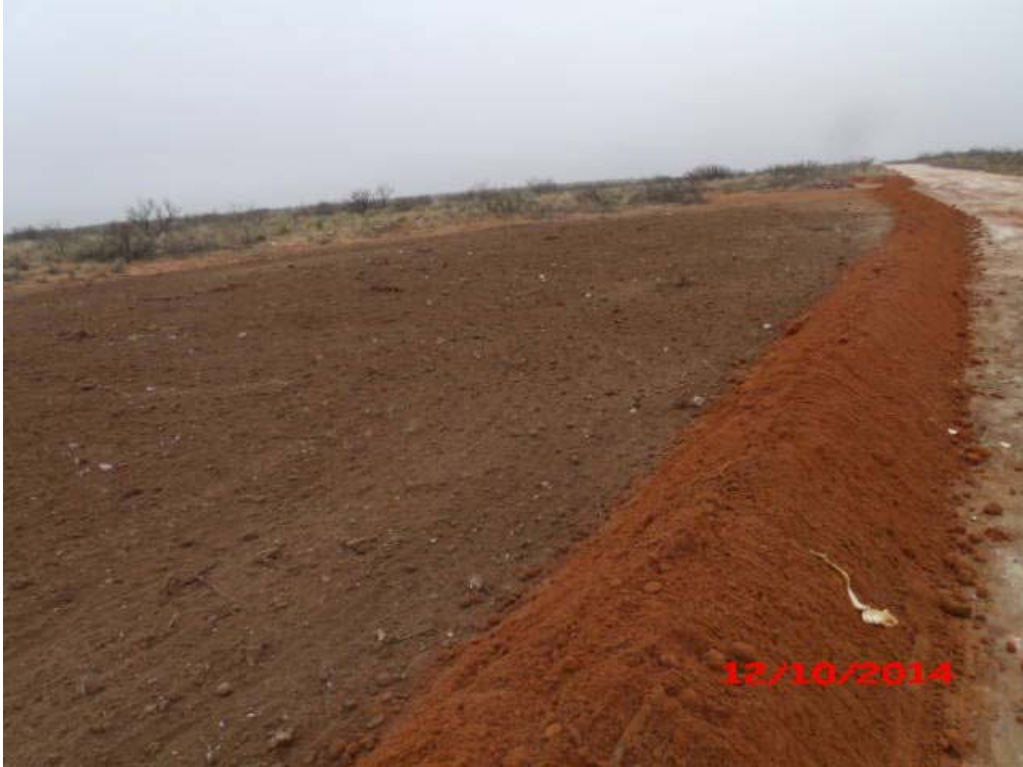
Photograph #9 – Reseeded

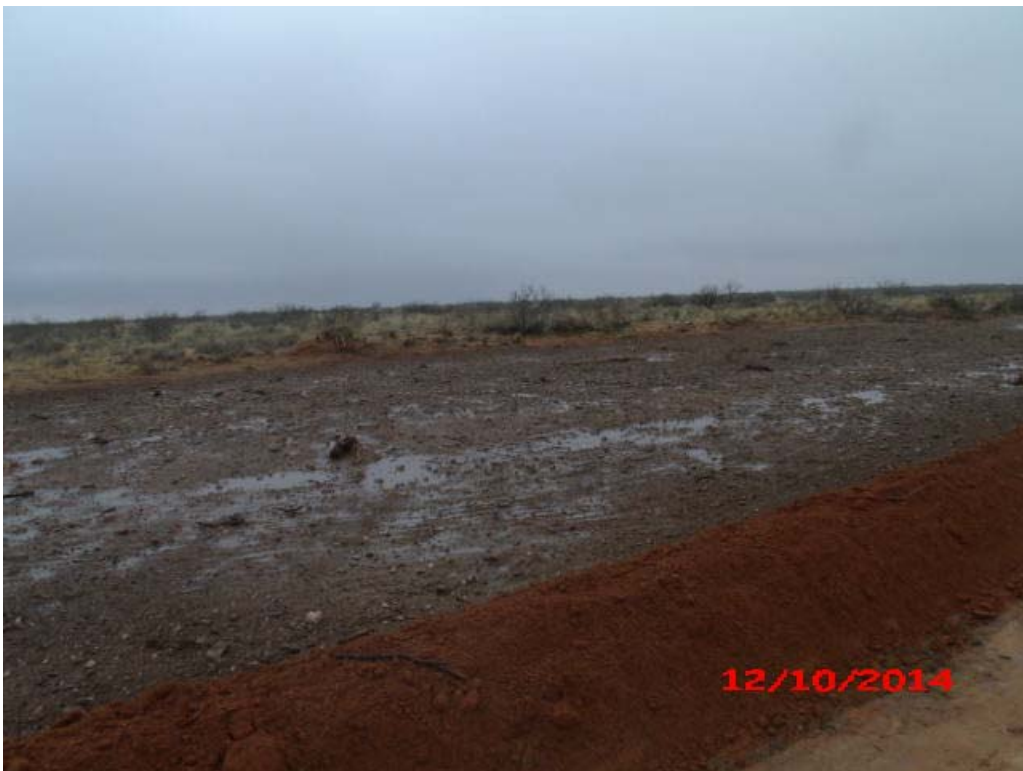
Photograph #10 – Watered
