REMEDIATION SUMMARY & SITE CLOSURE REQUEST

**BOPCO, LP
HASTA LA VISTA 1 DI FED. COM #002Y FLOW LINE
API 30-015-42705
Eddy County, New Mexico
Unit Letter "B" (NW/NE), Section 6, Township 20 South, Range 31 East
Latitude 32.60684° North, Longitude 103.90414° West
NMOCD Reference #2RP-2816**

March 2015

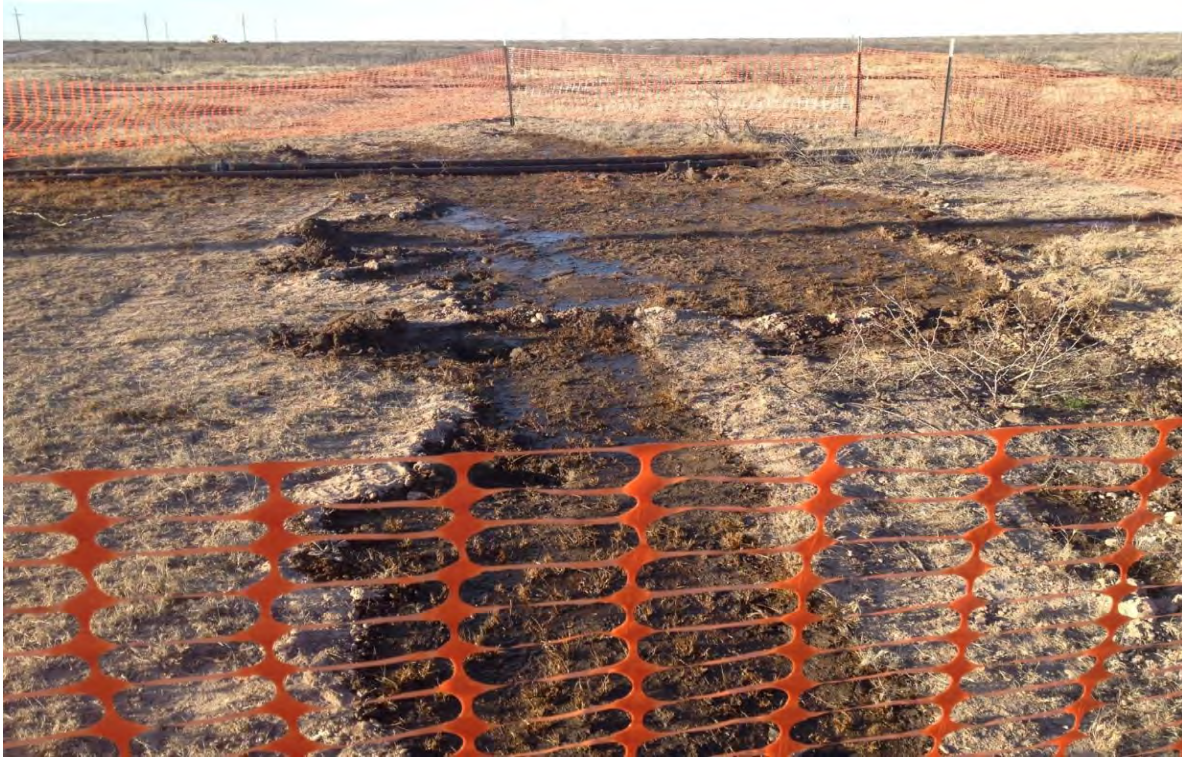
Hasta La Vista 1 DI Federal COM #002Y Flow Line - Release Site

Describe Cause of Problem and Remedial Action Taken.* A hammer union became loose due to vibration and movement on the line. The union was re-tightened and the line was secured.

The spill impacted approximately 1400 sq.ft. of pasture, all of the free product was recovered with a vacuum truck. On 2/13/15, crews started removing the saturated soil and placing it on plastic, Basin Environmental will oversee the soil removal and conduct the final remediation. BOPCO will submit a Final C-141 and closure report upon completion.

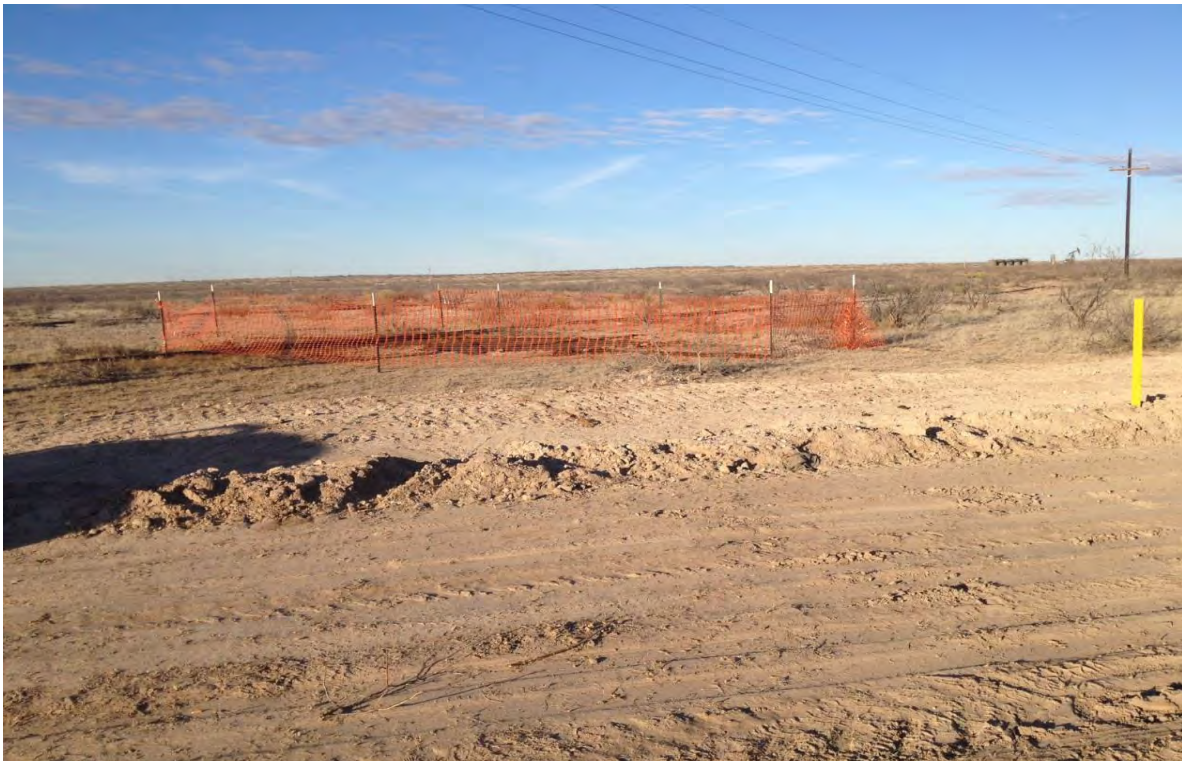
Hasta La Vista 1 DI Federal COM #002Y Flow Line - Release Site

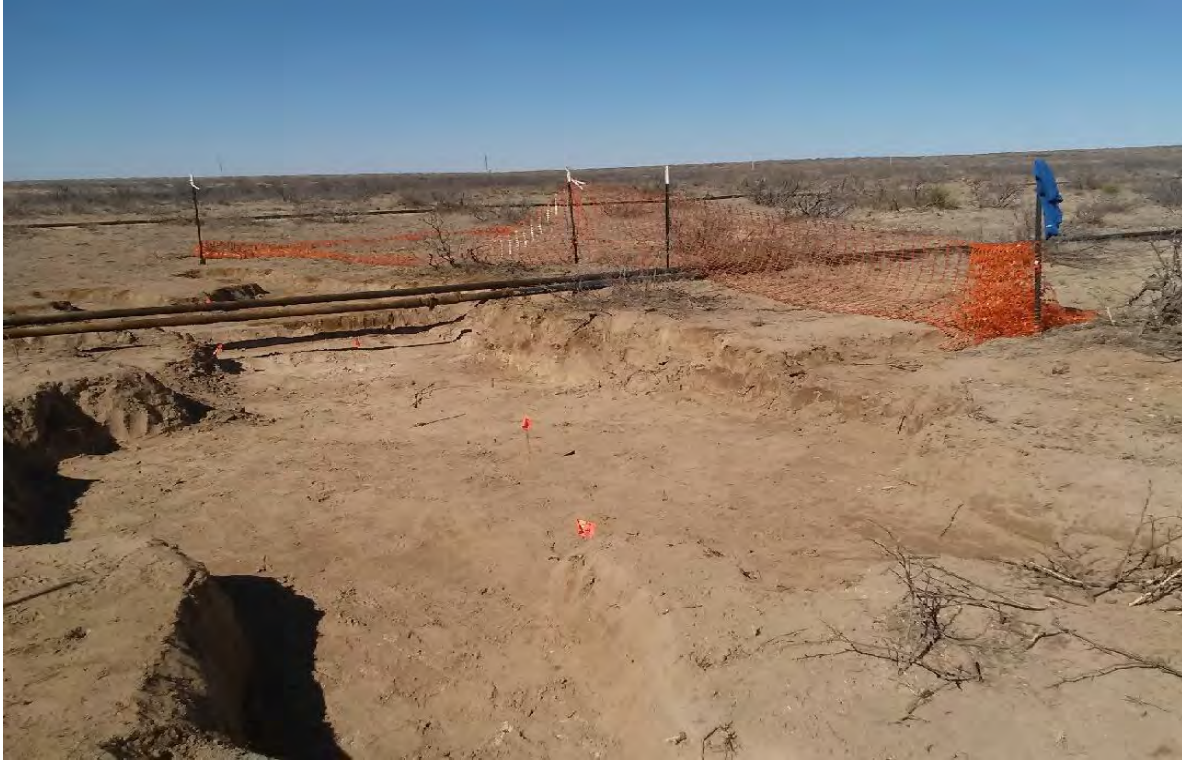
Hasta La Vista 1 DI Federal COM #002Y Flow Line - Excavation

On February 18, 2015, Basin Environmental assumed remediation responsibilities at the site. The floor and sidewalls of the excavation were advanced until chloride field-test results and olfactory/visual senses suggested contaminants of concern were below the recommended remediation action levels (RRALs) established for the site by the NMOCD. Excavated soil was stockpiled on-site, pending final disposition.

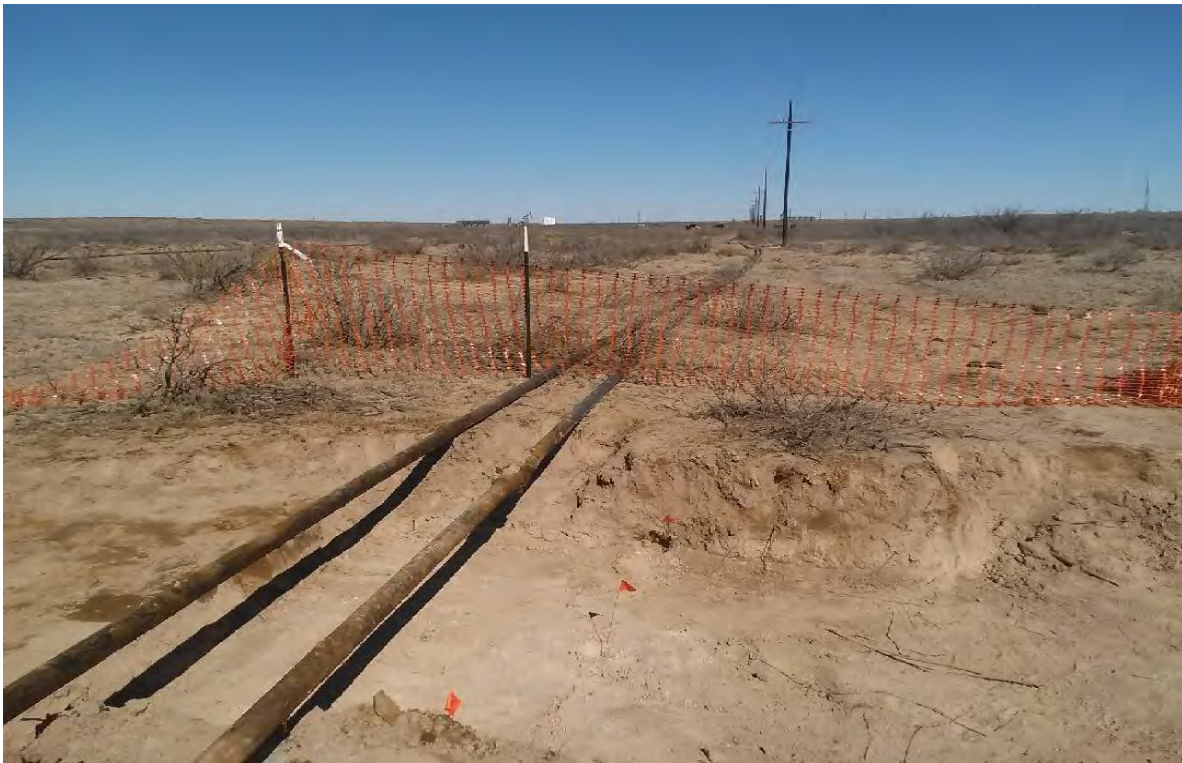
Hasta La Vista 1 DI Federal COM #002Y Flow Line - Excavation

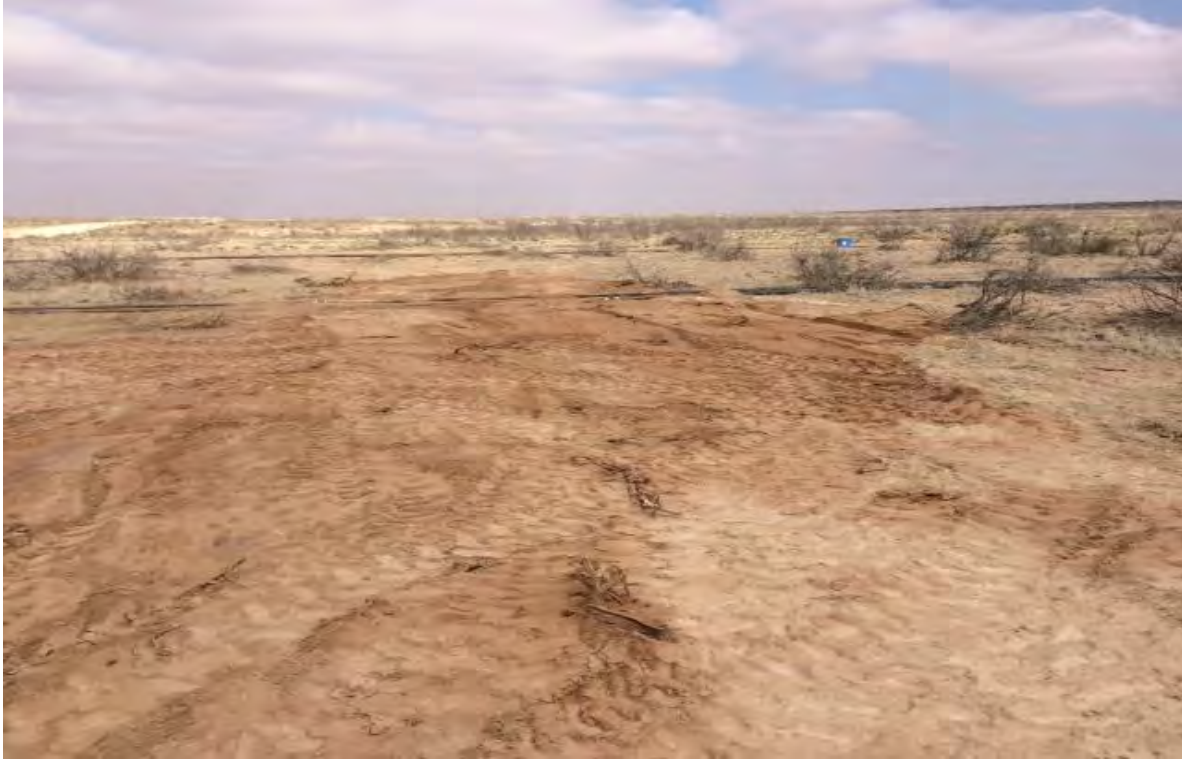
Hasta La Vista 1 DI Federal COM #002Y Flow Line – Backfilled Excavation

On March 4, 2015, based on laboratory analytical results, the excavation was backfilled with locally acquired, non-impacted soil, compacted, and contoured to fit the surrounding topography. Final dimensions of the excavation were approximately sixty-two feet (62') in length, twenty-eight feet (28') in width, and one (1) to two feet (2') in depth. In addition, approximately forty cubic yards (40 yd³) of impacted soil was transported to Lea Land, Inc. (NMOCD Permit #WM-01-035), for disposal.
