### Report Type: Work Plan

| Site: | Burch Keely Unit #205 | | | | | |
| Company: | COG Operating LLC | | | | | |

**Re: Work Plan for the COG Operating LLC., Burch Keely Unit #205, Unit O, Section 26, Township 17 South, Range 97 East, Eddy County, New Mexico.**

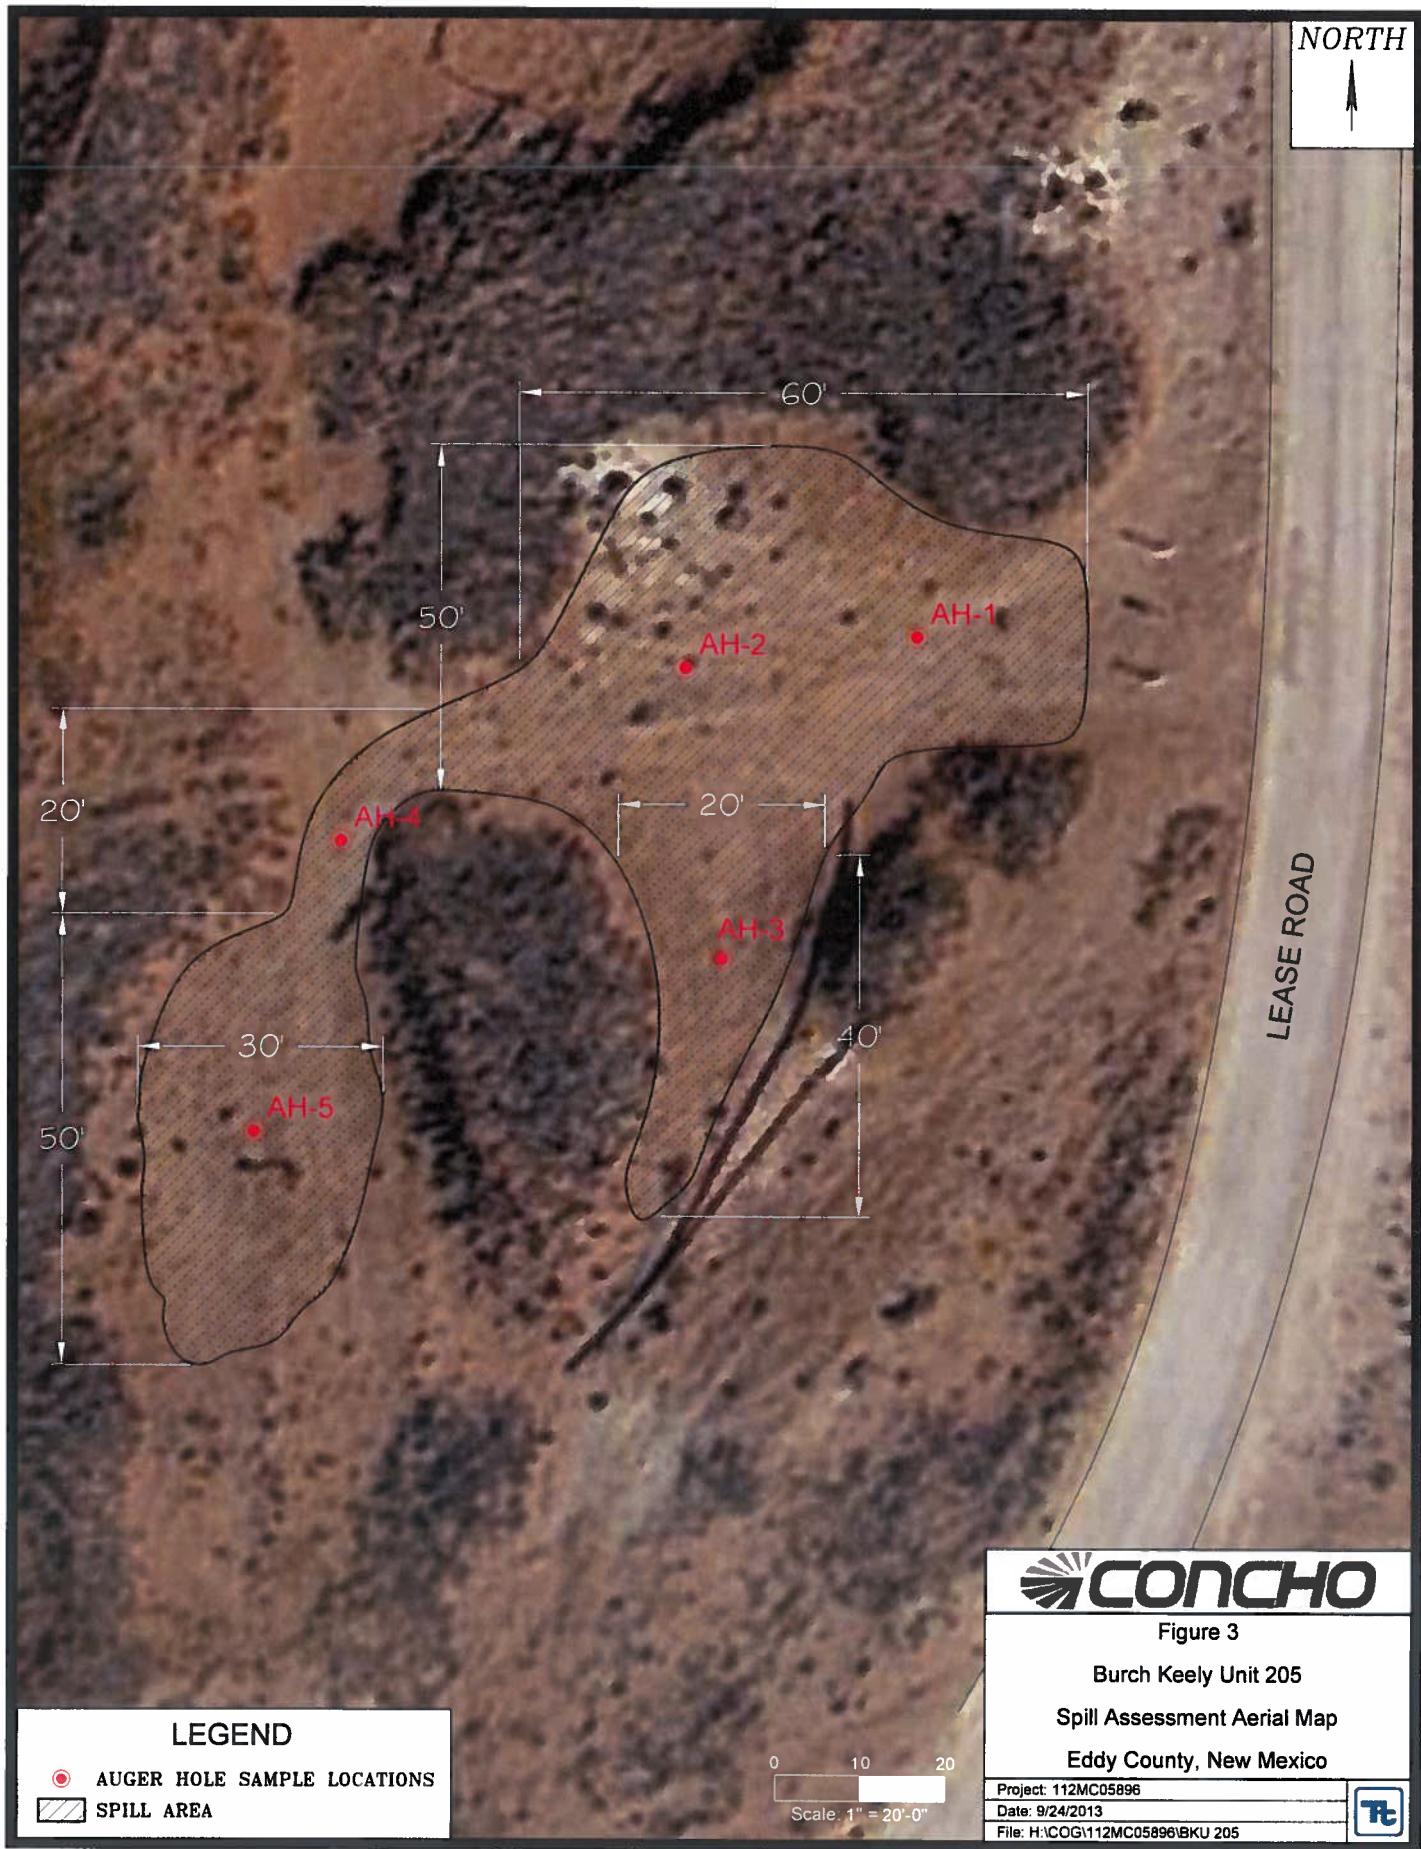
**Figure 3**

On September 3, 2013, Tetra Tech personnel inspected and sampled the spill area. Five (5) auger holes (AH-1 through AH-5) were installed using a stainless steel hand auger to assess the impacted soils. Selected samples were analyzed for TPH analysis by EPA method 8015 modified, BTEX by EPA Method 8021B and chloride by EPA method 300.0. Copies of laboratory analysis and chain-of-custody documentation are included in Appendix C. The sampling results are summarized in Table 1. The auger hole locations are shown on Figure 3.

Burch Keely Unit 205  
Spill Assessment Aerial Map  
Eddy County, New Mexico

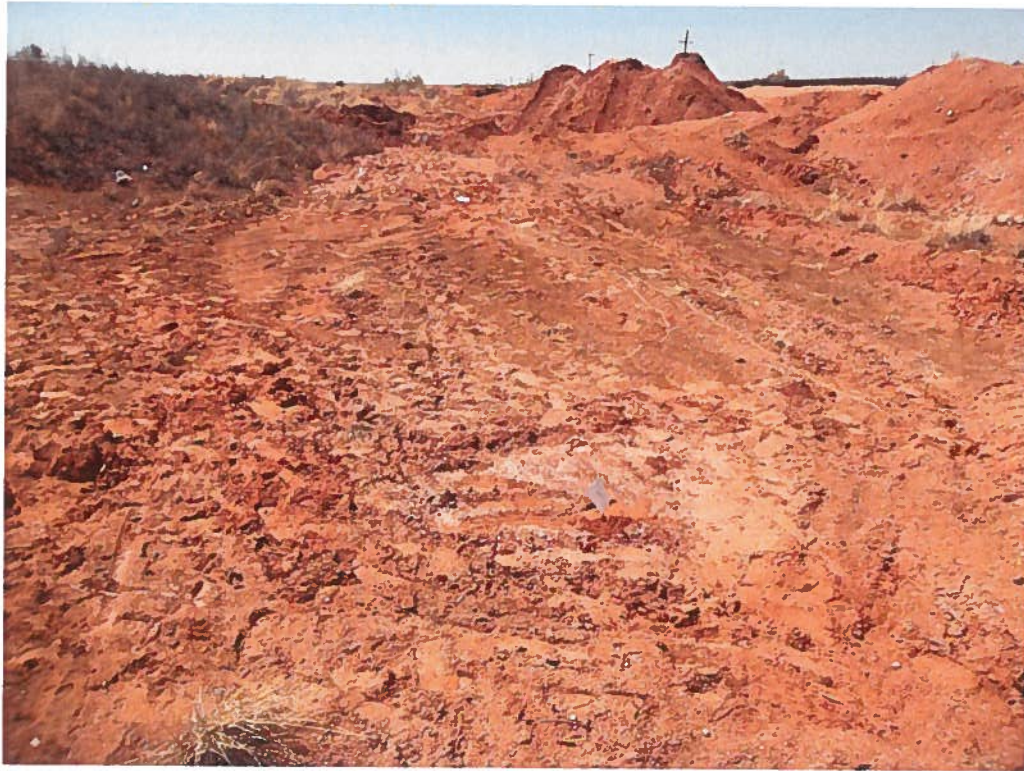
View West – Area of AH-1 and AH-2

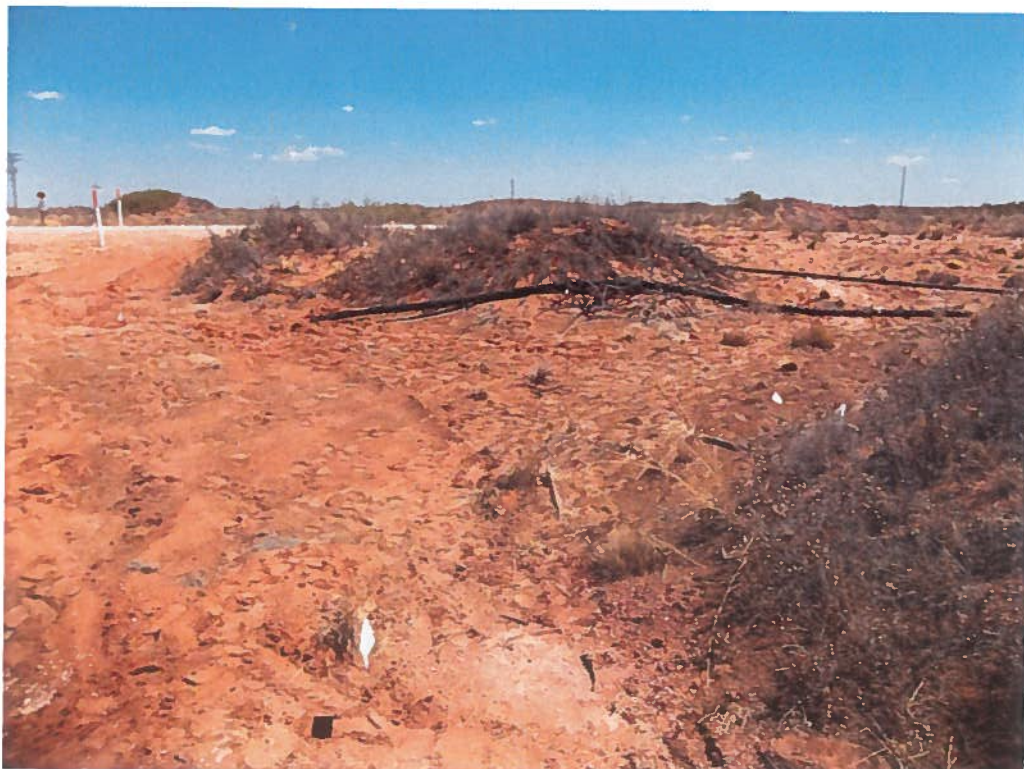
View East – Areas of AH-2 and AH-3

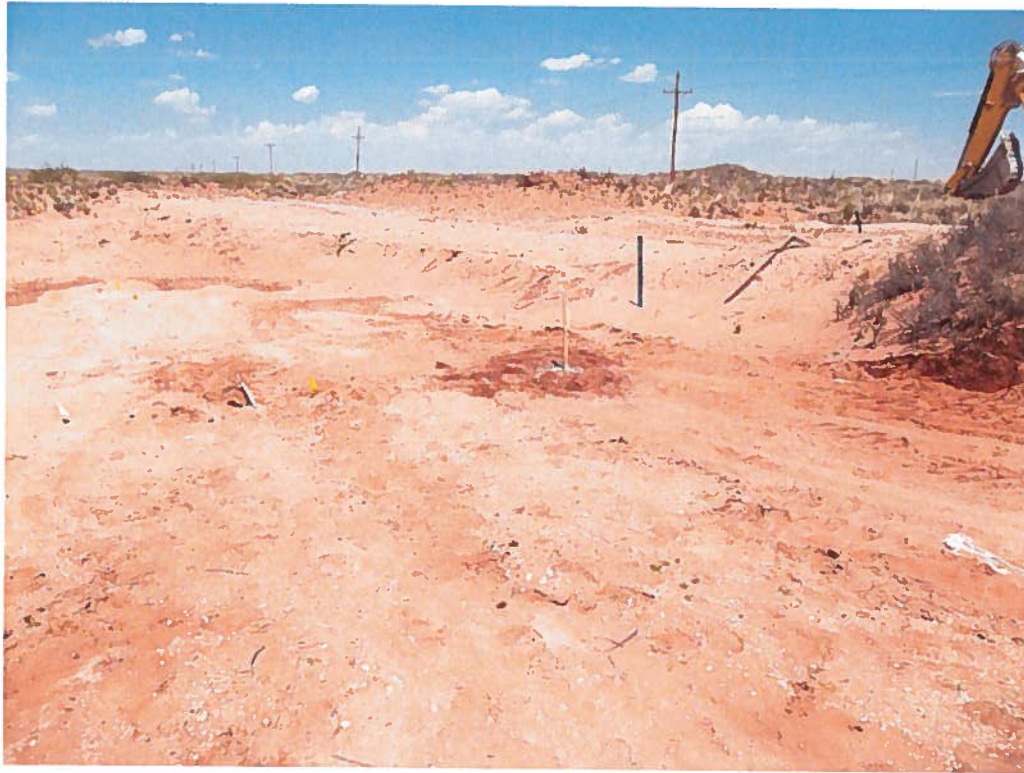
On June 18, 2014, Tetra Tech personnel supervised the installation of a borehole in order to vertically delineate the chloride impact in the areas of auger holes (AH-1 and AH-2). A shallow underground line (Phillips pipeline) located in the center of the spill area. Due to access issues and safety concerns, one (1) borehole (BH-1) was installed between auger holes (AH-1 and AH-2). The area of BH-1 showed elevated chloride concentrations with a chloride high of 12,900 mg/kg at 6'-7' below surface, but declined with depth to 148 mg/kg at 29'-30' below surface. Based on the data, the impacted area was vertically defined.

View North – Area of BH-1
