CLOSURE REPORT

BOPCO, L.P.
PLU #100
Eddy County, New Mexico
Unit Letter "O", Section 24, Township 24 South, Range 30 East
Latitude 32.197390 North, Longitude 103.832060 West
NMOCD Reference #2RP-2817

RE: Final Closure Report
Bopco – PLU #100
UL-O, Section 24, Township 24 South, Range 30 East
Eddy County, New Mexico
NMOCD Reference # 2RP 2817

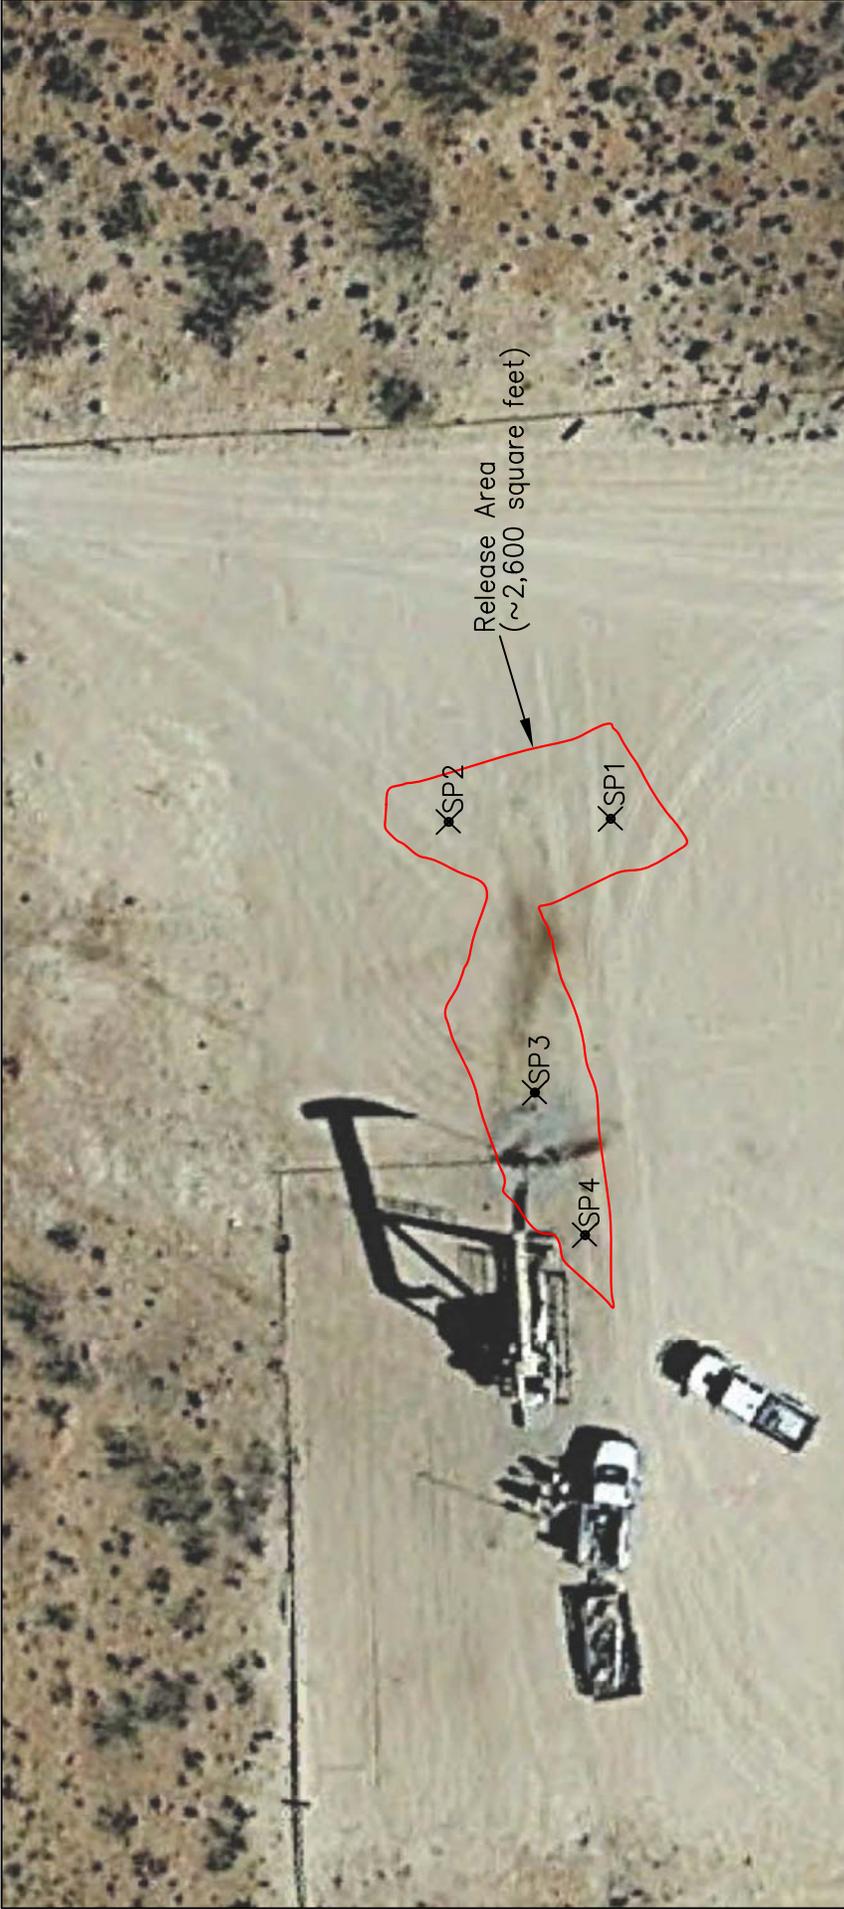
Figure 3
Site/Sample Map
Bopco, L.P.
PLU #100

Release Area
(~2,600 square feet)

EPI personnel mobilized on the site on February 13, 2015 to collect soil samples via hand auger to determine the vertical extent of contamination. A total of twelve (12) soil samples were collected from four (4) sample locations; SP1-SP4. All samples were sent to Cardinal Labs in Hobbs, New Mexico, for testing. Laboratory analytical results indicate that, deeper than ground surface, the area is void of Benzene, BTEX, TPH, and Chloride concentrations in excess of NMOCD Recommended Remedial Action Levels (RRALs) of 10 mg/Kg, 50 mg/Kg, 5,000 mg/Kg, and 1,000 mg/Kg respectively (reference *Figure 3* and *Table 2*).

The release area was excavated to a depth of six (6) inches bgs, removing surface chloride contamination, with approximately 111 tons of contaminated soil excavated and hauled to a state approved facility for disposal.

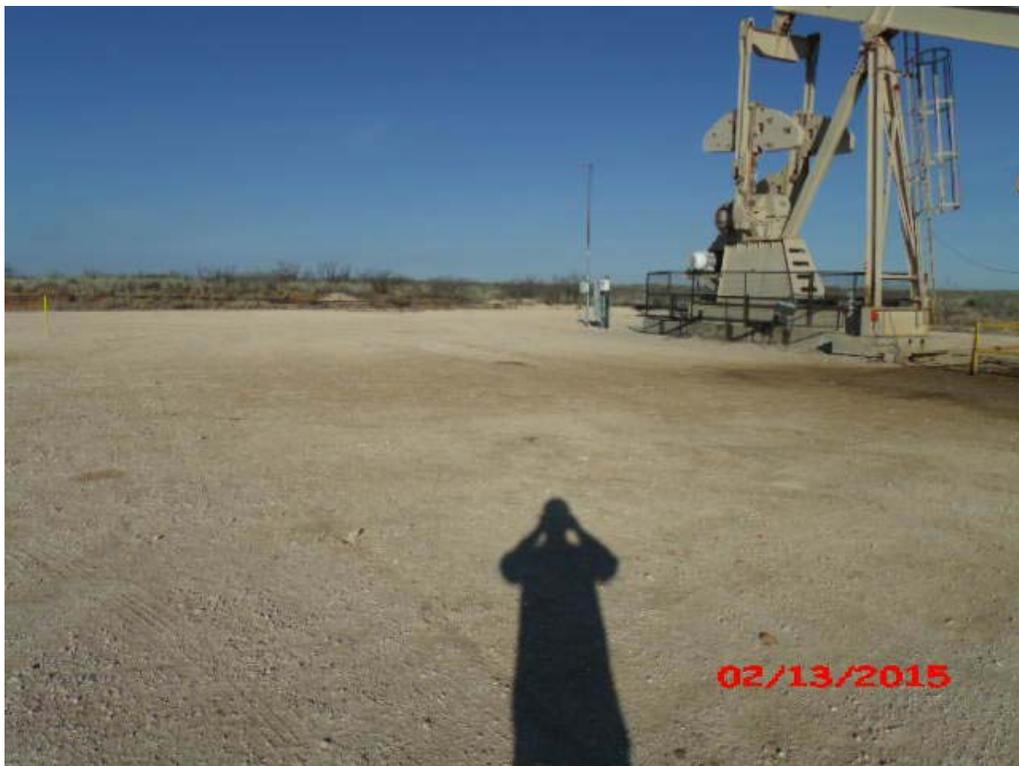
Photograph #2 – Release area

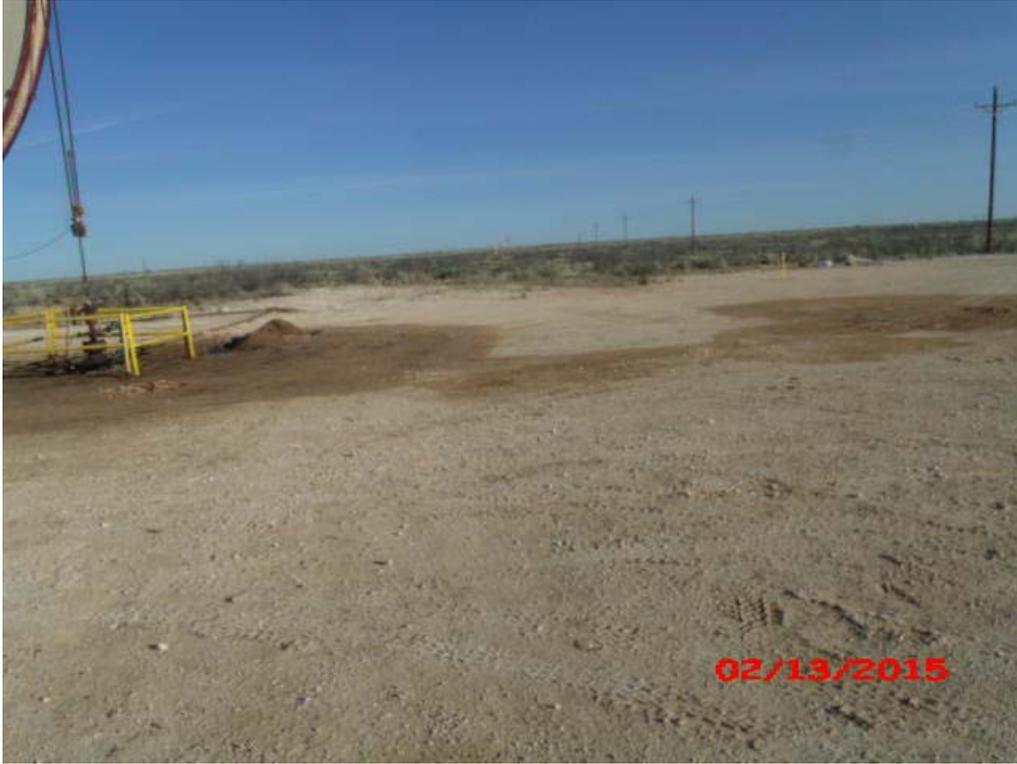
Photograph #3 – Release area

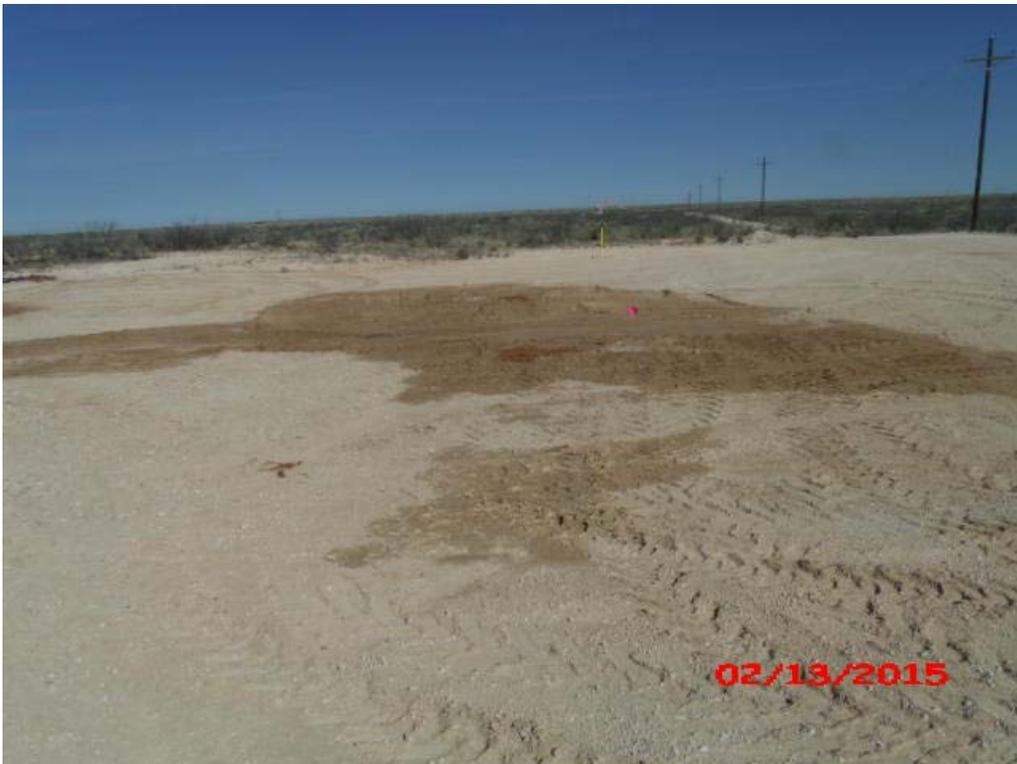
Photograph #4 – Release area

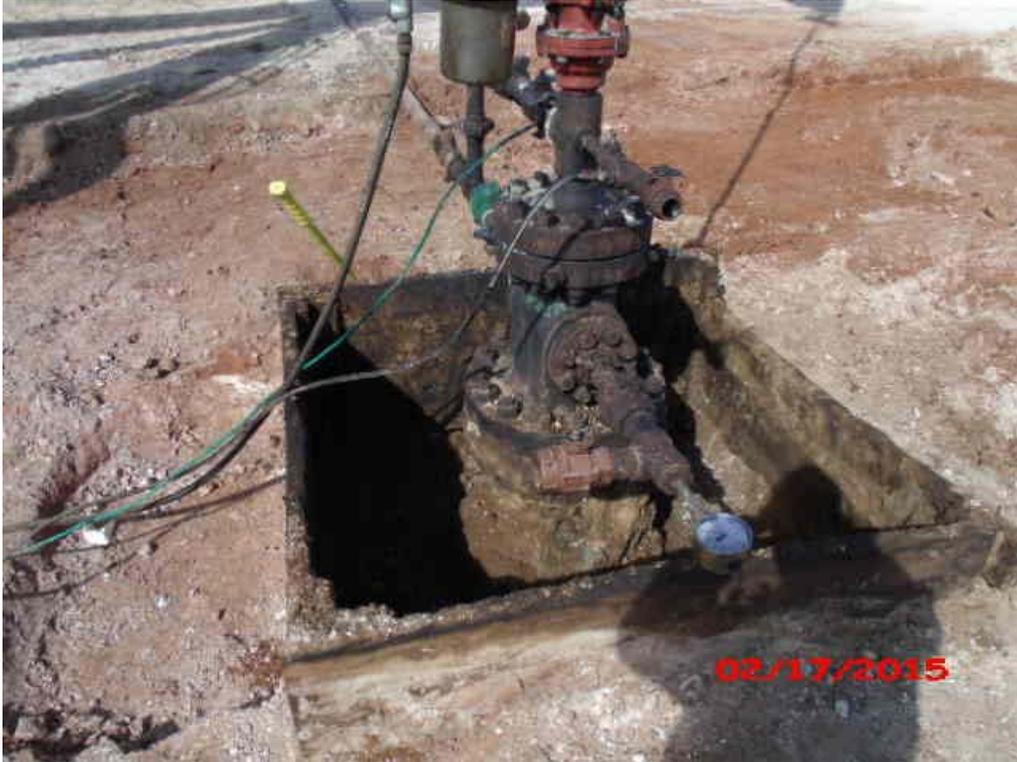
Photograph #5 – Excavated area

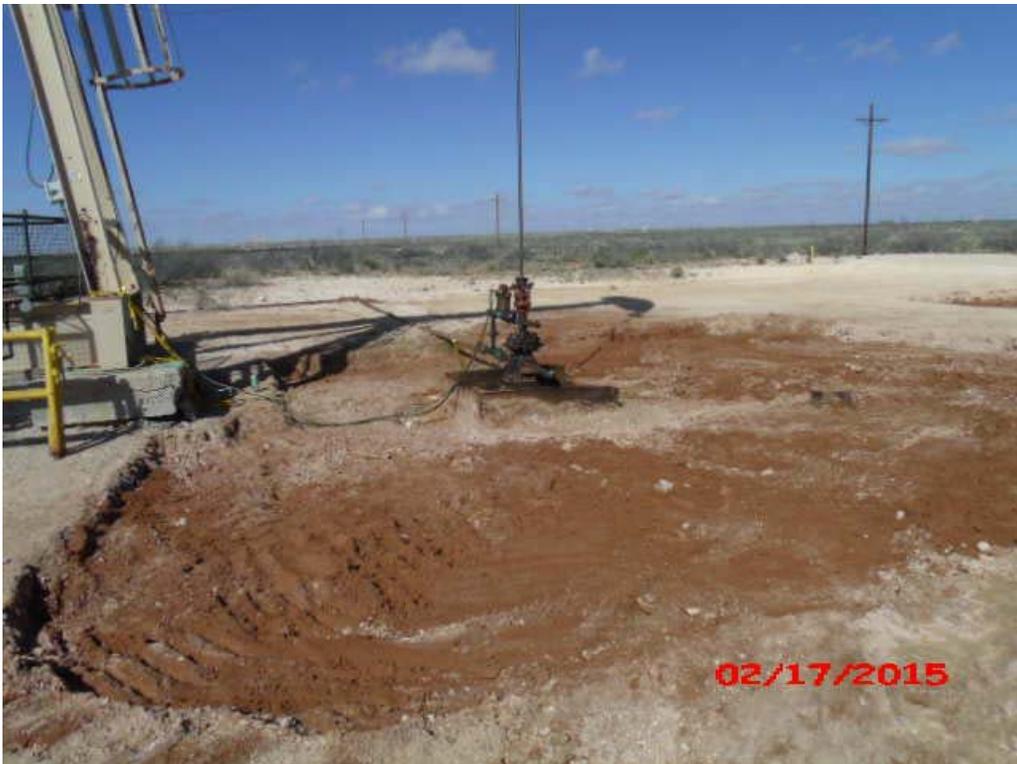
Photograph #6 – Excavated area

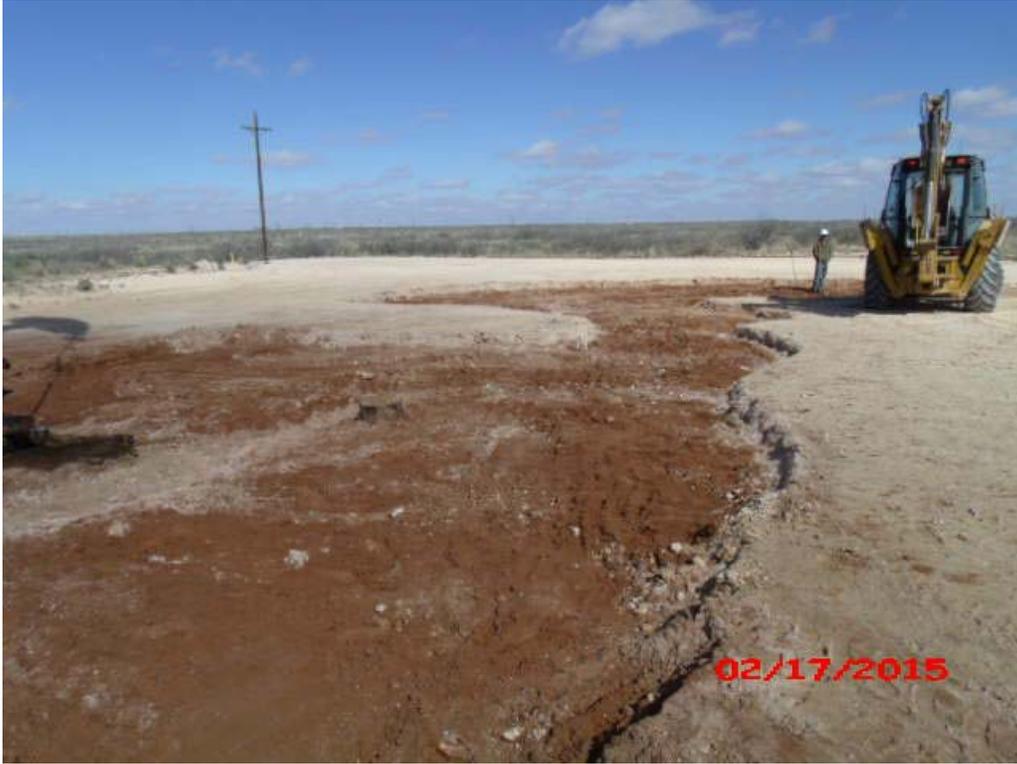
Photograph #7 – Excavated area

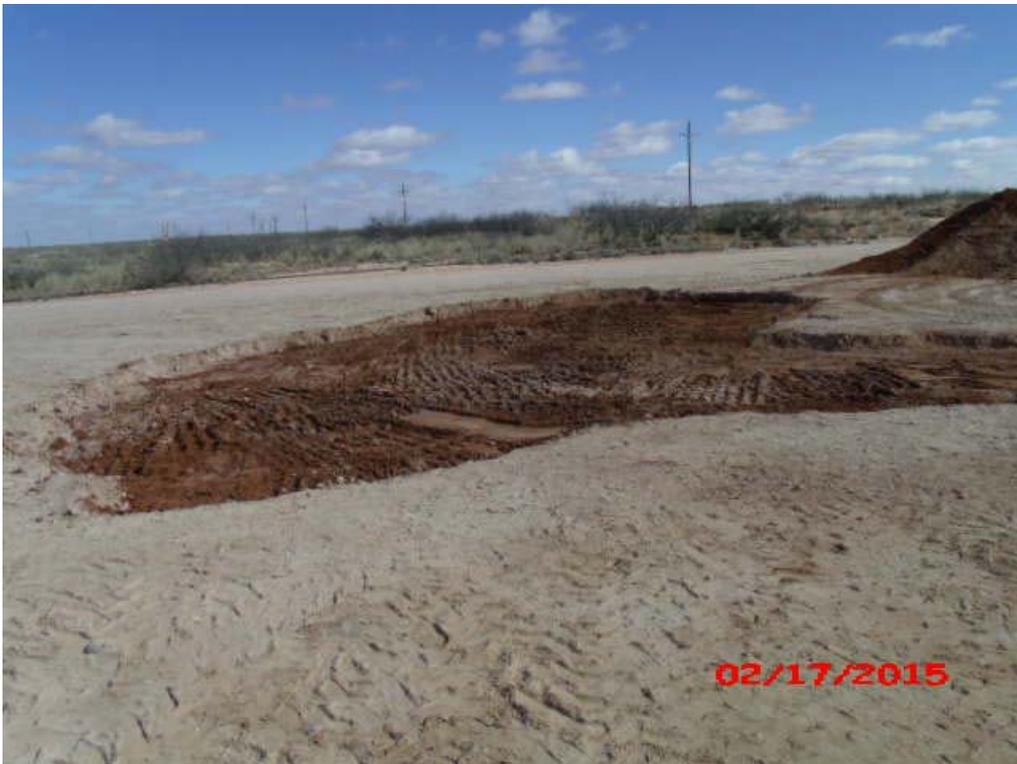
Photograph #8 – Excavated area

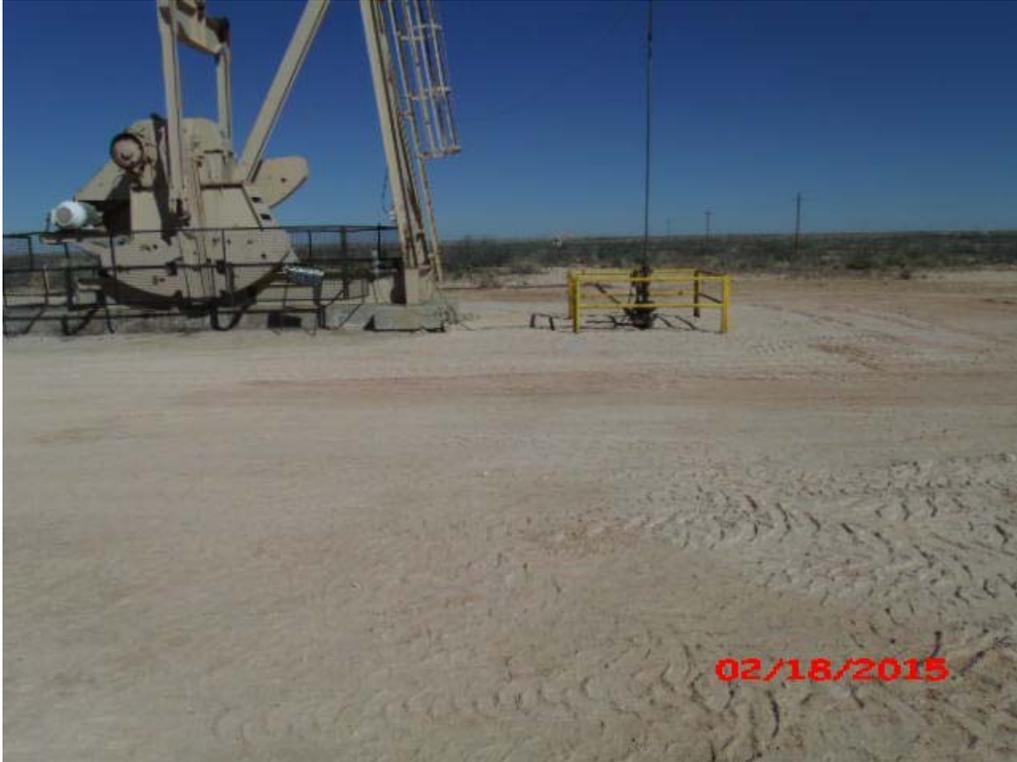
Photograph #9 – Backfilled

From February 17-18, 2015 backfill activities commenced and continued until the excavation was closed. The excavation was backfilled with approximately 111 tons of clean soil free of rocks, clumps or deleterious material. The entire disturbed area was then contoured to blend with existing pad area and protected against wind/water erosion.

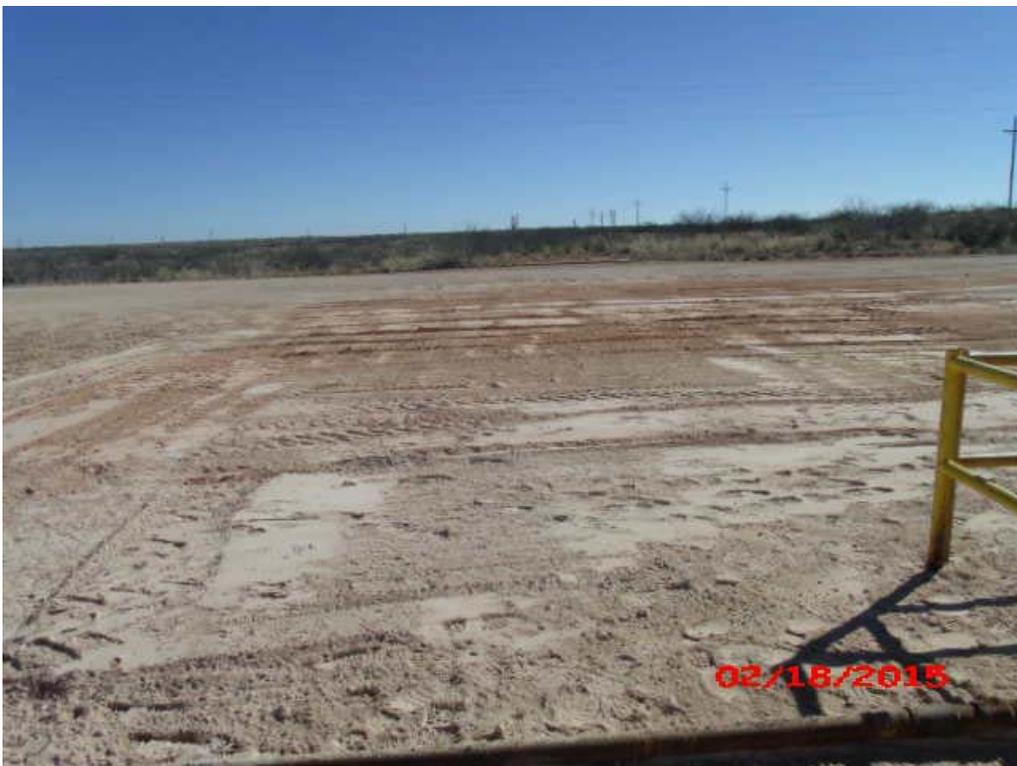
Photograph #10 – Backfilled

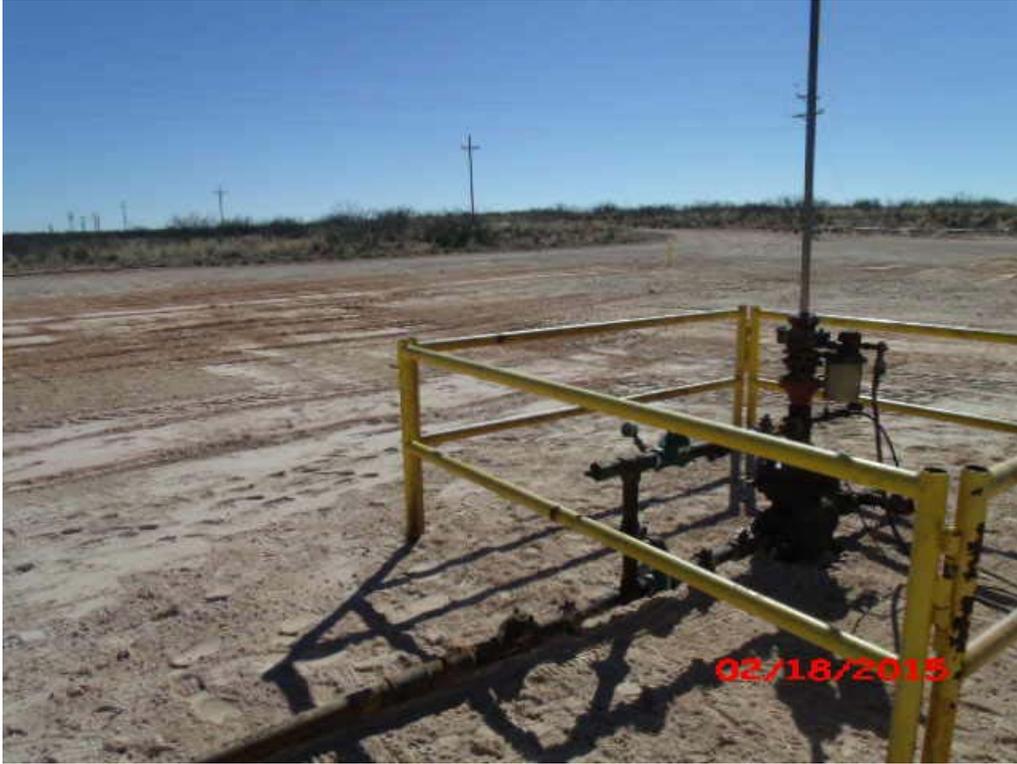
Photograph #11 – Backfilled

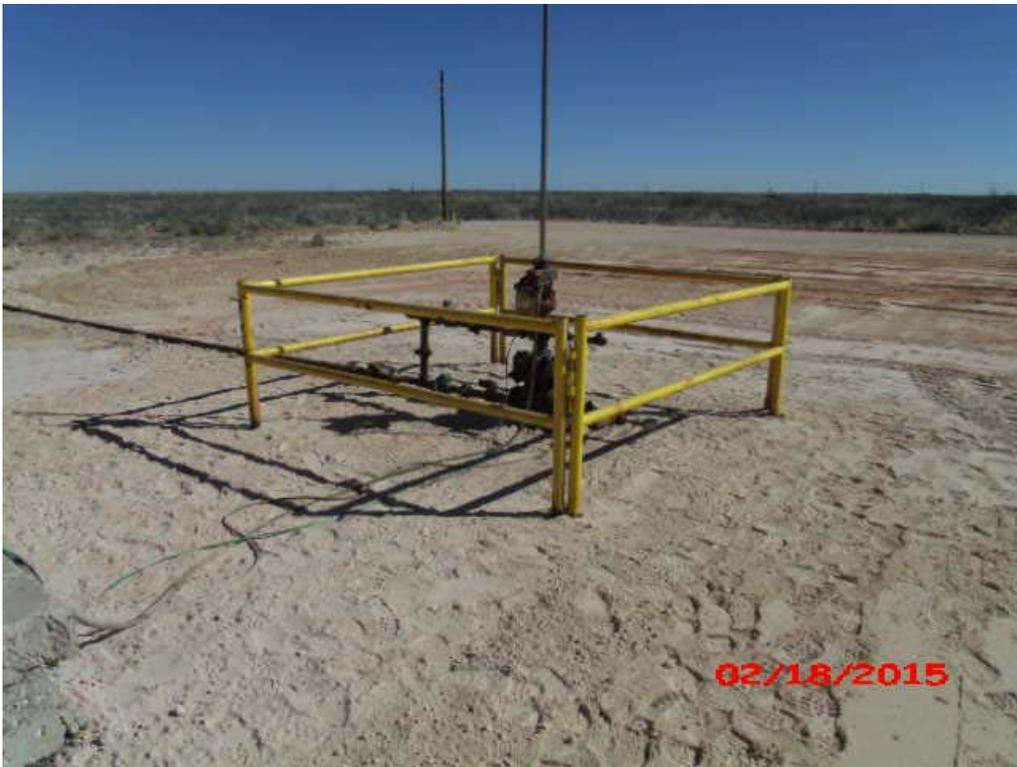
Photograph #12 – Backfilled
