## **REMEDIATION SUMMARY & SITE CLOSURE REQUEST**

**BOPCO, LP  
SOUTH LOOP 10-INCH SWD MAINLINE  
API 30-015-41554 (Nearest BOPCO Well)  
Eddy County, New Mexico  
Unit Letter "N" (SE/SW), Section 13, Township 25 South, Range 30 East  
Latitude 32.124577° North, Longitude 103.835877° West  
NMOCD Reference #: 2RP-2489**

**April 2015**

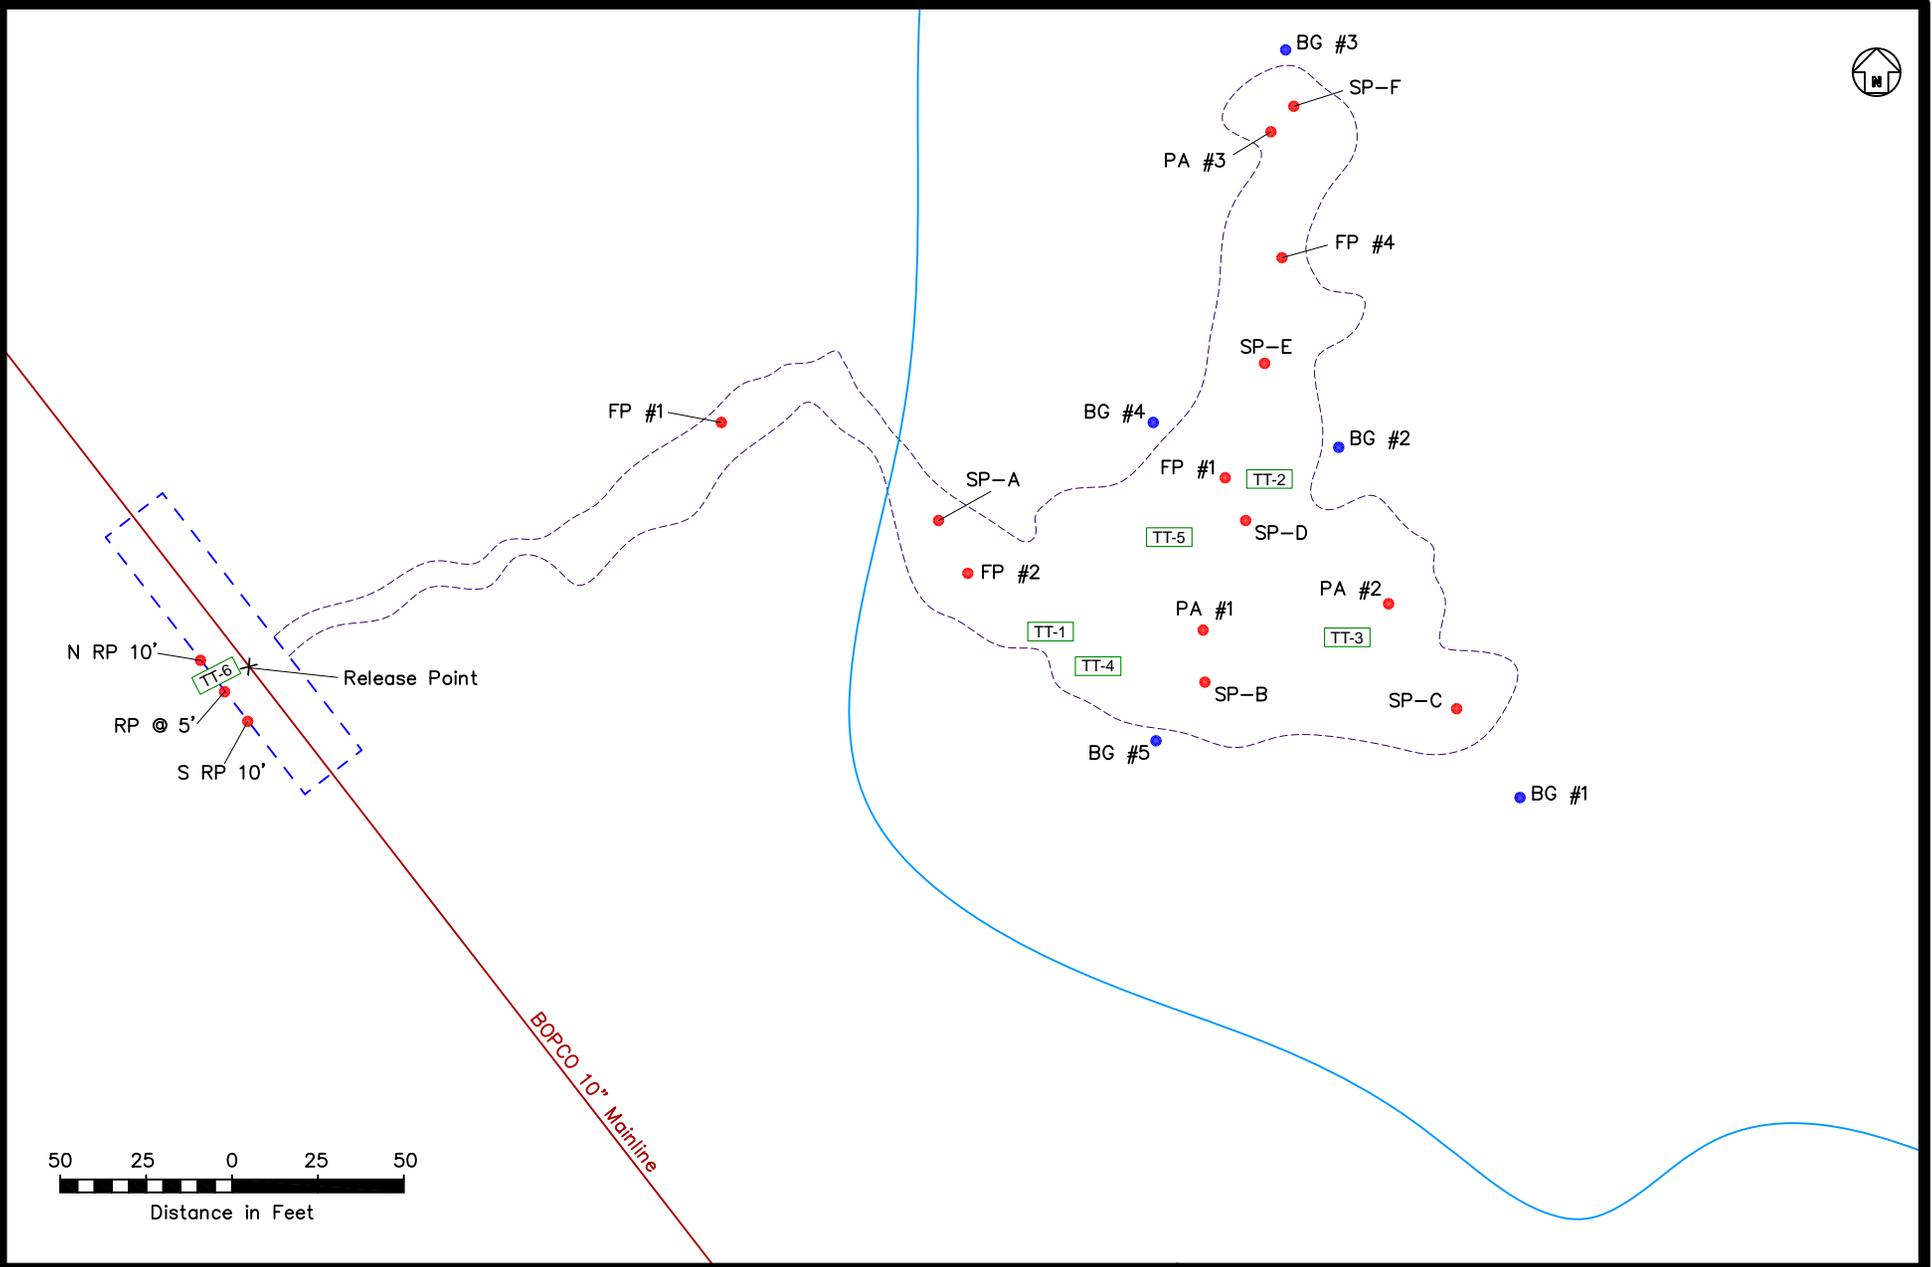
Figure 2 – Site & Sample Location Map

----- Inferred Release Margins	— Playa Watershed
- - - - Excavation Extent	• Sample Location
— Delineation Trench	• Background Sample
— Pipeline

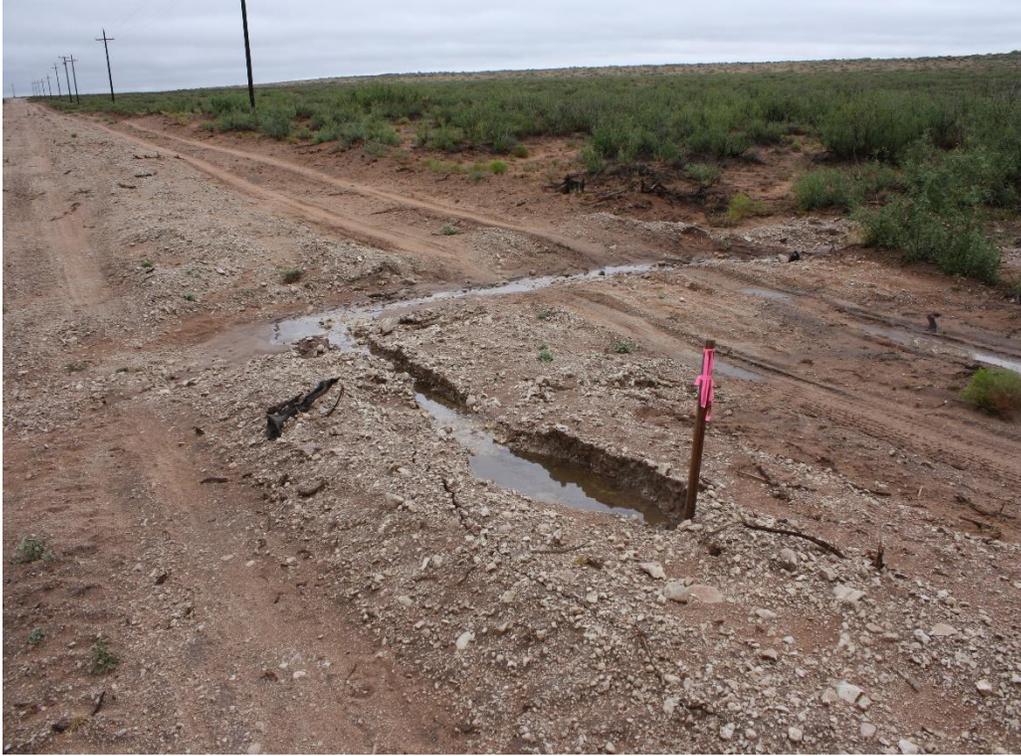
South Loop 10-Inch Mainline – Point of Release

Describe Cause of Problem and Remedial Action Taken.\*  
A weld failed on the poly pipe. The affected portion of pipe was isolated by block valves located to the north and south of the release point. The section of pipe with the failed weld was cut out and replaced on 9/8/14.

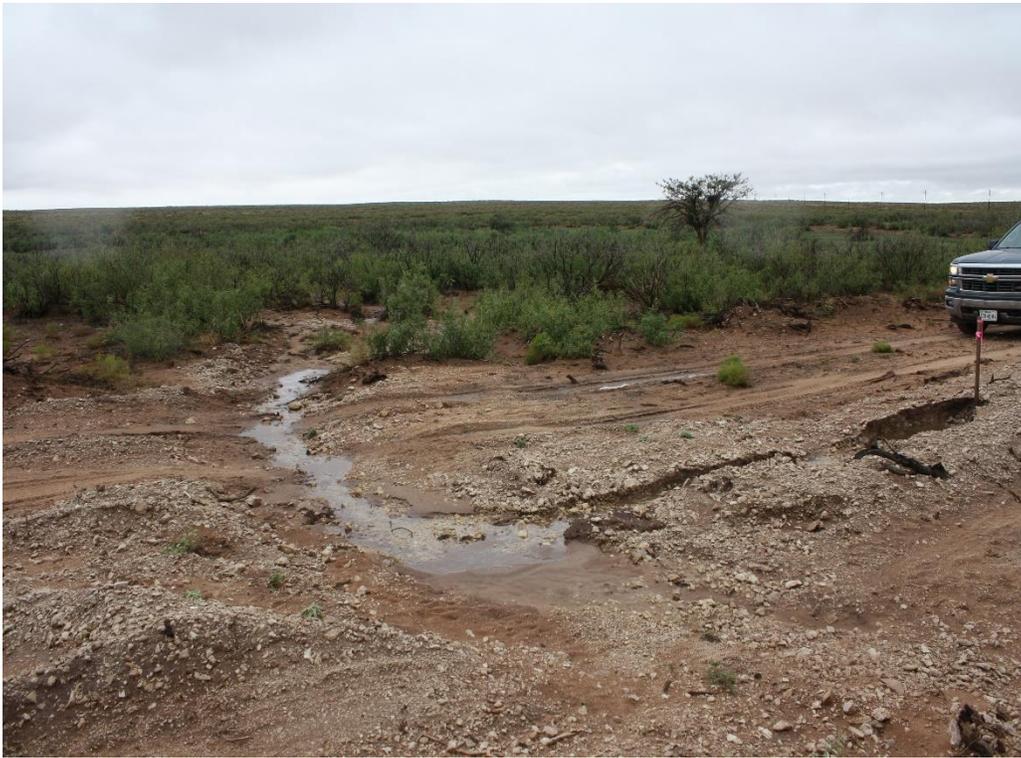
South Loop 10-Inch Mainline – Flow Path

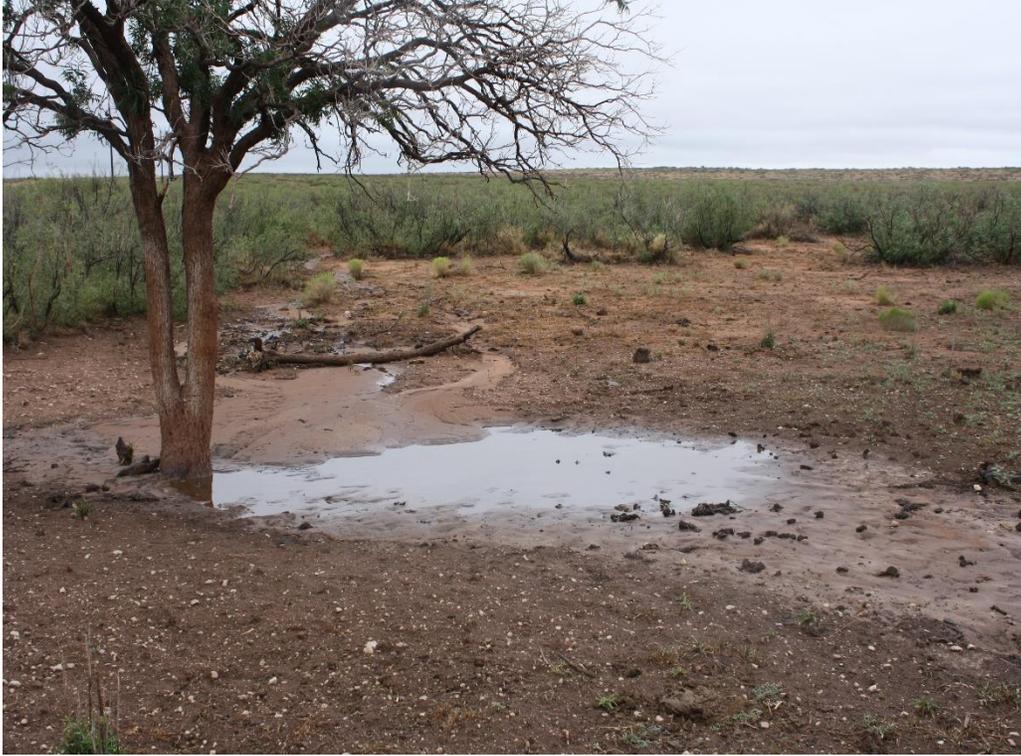
South Loop 10-Inch Mainline – Pooling Area in Playa Watershed

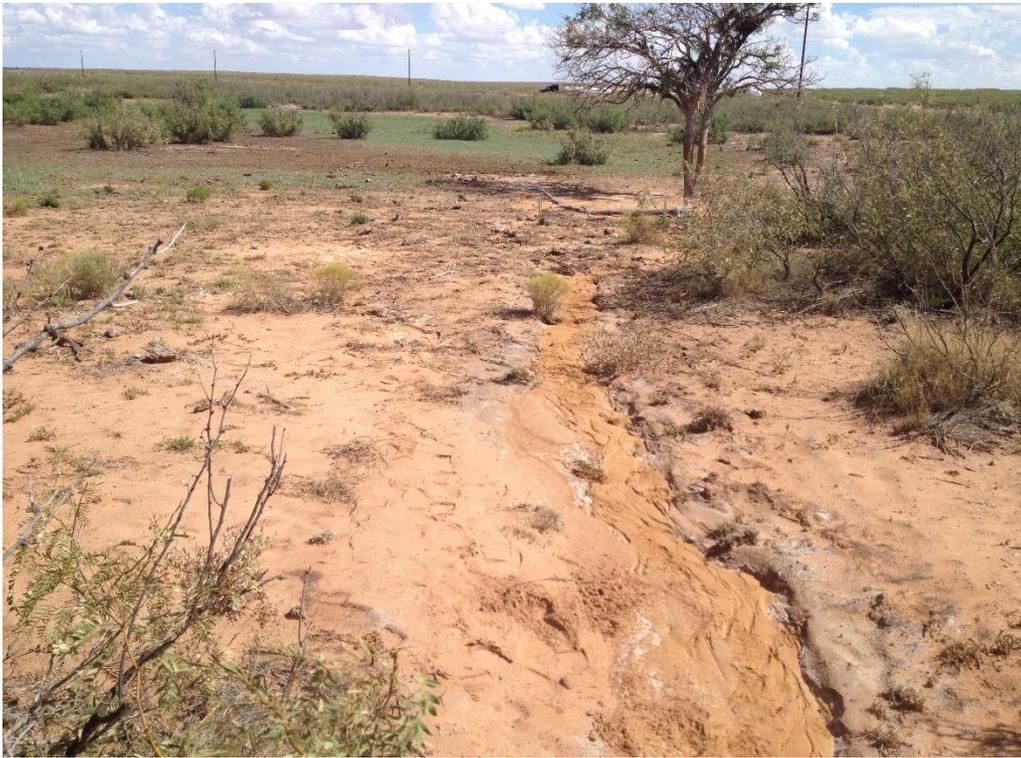
South Loop 10-Inch Mainline – Flow Path (Following Initial Rain Event)

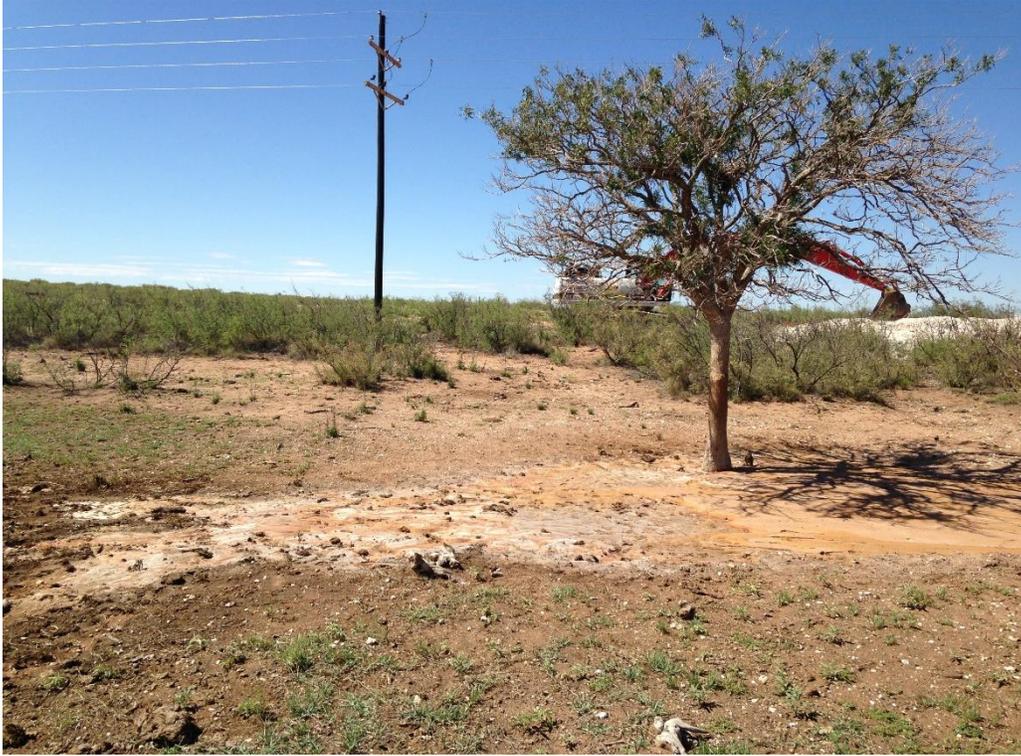
South Loop 10-Inch Mainline – Pooling Area in Playa Watershed  
(Following Initial Rain Event)

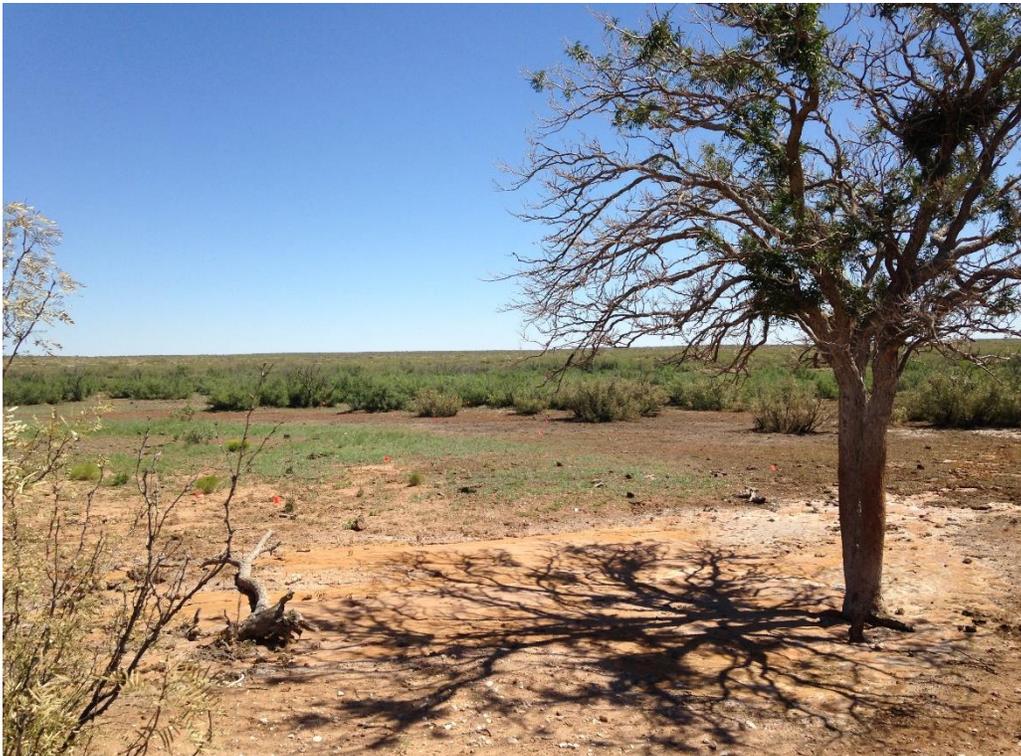
South Loop 10-Inch SWD Mainline – Pooling Areas in Playa Lake  
(Following Initial Rain Event; Locations of Hand-Augered Soil Borings Flagged in Orange)

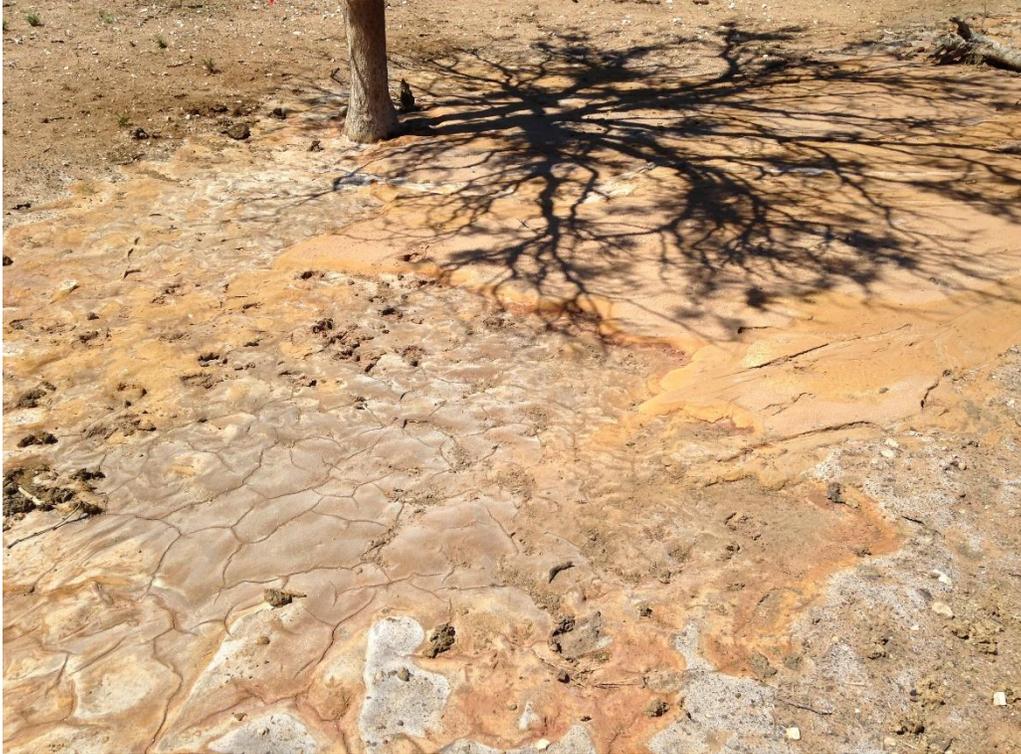
South Loop 10-Inch SWD Mainline – Pooling Area Near Tree in Playa Watershed  
(Following Initial Rain Event)

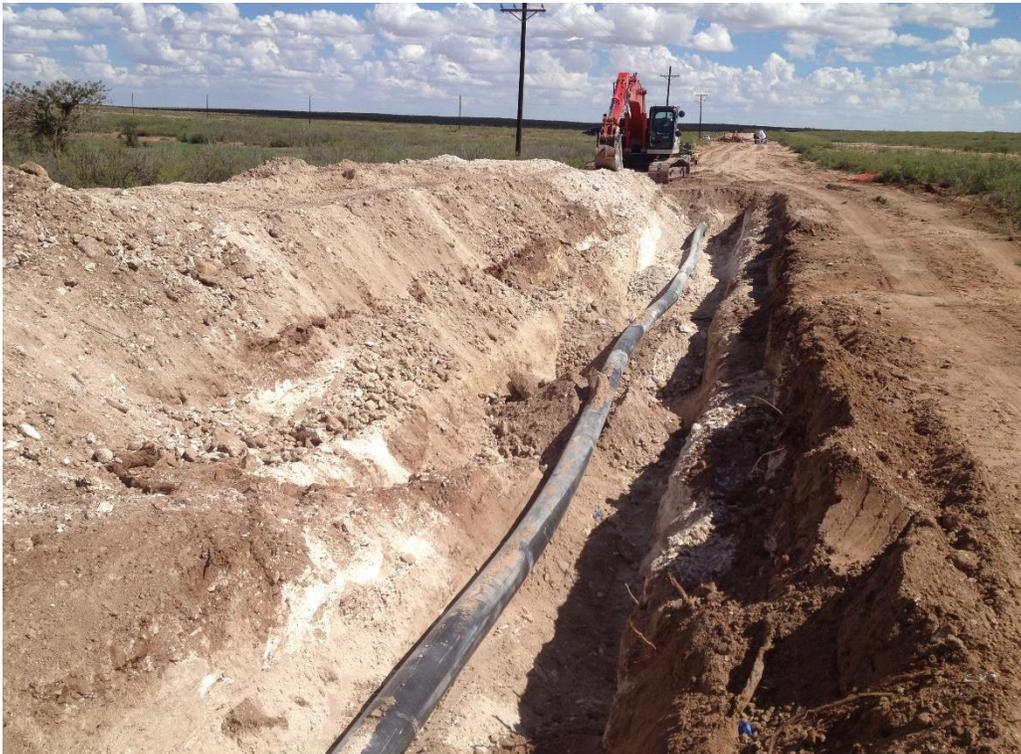
South Loop 10-Inch SWD Mainline – Excavation

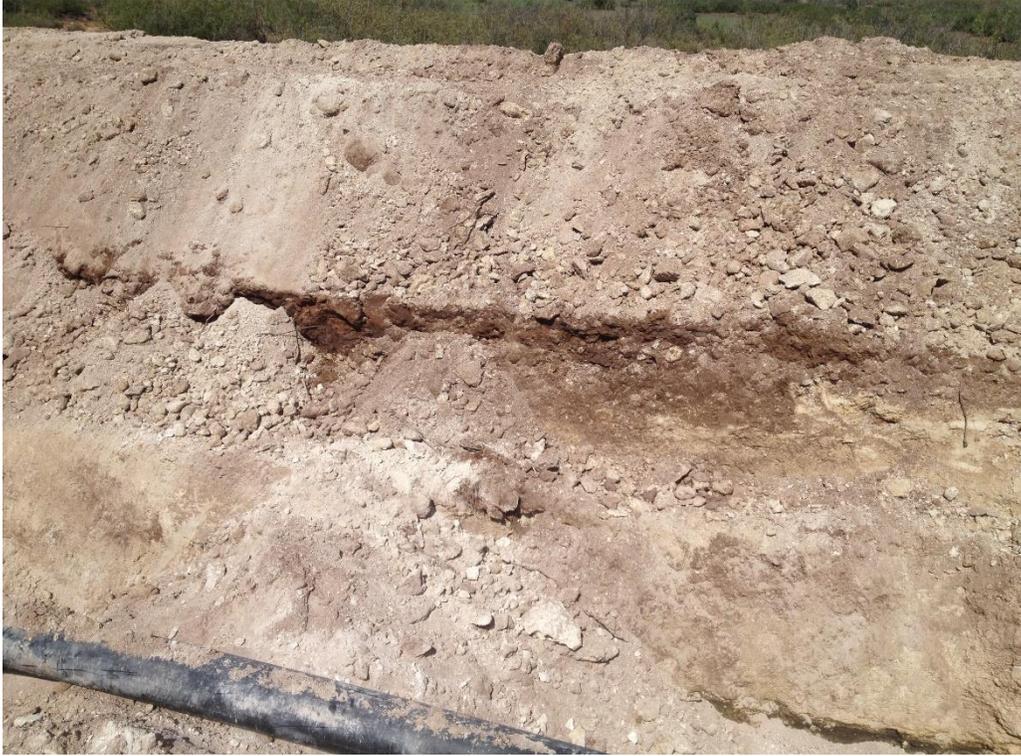
South Loop 10-Inch SWD Mainline – Staining Near Point of Release

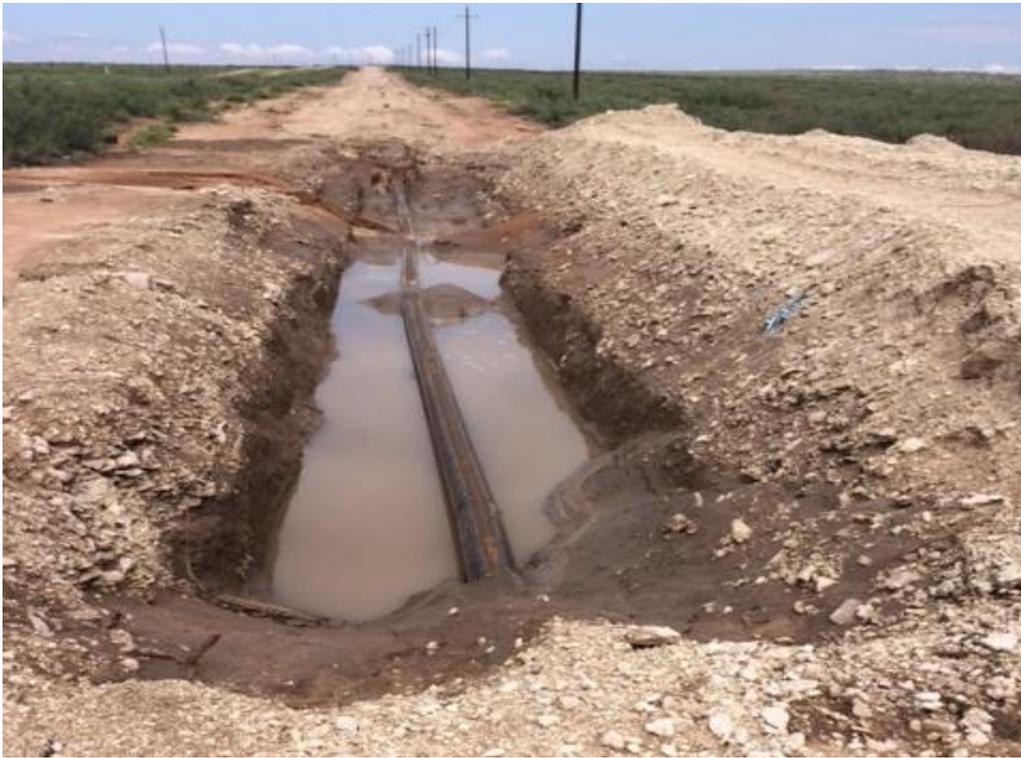
South Loop 10-Inch SWD Mainline – Excavation (Following Second Rain Event)

On October 9, 2014, following a second rain event in the region, additional soil samples were collected in the areas represented by background samples BG #1 through BG #5 to determine if chloride contamination had spread beyond the previously established zone of impact. The samples were field-screened with a chloride test kit, and field-test results indicated chloride concentrations were less than the recommended remediation action level established for the site by the NMOCD. A confirmation sample [(Post Flood) BG #1] collected in the area of sample BG #1 was submitted to the laboratory for analysis, and analytical results indicated the chloride concentration was less than the laboratory MDL.
