H E West B Federal #33

CLOSURE REPORT

API No. 30-015-25944

Release Date: February 12th, 2015

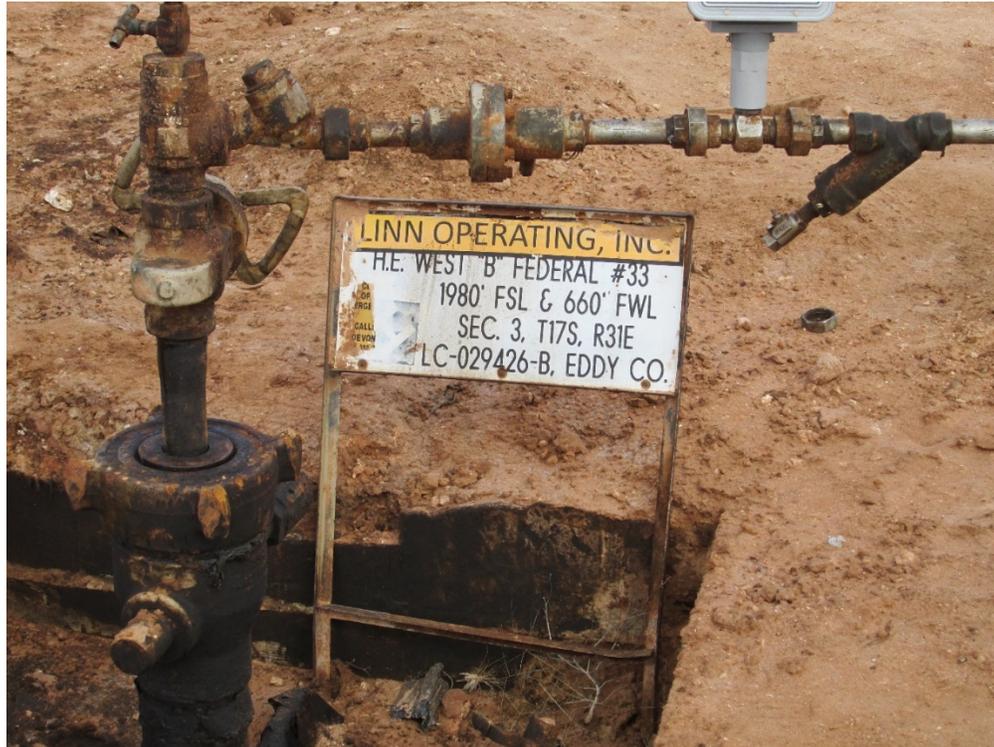
Sign marking location

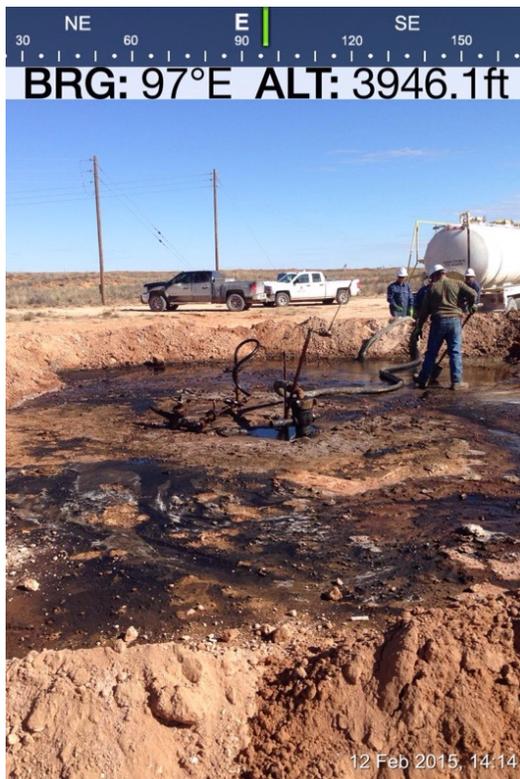
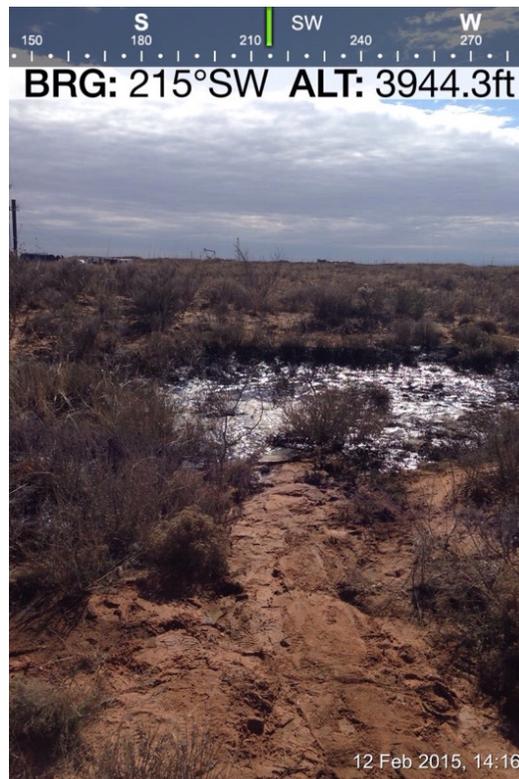
The site is located northeast of Loco Hills, NM, in Eddy County. The leak site resulted from a truck hitting the well and breaking off a tubing valve. The impacted area is the caliche pad and south into the pasture. A site map is attached. A C-141 (Appendix I) was submitted to the NMOCD on February 17, 2015.

Spill area around wellhead, pasture area

On February 17, 2015 DFSI personnel responded to the location and placed a berm around the well to contain the fluid. DFSI personnel scraped up the saturated soil in the pasture and on the caliche pad. Four soil samples of the spill area were taken. Each sample was tested for chloride levels as well as TPH. The TPH samples were performed using a Mini Rae Photoionization Detector (PID). All field samples that field tested below state/BLM requirements were taken to Cardinal Lab of Hobbs to obtain confirmation samples. The results are attached (Appendix IV).

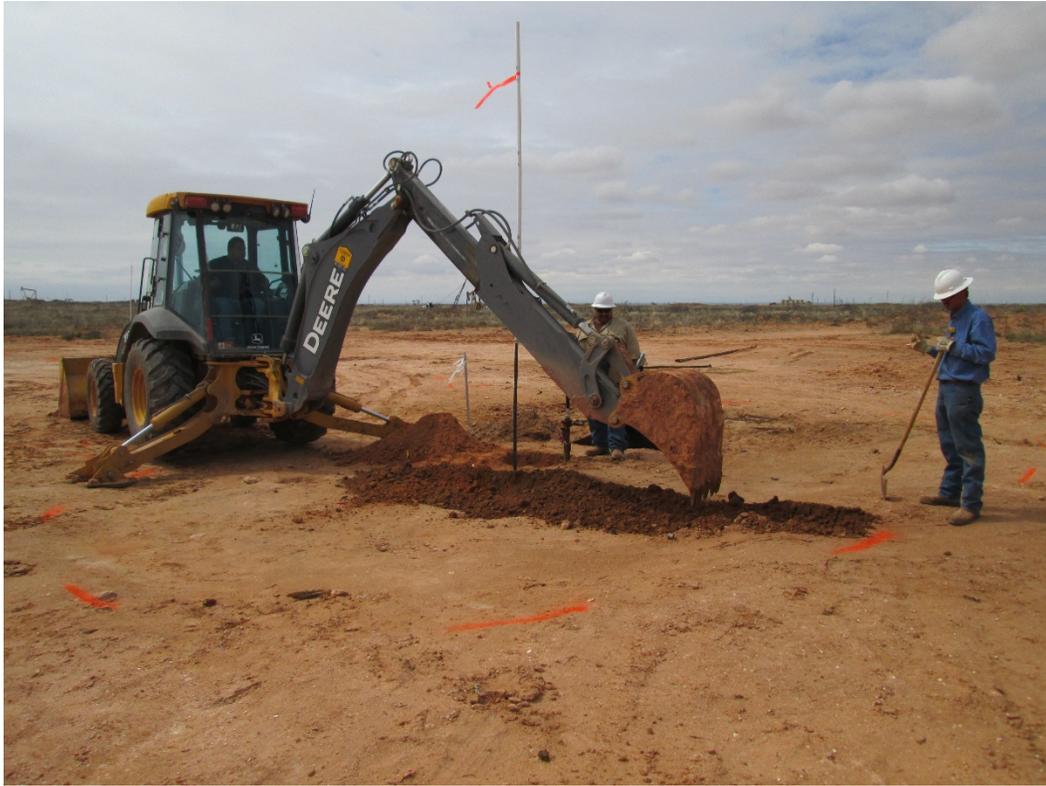
Excavating pad area

On March 19, 2015, DFSI personnel returned to the site to start excavation. The impacted caliche pad was removed at 6" below ground surface.

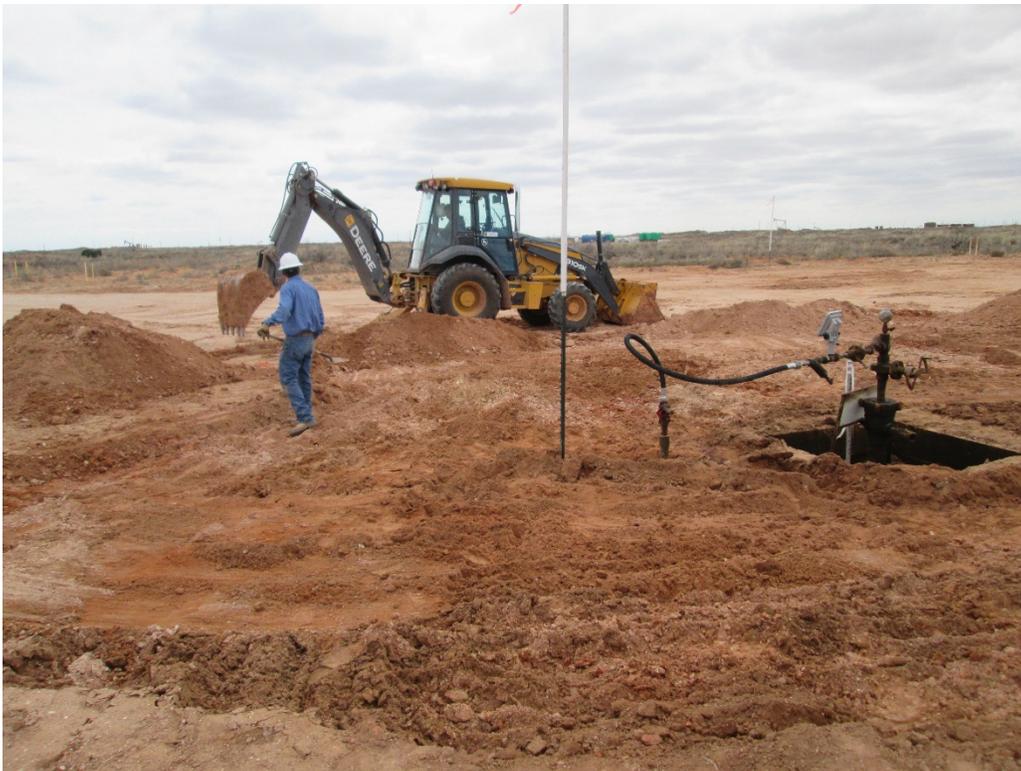
Excavating area around injection well on pad

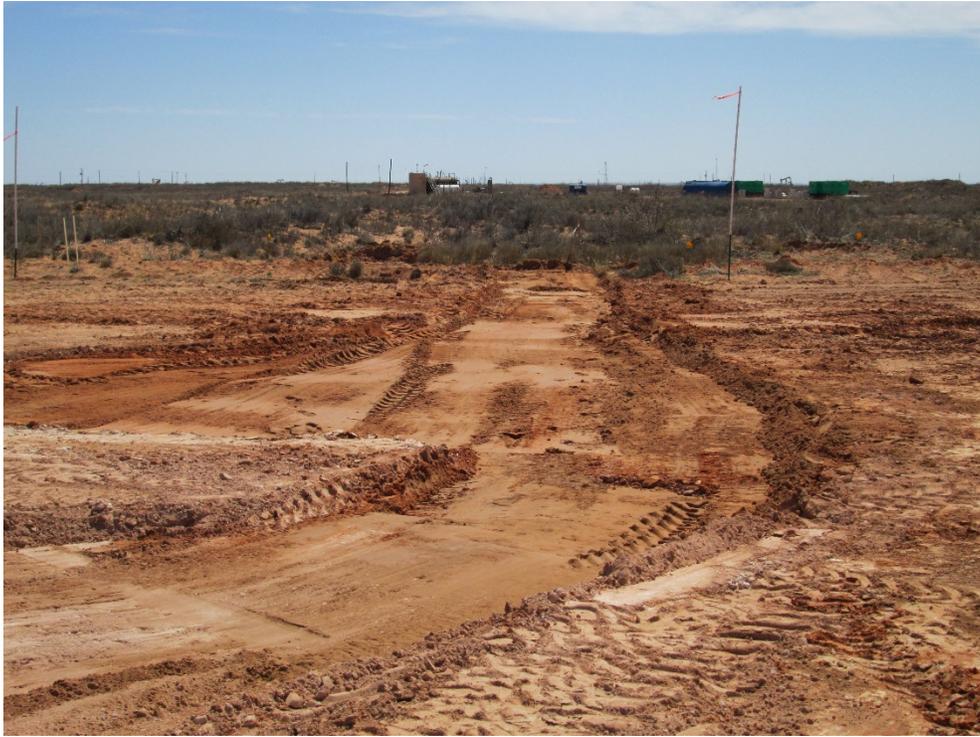
Excavated pad area

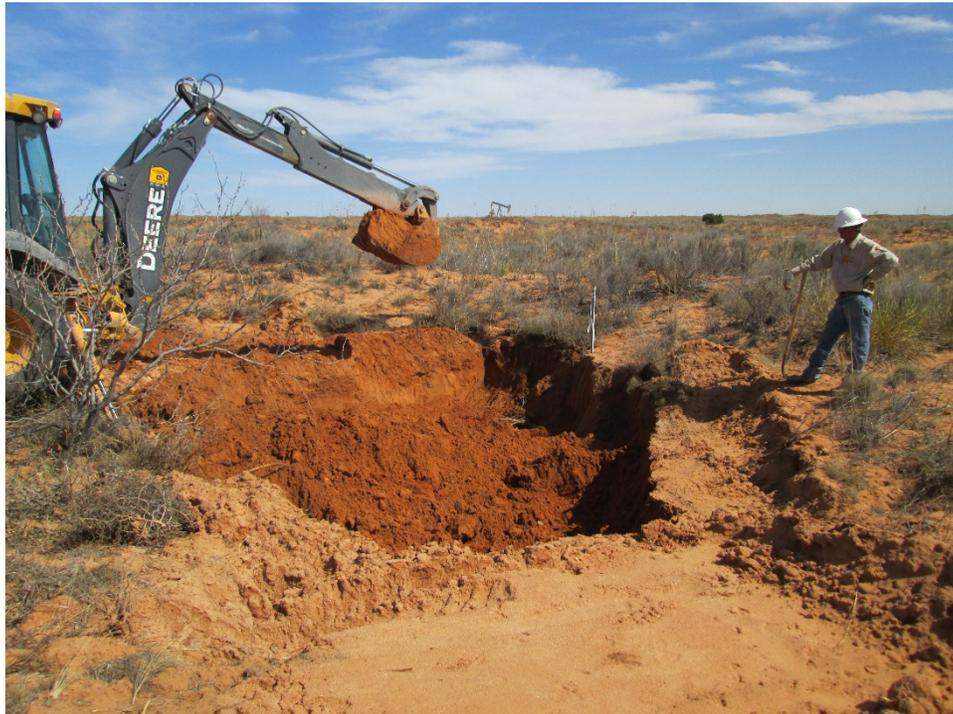
Excavating pasture area

On March 20, 2015, the impacted soil in the pasture was excavated to 3'bgs. DFSI personnel returned to the site on March 23, 2015 to backfill the excavated area on the pad with fresh caliche. DFSI used the surrounding terrain for backfill in the pasture area, and the site was completed on March 25, 2015. Photographs are attached (Appendix II). All contaminated soil was hauled to a BLM/NMOCD approved facility.

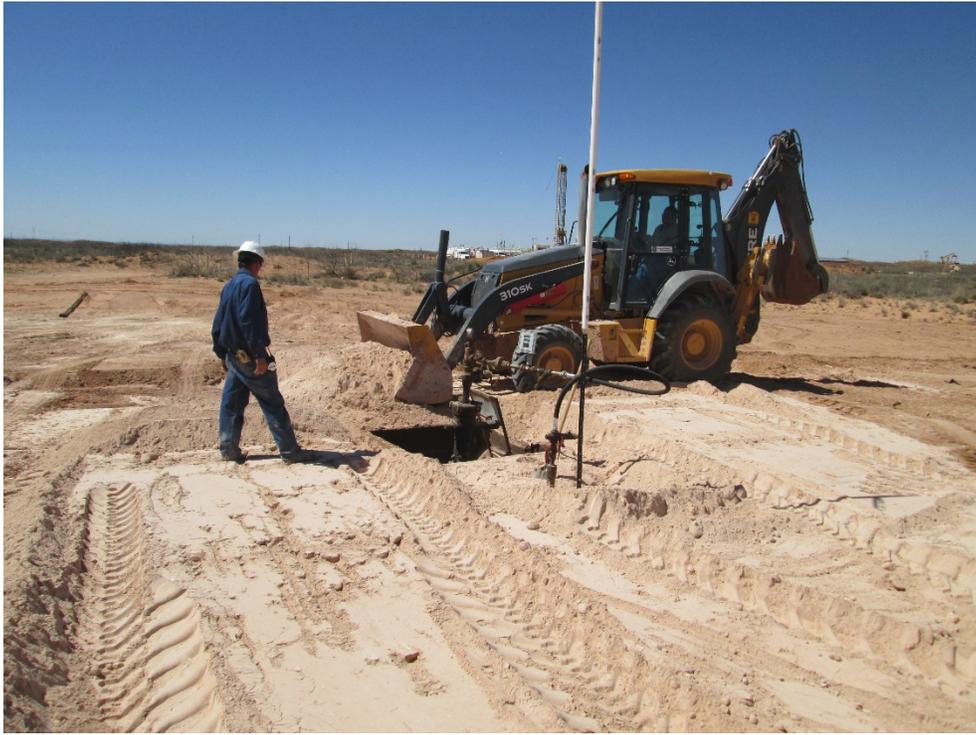
Backfilling pad with fresh caliche

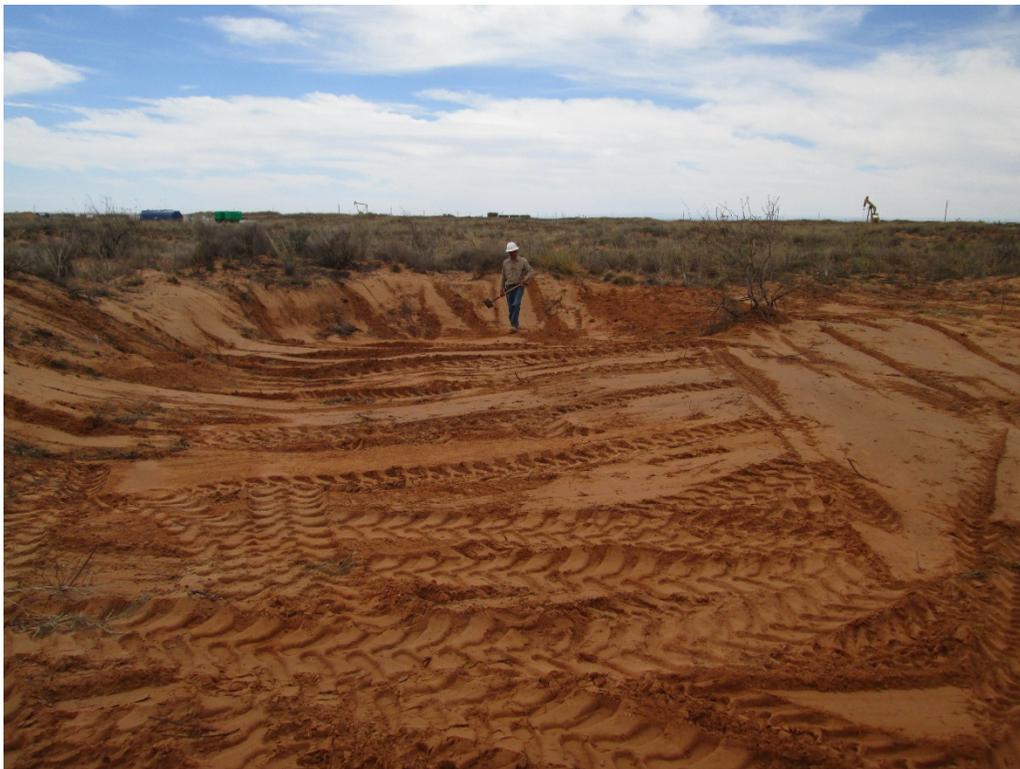
Contoured and blended pasture area

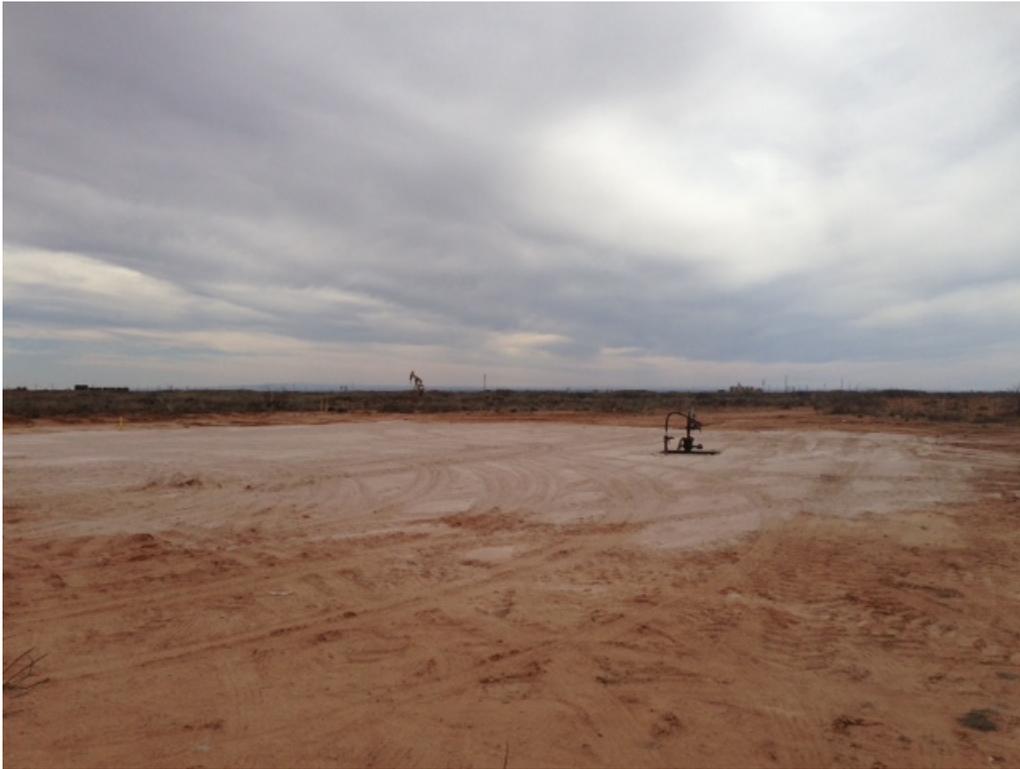
Backfilled pad area, closure pic

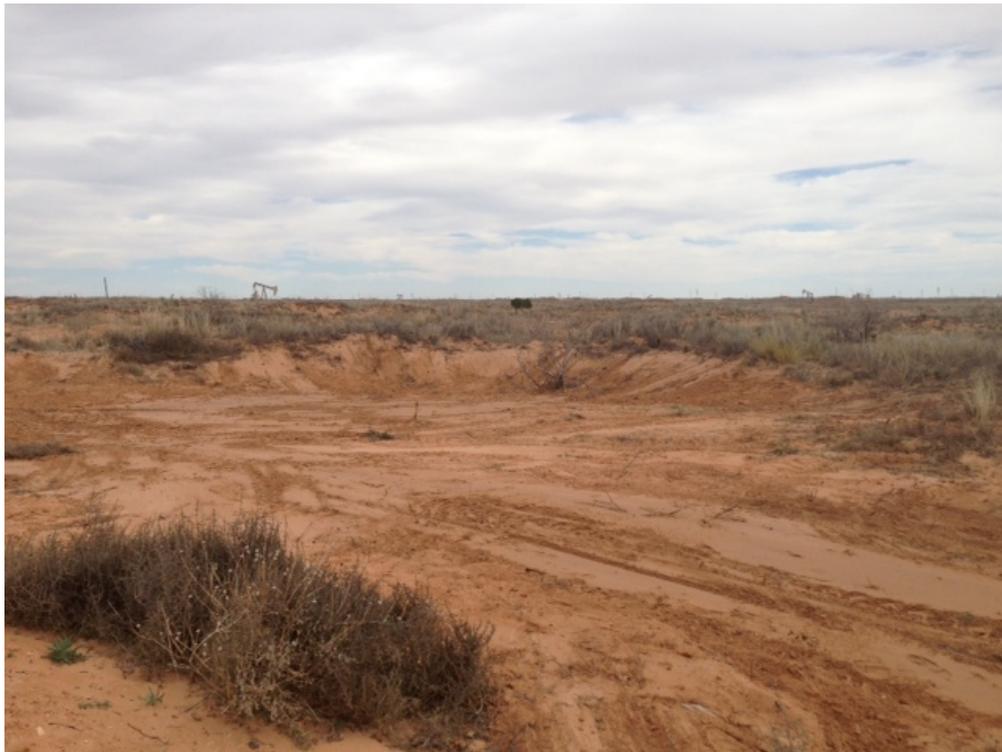
Backfilled and contoured pasture area, closure pic
