Environmental Site Summary & Spill Remediation Plan

Site Name: Palladium 7-1 4-Inch Poly NMOCD Reference#: _____

Attachment #3
Site & Sample Location Map
Plains Pipeline, LP
Palladium 7-1 4-Inch Poly
Eddy County, New Mexico
Plains SRS #: 2013-044

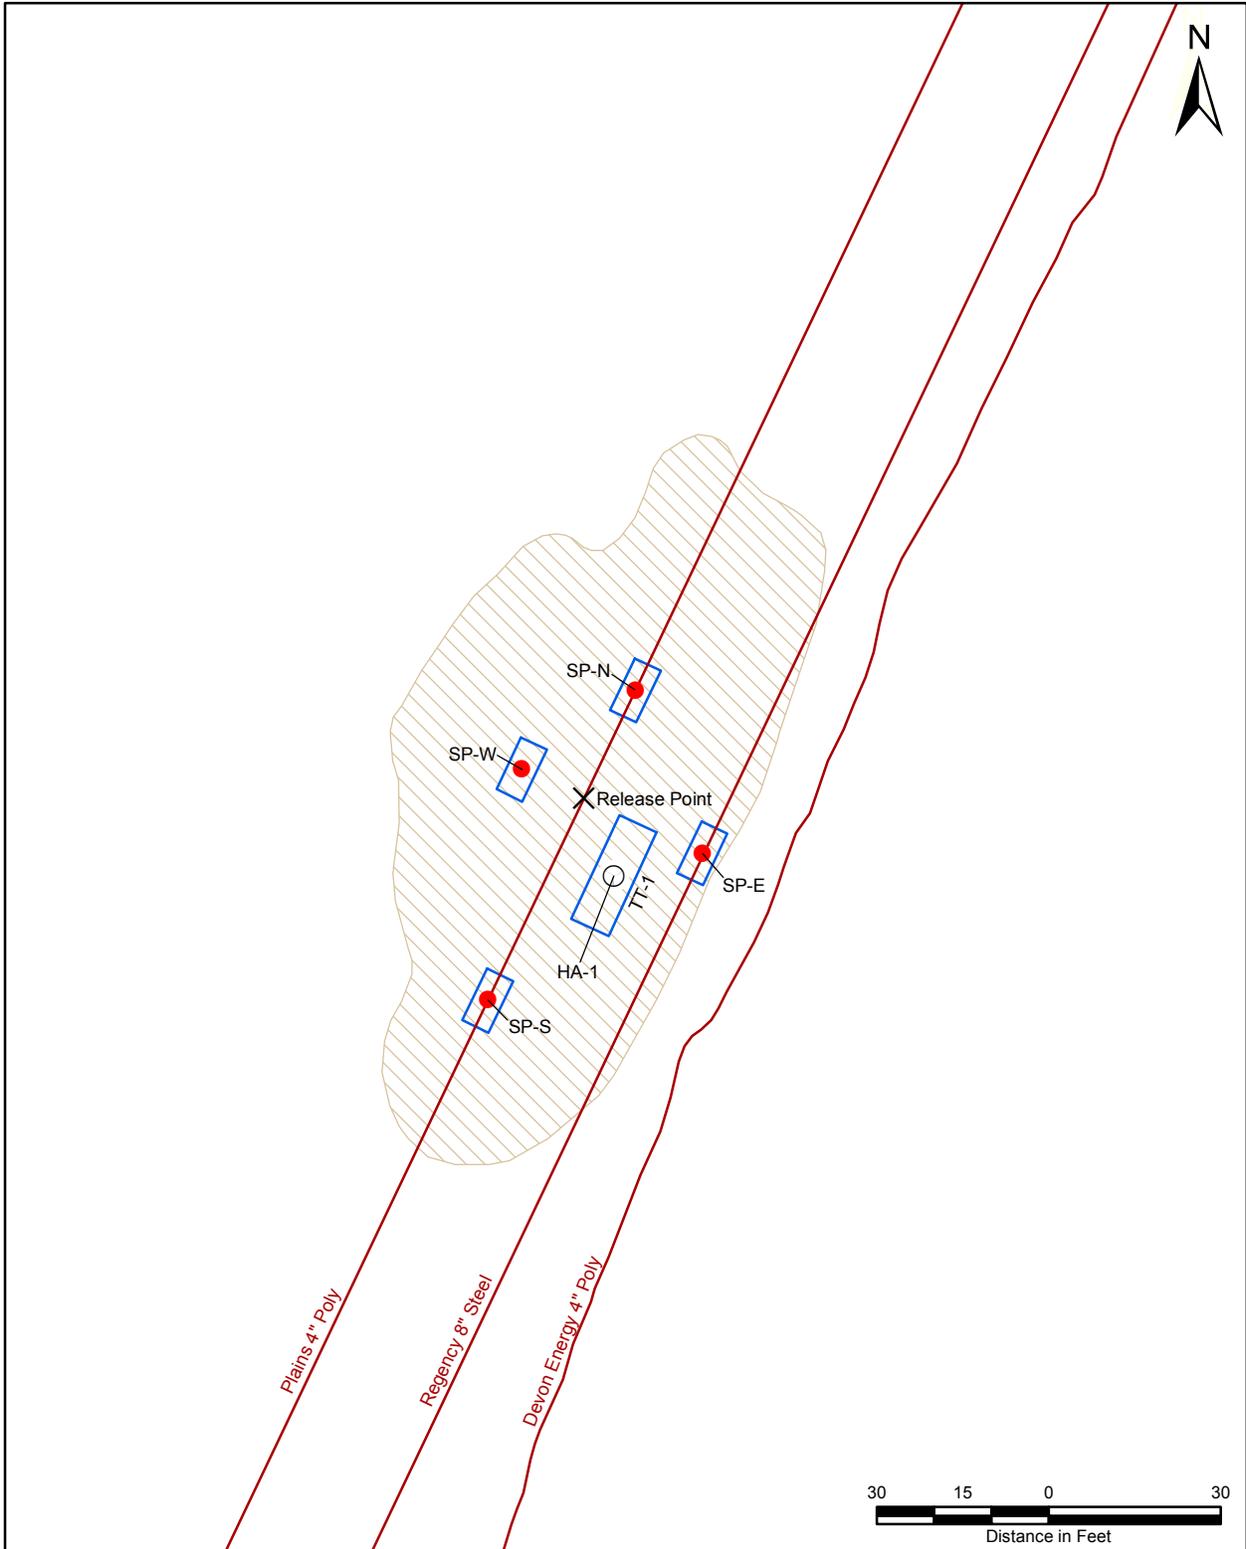
Locations of the hand-augered soil boring, delineation trenches, and soil samples are depicted in Attachment #3, "Site & Sample Location Map". Laboratory analytical results are summarized in Attachment #4, "Concentrations of Benzene, BTEX, TPH & Chloride in Soil", and analytical reports are provided in Attachment #6.

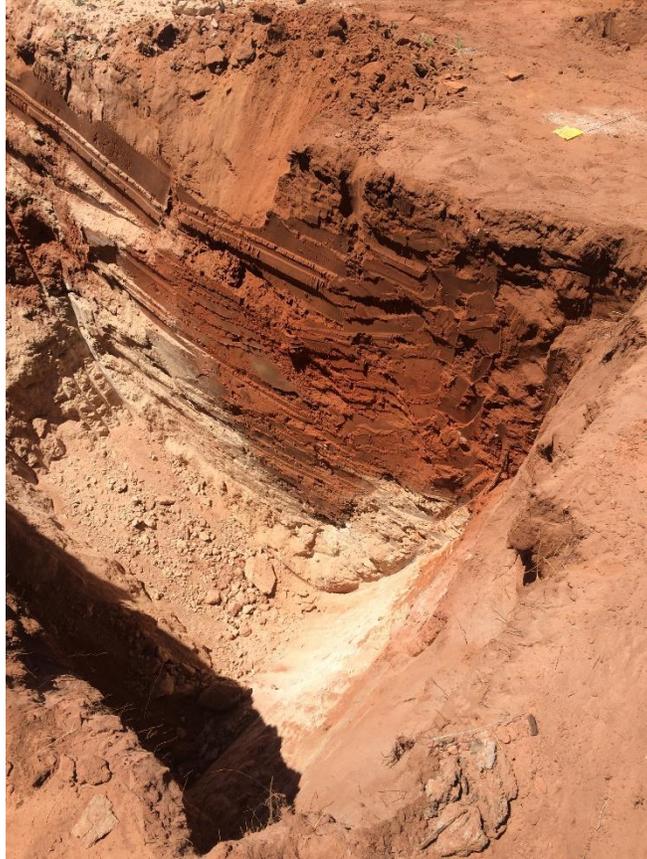
Laboratory analytical results indicate vertical delineation was not achieved in trenches TT-1 and S. Additional vertical delineation is required in the areas represented by these trenches. Horizontal and vertical delineation to the north, east, and west of the release point was achieved.

Palladium 7-1 4-Inch Poly – Delineation Trench TT-1
(Staining Visible on Wall of Trench)

- The area around delineation trench TT-1 will be excavated to approximately five feet (5') bgs to allow access for heavy equipment to further advance the trench. The trench will be advanced to the extent practicable. Soil samples will be collected at one (1) to two-foot (2') vertical intervals and field-screened with a PID. A representative selection of samples will be submitted to the laboratory for confirmatory analyses of BTEX, TPH, and/or chloride concentrations using the EPA laboratory analytical methods described above. If vertical delineation cannot be achieved via trenching, a drilling rig will be employed to advance one (1) soil boring (SB-1) in the area of trench TT-1.
