**Devon Energy Production Co LP
Cotton Draw Unit 214H
Produced Water Transfer Line Release
Delineation Report and Work Plan**

**Unit Letter C, Section 36, T24S, R31E
Lea County, New Mexico**

May 27, 2015

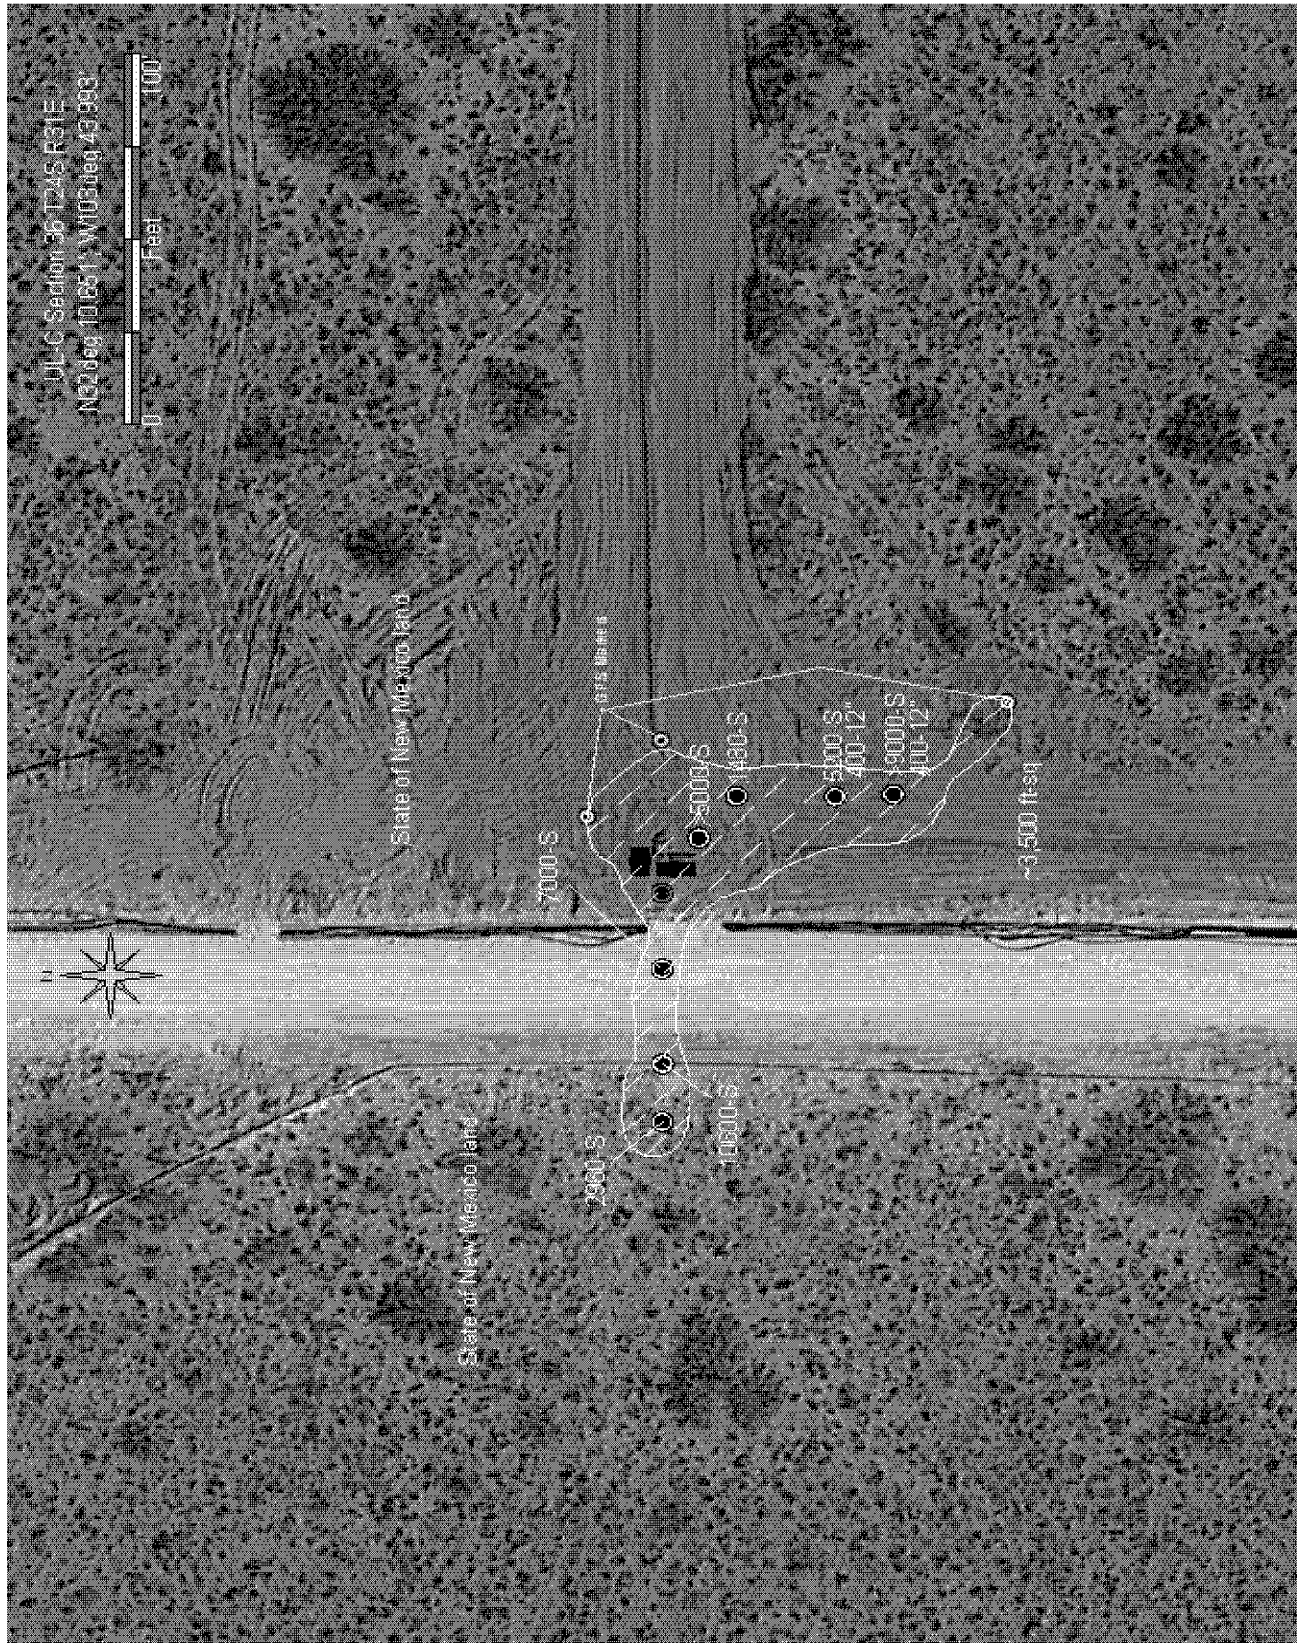
Figure 2

Site Plan

Site plan with chloride surface sample concentrations (PPM)

On May 21, 2015, SESI was onsite with Alfredos Trucking to begin delineation. Five test trenches were dug for sampling and a trench 15 ft x 40 ft. was excavated to a depth of 2 ft. Approximately 45 cubic yards of material was loaded in to a 20 yd. dump truck and hauled to Lea Land for disposal.

Excavate and remove all chloride-contaminated soil to the depth where the chloride concentration is 1,000 mg/kg or less as determined by sampling of sidewalls and bottom of the excavation. Contaminated soils will be transported to an approved NMOCD facility for disposal. Composite confirmation samples will be taken from the sides and bottom of the excavation area. The excavated area will be backfilled with material similar to that removed.

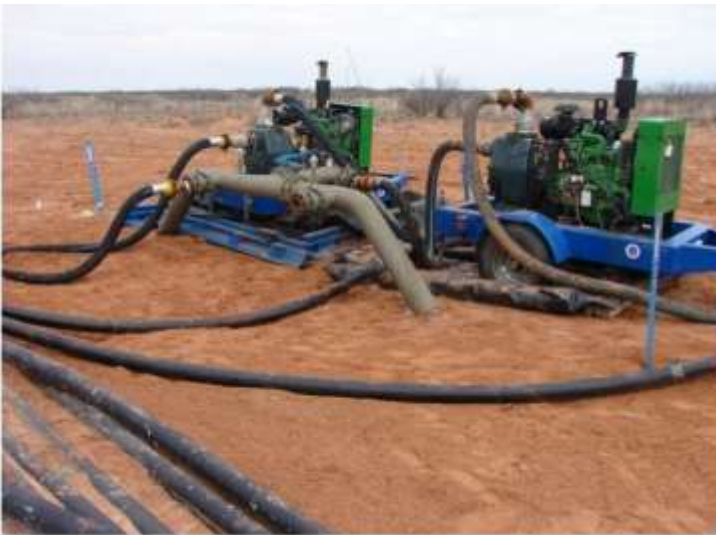
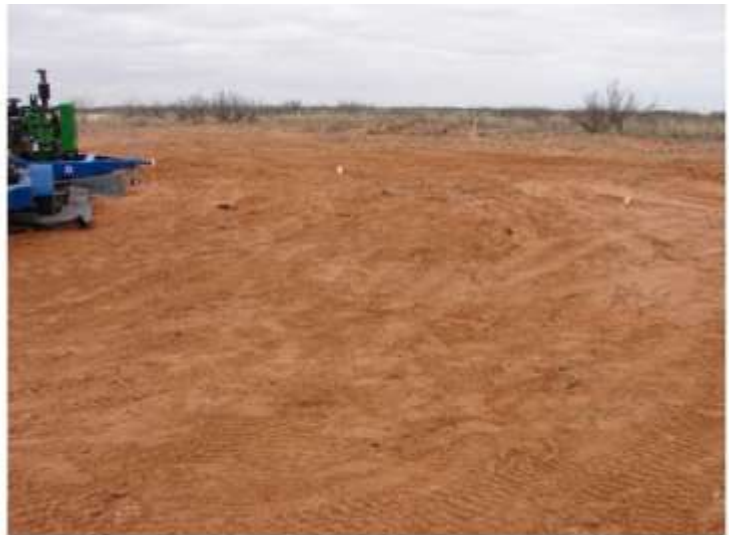
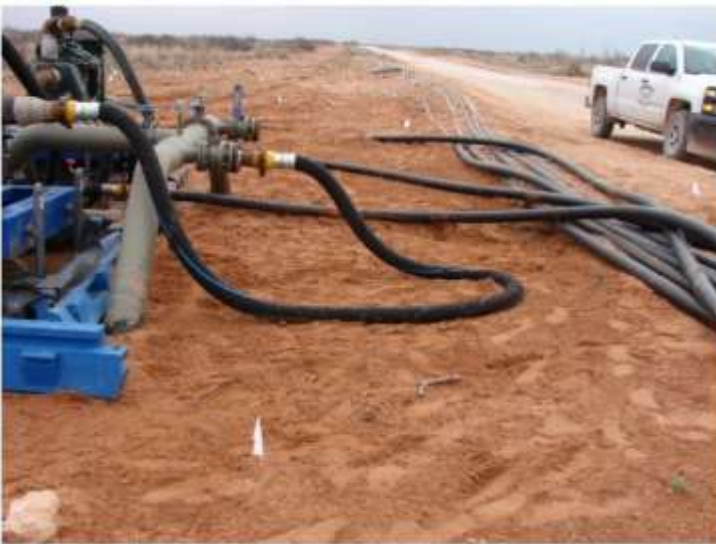
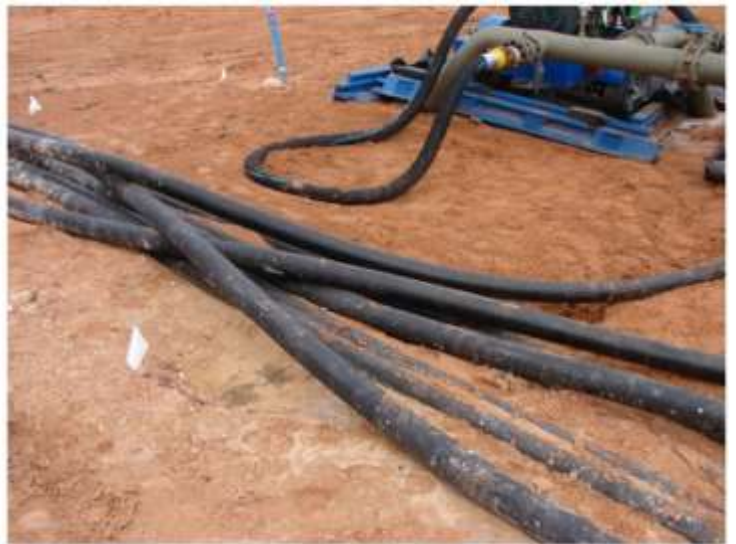
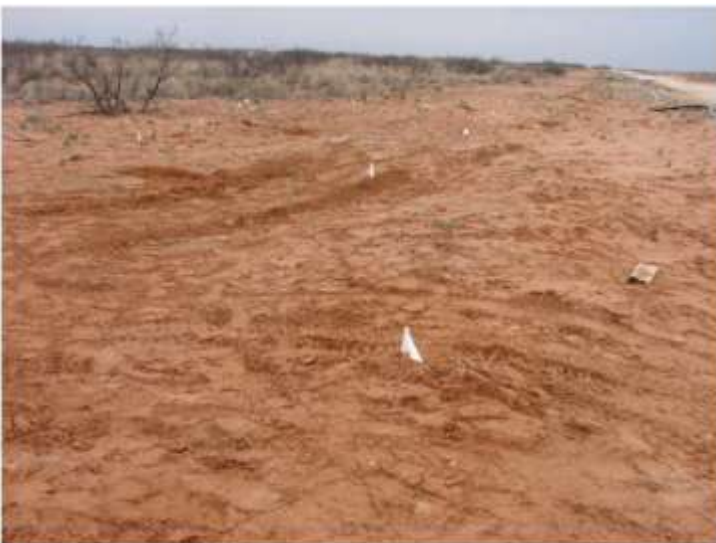
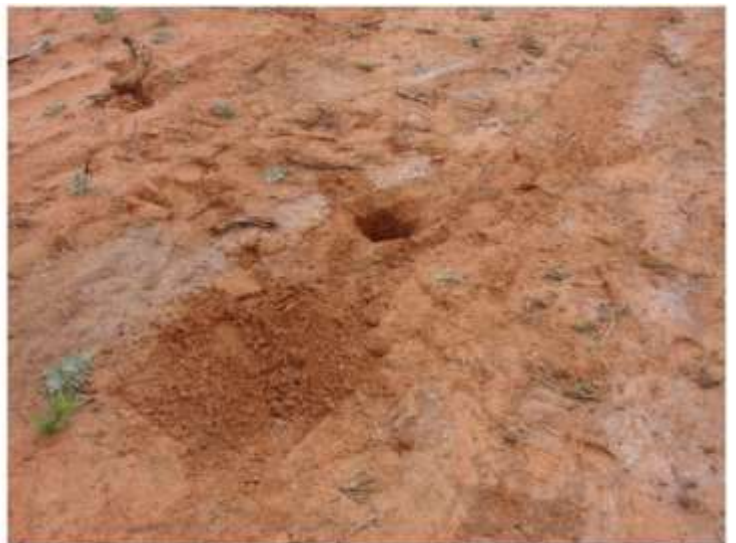
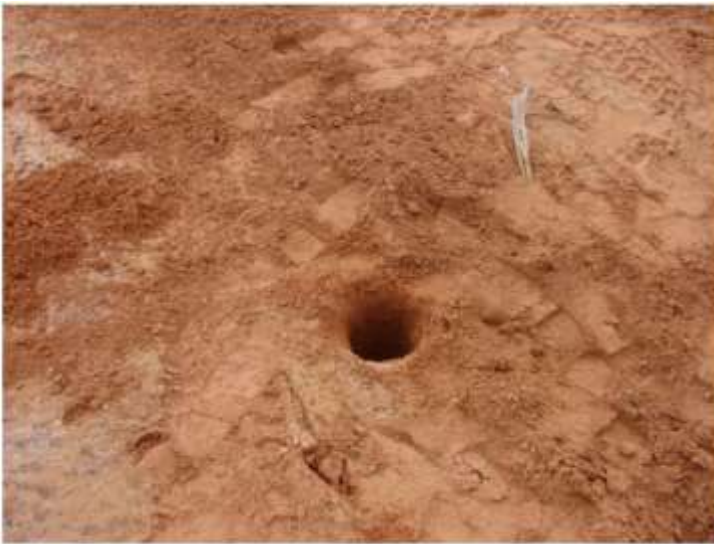
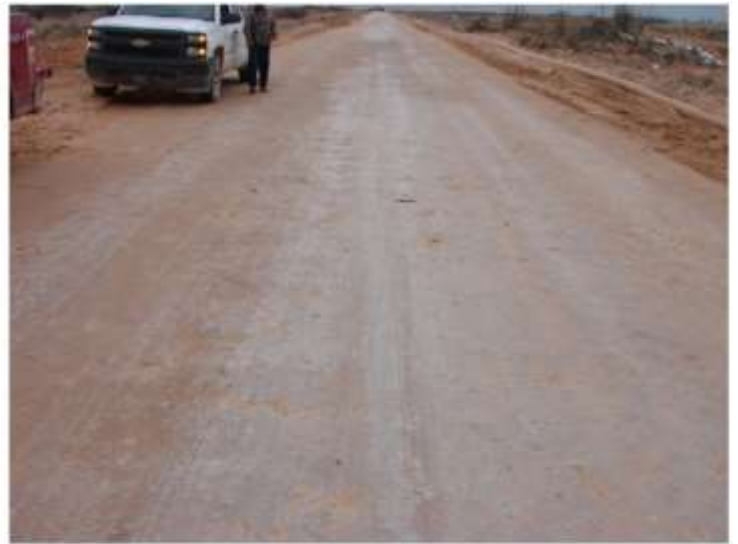
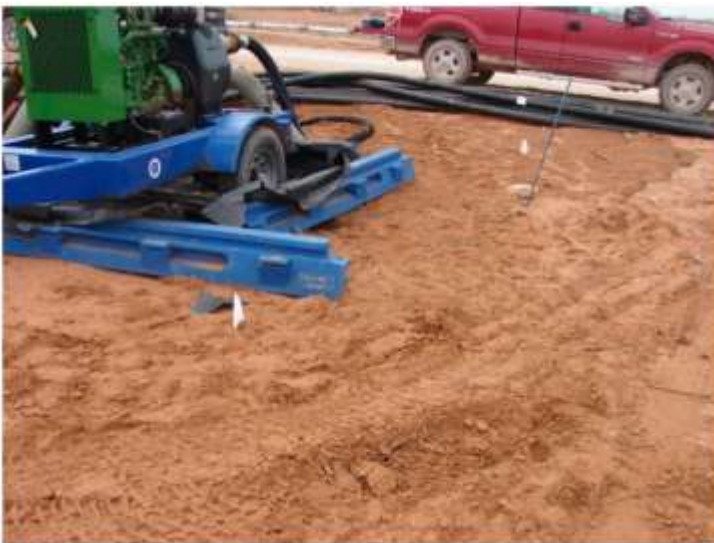
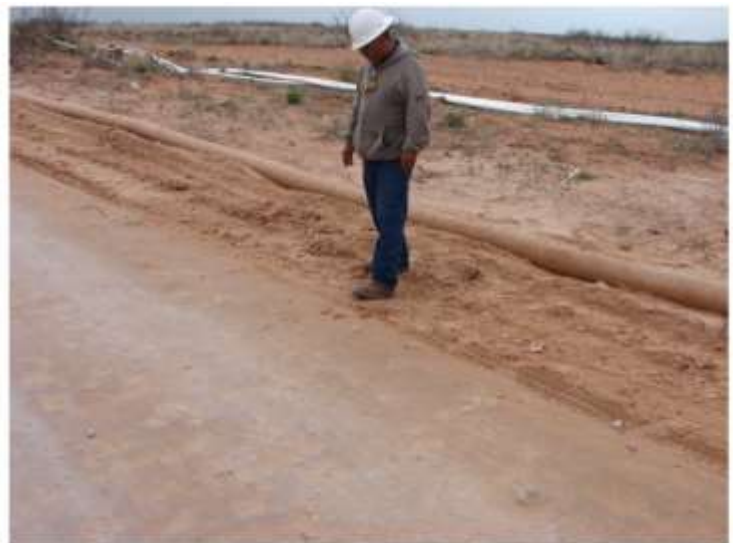
Site Photographs

Photographs taken by Alfredo's Trucking.
