Hudson #13

REMEDIATION WORK PLAN

API No. 30-015-30995

RE: Linn Energy Hudson #13 – Remediation Work Plan
UL/D, Section 17, T17S, R31E
API No. 30-015-30995

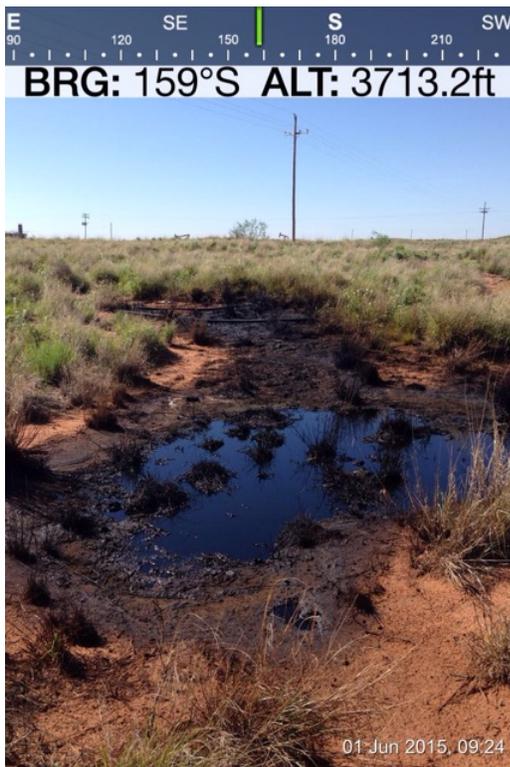
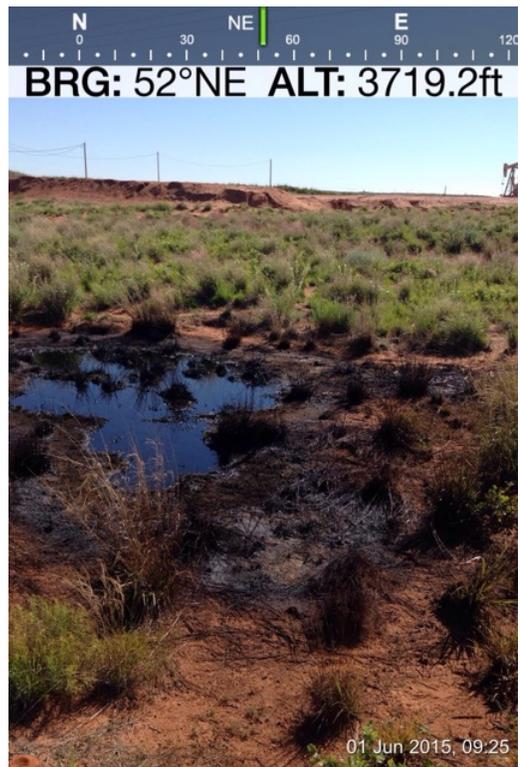
PHOTO PAGE

The site is located northeast of Loco Hills NM, in Eddy County. The leak site resulted from a failure in the flow line. The impacted area is approx. 300 yards west of the location in the pasture. Approx. 3 bbls of produced water and 1 bbl of oil were released. Nothing was recovered. A site map is attached. A C-141 was submitted to the NMOCD on June 6th, 2015.

Remove the pasture impacted soil down to 4' bgs then set a .20 mil liner. All contaminated soil will be hauled to a NM state approved disposal facility. DFSI proposes to use the surrounding terrain for backfill and contour; then seed with a BLM, OCD approved seed mix.

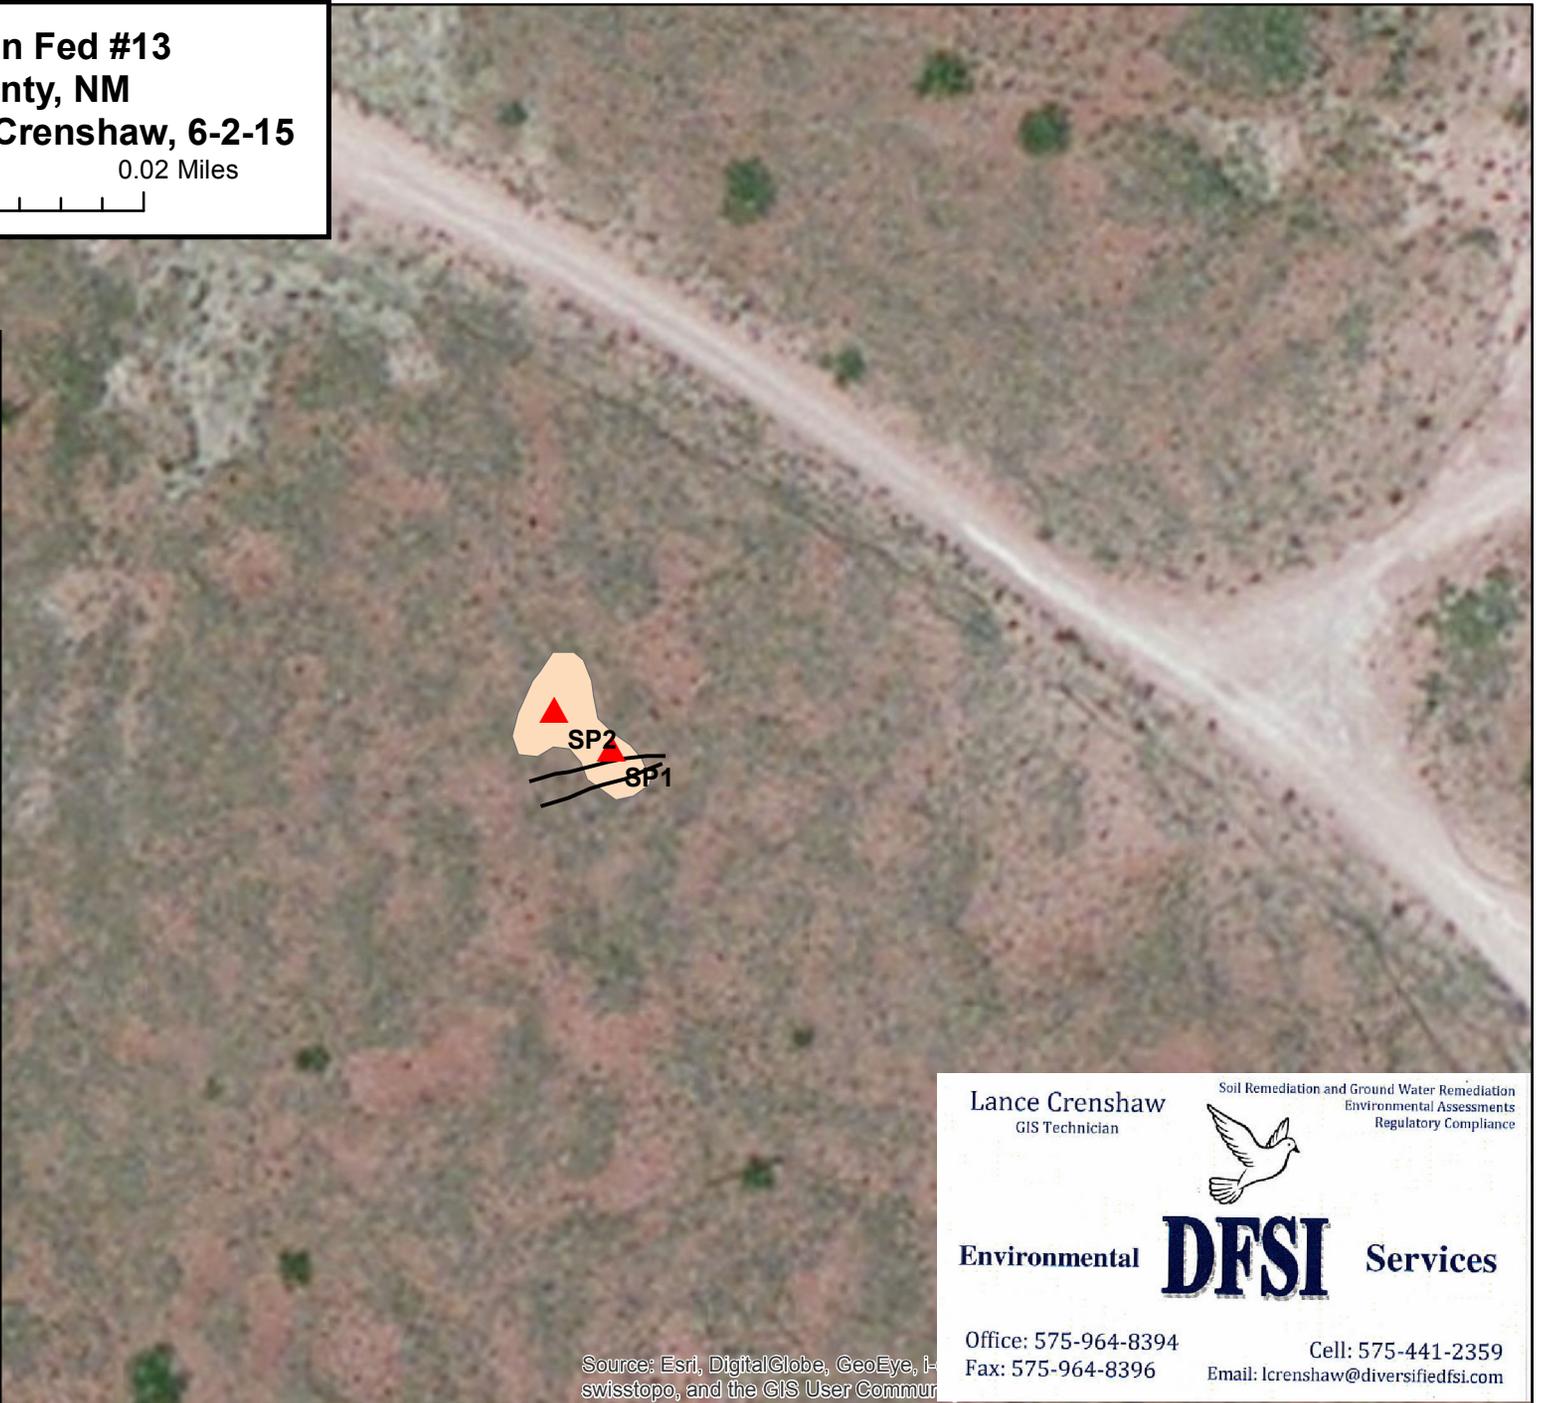
Site Diagram

Linn, Hudson Fed #13
Eddy County, NM
Drafted By: Lance Crenshaw, 6-2-15
