SUBJECT: FINAL CLOSURE REPORT FOR INCIDENT 2RP-2809 MCINTYRE A WEST #16, EDDY COUNTY, NEW MEXICO

FINAL CLOSURE REPORT FOR INCIDENT 2RP-2809

COG OPERATING LLC

MCINTYRE A WEST #16
API# 30-015-31855
SECTION 20, T17S R30E, NMPM
EDDY COUNTY, NM

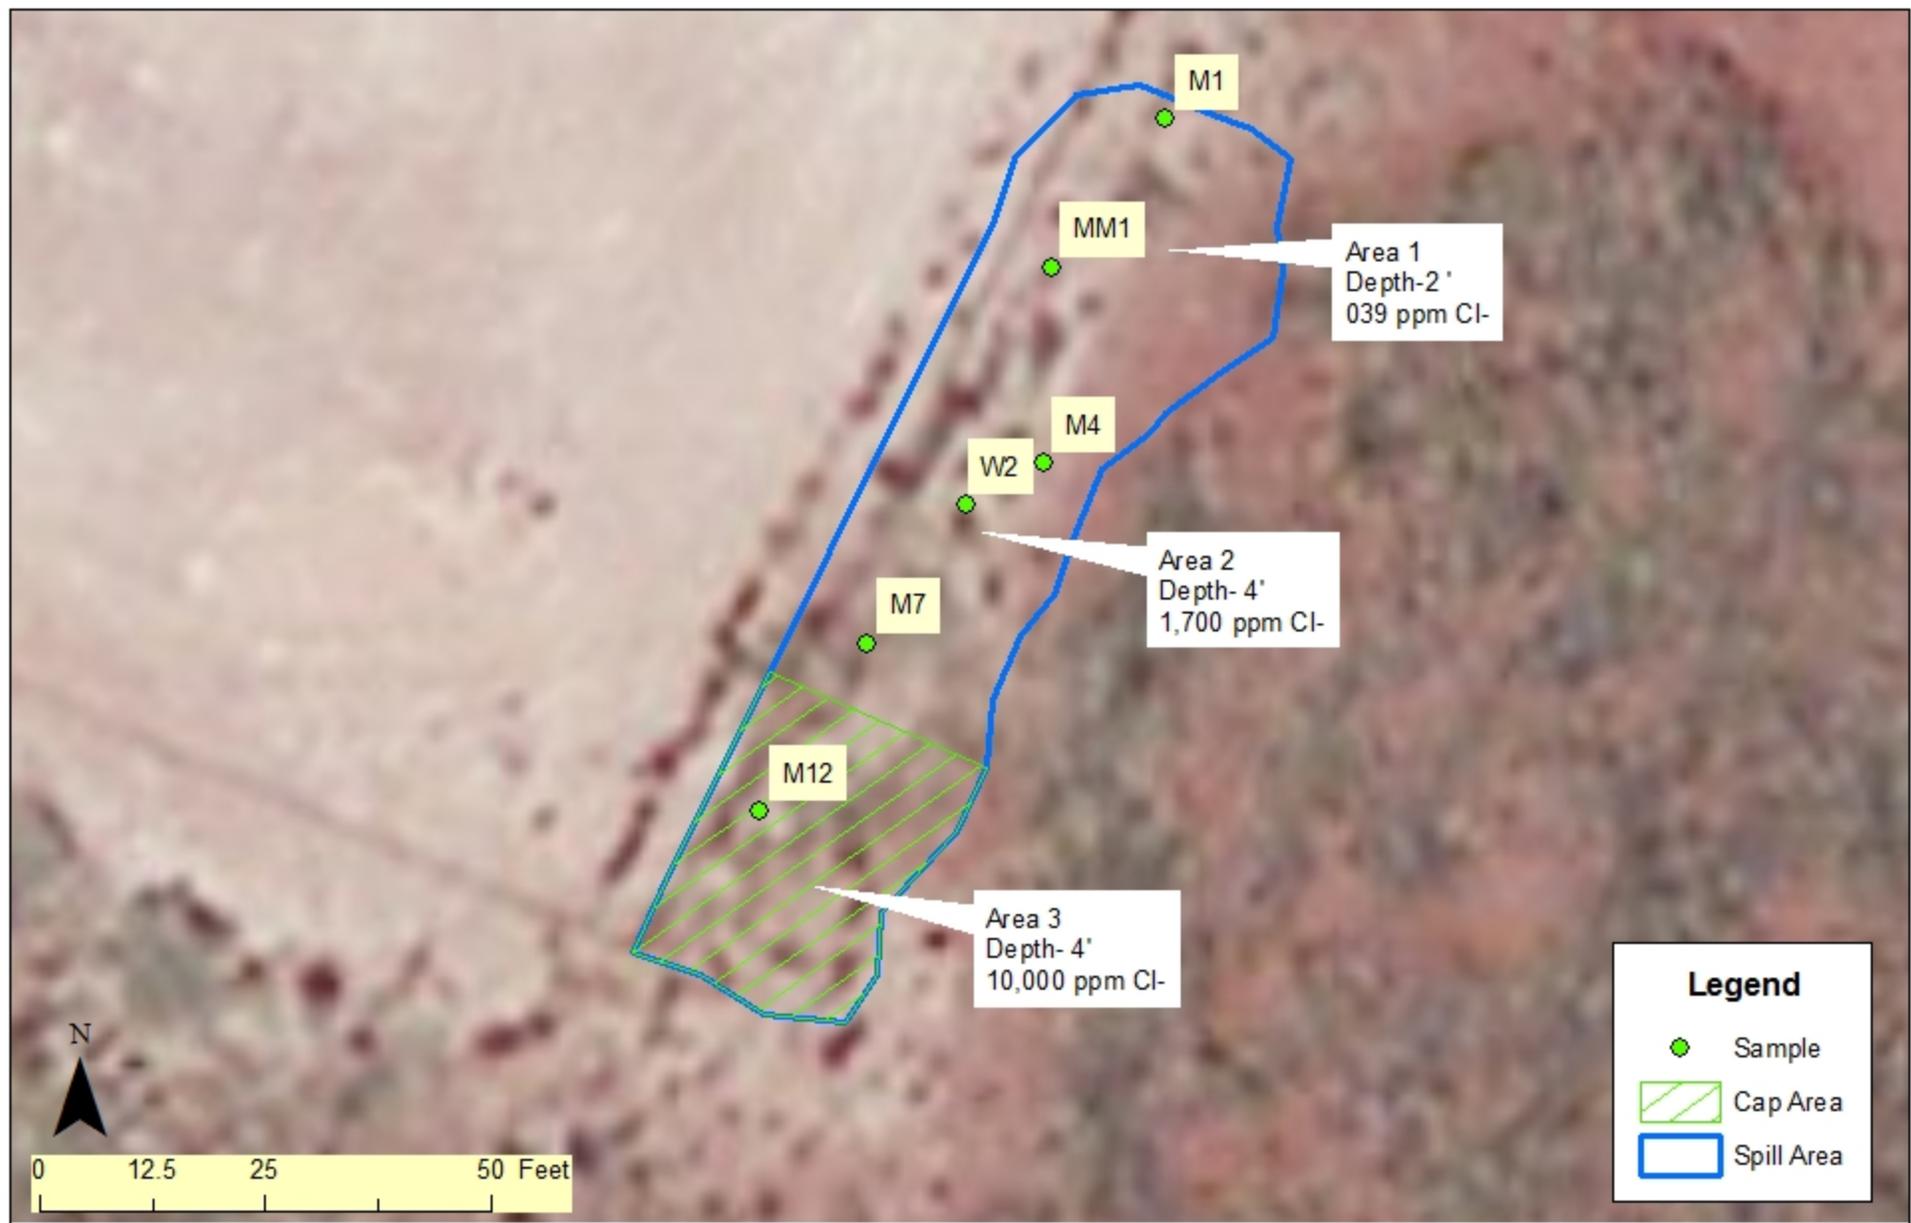
FIGURE 2

Soil contaminant concentrations are illustrated in Figure 2. A summary of laboratory analytical results is included in Table 3. Laboratory reports are included in Appendix C.

SITE MAP

Site Map
McIntyre A West #16 - COG
Loco Hills, New Mexico

A total of 5 soil samples were submitted for closure confirmation by laboratory analysis per EPA Methods: 8021 for benzene, toluene, ethylbenzene, and xylenes (BTEX) and 418.1 for Total Petroleum Hydrocarbons. All samples were analyzed by Hall Environmental Analytical Laboratory in Albuquerque, New Mexico. Figure 2 illustrates the extent of the excavation, laboratory soil sample locations, and laboratory results.

SMA recommends no further action at the McIntyre A West #16 release location with regards to Incident #2RP-2809.
