Re: Owl 20504 JV-P #5 SWD
30-015-35435
Sec. 18, T26S-R27E
Eddy County, NM

COG Operating LLC would like to submit for your consideration the enclosed work plan/closure report for the above captioned well. The plan is in response to the C-141 Initial report dated July 9, 2015.

Owl 20504 JV-P #5 SWD

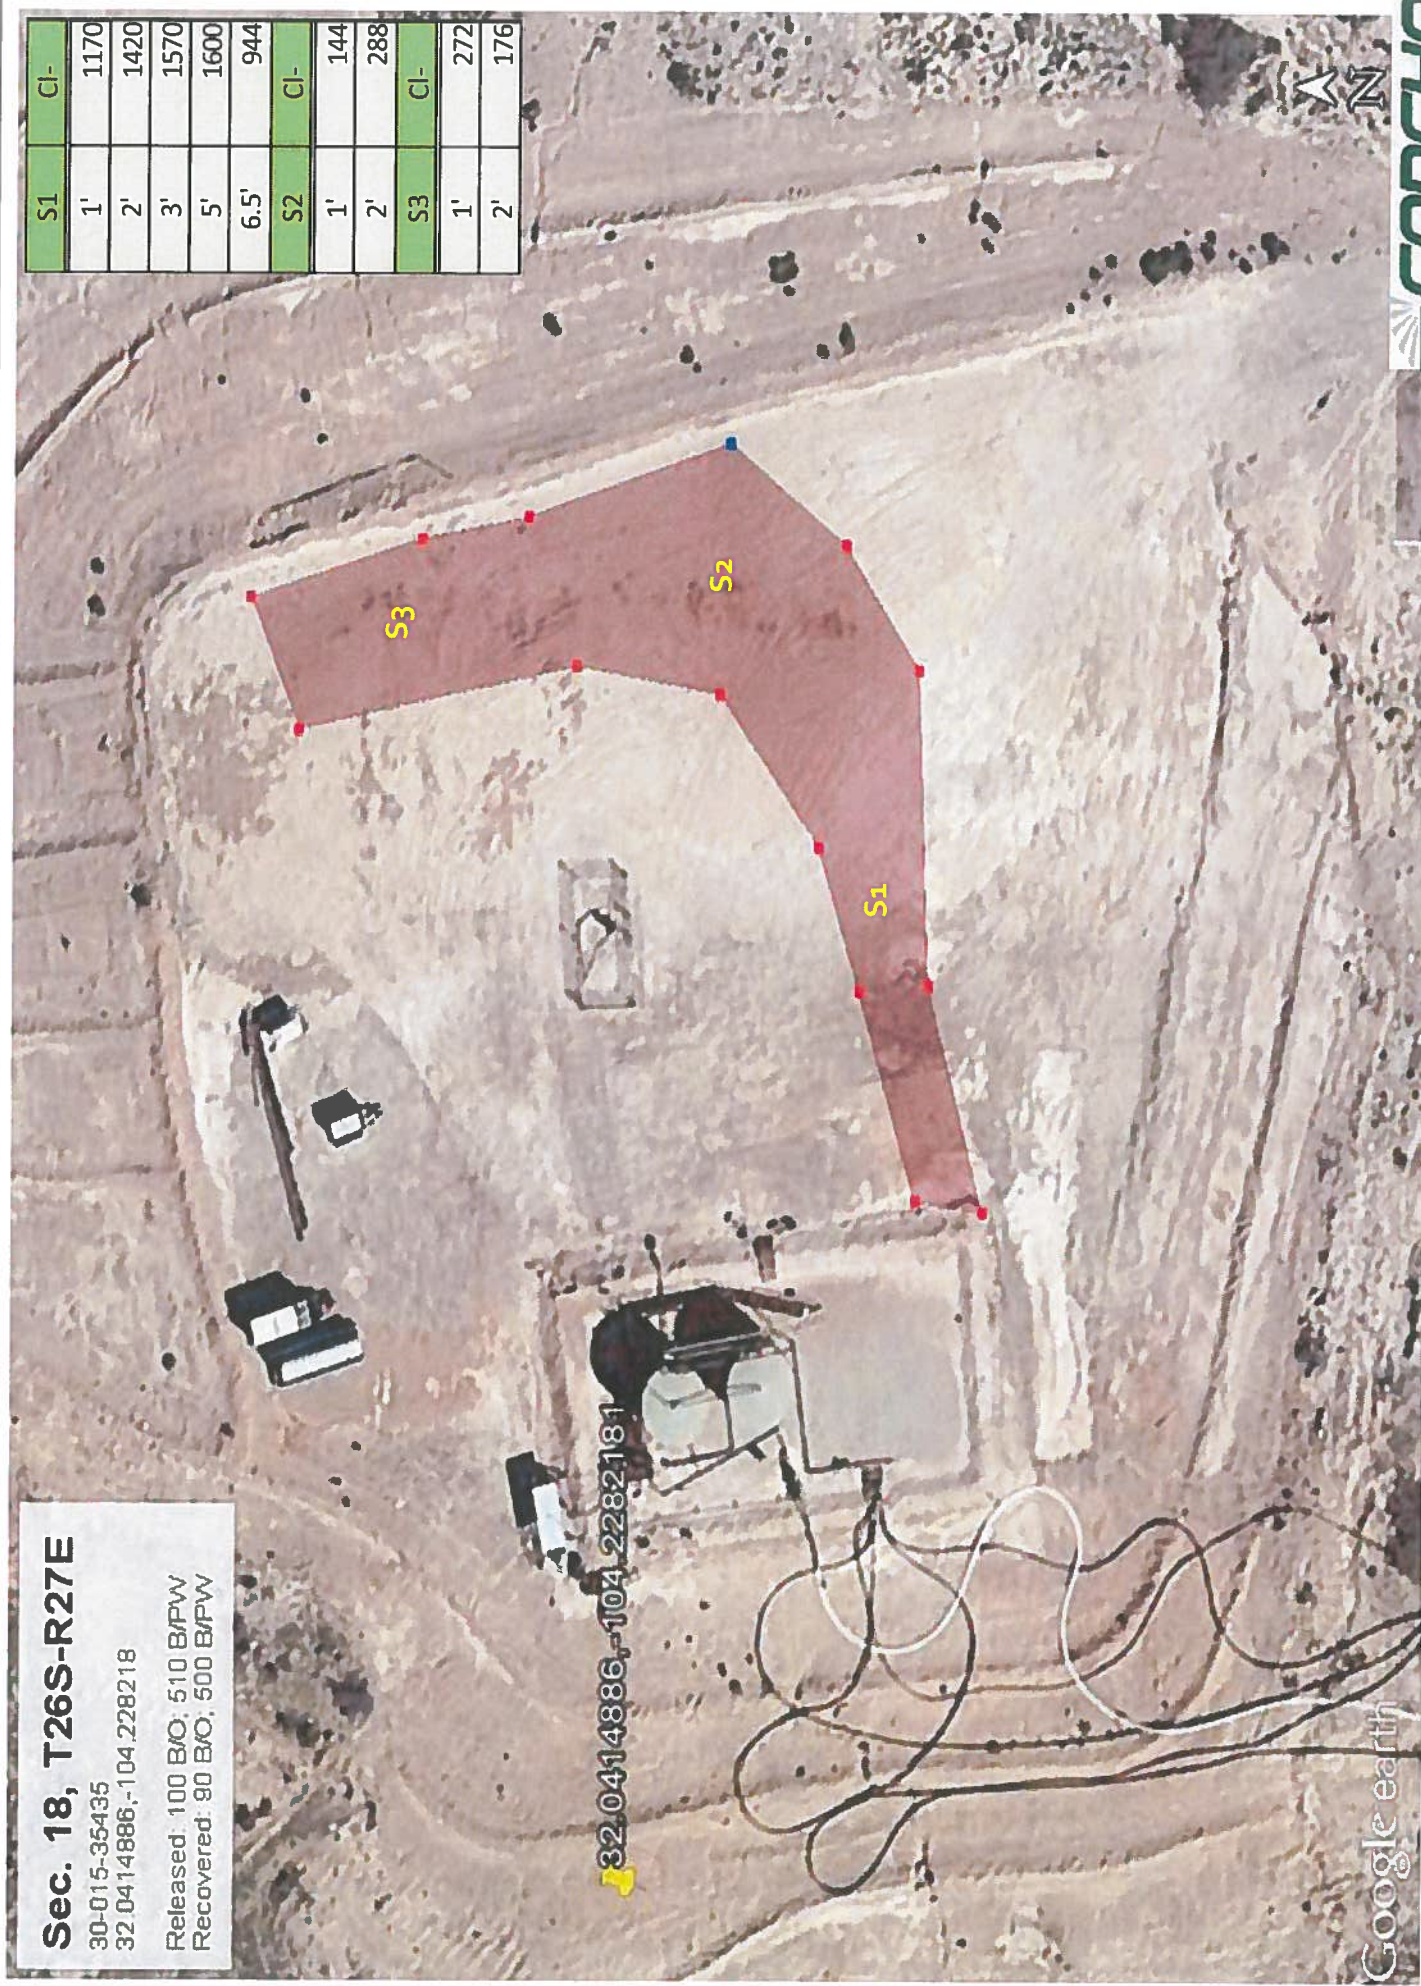
The release was due to a tank over flow resulting in the release of 100 barrels of oil and 510 barrels of produced water of which 90 barrels of oil and 500 barrels of produced water were recovered. The majority of the released fluid was contained within the lined facility and a portion of the release (approximately 15 barrels) overran the dike and remained on the location. Upon discovery, vacuum trucks were dispatched to recover standing fluid and an initial scrape was completed on the location. The attached Site Diagram depicts the approximate area impacted by the release and the approximate location of the points sampled.

Sample points noted on the attached Site Diagram are labeled with an S to denote samples taken within the release area.

Sec. 18, T26S-R27E
30-015-35435
32.0414886,-104.2282181
Released: 100 B/O; 510 B/PW
Recovered: 90 B/O; 500 B/PW

S1	CI-
1'	1170
2'	1420
3'	1570
5'	1600
6.5'	944
S2	CI-
1'	144
2'	288
S3	CI-
1'	272
2'	176

COG Operating LLC proposes that no further excavation be required due to chloride levels left in place being within tolerable levels for future reclamation of the location and depth to ground water at greater than 100'.
