**Re: Western Hawk State Com #1**  
**30-015-33400**  
**Sec. 3, T25S-R28E**  
**Eddy County, NM**

COG Operating LLC would like to submit for your consideration the enclosed work plan for the above captioned well. The plan is in response to the C-141 Initial report dated December 5, 2014.

# Western Hawk State Com #1

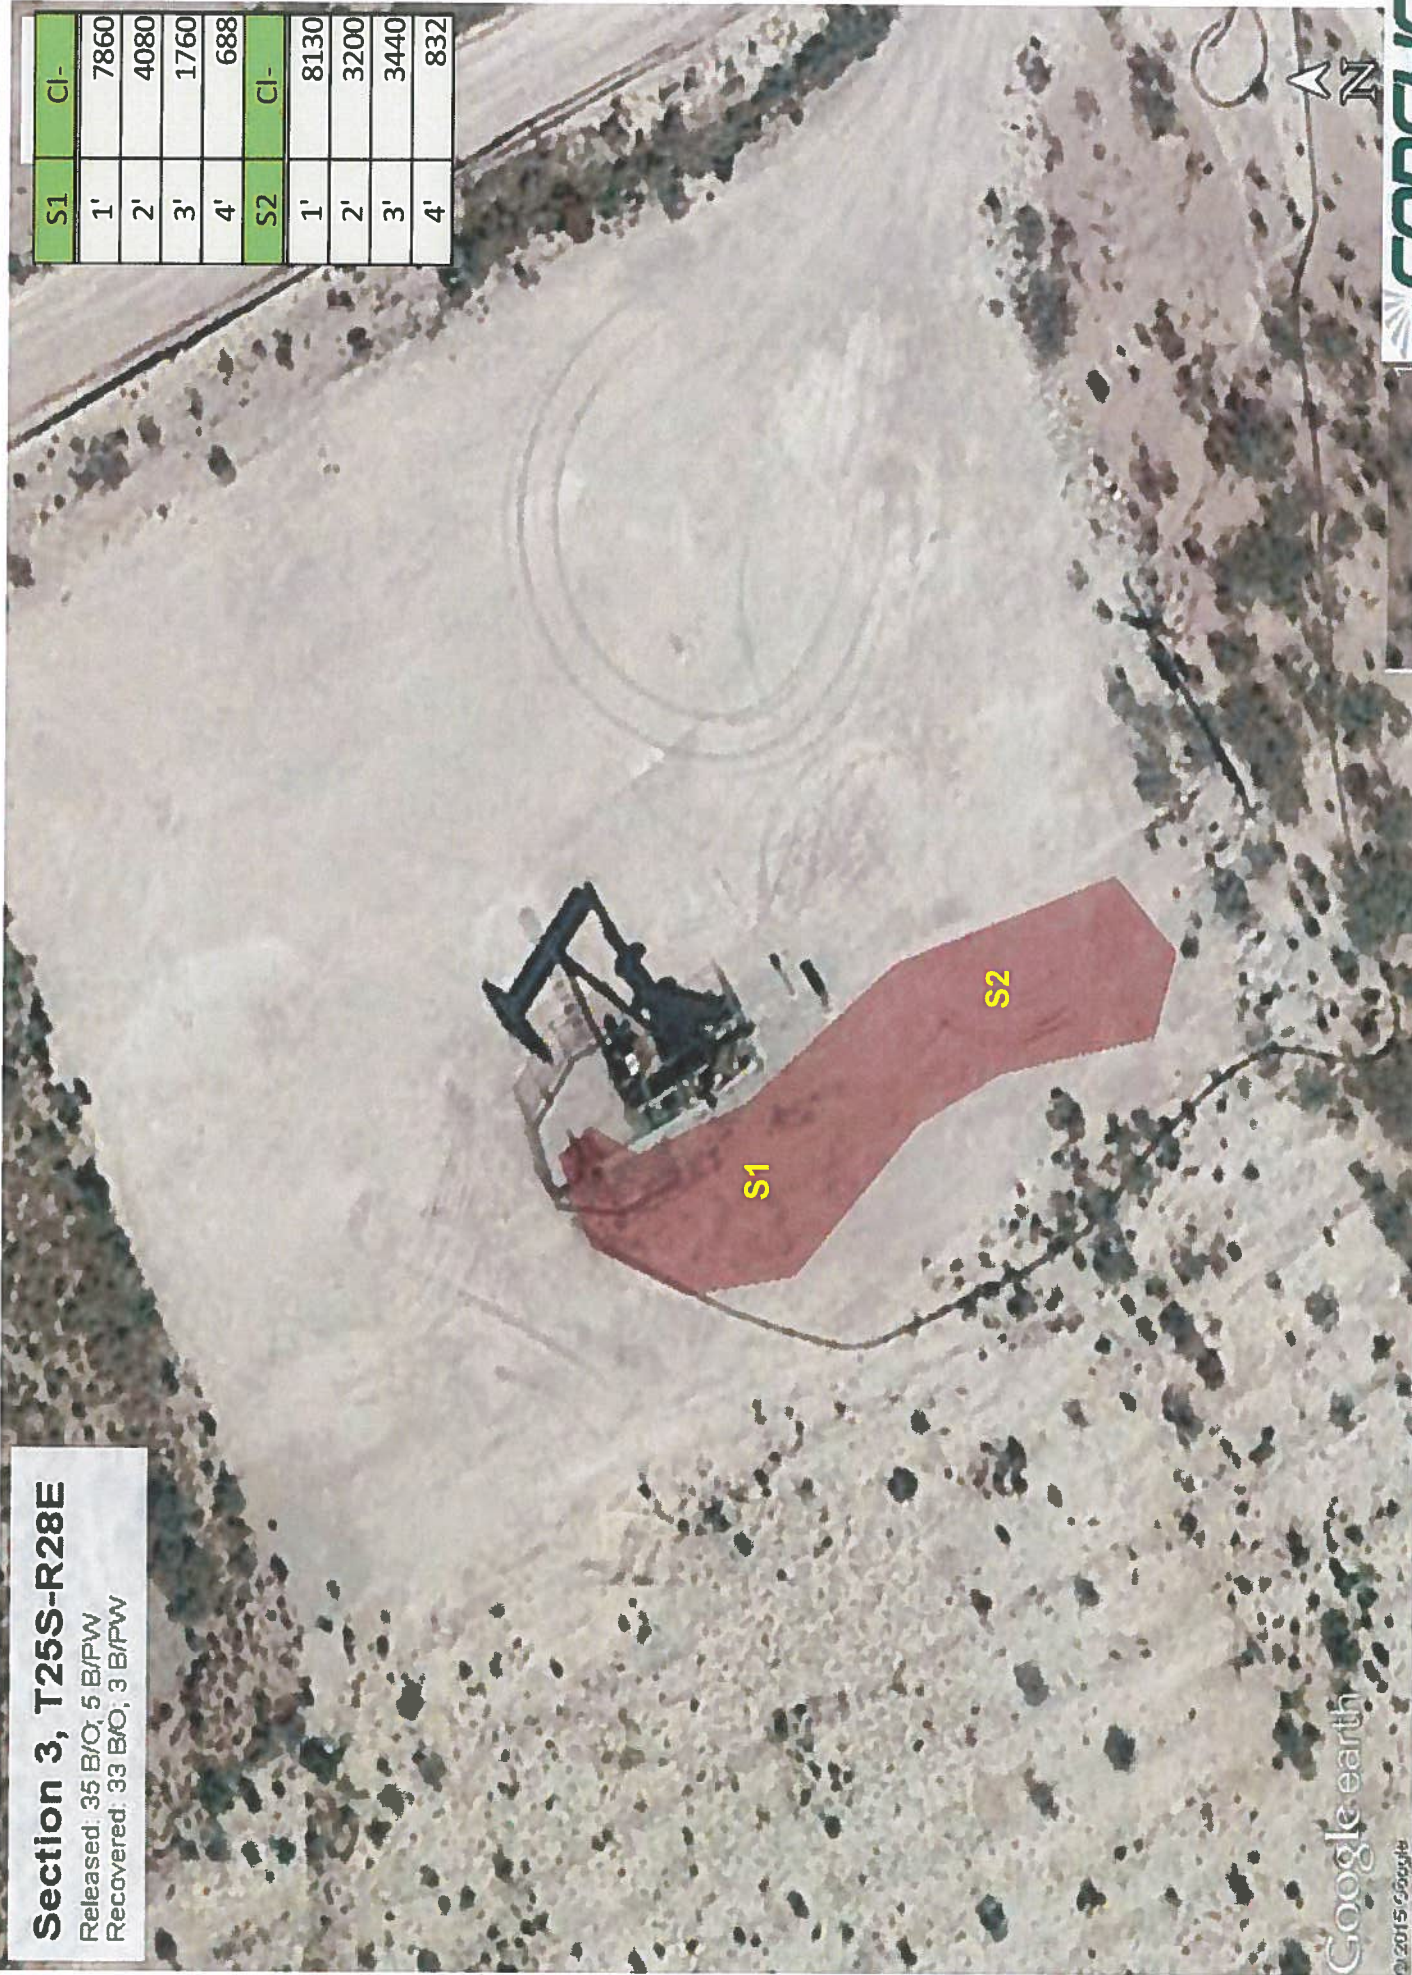
Sample points labeled as S1 and S2 on the attached site diagram depict the approximate sample locations within the release area along with a summary of the analytical results. Sample results show TPH and BTEX to be non-detect for both sample points at a depth of 1'. Chloride results show to be elevated for both sample points to a depth of 3'.

Released: 35 B/O; 5 B/PW  
Recovered: 33 B/O; 3 B/PW

S1	CI-
1'	7860
2'	4080
3'	1760
4'	688
S2	CI-
1'	8130
2'	3200
3'	3440
4'	832

**S1** - Excavate to a depth of 3.5' and haul for disposal.

**S2** - Excavate to a depth of 3.5' and haul for disposal.
