CLOSURE REPORT

BOPCO, L.P.
PLU #85
Eddy County, New Mexico
Unit Letter "H", Section 25, Township 24 South, Range 30 East
Latitude 32.190801 North, Longitude 103.827930 West
NMOCD Reference #2RP-2952

RE: Final Closure Report
Bopco – PLU #85
UL-H, Section 25, Township 24 South, Range 30 East
Eddy County, New Mexico
NMOCD Reference # 2RP 2952

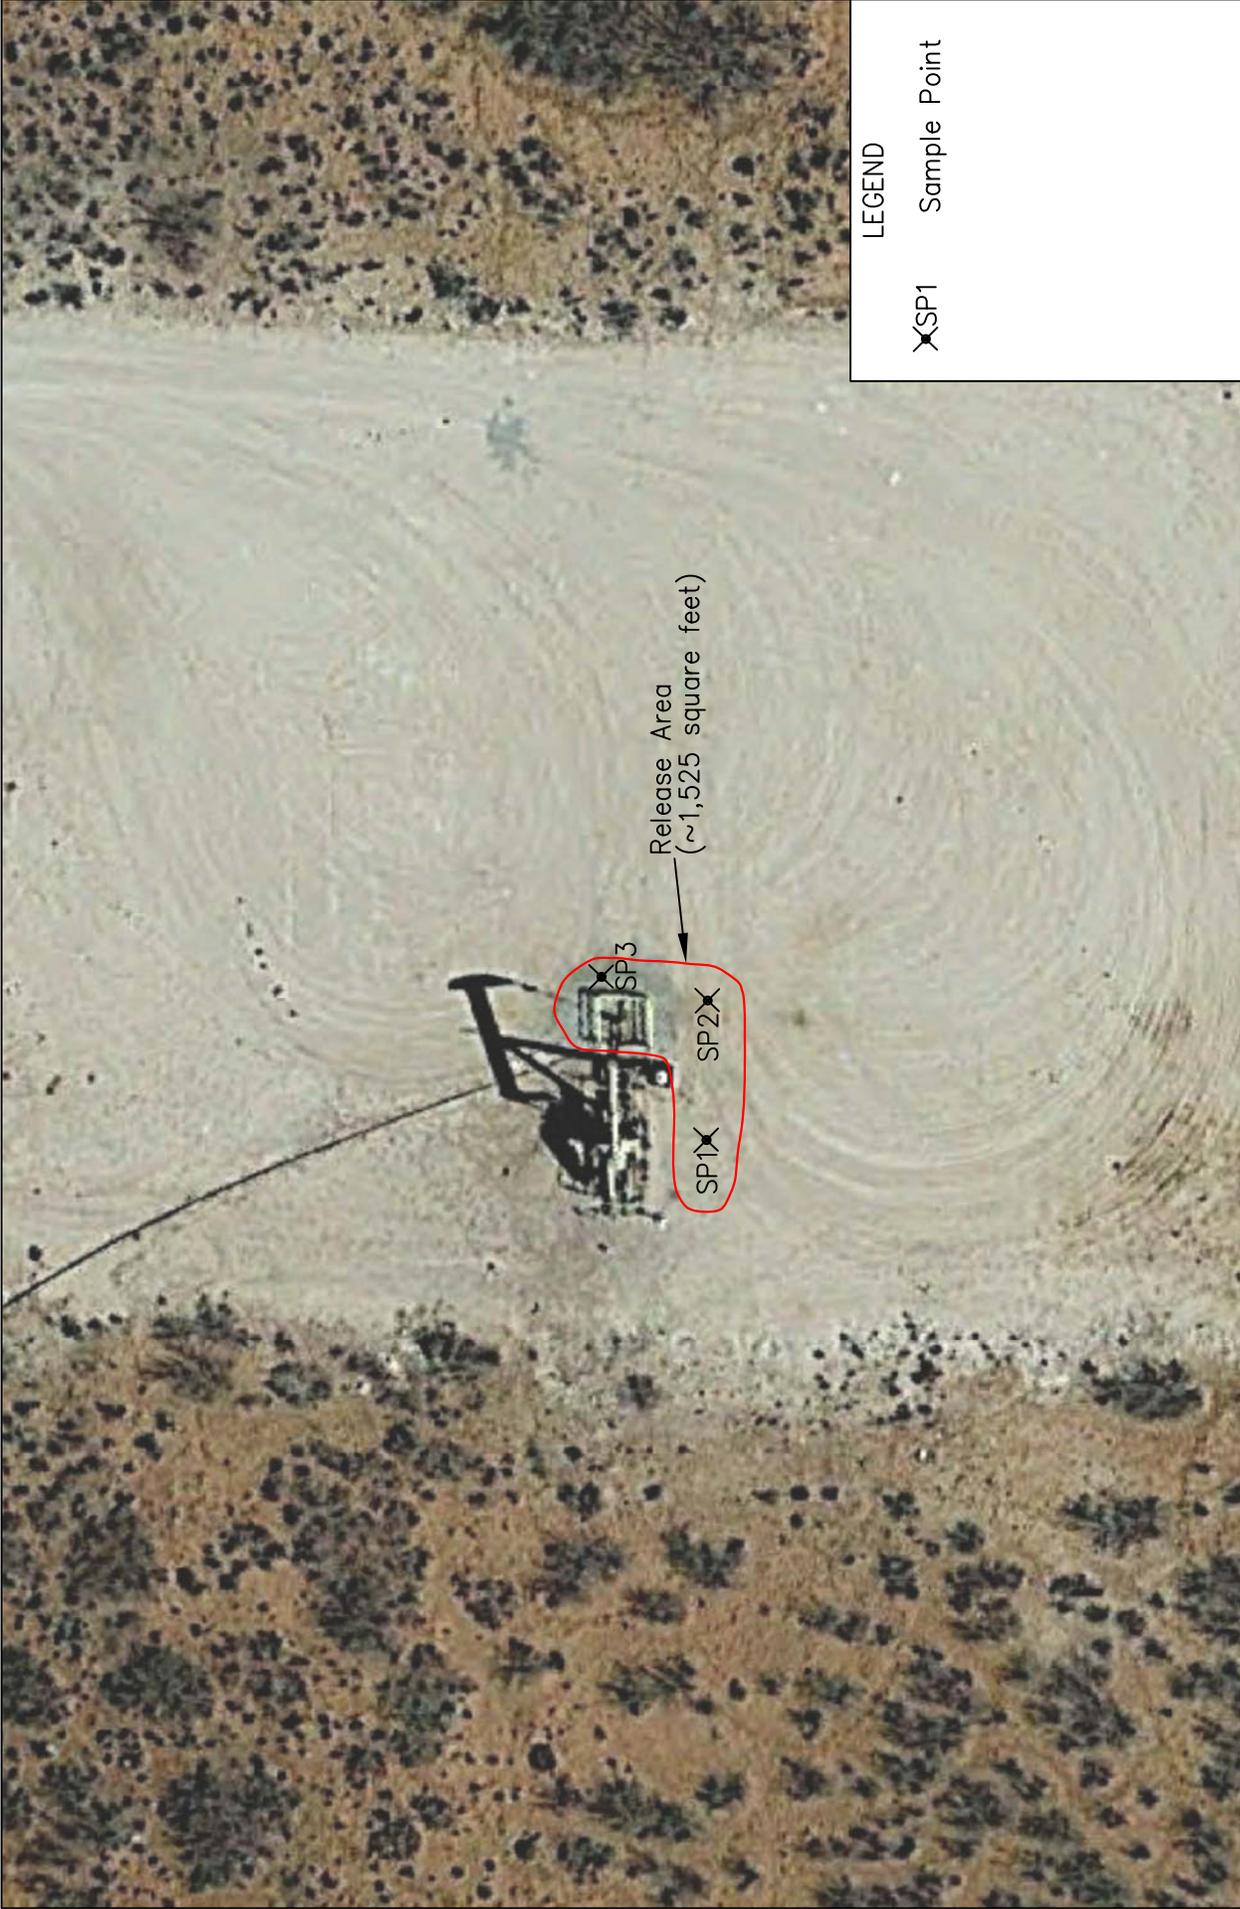
<p>Figure 3 Site/Sample Map Bopco, L.P. PLU #85</p>	<p>Eddy County, New Mexico SE 1/4 of NE 1/4, Sec. 25, T24S, R30E N 32° 11' 26.87" W 103° 49' 40.55" Elevation: 3,453 feet amsl</p>		<p>DWG By: D Dominguez August 2015</p>	<p>REVISED:</p>	
			<p>0 40 80 Feet</p>	<p>SHEET 1 of 1</p>

Release Area
(~1,525 square feet)

SP3

SP1

SP2

EPI personnel mobilized on the site on July 13, 2015 to collect soil samples via hand auger to determine the vertical extent of contamination. A total of six (6) soil samples were collected from three (3) sample locations; SP1, SP2, SP3. Three (3) of the six (6) samples, each collected at one (1) foot bgs, were sent to Cardinal Labs in Hobbs, New Mexico, for testing. Laboratory analytical results indicate the release area is void of Benzene, BTEX, TPH, and Chloride concentrations in excess of NMOCD Recommended Remedial Action Levels (RRALs) of 10 mg/Kg, 50 mg/Kg, 5,000 mg/Kg, and 1,000 mg/Kg, respectively (reference *Figure 3* and *Table 2*).

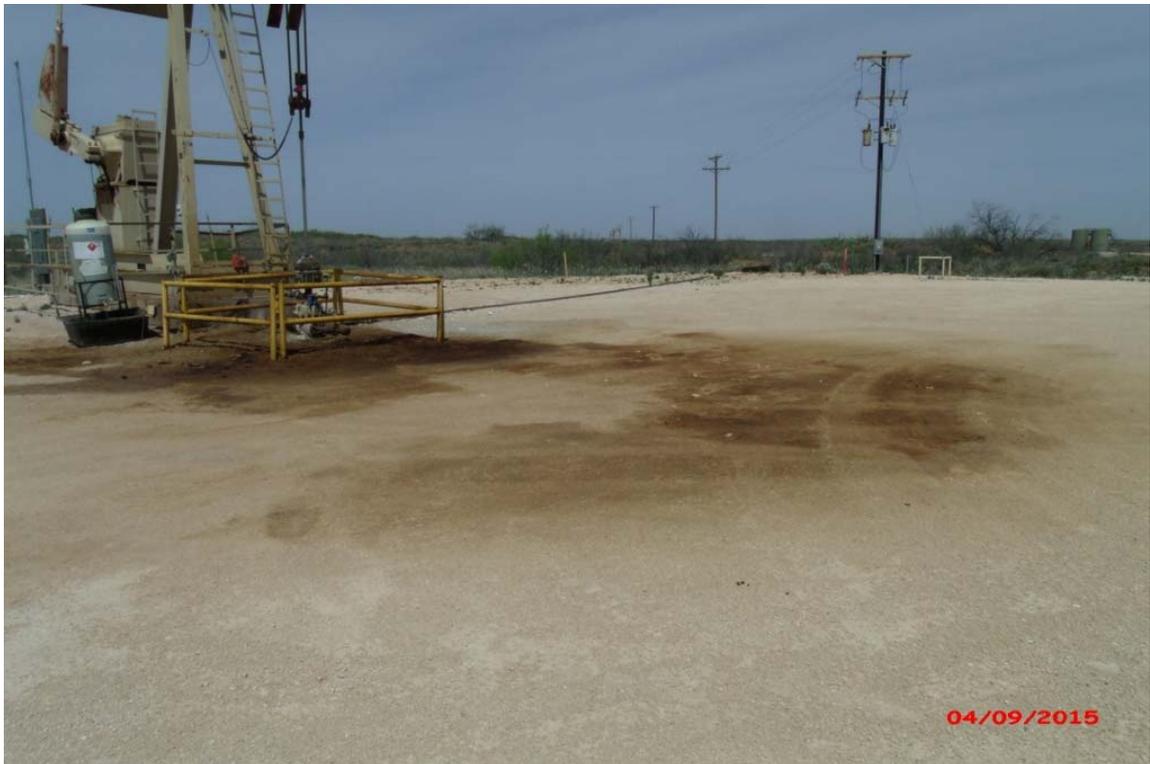
Photograph #2 – Looking across release area

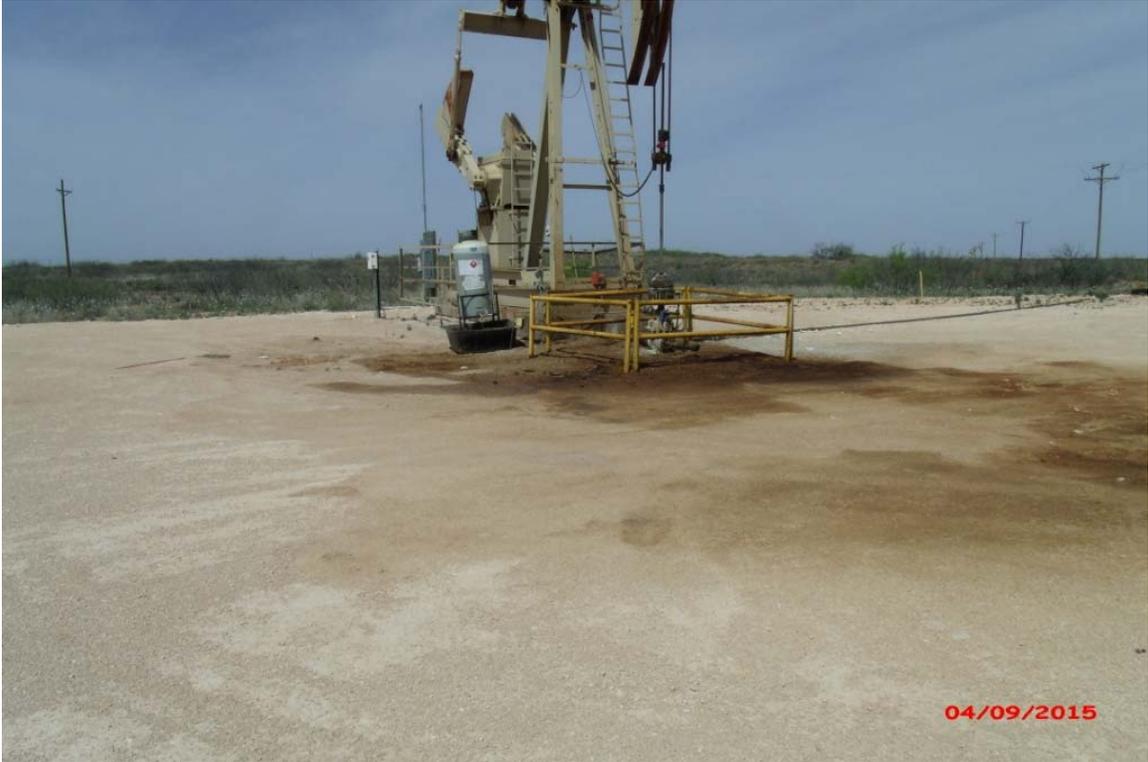
Photograph #3 – Looking across release area

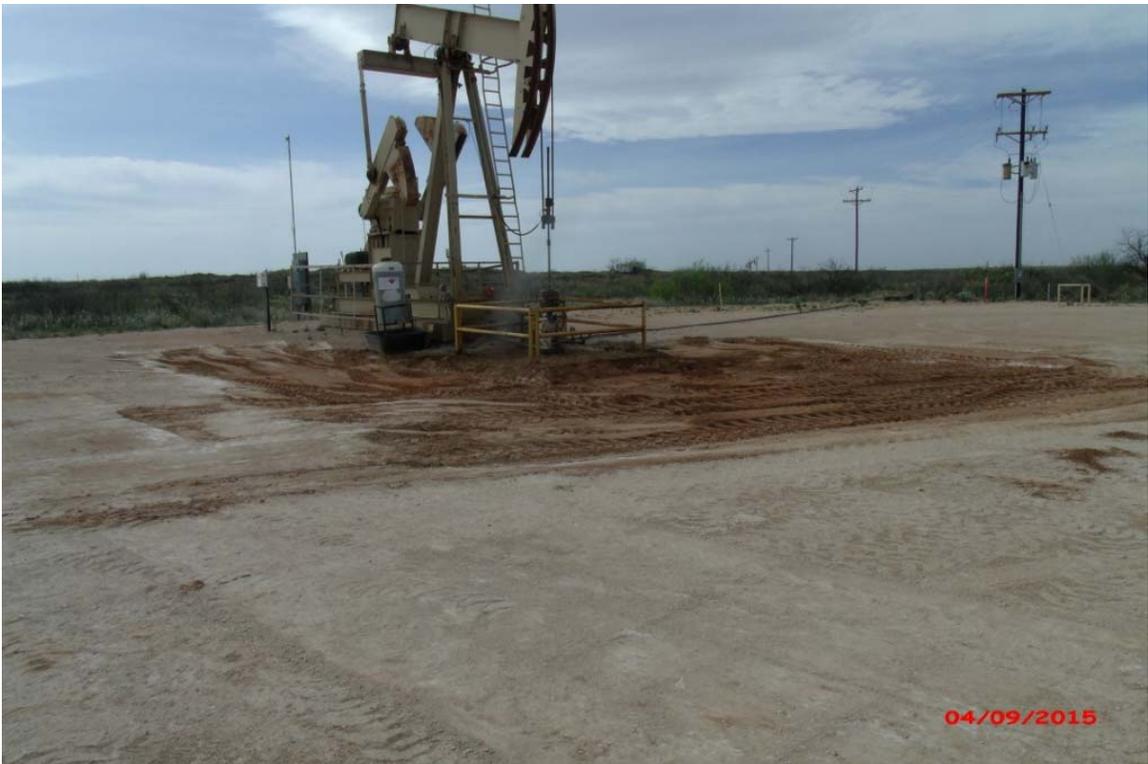
Photograph #4 – Excavated area

The release area was excavated to a depth of approximately six (6) inches bgs. Approximately 42 tons of contaminated soil was excavated and hauled to a state approved facility for disposal.

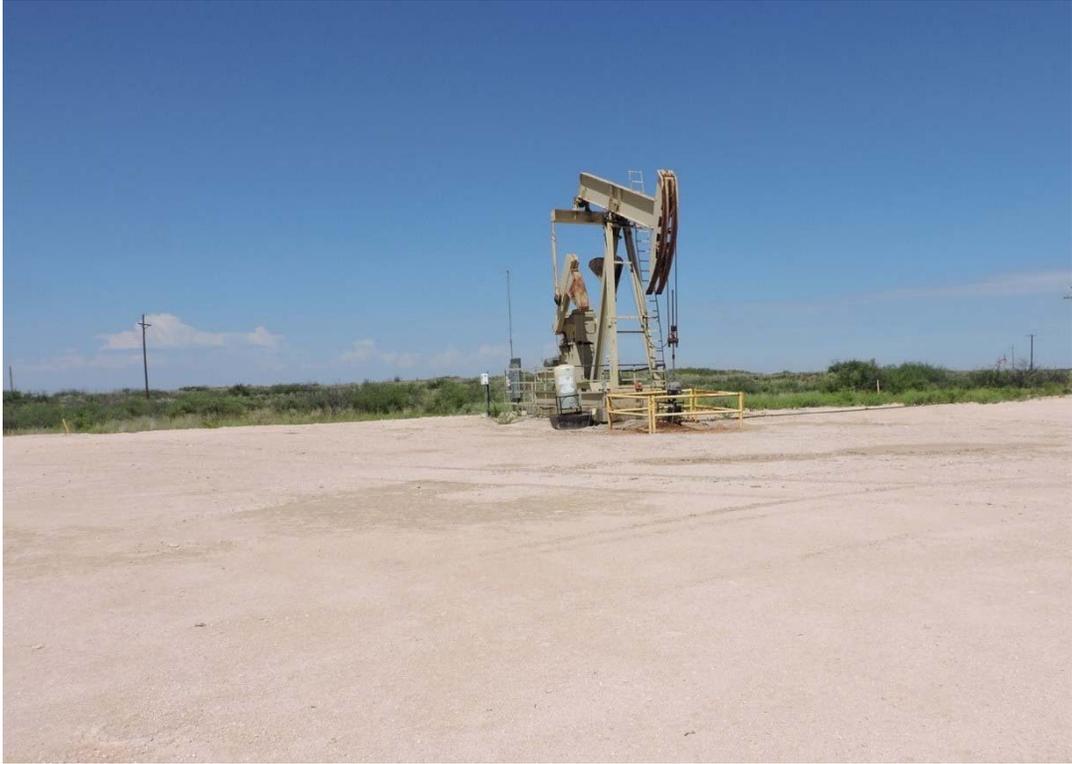
Photograph #5 – Backfilled area

With NMOCD approval the excavation was backfilled with approximately 42 tons of clean soil. All soil was free of rocks, clumps or deleterious material. The entire disturbed area was then contoured to blend with existing pad area and protected against wind/water erosion.

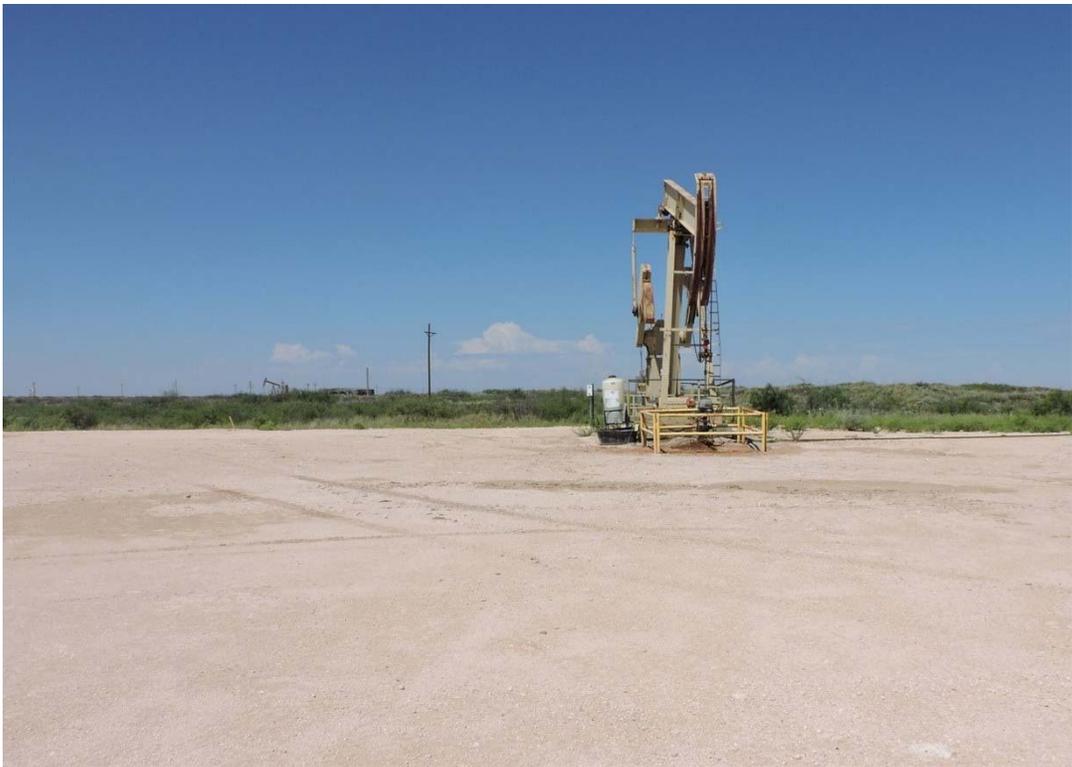
Photograph #6 – Backfilled area
