Bonnie Fed Com 1H

CLOSURE REPORT

Release Date: 6/18/2015

UL/P Sec 35, T25 south, R26 east, Eddy County, NM

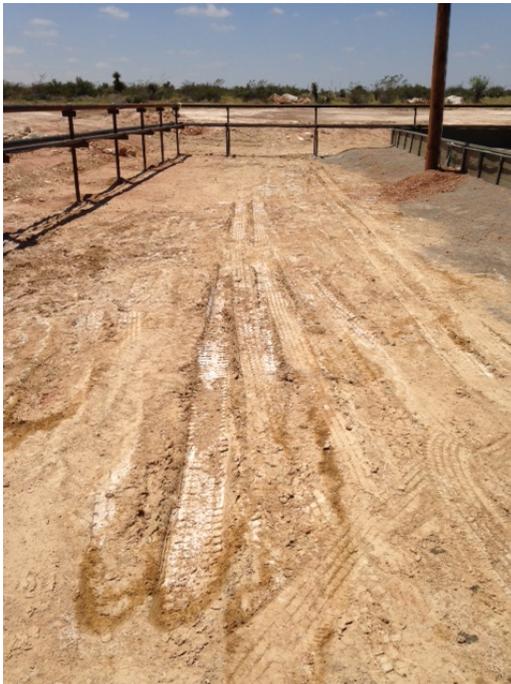
Spill area on east side of battery

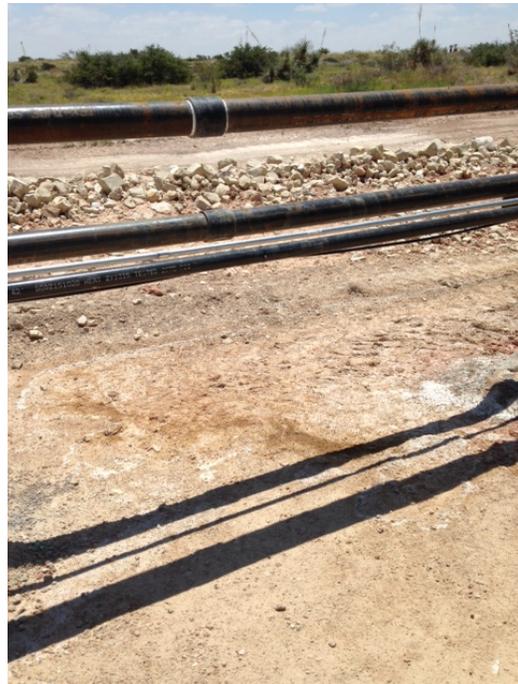
Spill area on east side of battery

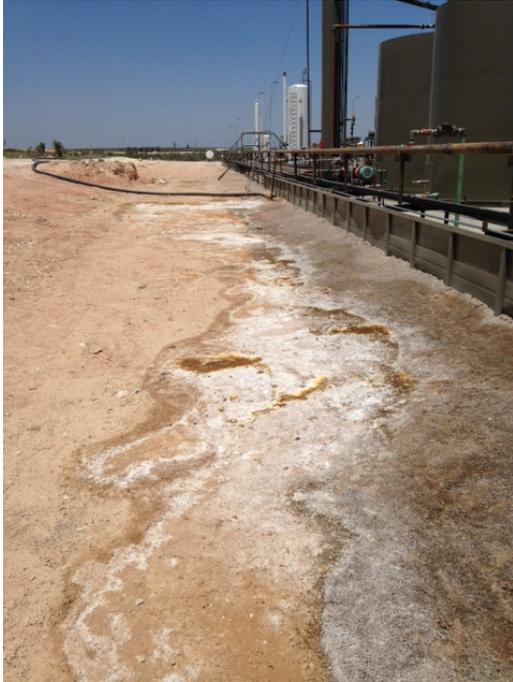
Spill area behind battery

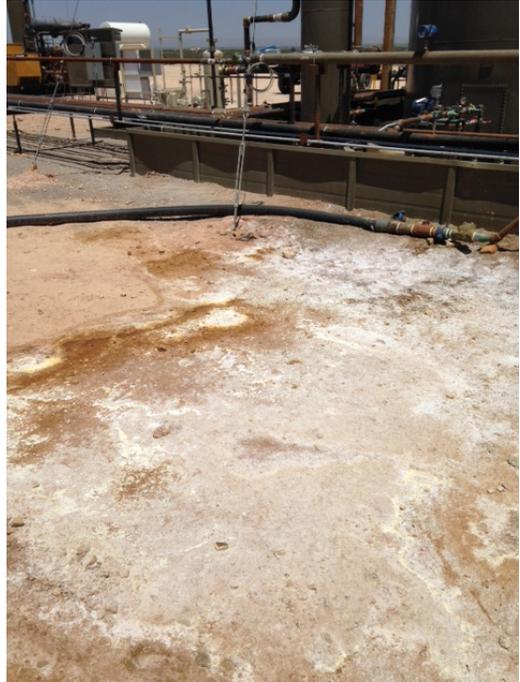
Spill area behind battery

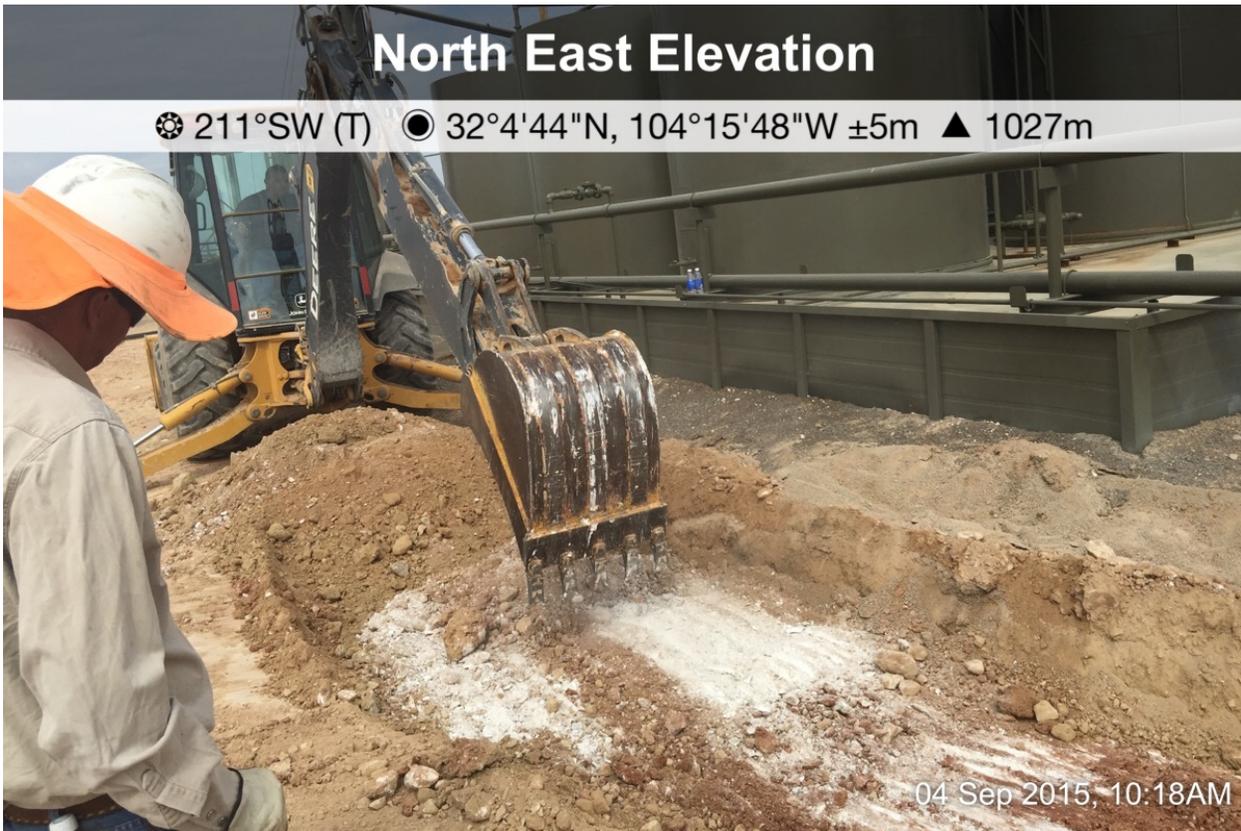
North Elevation

Digging to 1' bgs behind battery area

On September 1, 2015, Diversified Environmental personnel revisited the site to begin excavation. The entire spill area was dug out to 1' bgs. Clean caliche was brought in for backfill. All contaminated soil was hauled to an approved NM state disposal. Photos are attached (Appendix II).

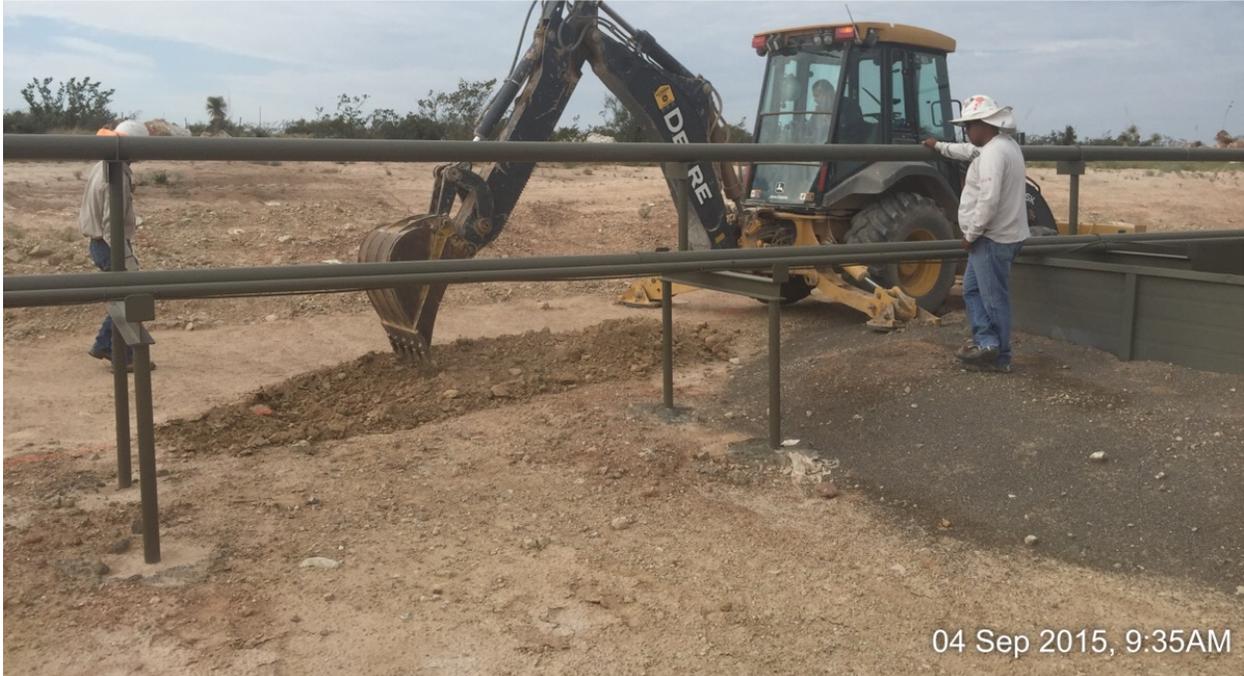
South East Elevation

Digging to 1' bgs behind battery

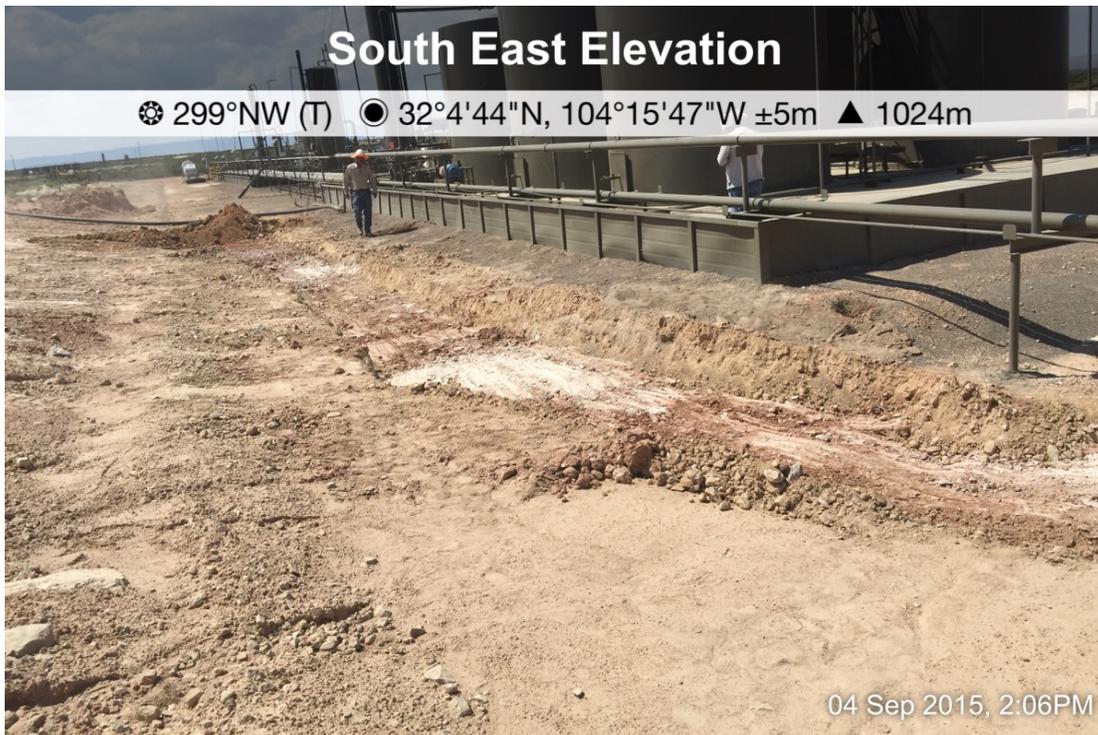
East Elevation

Excavated area behind battery

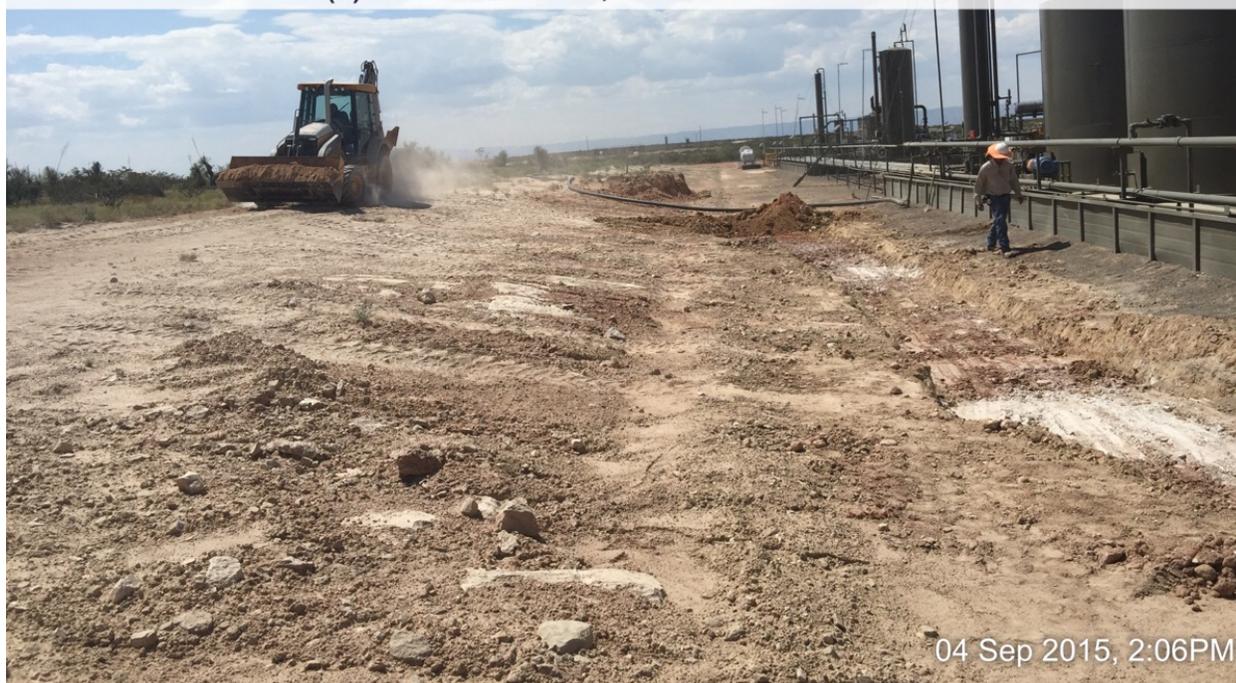
Hauling off contaminated soil after 1' excavation behind battery

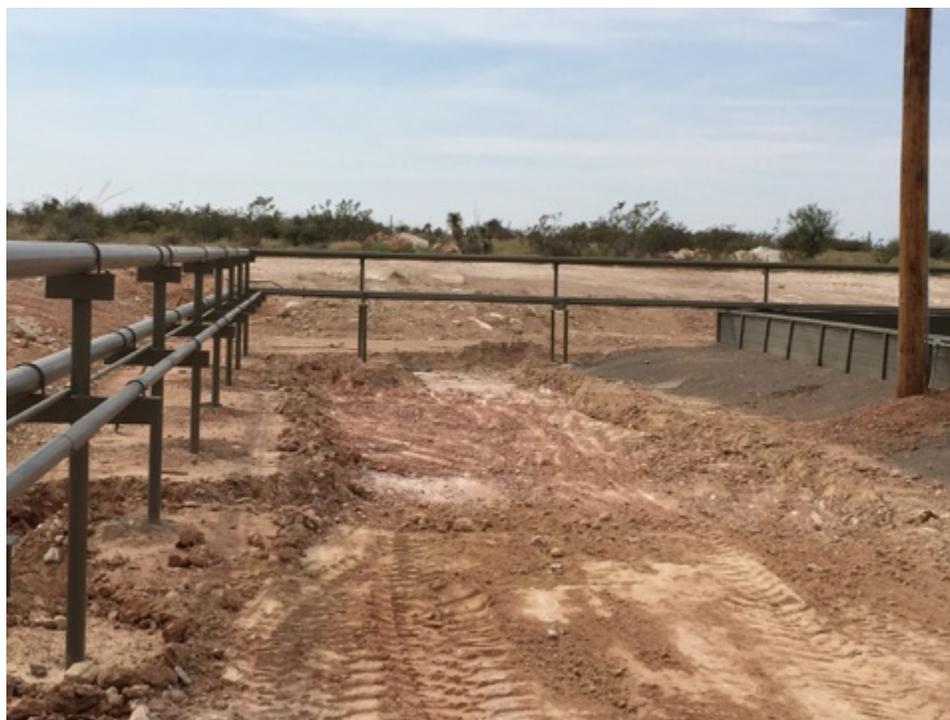
Excavated area on east side of battery

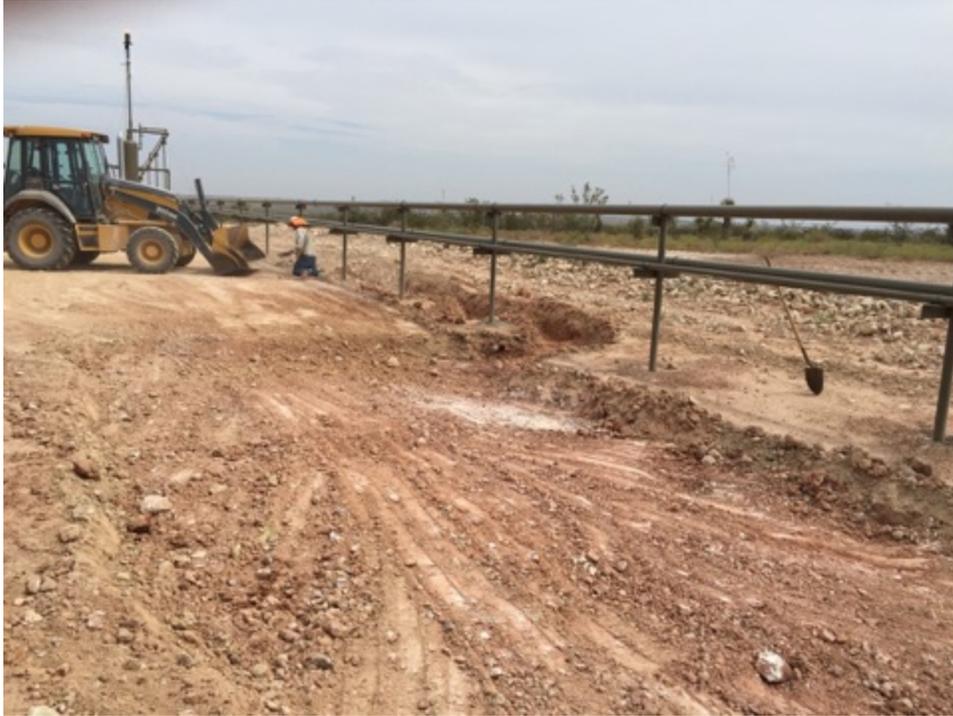
Excavating spill area on east side of battery

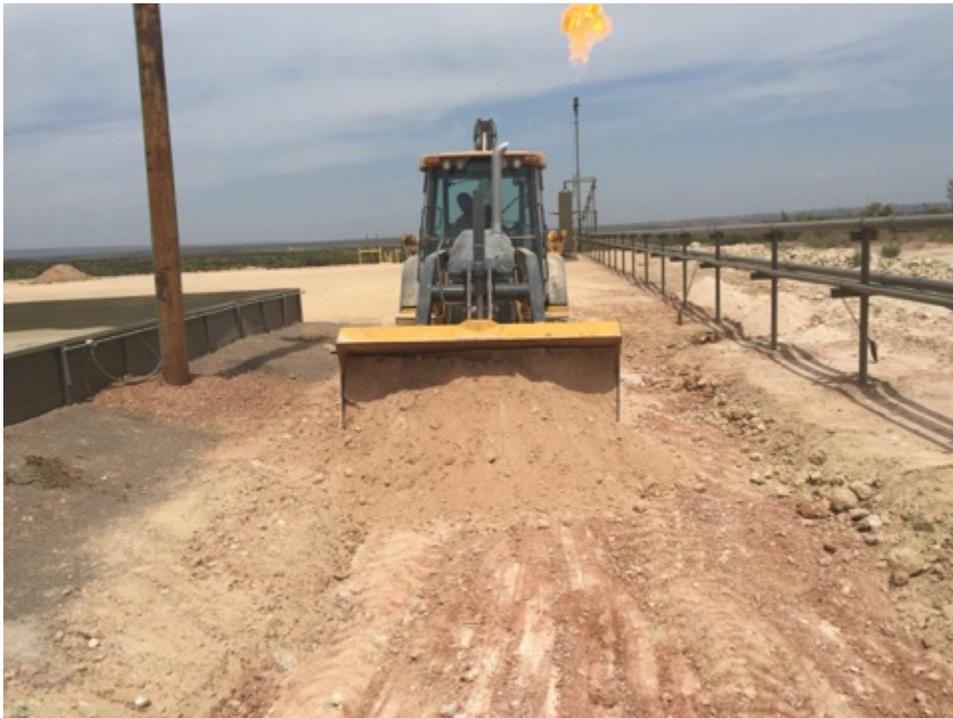
Backfilling excavated area with fresh caliche

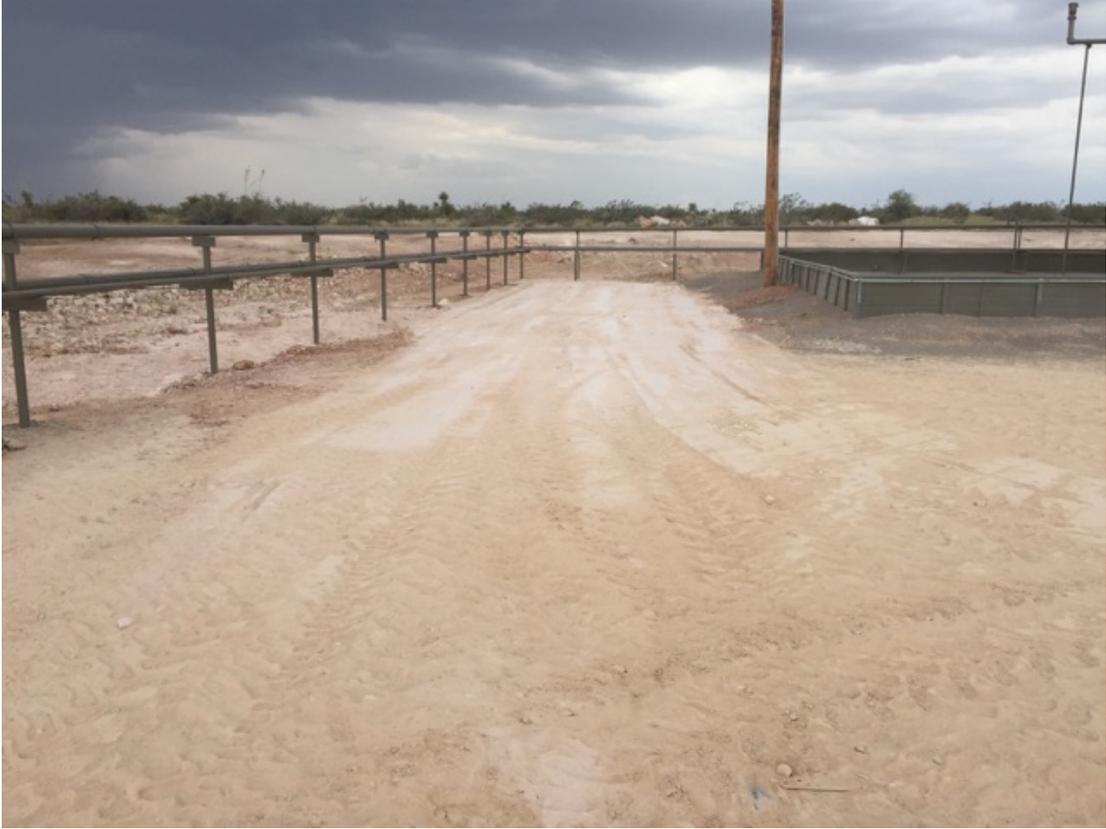
Completed location, east side of battery

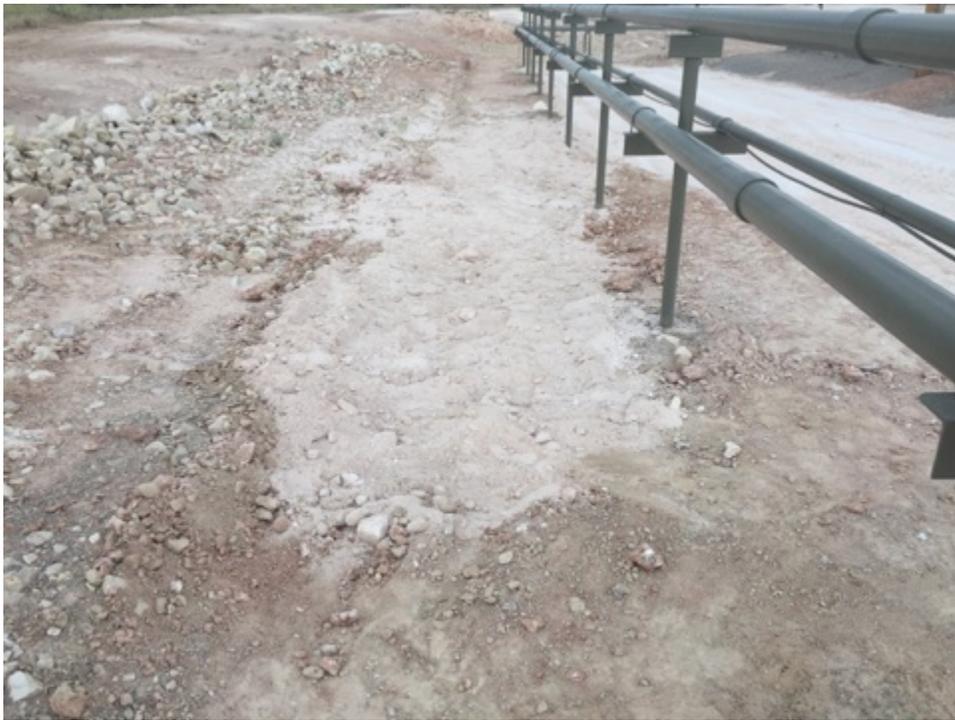
Completed location, behind battery

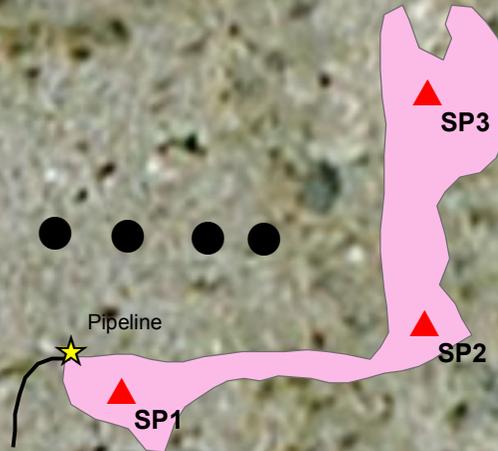
Site Diagram

**Spill Area:
2,842 sq. ft.**
