**RE: OCD Workplan for Release at Brushy Draw Fed 35-6H and Interim C-141 Report Unit B, Sec. 35, T25S R29E Eddy County, New Mexico**

**Area of Release and Soil Sample Locations**  
 RKI Exploration & Production  
 Brushy Draw 35-6H  
 Unit B, Sec. 35, Township 25S, Range 29E  
 Eddy County, New Mexico

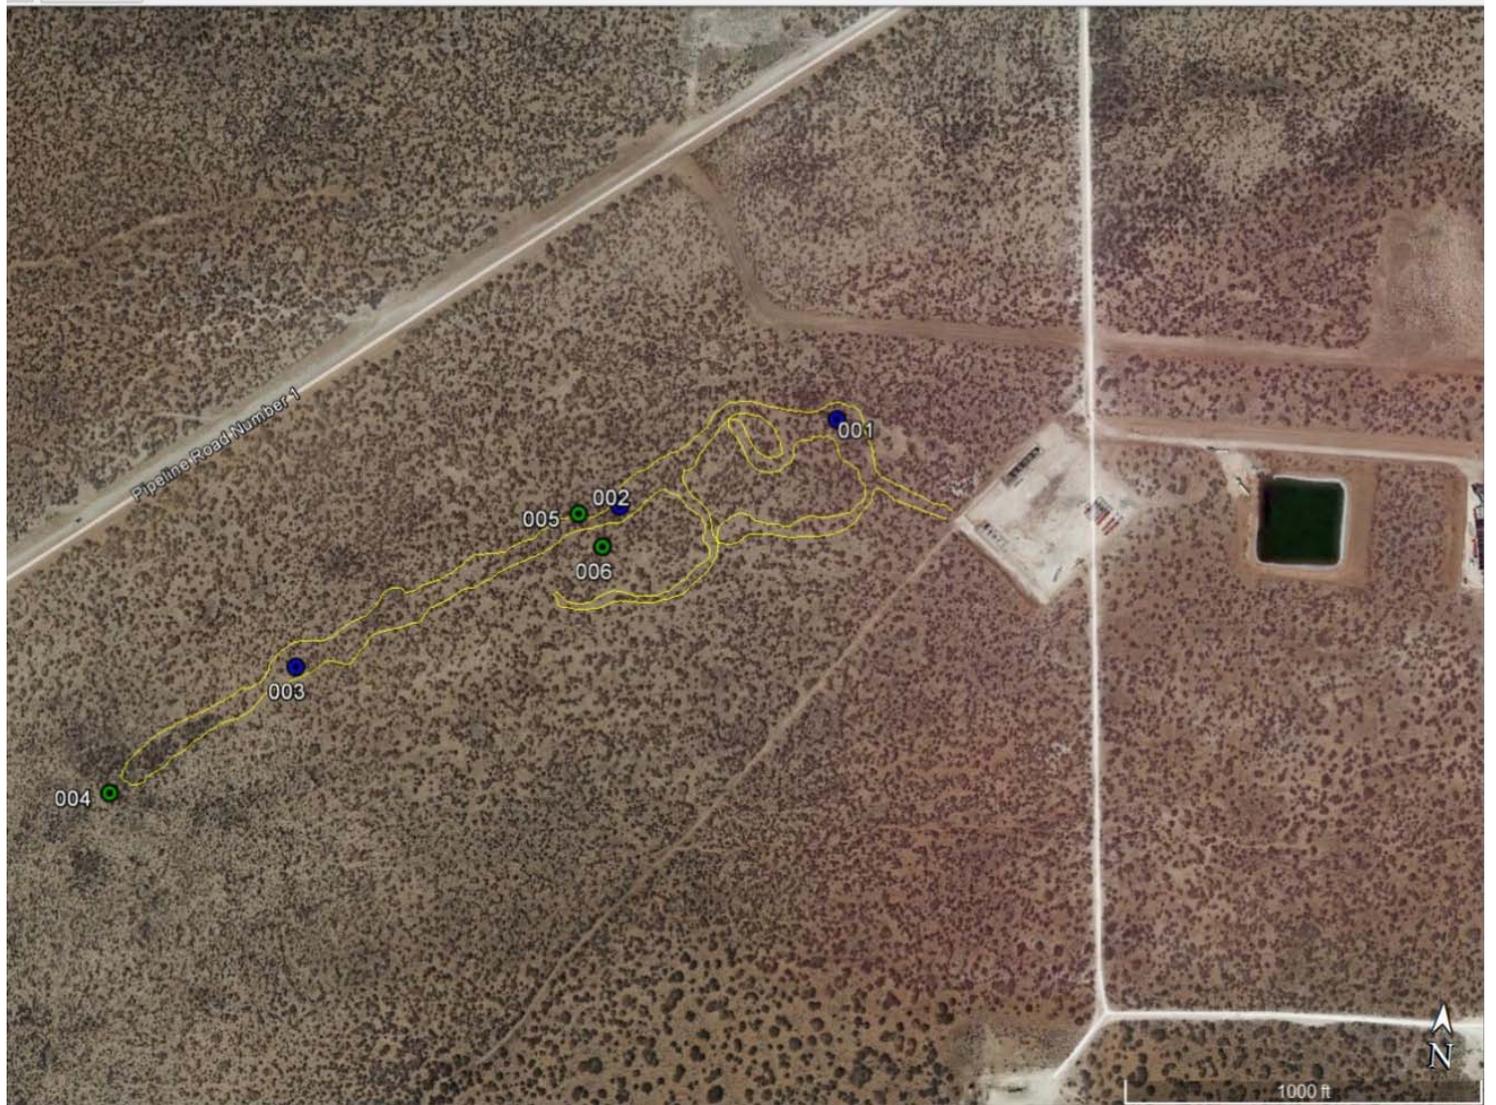
Drawn By:	ECS	
Date:	10/2/2015		Project Mgr.:	ECS	
2405 East County Road 123, Midland, Texas 79706					
Project No.:	RKIRTX0005			Figure:	1

RKI Exploration & Production (RKI) retained Enviro Clean Services, LLC (ECS) to collect soil samples and remediate the release at the Brushy Draw Fed 35-6H site located in Section 35, Township 25S, Range 29E, in Eddy County, New Mexico (approximately 32.092512°N, 103.953869°W), following a drilling mud and fracking fluids release. **Figure 1** is a site map depicting the area of release and soil sample locations.

For remediation, ECS recommends excavation in the vicinity of sample 003 until laboratory confirmation is below 1,000 ppm chlorides, or to 4-feet bgs, whichever occurs first. A BTEX sample will be collected near 003 for RRAL confirmation. In other areas the impacted soil is much shallower, and will be excavated, as determined with field screening and laboratory confirmation. Excavated areas will be backfilled with similar soil from a BLM-approved, weed-free source.

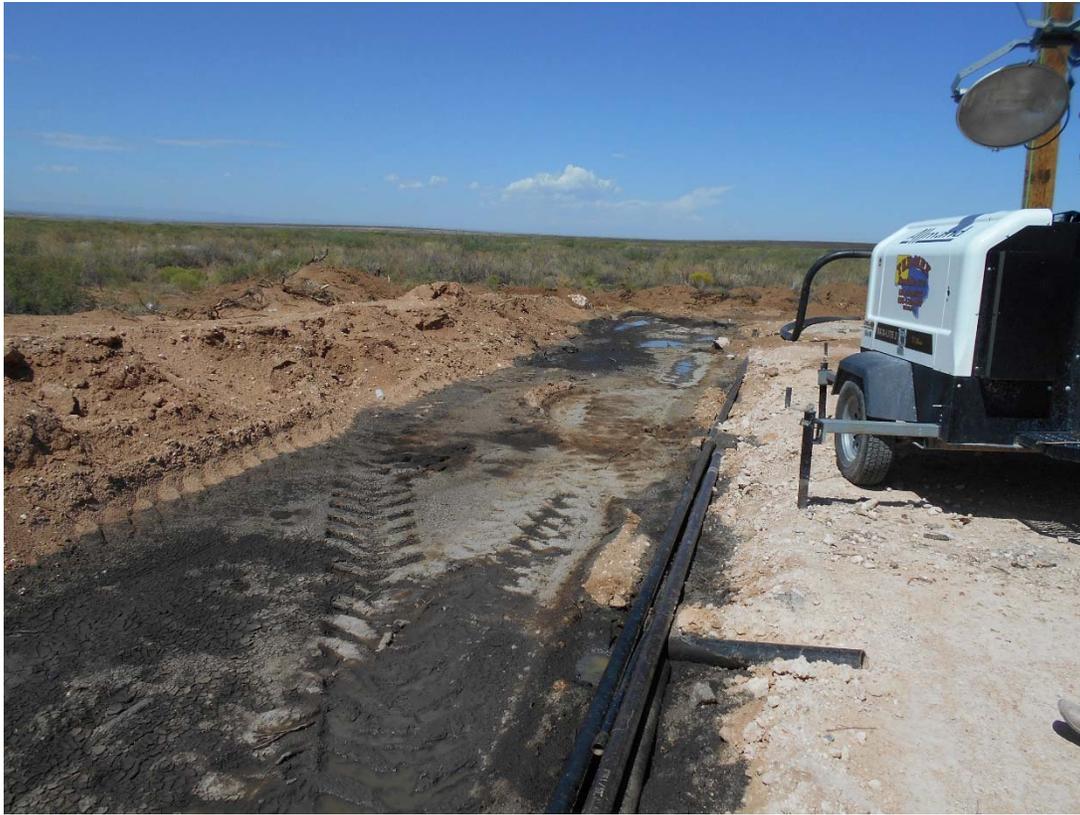
Viewing West. The flowpath leads west, off of the pad site.

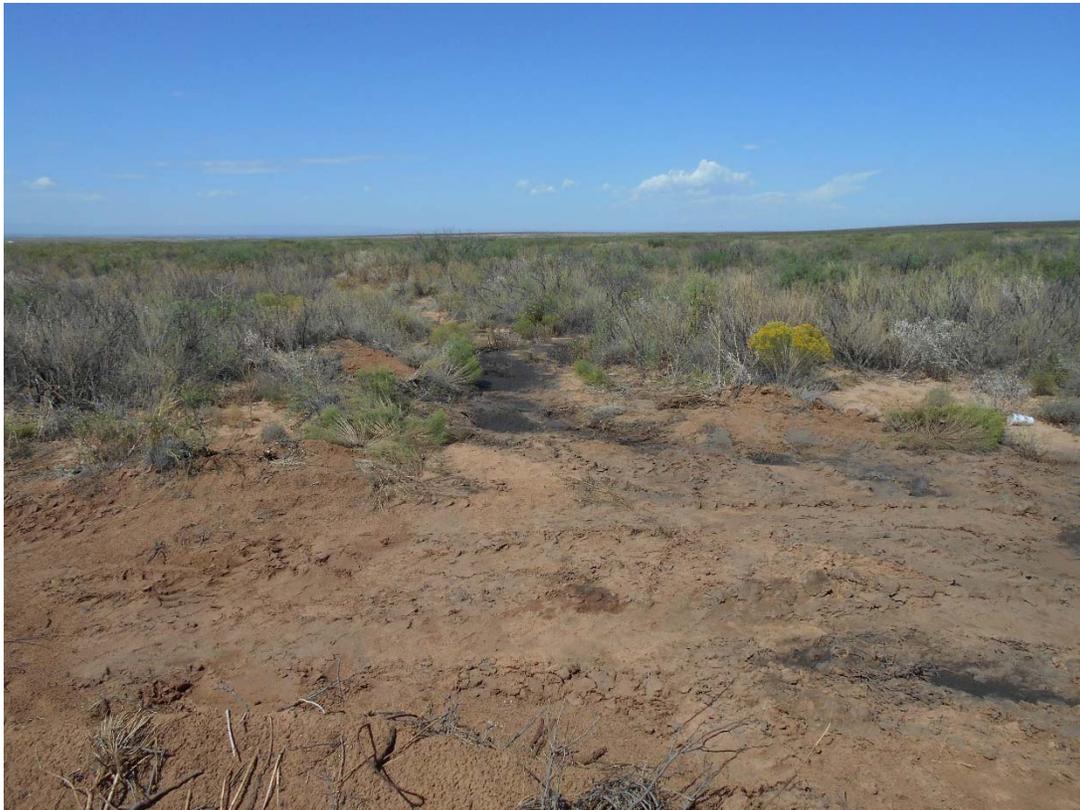
Viewing West. The release consisted of produced water, which left a notable soil discoloration.

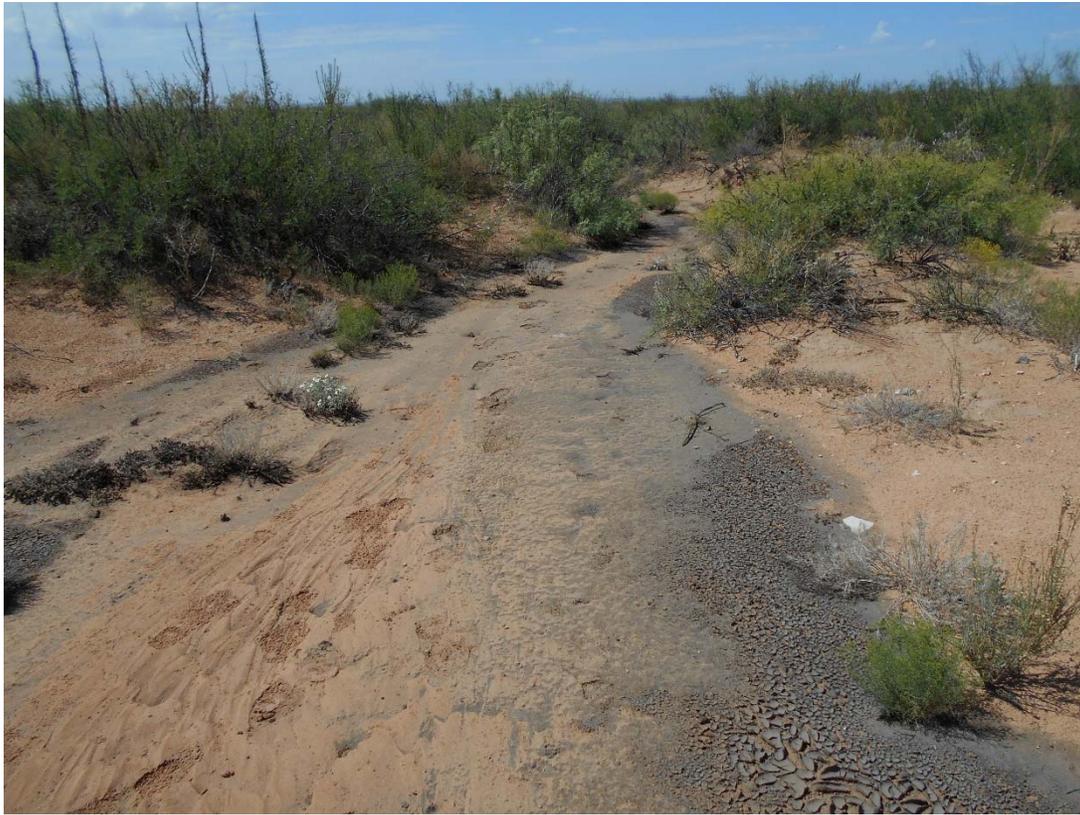
Viewing Southwest. This is a typical flow path, which aids in horizontal delineation. This is near Sample 002. Chloride concentrations were within WQCC standards at 1-foot below ground surface.

The flow path is narrow and long, approximate 3,000 feet in length. Screening samples will be selected at approximately 100 foot linear intervals, with laboratory samples selected at approximately 500 foot intervals. The results of both field screening and the laboratory analyses will be tabulated in a final report.

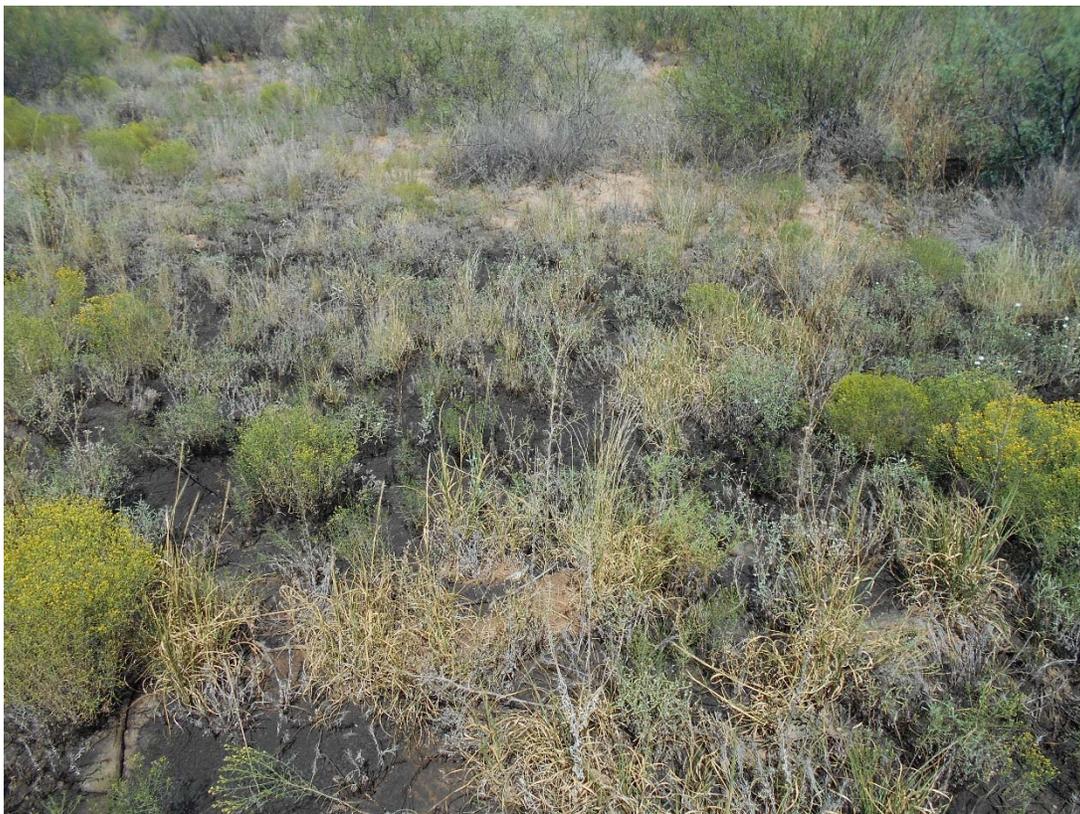
Viewing Southwest. Beyond Sample 003 location, the flowpath enters heavier desert vegetation. None appears to have been affected by the release.
