## **CLOSURE REPORT**

**BOPCO, L.P.**  
**PLU #423H Lact Unit**  
**Eddy County, New Mexico**  
**Unit Letter "I", Section 19, Township 25 South, Range 30 East**  
**Latitude 32.113042 North, Longitude 103.914955 West**  
**NMOCD Reference #2RP-3049**

RE: Final Closure Report  
Bopco – PLU #423H Lact Unit  
UL-I, Section 19, Township 25 South, Range 30 East  
Eddy County, New Mexico  
NMOCD Reference # 2RP 3049

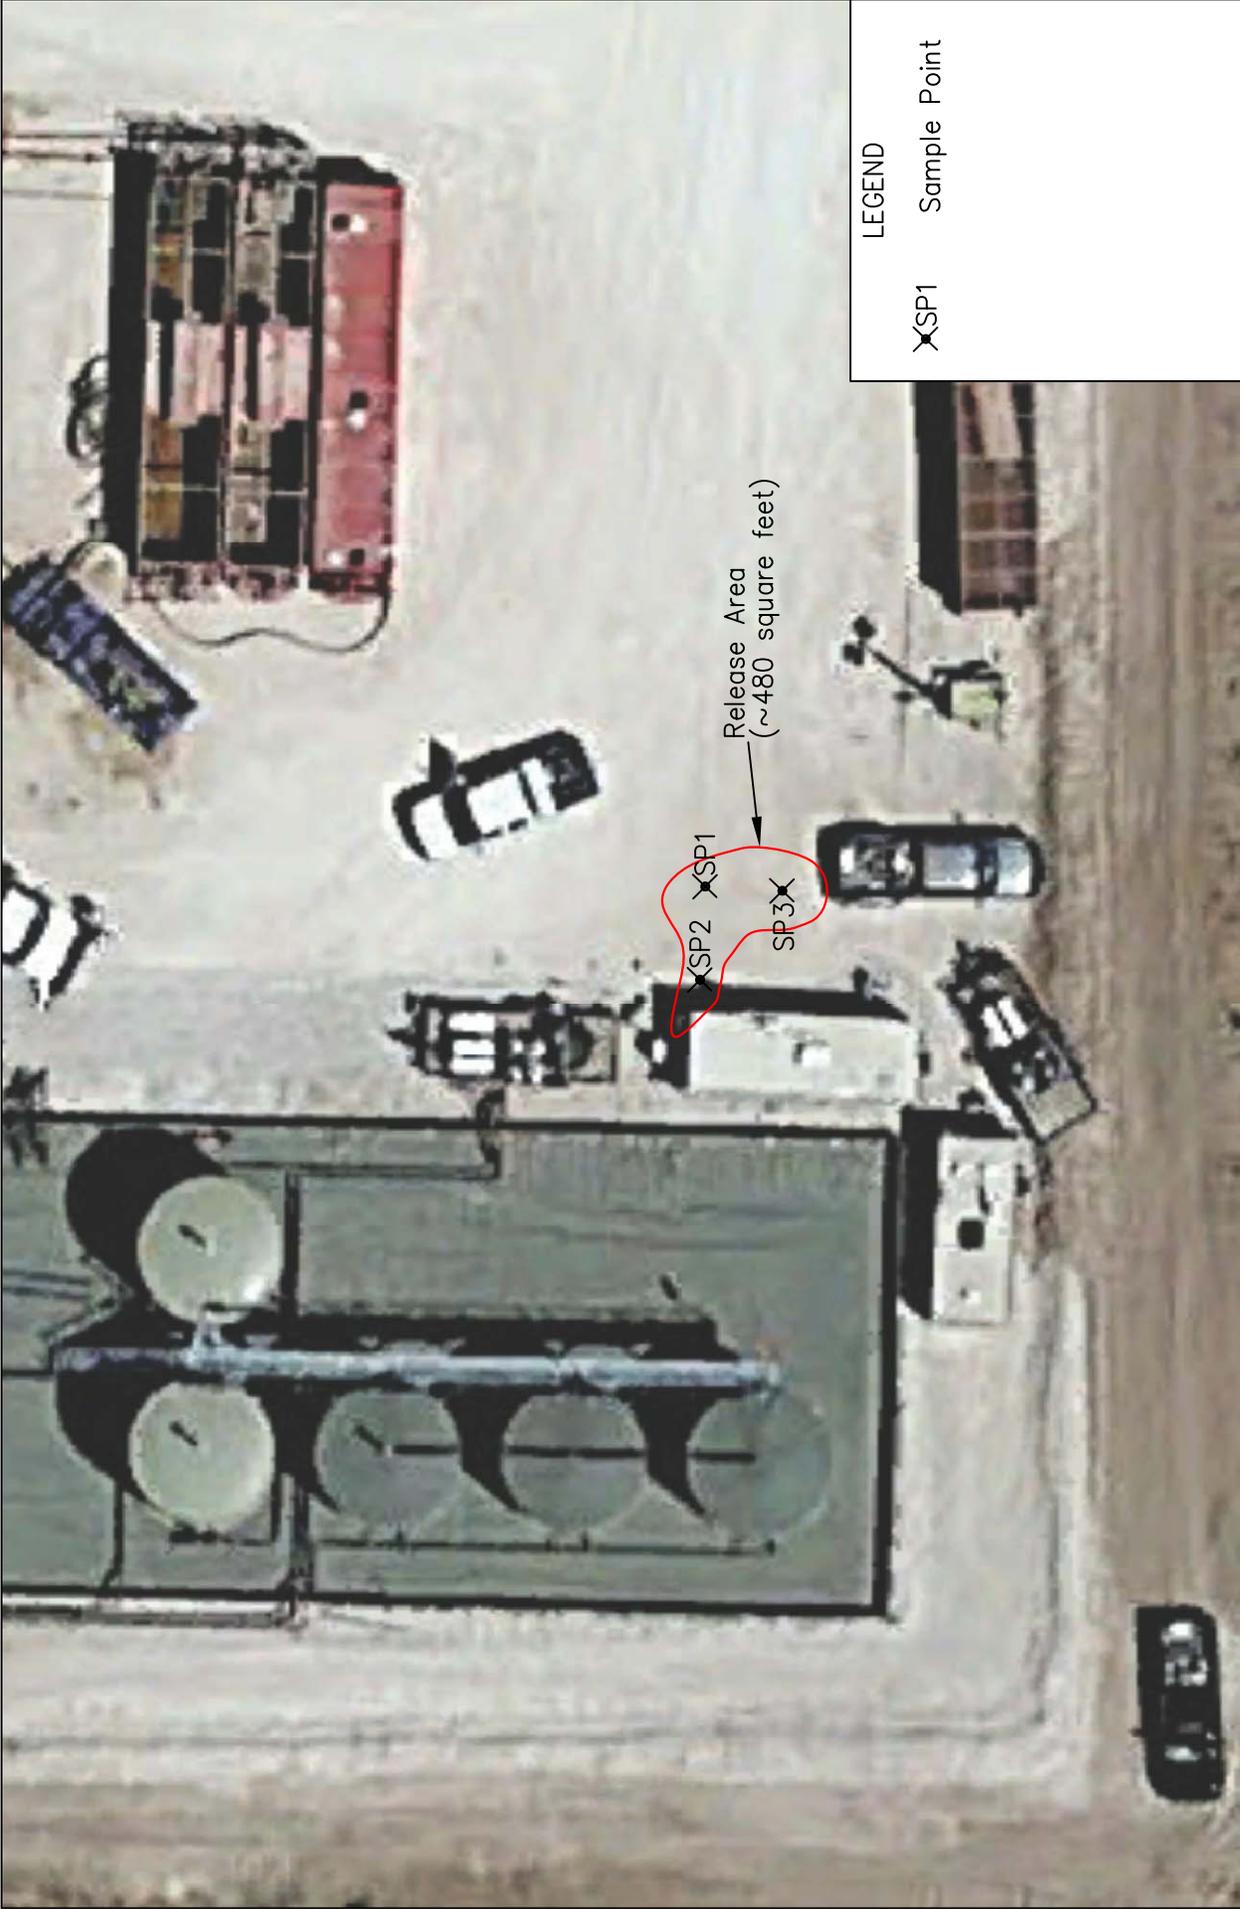
Figure 3  
Site/Sample Map  
Bopco, L.P.  
PLU #423H Lact Unit

Laboratory analytical results indicate the release area to be void of Benzene, BTEX, TPH and Chloride concentrations in excess of NMOCD Recommended Remedial Action Levels (RRALs) of 10 mg/Kg, 50 mg/Kg, 5,000 mg/Kg, and 1,000 mg/Kg, respectively (reference *Figure 3* and *Table 2*).

XSP1 Sample Point

On September 21, 2015 the release area around SP1 was excavated to a depth of one (1) foot bgs; the remainder of the release area was surface scraped, with approximately 5 cubic yards of contaminated material excavated and transported to a state approved disposal facility.

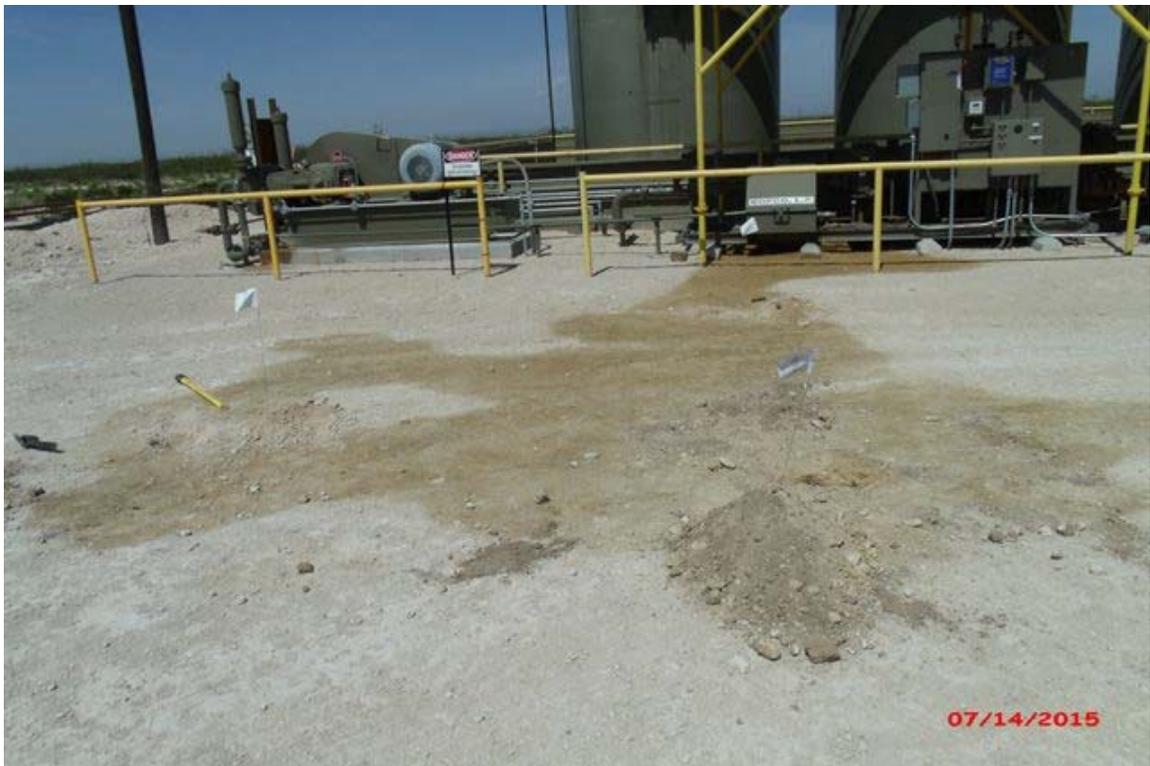
Air eliminator on battery LACT unit failed and oil was released. Standing fluids were recovered and the air eliminator was repaired. The leak affected approximately 480 square feet of well pad.

Photograph #2 – Looking across release area

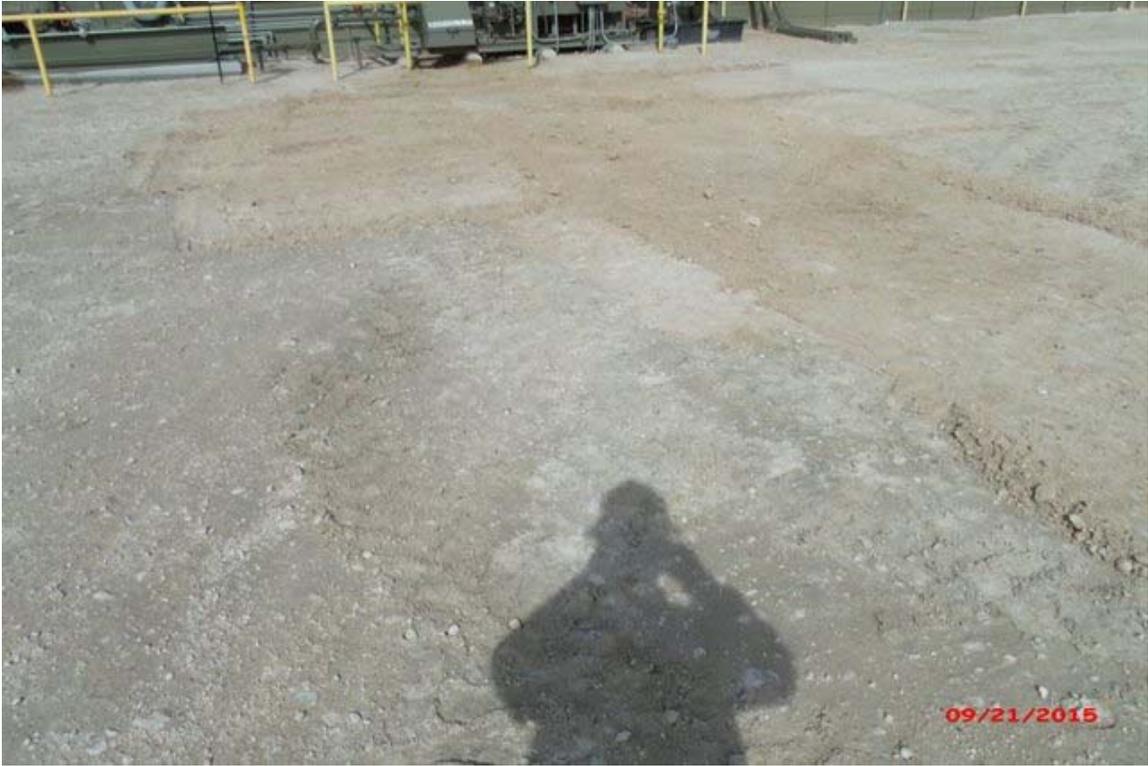
Photograph #3 – Excavated area

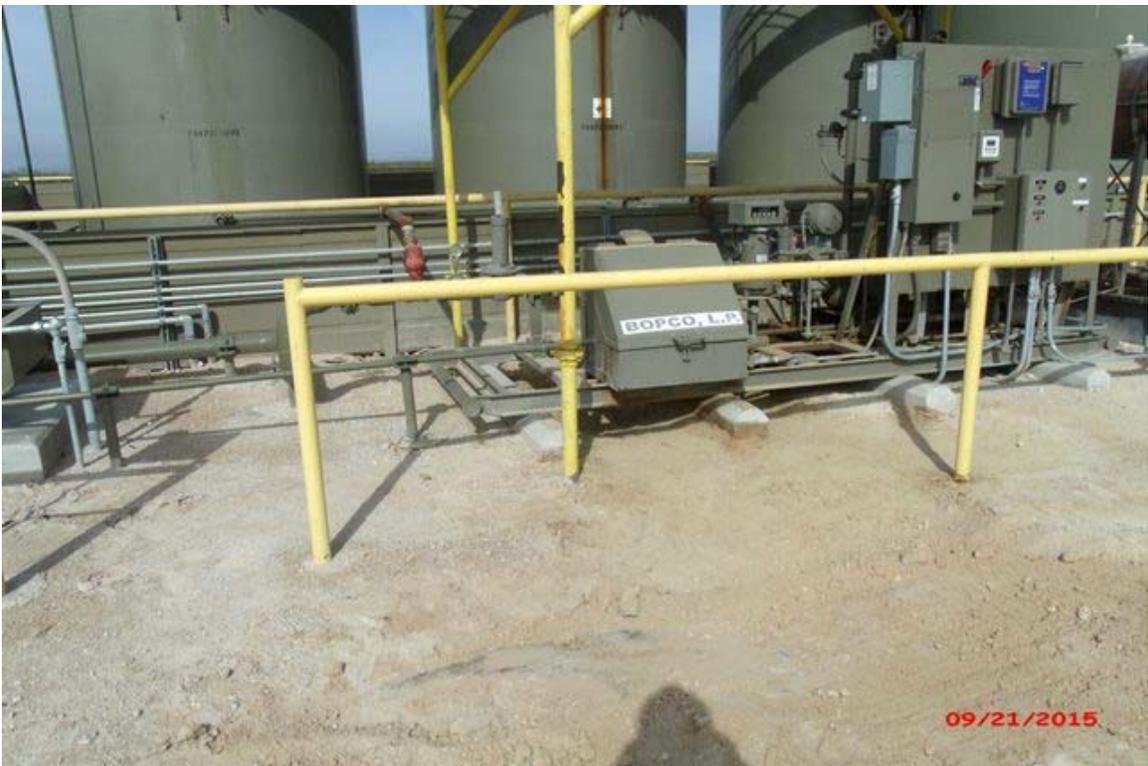
Photograph #4 – Excavated area

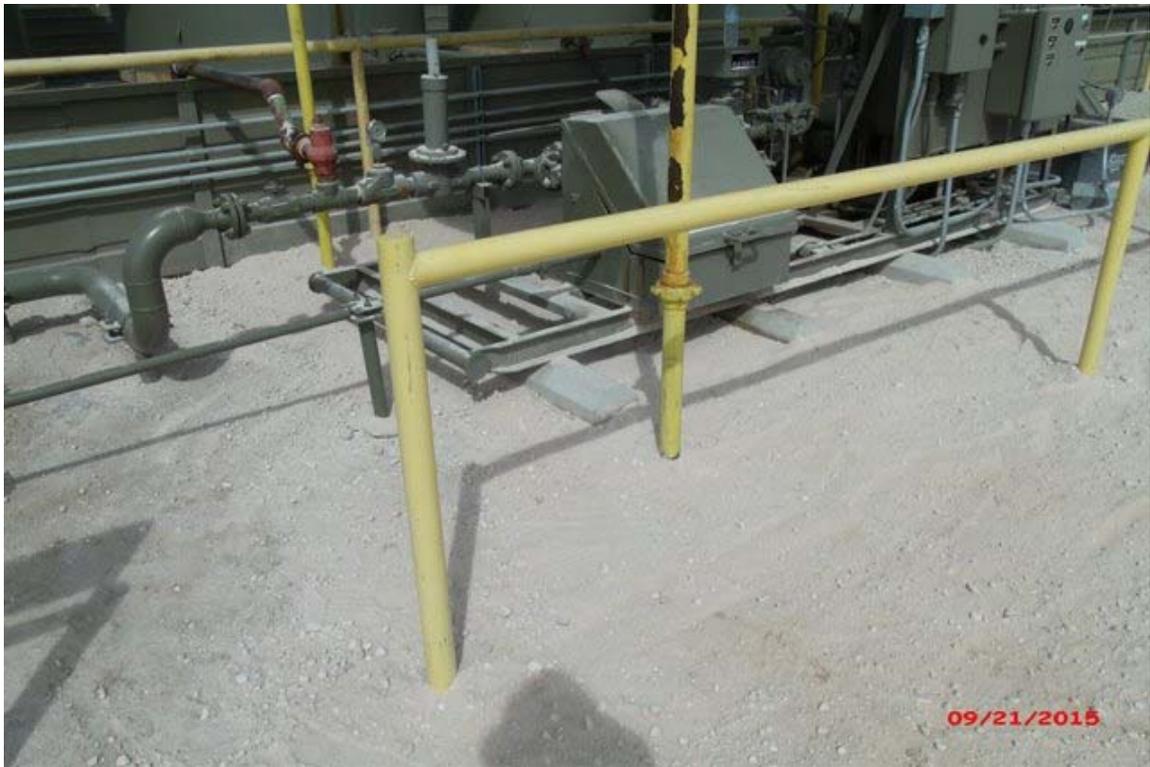
Photograph #5 – Backfilled area

On September 21, 2015 the excavation was backfilled with approximately 5 cubic yards of clean soil and contoured to blend with existing pad area to protect against wind/water erosion.

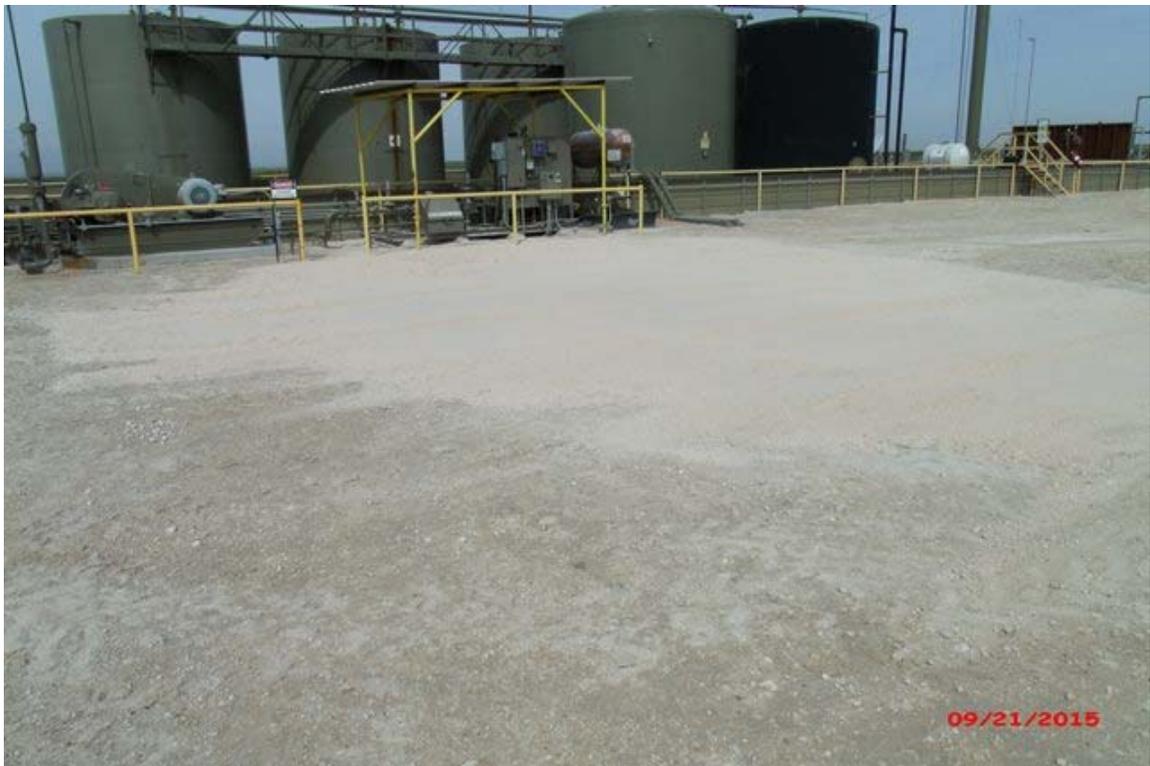
Photograph #6 – Backfilled area
