SUBJECT: SOIL REMEDIATION WORK PLAN FOR INCIDENT 2RP-3354 COPPERHEAD 31 FEDERAL COM #2H, EDDY COUNTY, NEW MEXICO

SOIL REMEDIATION WORK PLAN FOR INCIDENT 2RP-3354

COG OPERATING LLC

COPPERHEAD 31 FEDERAL COM #2H
API# 30-015-39791
SECTION 31, T26S R29E, NMPM
EDDY COUNTY, NM

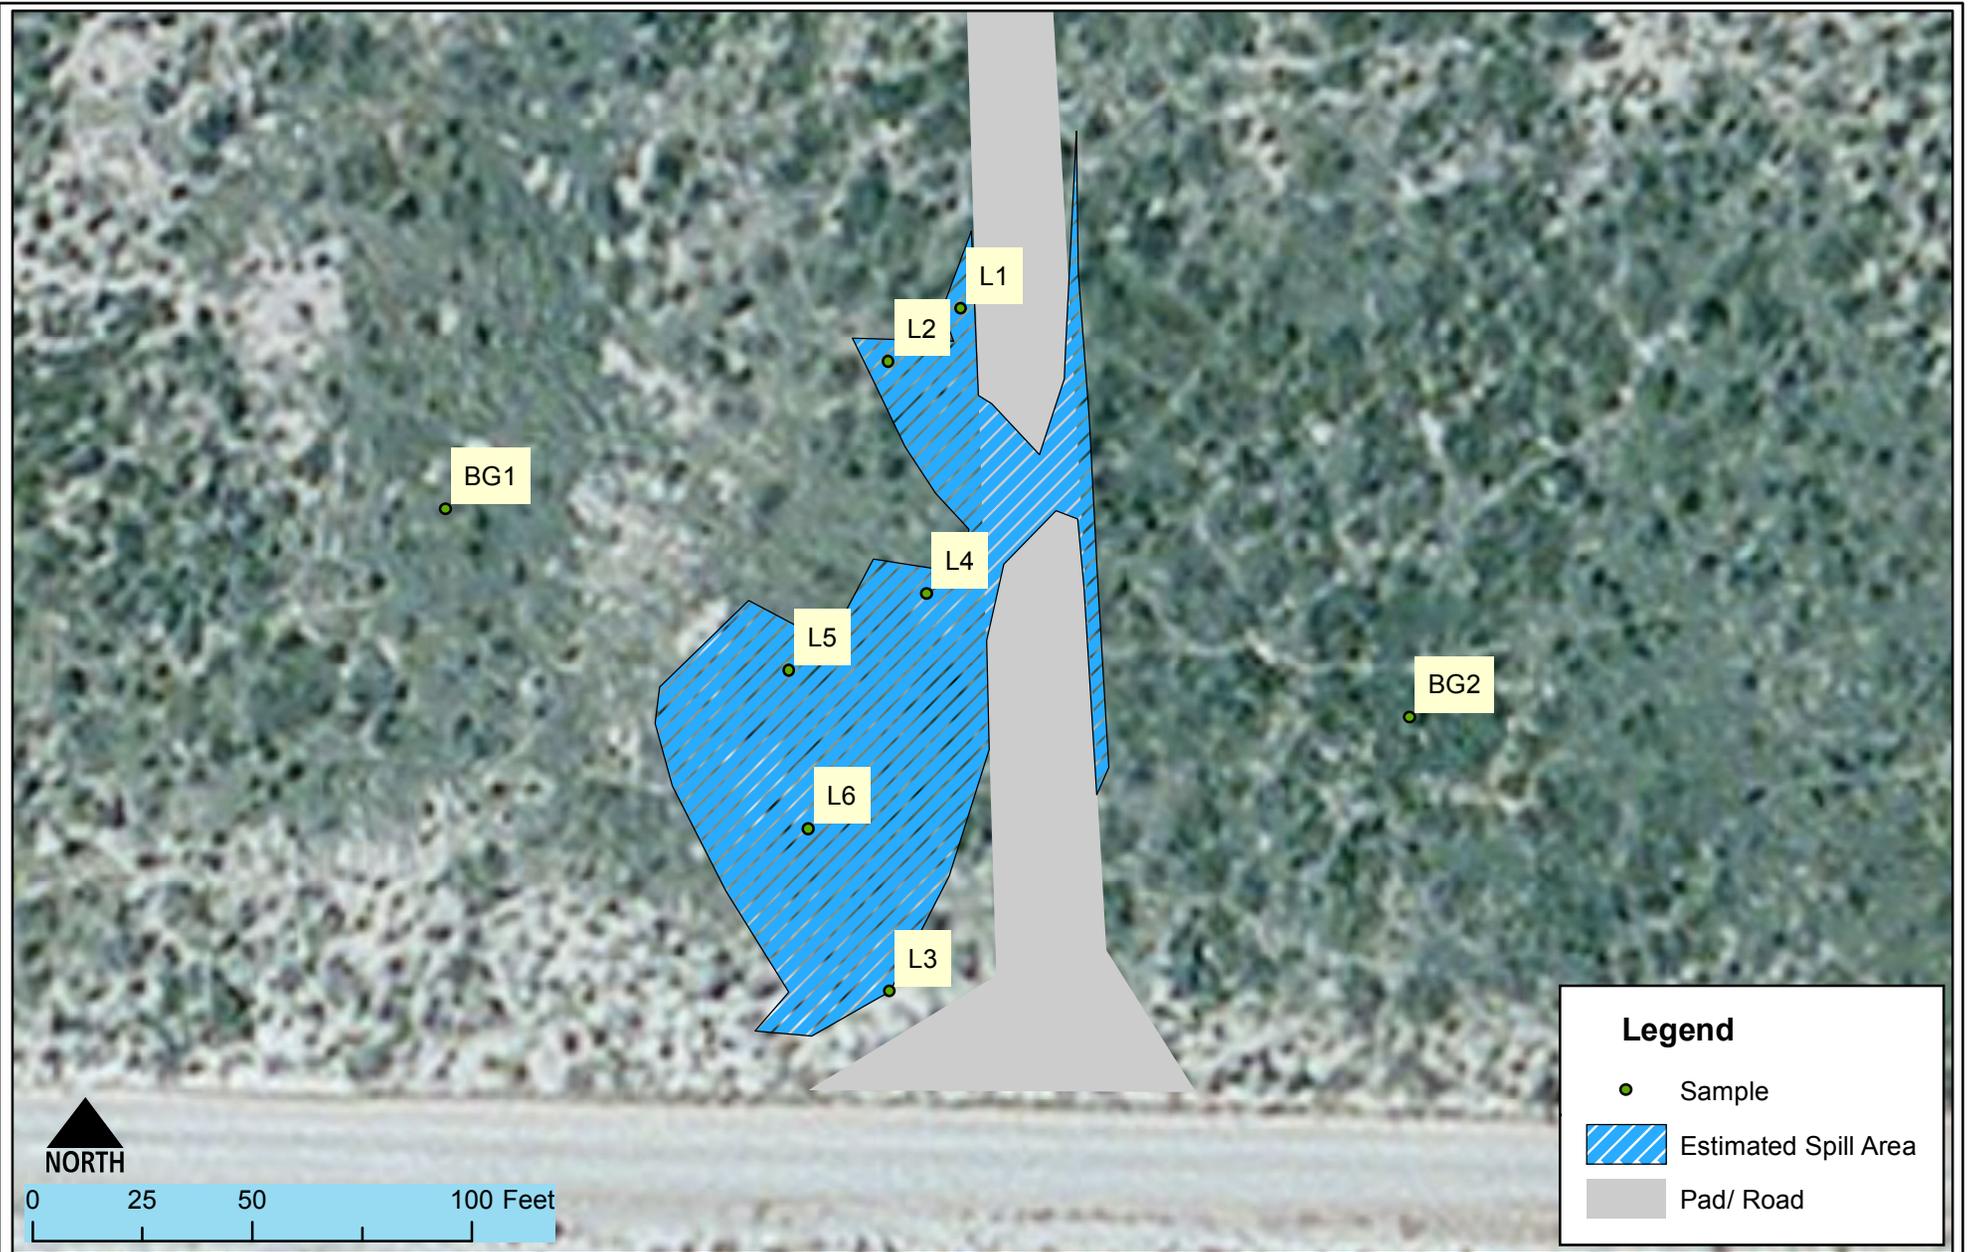
FIGURE 2

The release site is located approximately 2 miles (> 1,000 feet) east of Pecos River, in an area administered by BLM with an elevation of approximately 2,900 feet above sea level. After evaluation of the site using aerial photography and topographic maps, depth to groundwater is estimated to be less than 100 feet but greater than 50 feet below ground surface (bgs). Figure 1 depicts the site vicinity and Figure 2 depicts the site details and sample locations.

Soil contaminant concentrations found during the initial delineation are illustrated in Figure 2. A summary of the laboratory analyses is included in Table 2. Laboratory reports are included in Appendix A.

SITE DETAILS AND SAMPLE LOCATIONS MAP

Site Detail and Sample Locations
 COG-Copperhead 31 Fed Com 2H
 Malaga, New Mexico
