**Devon Energy Production Co LP  
Cotton Draw 10 Fed 3H  
Closure Report**

**Unit Letter A, Section 10, T25S, R31E  
Eddy County, New Mexico  
2RP-2983**

**October 16, 2015**

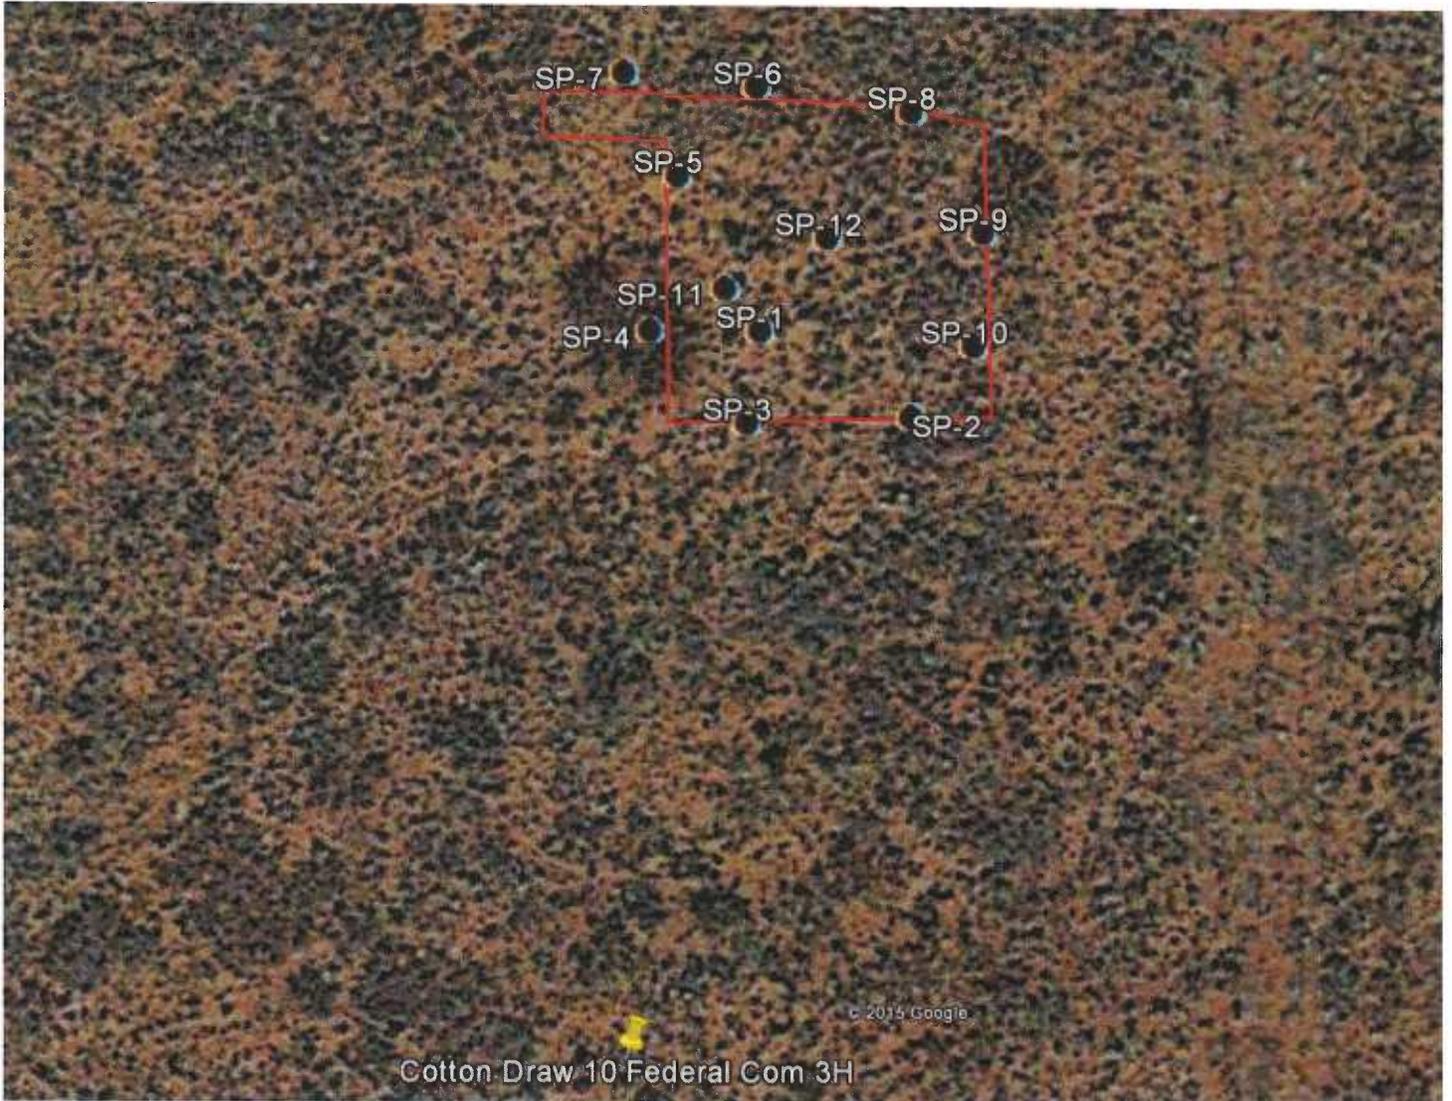
**Figure 2  
Site Plan**

5' radius around the dead man should remain undisturbed. These two areas were not excavated (Figure 2).

On October 05, 2015 and based on the above analytical confirmation: SESI personnel were on site with Custom welding of Hobbs, NM. The excavated area was lined with a 20 mil. Liner. The lined area was backfilled with a layer of fresh imported topsoil and capped with Caliche (Appendix C). All impacted soils were removed to an NMOCD approved facility. Based on the removal of impacted soils and restoration of the site, SESI on behalf of Devon Energy Production, respectfully requests closure of the regulatory file for this incident.

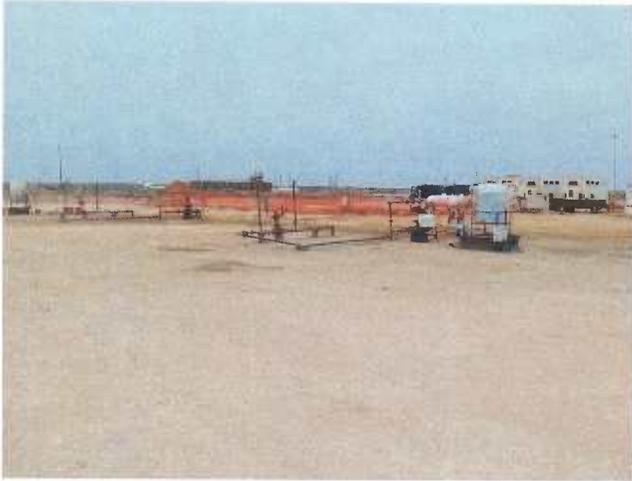
Site photo looking northwest to wells and excavation

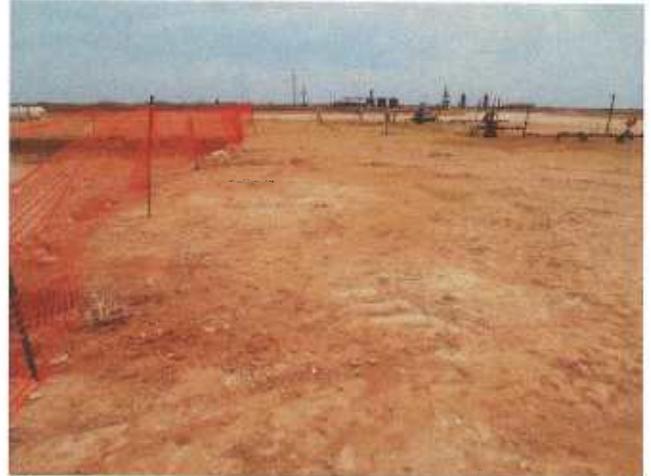
Southwest corner of excavation looking east to wells

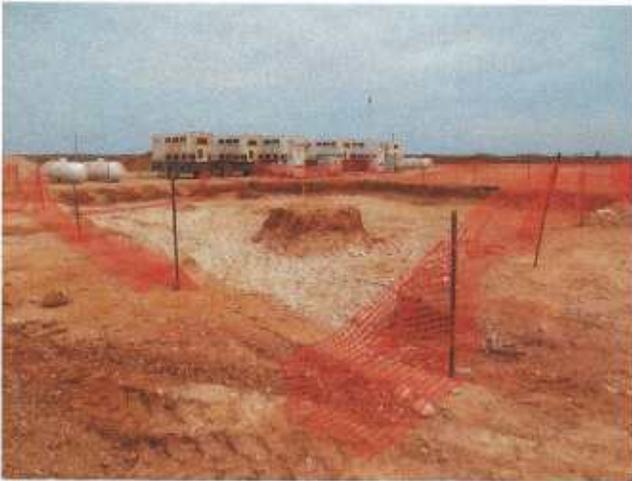
Southwest corner of excavation looking northeast

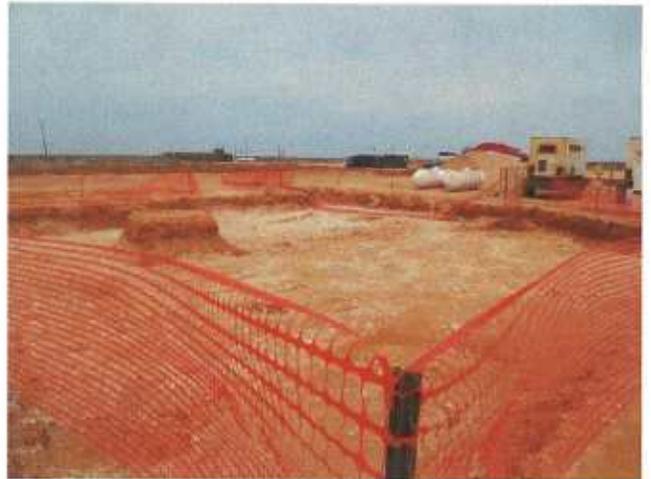
Southeast corner of excavation looking northwest

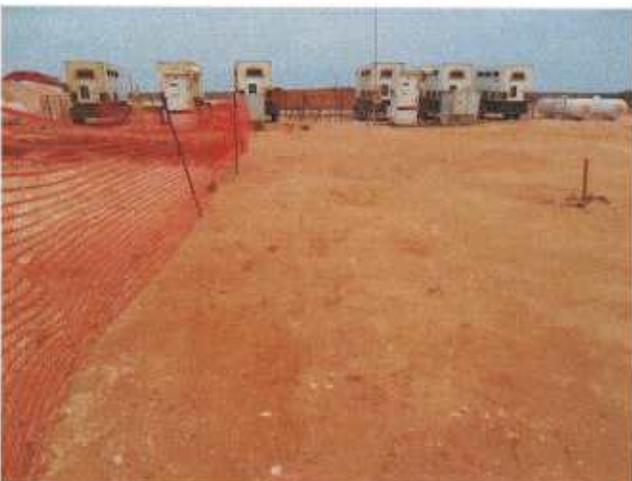
Southeast corner of excavation looking north

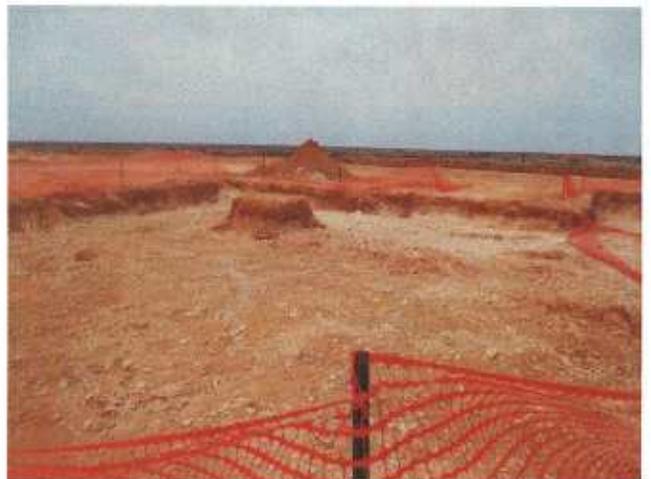
Northeast corner of excavation looking southwest

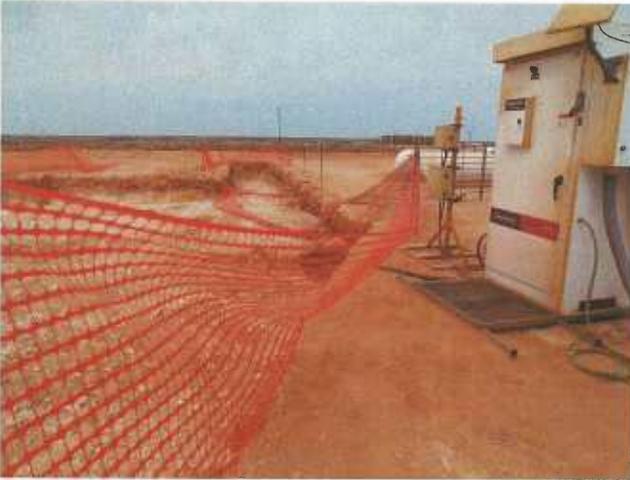
Northeast corner of excavation looking west

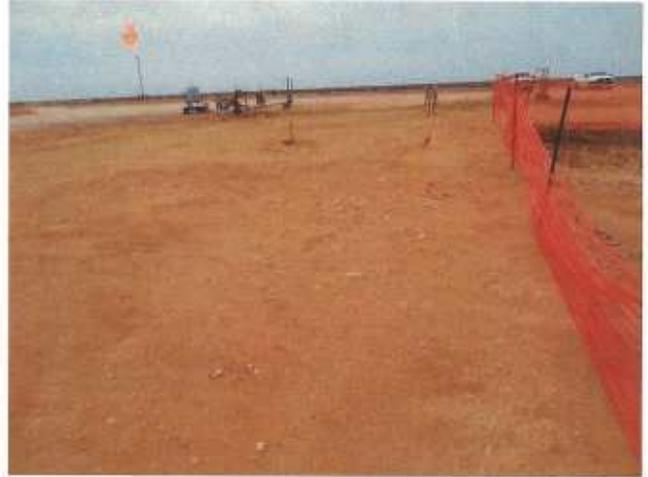
Northeast corner of excavation looking south to wells

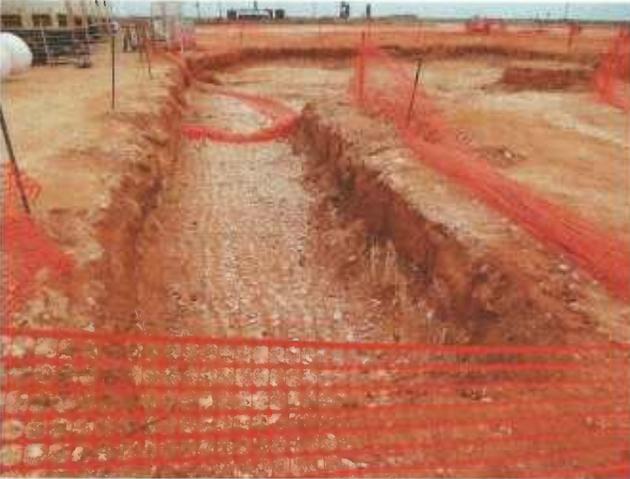
Northwest excavation extension looking east

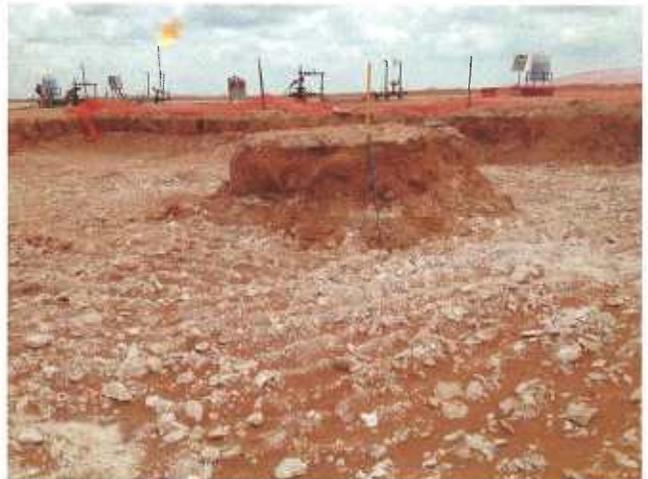
Interior of excavation looking southeast

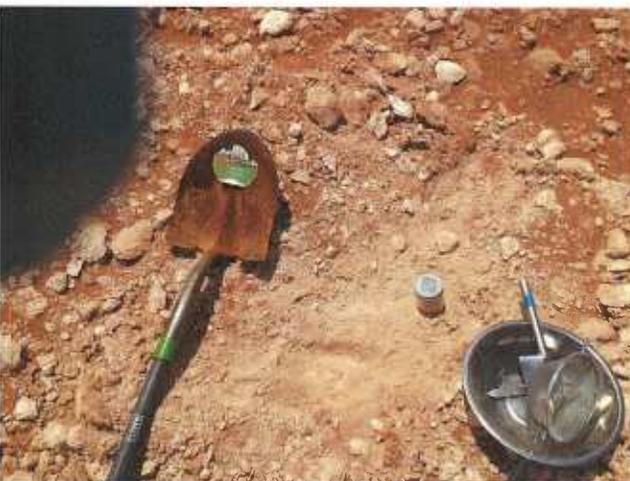
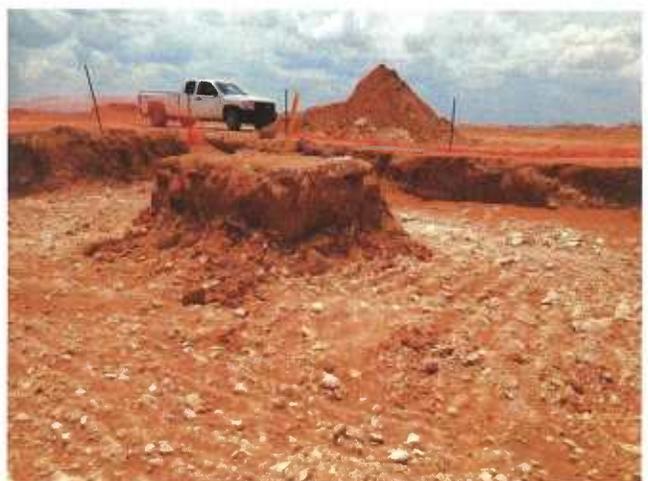
SP-12. Sample from approximate center of excavation, scrapings from bottom in hard caliche. Right photo looking southwest from approximate center of excavation.

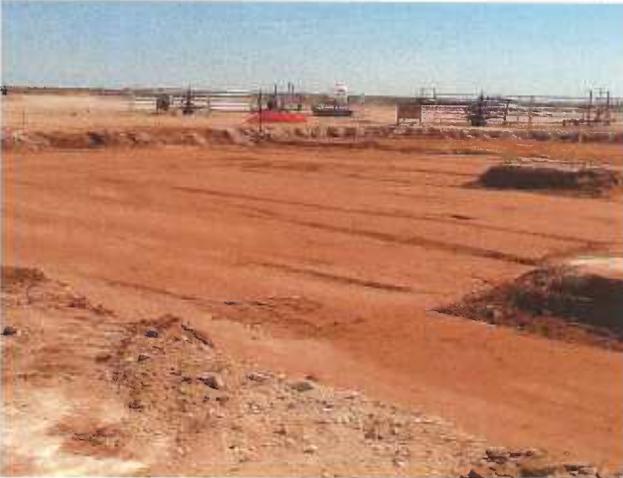
10-08-15 Excavation looking South

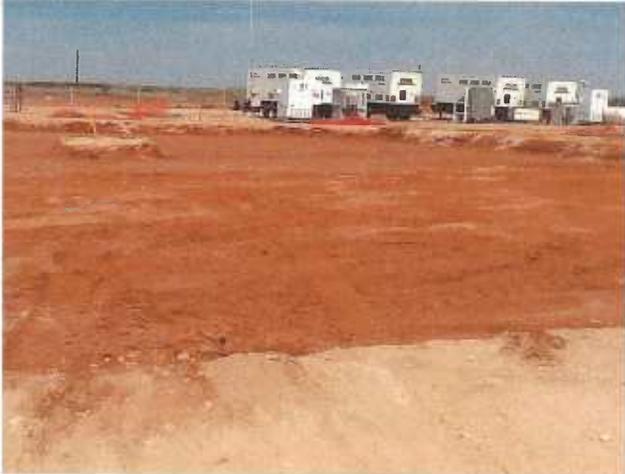
Excavation looking Northeast

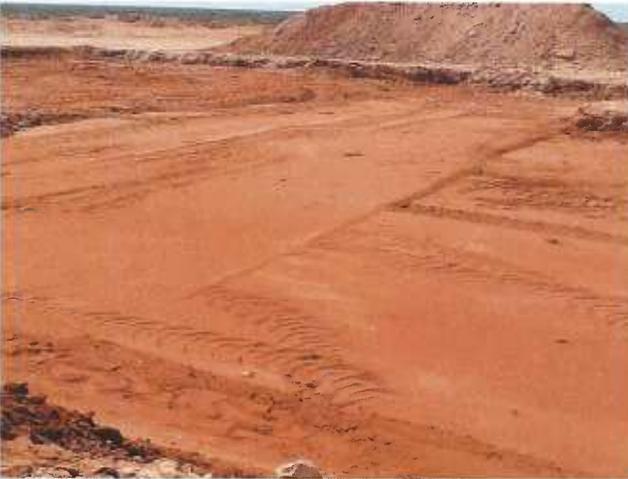
10-08-15 Stockpile of Backfill

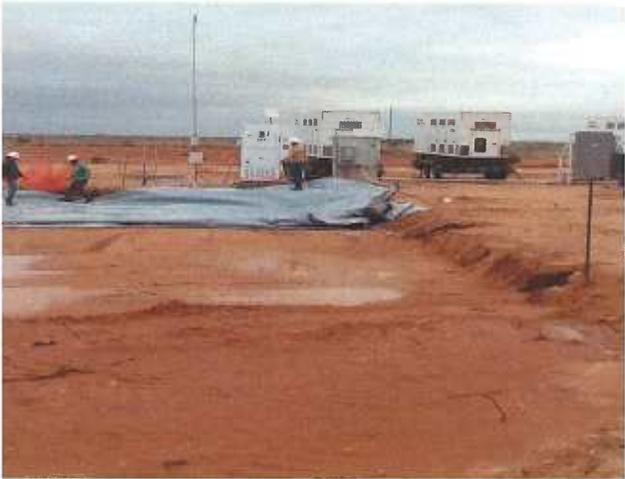
Liner Installation

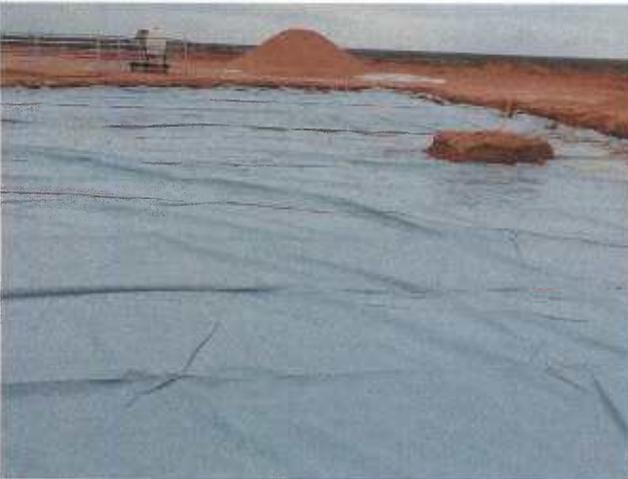
Liner Installation looking South

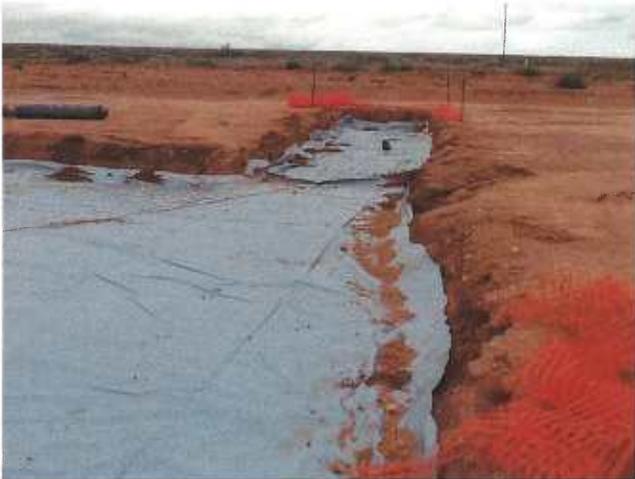
Liner Installation Northwest

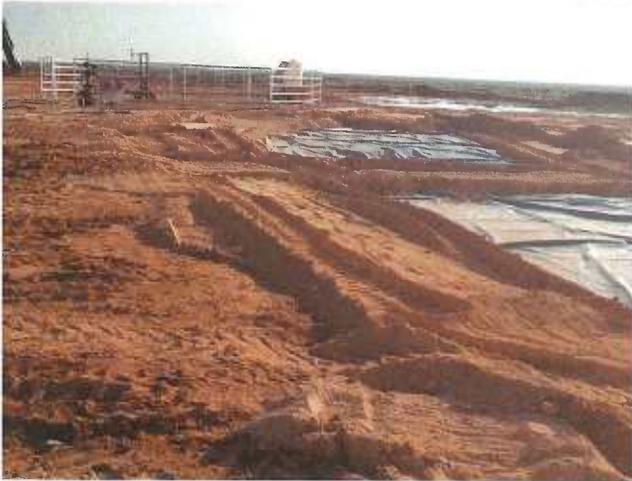
Liner Installation around Electrical Conduit

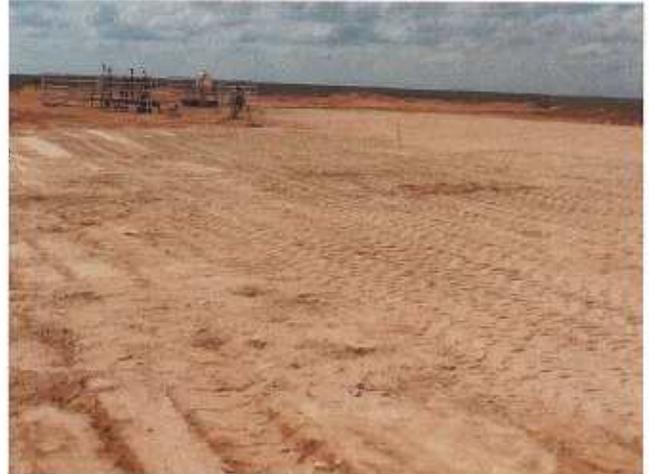
Site at Completion looking South

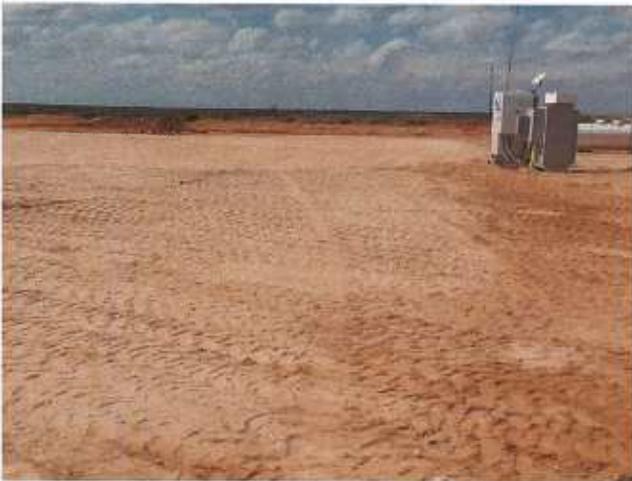
Site at completion

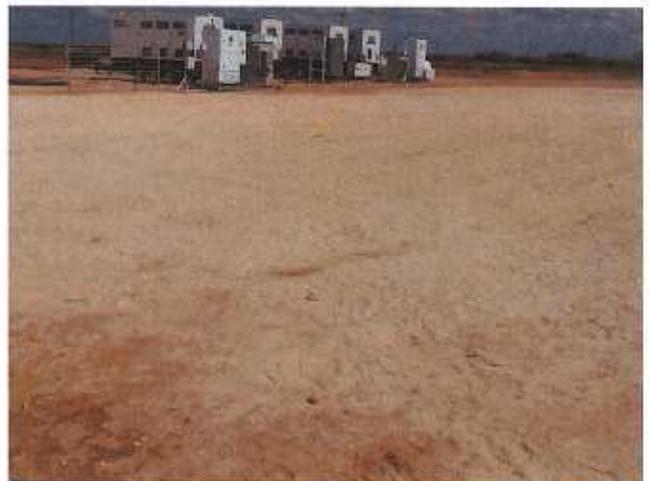
Northeast at Completion

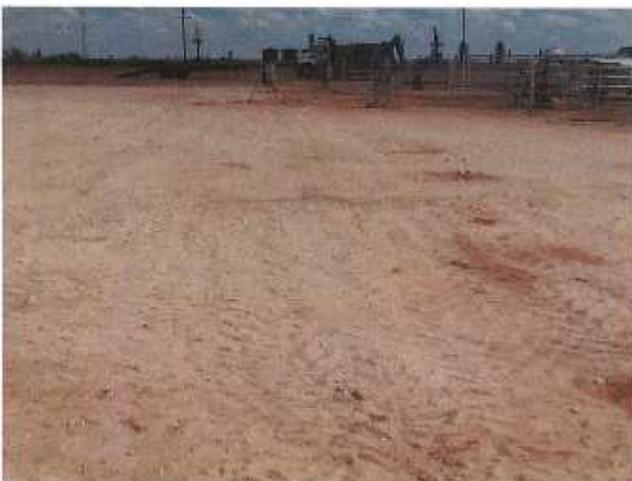
Southern part of excavation at completion

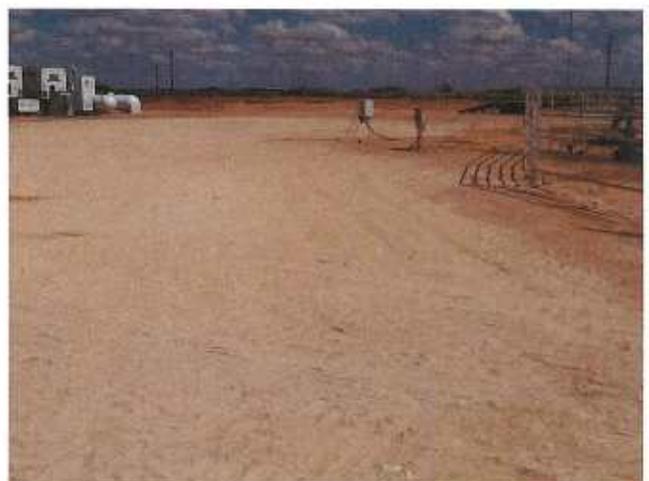
Site Completion looking East
