**Re: BKU Central Tank Battery SWD
Sec. 24, T17S-R29E
Eddy County, NM**

COG Operating LLC would like to submit for your consideration the enclosed work plan for the above captioned well. The plan is in response to the C-141 Initial report dated August 20, 2015.

BKU Central Tank Battery SWD

Sec. 24, T17S-R29E

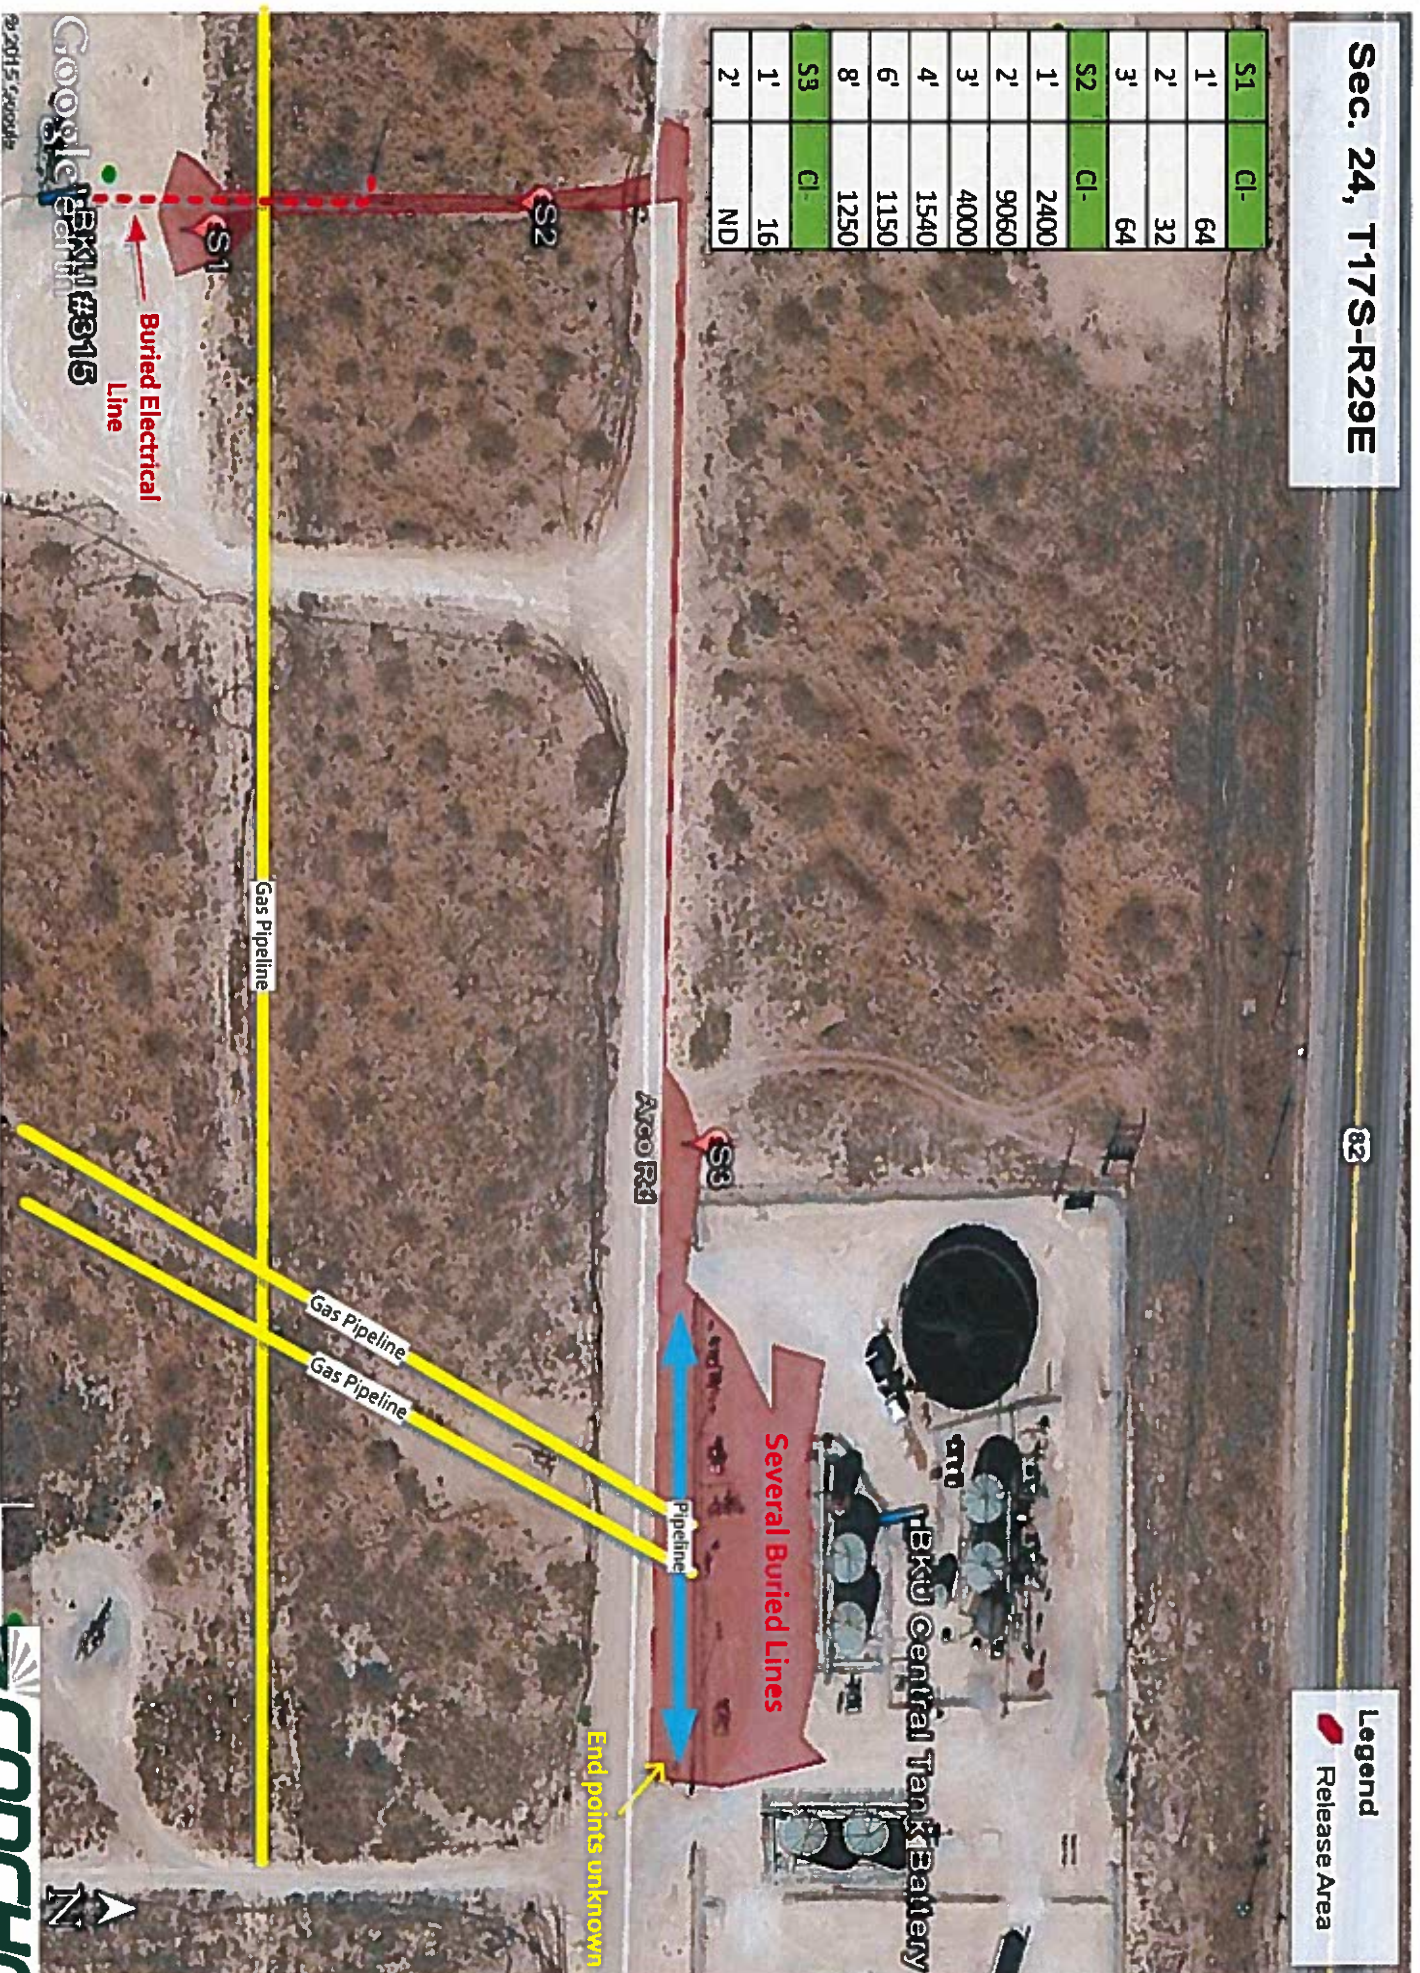
The release was due to an alarm failure causing the tanks to overflow resulting in the release of 20 barrels of oil and 580 barrels of produced water. The majority of the fluid released was contained within the lined facility of which 10 barrels of oil and 560 barrels of produced water were recovered. The produced water that overflowed the containment impacted the pad, the northside of the lease road, a two track road that ran across a nearby pasture, and a portion of the pad associated with the BKU #315. The attached diagram depicts the area impacted along with approximate sample points.

S1	Cl-
1'	64
2'	32
3'	64
S2	Cl-
1'	2400
2'	9060
3'	4000
4'	1540
6'	1150
8'	1250
S3	Cl-
1'	16
2'	ND

Legend
Release Area

COG Operating LLC proposes that the no excavation be required for the impacted area on the lease road and the pad due to the associated safety hazards with buried electrical lines, gas pipelines, and produced water lines. These hazards pose a high safety concern with respect to sampling and excavation. At a site ranking of Zero, any chlorides found on this location from this release or historic releases pose no threat to ground water. The area labeled as S2 would be excavated no greater than a depth of 3' and field titrations will be used to further delineate the area. The area associated with the pipeline right of way (between S1 & S2) would be treated as a minor scrape and any work perform in this area will be done under the supervision of a representative for the respective pipeline. The area labeled as S3 should require no further excavation. An initial scrape was performed in this area upon discovery of the release.
