### Report Type: Work Plan

| Site: | Loco Hills SWD 35 #001 | | | | | |

**Re: Work Plan for the COG Operating LLC., Loco Hills SWD 35 #1, Unit F, Section 36, Township 17 South, Range 30 East, Eddy County, New Mexico.**

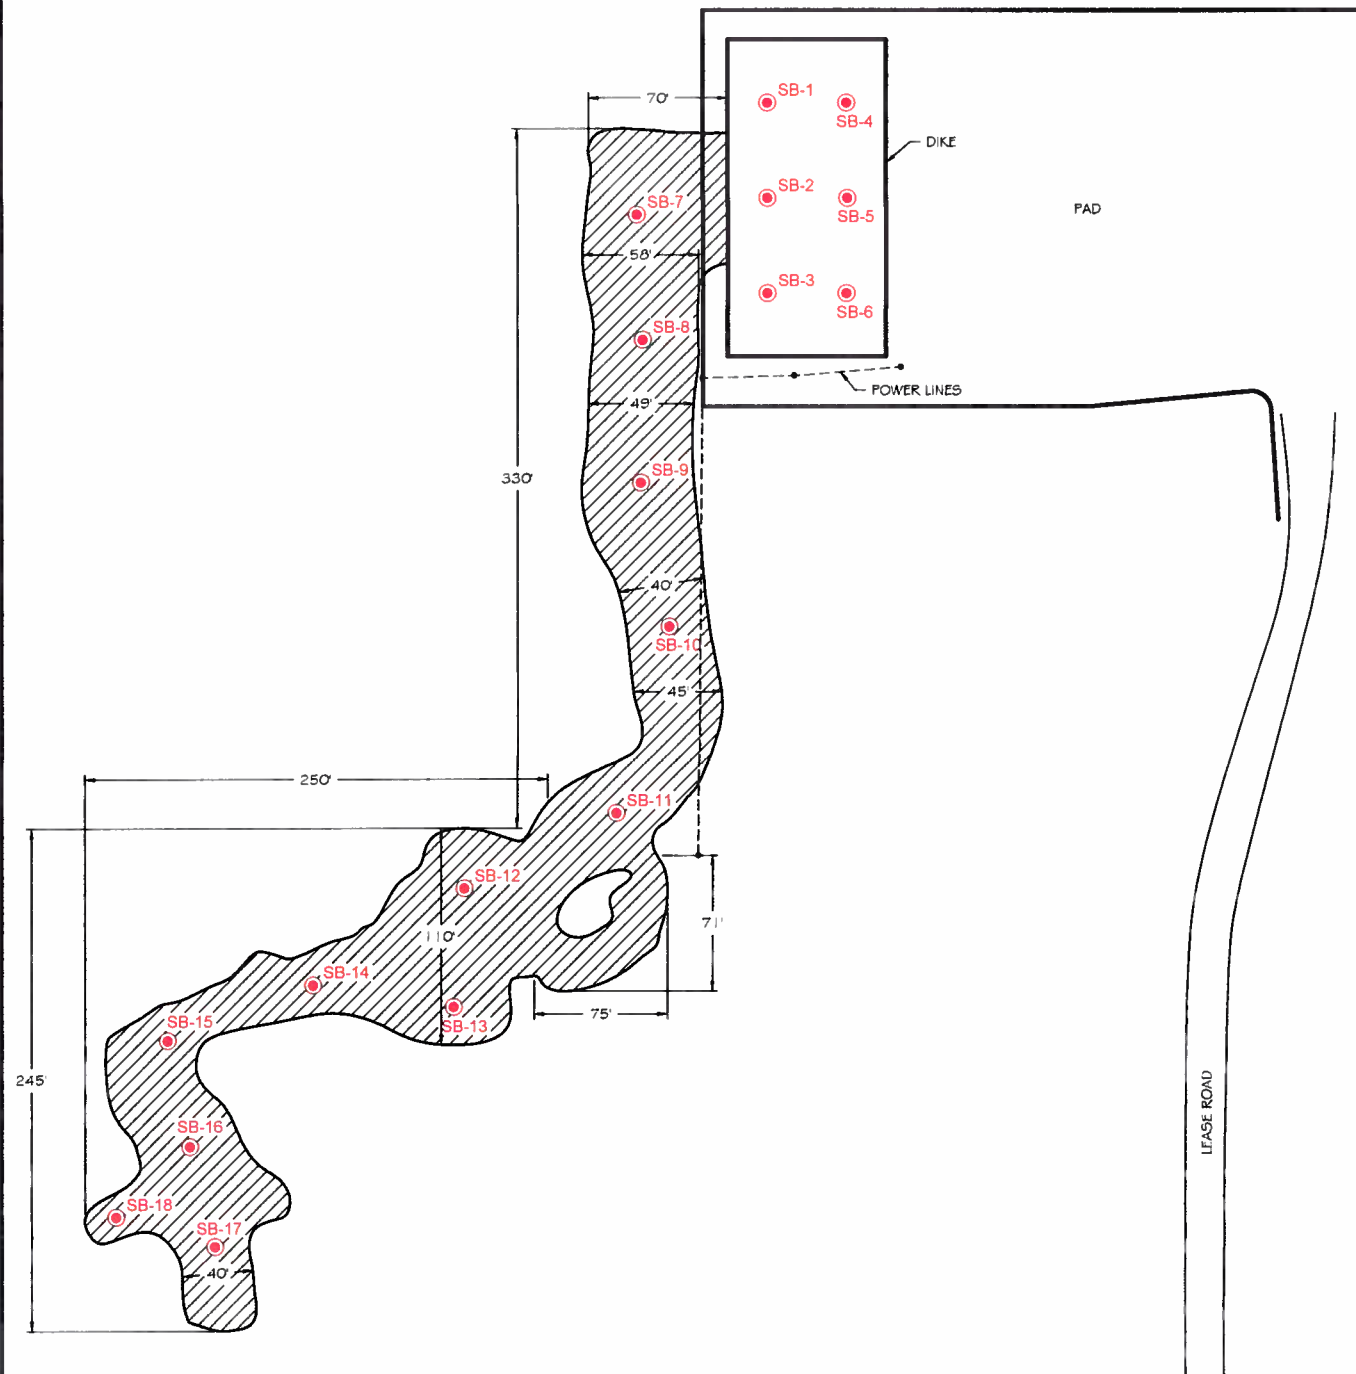
Figure 3

- SAMPLE BORING HOLE LOCATIONS
- SPILL AREA

Spill Assessment Map

On August 24 through 26, 2013, Tetra Tech supervised the installation of eighteen (18) soil borings (SB-1 through SB-18) using an air rotary drilling rig to assess the soils. The soil bores were installed in the spill area on the pad and in the pasture to define the vertical extents. Selected samples were analyzed for TPH analysis by EPA method 8015 modified, BTEX by EPA Method 8021B and chloride by EPA method 300.0. Copies of the laboratory analysis chain-of-custody documentation are included in Appendix C. The soil boring results are summarized in Table 1 and shown on Figure 3.

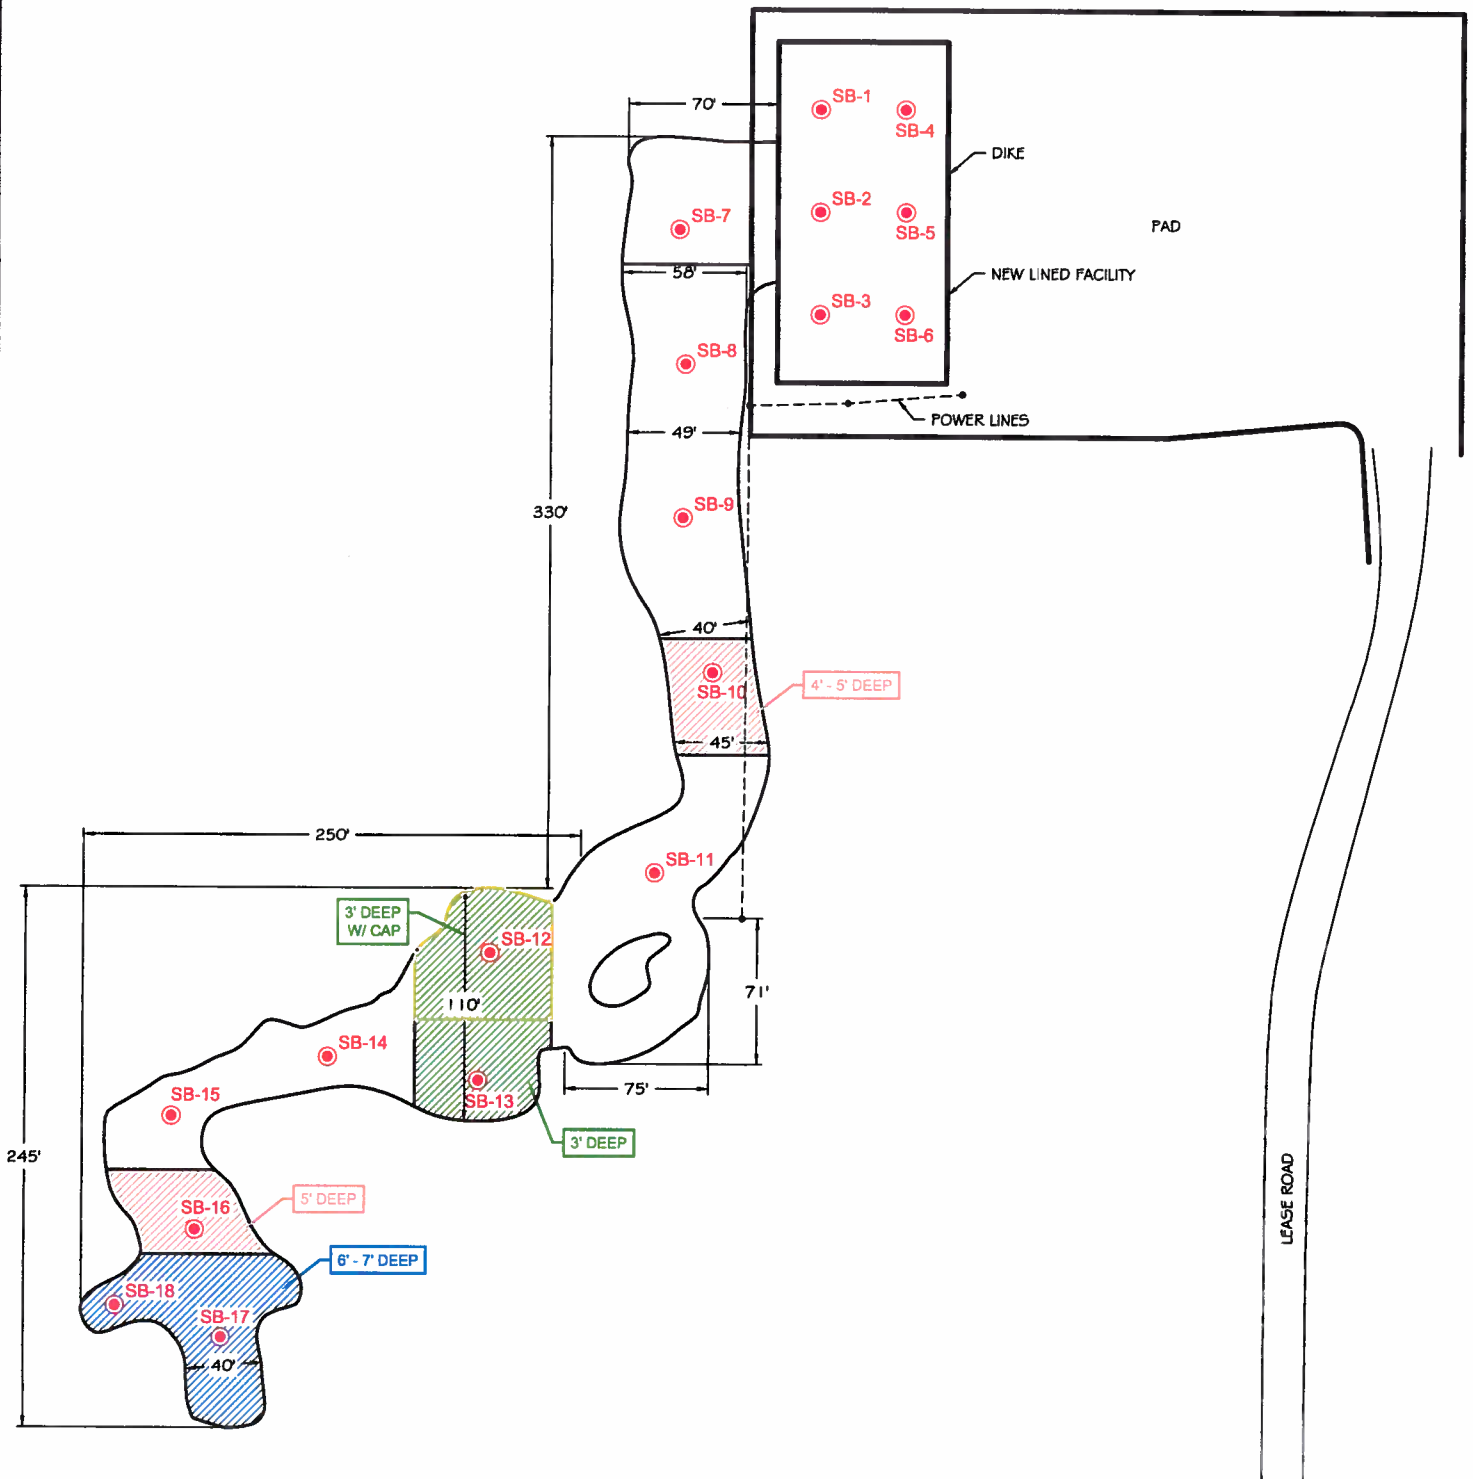
Figure 4

- SAMPLE BORING HOLE LOCATIONS
- CAPPED AREAS
- PROPOSED EXCAVATION AREAS

Proposed Excavation Areas & Depths Map

COG proposes to remove the impacted material as highlighted (green) in Table 1 and shown on Figure 4. After the sampling was performed, COG constructed a new facility in the same area. The new SWD is a lined facility and

In the pasture, the areas of SB-10, SB-12, SB-13, SB-16, SB-17 and SB-18 will be excavated to a depth of 4.0' to 7.0' below surface. Once excavated to the appropriate depth, the area of SB-12 will be capped with a 40 mil liner to cap the remaining impact. All of the remaining excavated soil will be transported to proper disposal.

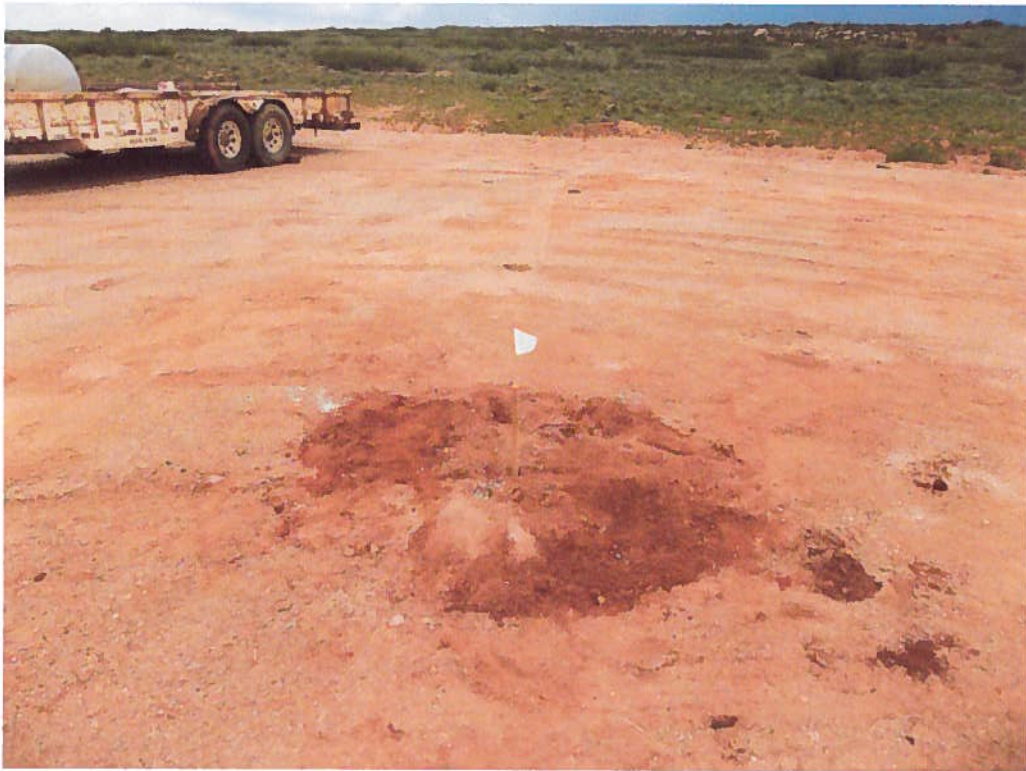
View East – Area of SB-1

Referring to Table 1, none of the samples exceeded the RRAL for TPH or BTEX. The soil borings on the pad (SB-1 through SB-6) showed a shallow chloride impact to the soils and were vertically defined at approximately 4-5' to 9-10' below surface. Soil boring (SB-1) did show a chloride spike at 9-10' to 19-20', but declined to 197 mg/kg at 24-25' below surface. After the sampling was performed, COG has constructed a new lined facility, which encompassed the areas of SB-1 through SB-6.

encompassed the areas of SB-1 through SB-6 on the pad. The impacted soil on the pad will be deferred until the abandonment of the facility.

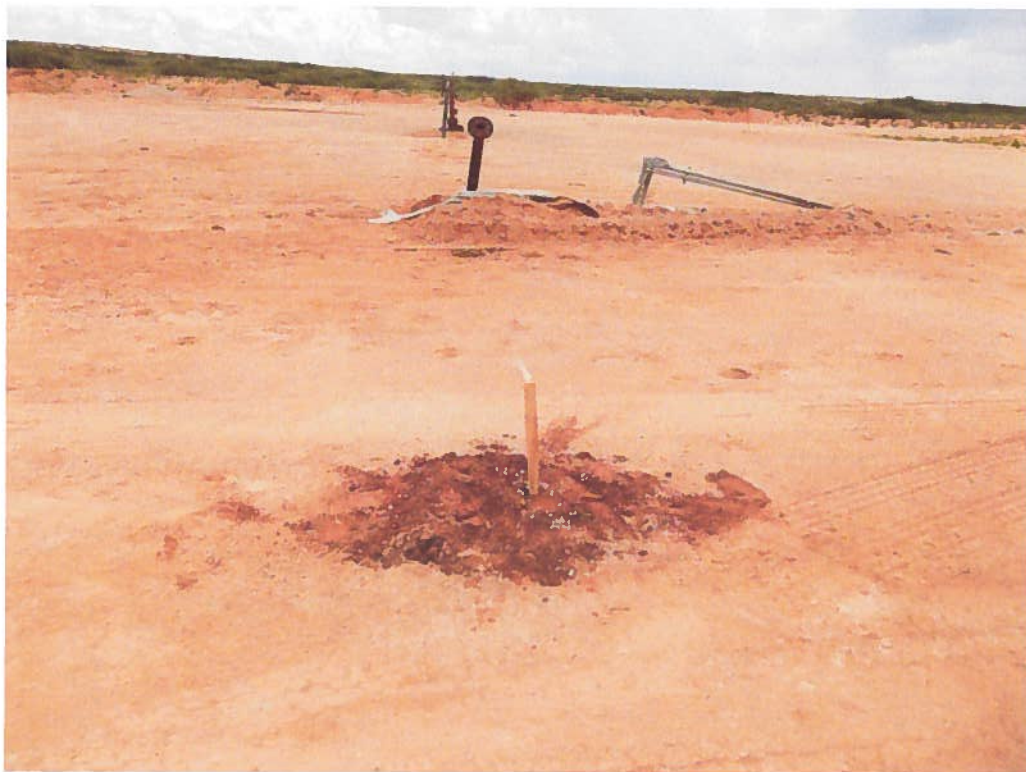
View South – Area of SB-5

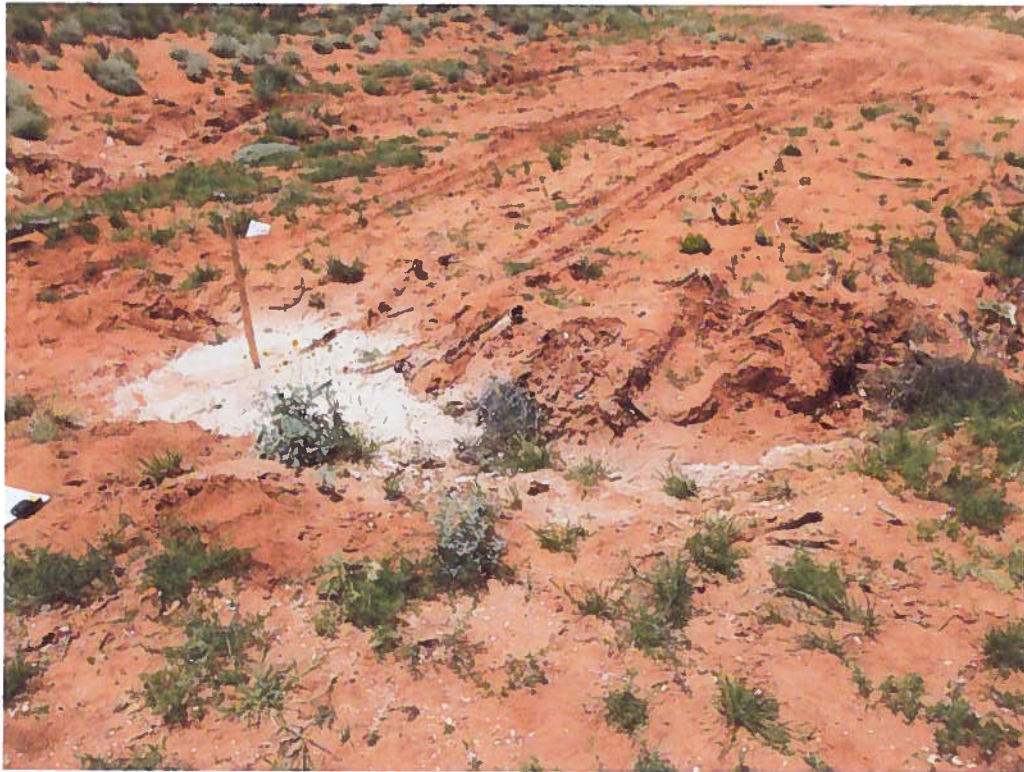
In the pasture, the soil borings (SB-7, SB-9 and SB-11) did not show a significant chloride impact to the soils. The areas of SB-8, SB-14 and SB-15 did not show a significant impact the shallow soil from (0 to 5.0'), but spiked at 6-7' to 9-10' and declined at 14-15' below surface. Based on the groundwater depth, these areas or limited spikes do not appear to an environmental concern.

View South – Area of SB-11

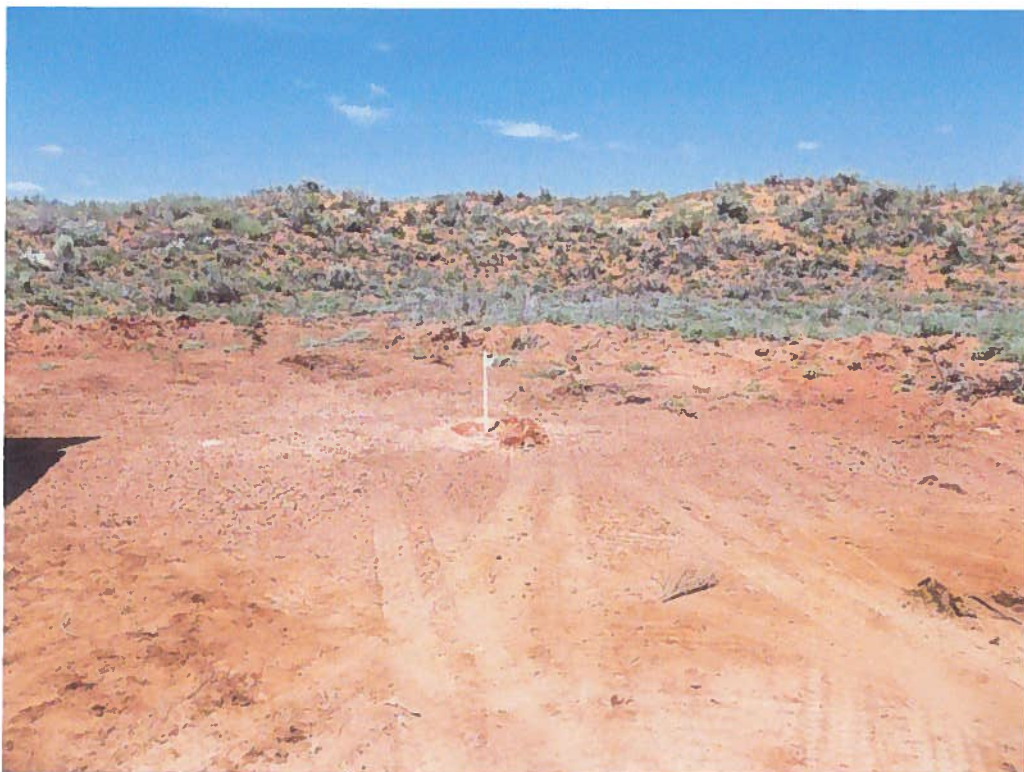
The areas of SB-10, SB-12, SB-13, SB-16, SB-17 and SB-18 showed elevated chlorides at depths ranging from surface to 3.0' to 10.0' below surface, which all declined with depth and were vertically defined.

View West – Area of SB-18
