CLOSURE REPORT

BOPCO, L.P.
PLU CVX JV PC #012H
Eddy County, New Mexico
Unit Letter "O", Section 16, Township 24 South, Range 30 East
Latitude 32.123948 North, Longitude 103.878668 West
NMOCD Reference #2RP-3430

RE: Final Closure Report
Bopco – PLU CVX JV PC #012H
UL-O, Section 16, Township 24 South, Range 30 East
Eddy County, New Mexico
NMOCD Reference # 2RP 3430

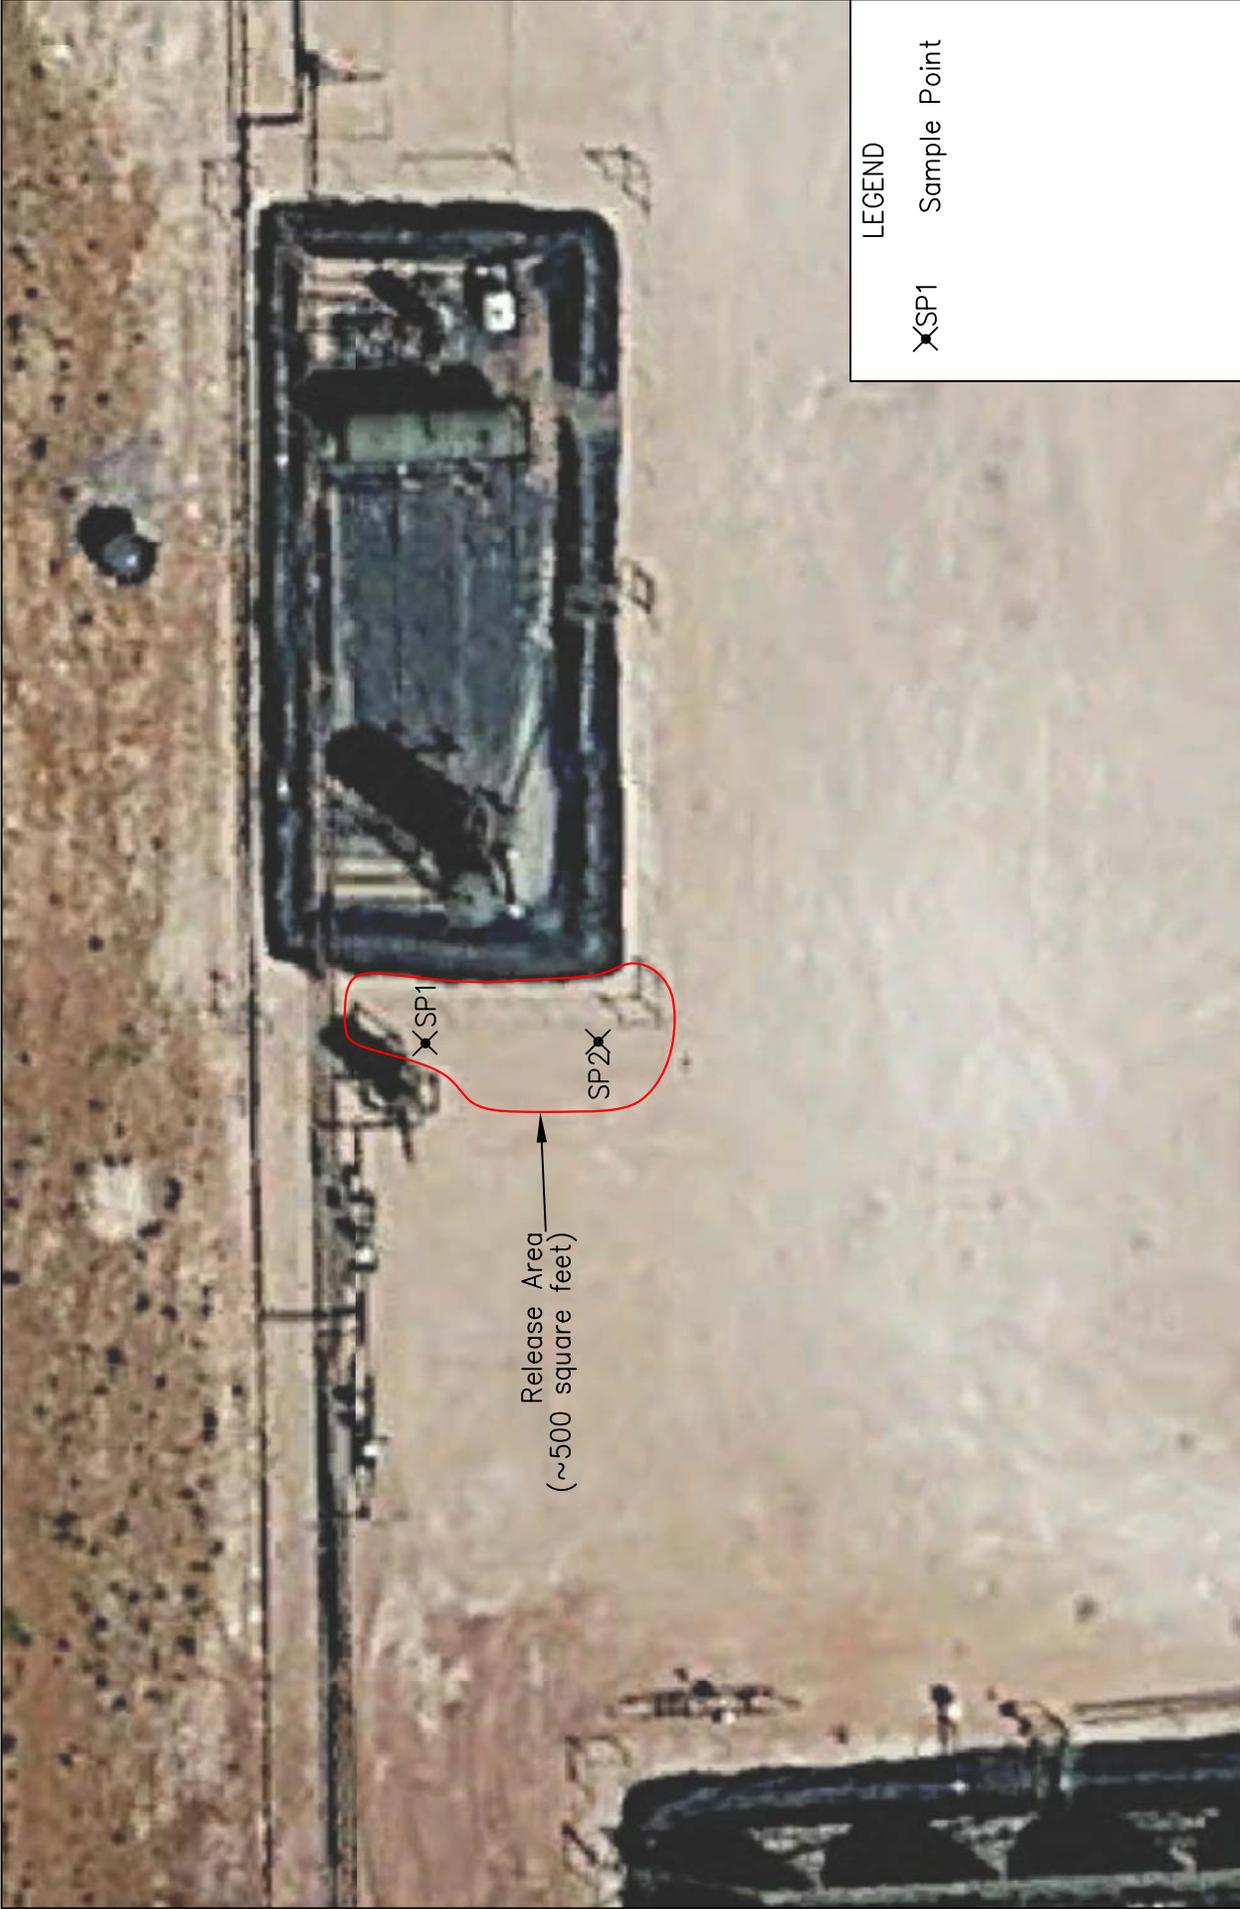
Figure 3
Site/Sample Map
Bopco, L.P.
PLU CVX JV PC #012H

EPI personnel mobilized on the site on December 4, 2015 to collect soil samples to determine the vertical extent of contamination. A total of five (5) soil samples were collected from two (2) sample locations; SP1 and SP2. Four (4) representative samples were sent to Cardinal Labs in Hobbs, New Mexico, for testing. Laboratory analytical results indicate, with the exception of SP1 and SP2 at surface level, the release area is void of Benzene, BTEX, TPH and Chloride concentrations in excess of NMOCD Recommended Remedial Action Levels (RRALs) of 10 mg/Kg, 50 mg/Kg, 5,000 mg/Kg, and 1,000 mg/Kg, respectively (reference *Figure 3* and *Table 2*).

Release Area
(~500 square feet)

The release area was excavated to a depth of approximately six (6) inches bgs. Approximately 8 tons of contaminated soil were excavated and hauled to a state approved facility for disposal.

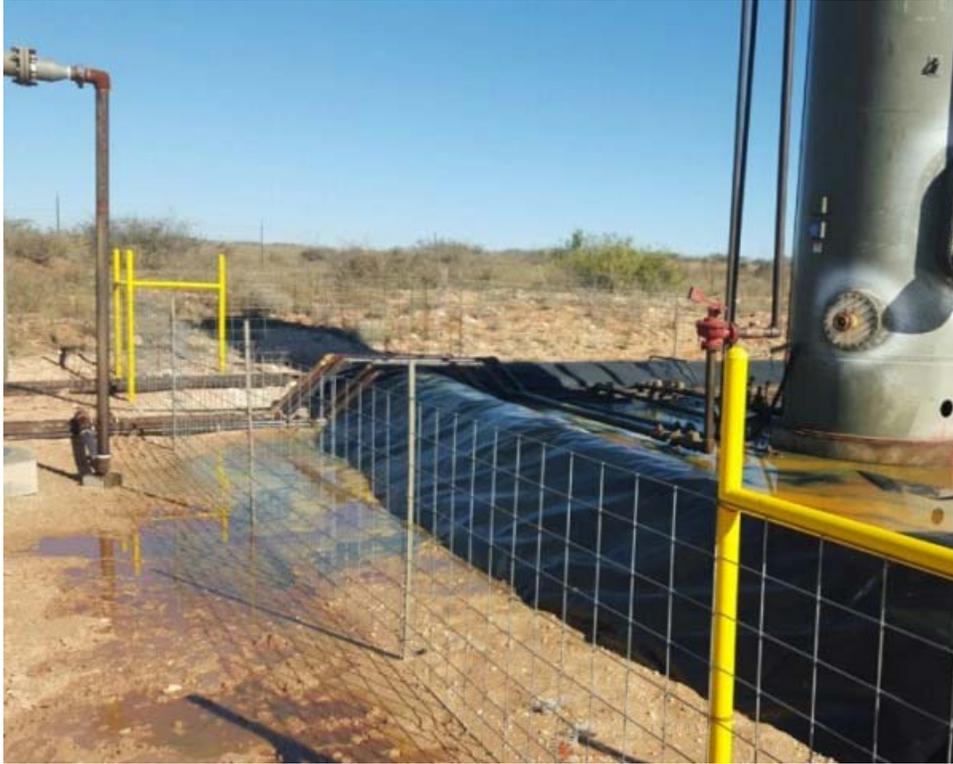
Photograph #1 – Looking across release area

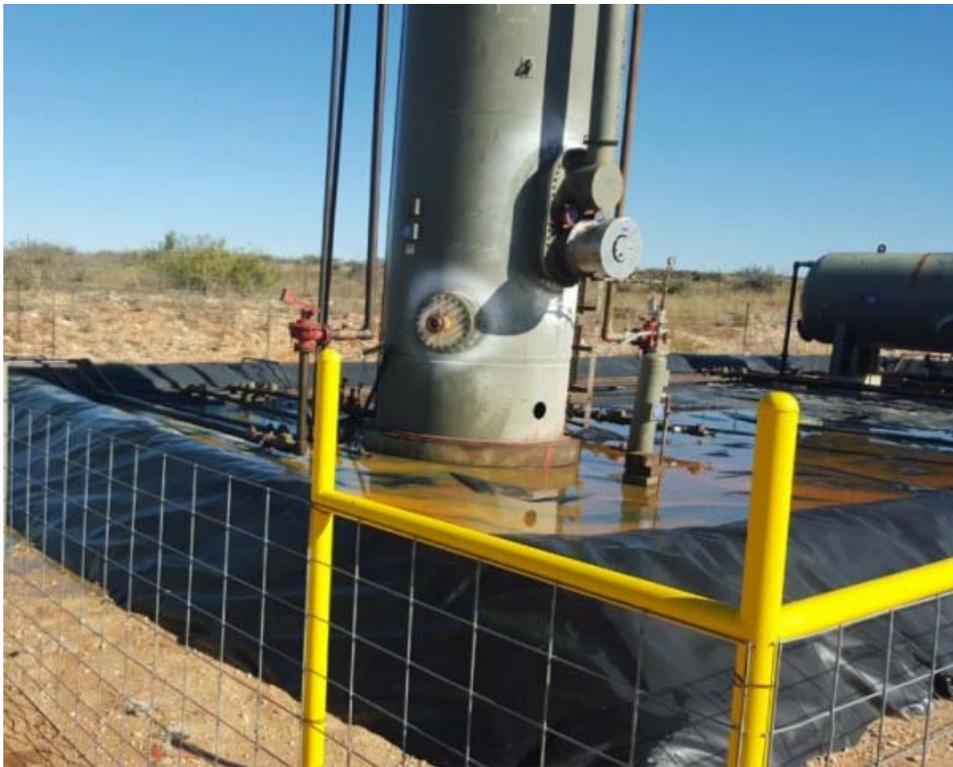
Photograph #2 – Looking across release area

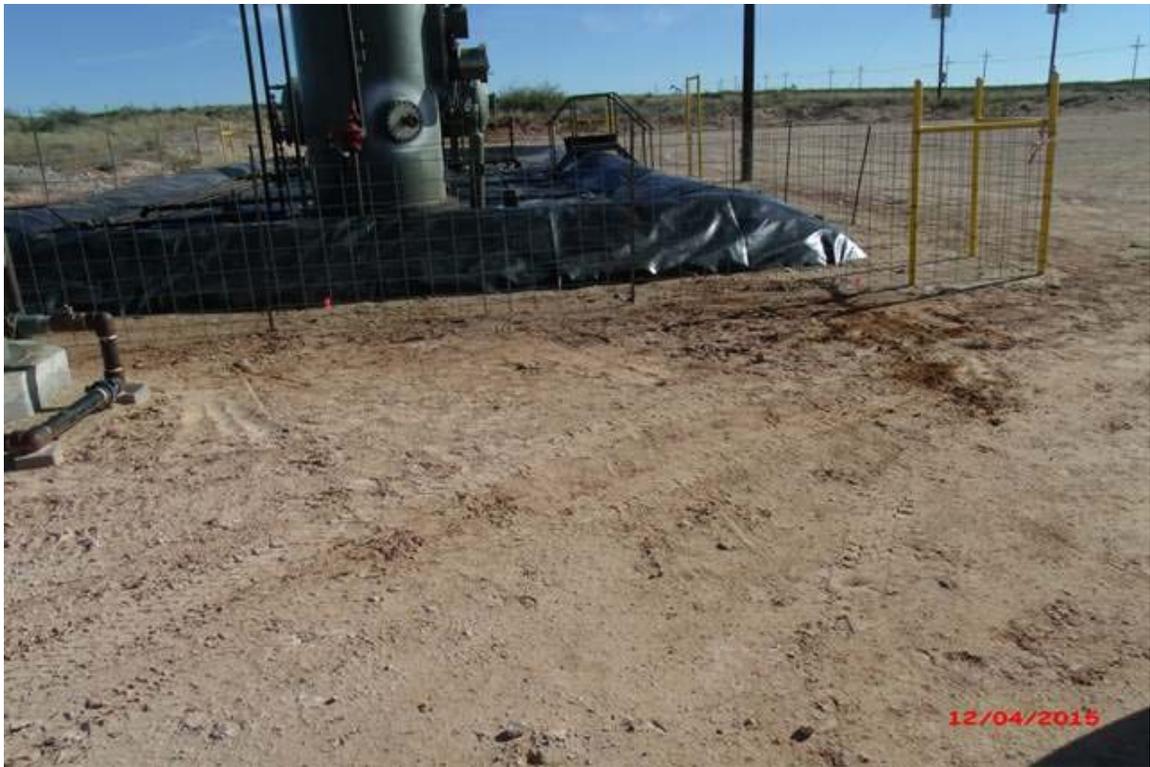
Photograph #3 – Looking across release area

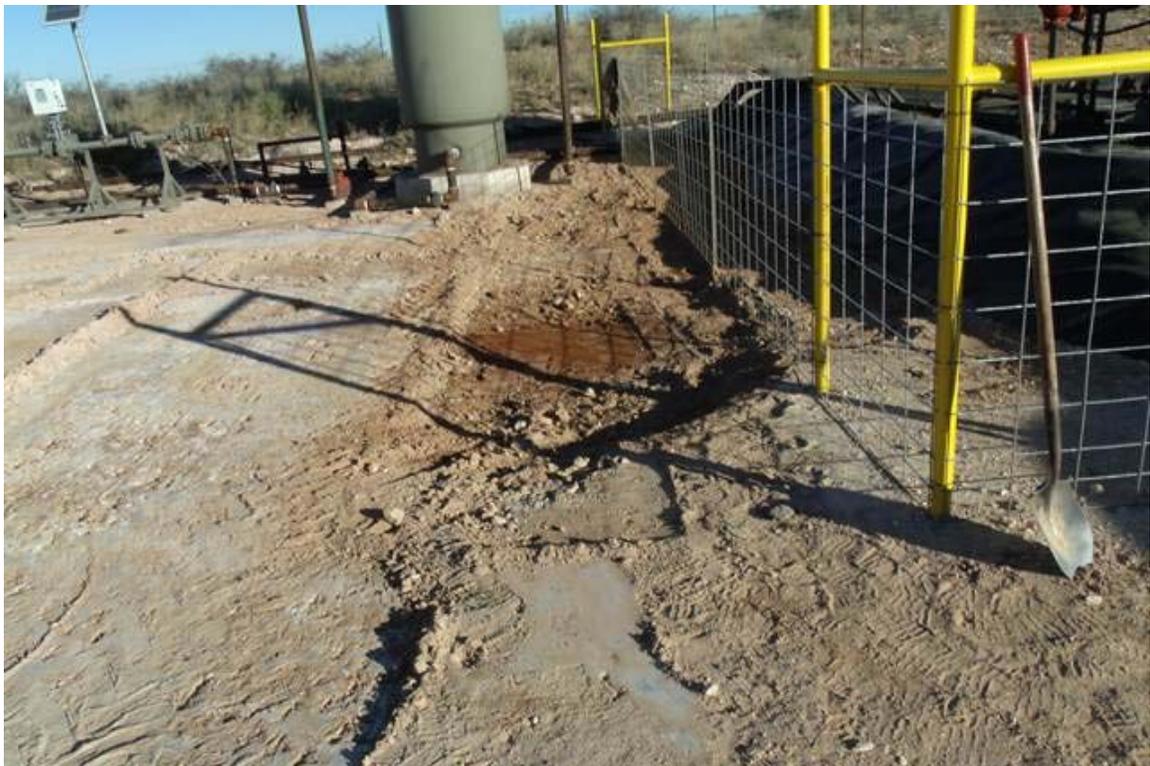
Photograph #4 – Excavated area

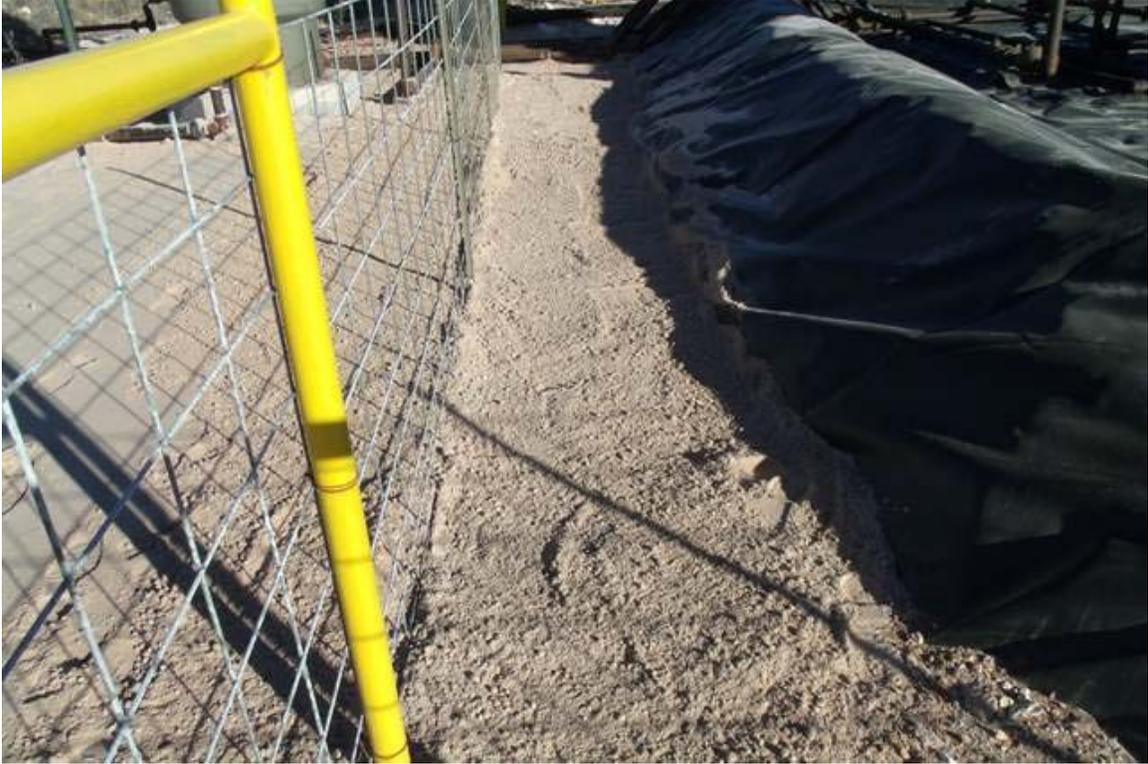
Photograph #5 – Backfilled

Based on laboratory analytical results and with NMOCD approval, the excavation was backfilled with approximately 8 tons of clean soil. All soil was free of rocks, clumps or deleterious material. The entire disturbed area was then contoured to blend with existing well pad area and protected against wind/water erosion.

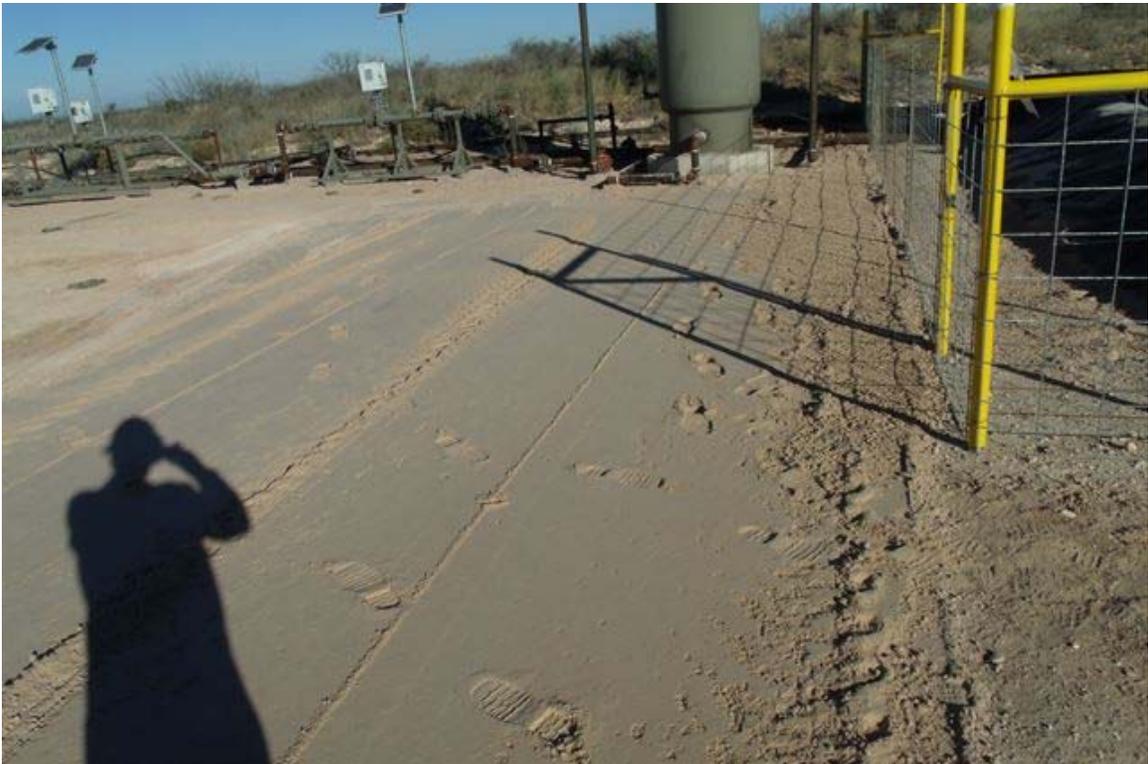
Photograph #6 – Backfilled
